Reliable Home Inspection Service
100 Old Kennett Rd
Wilmington, DE 19807
302-993-9100
<https://www.reliablehomeinspectionsservice.com/>

Inspected By:
Francis Glynn H4-0000078 ASHI #253366 MD# 33646

Inspection Summary

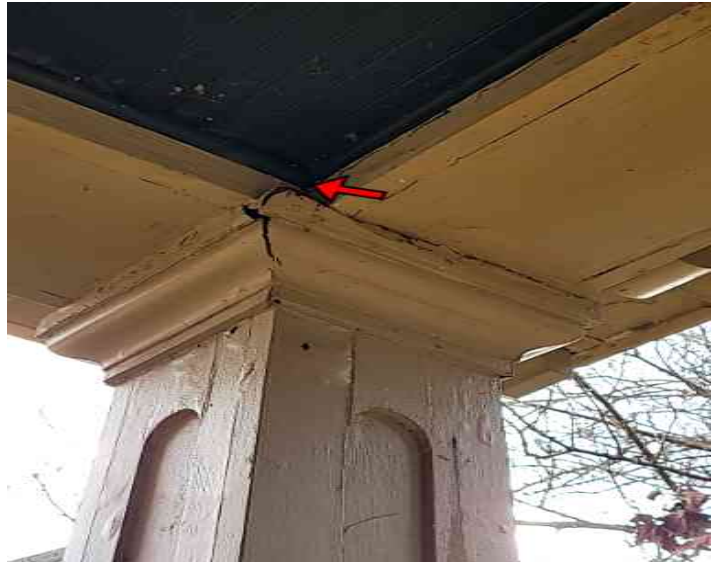
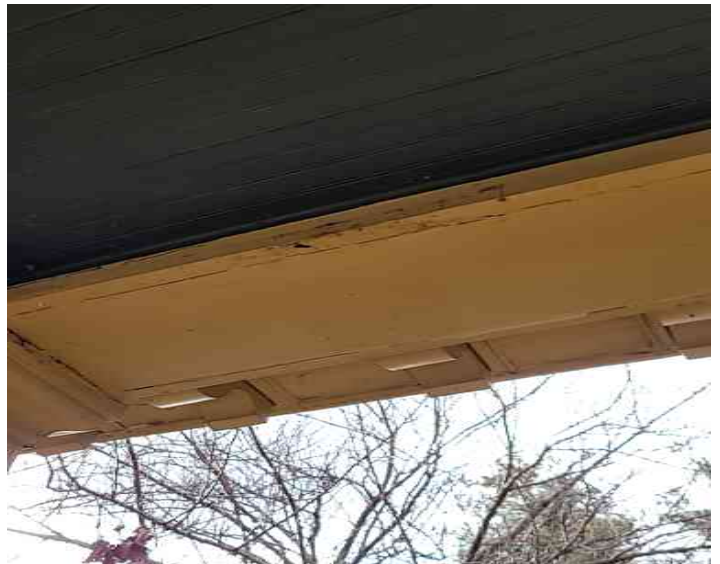
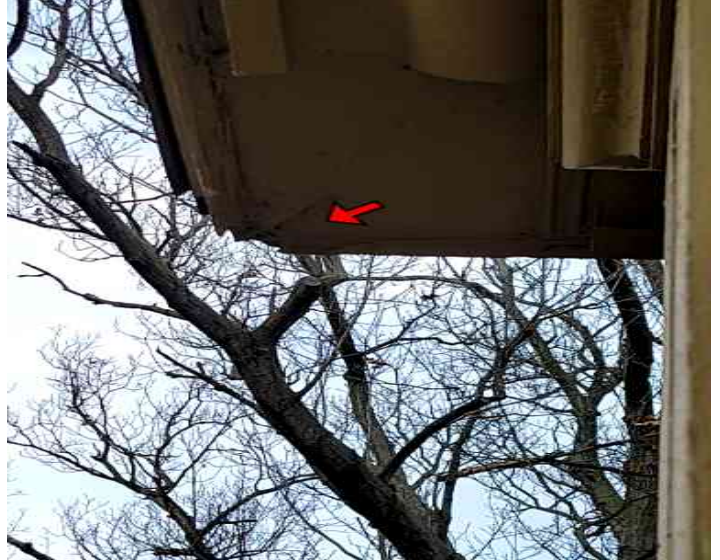
0206: Porches

Some loose paint and rot noted.

Evidence of on going leaking was noted at the front right corner of the front porch. The entire porch system should be evaluated and all needed repairs should be made.

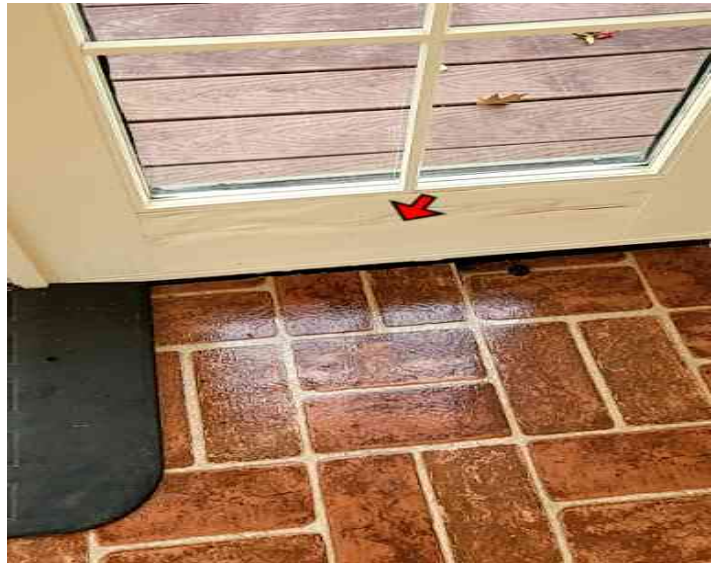
0313: Patio Doors

Rotted fixed door at the right side and should be evaluated and repaired.
The door sticks to open.

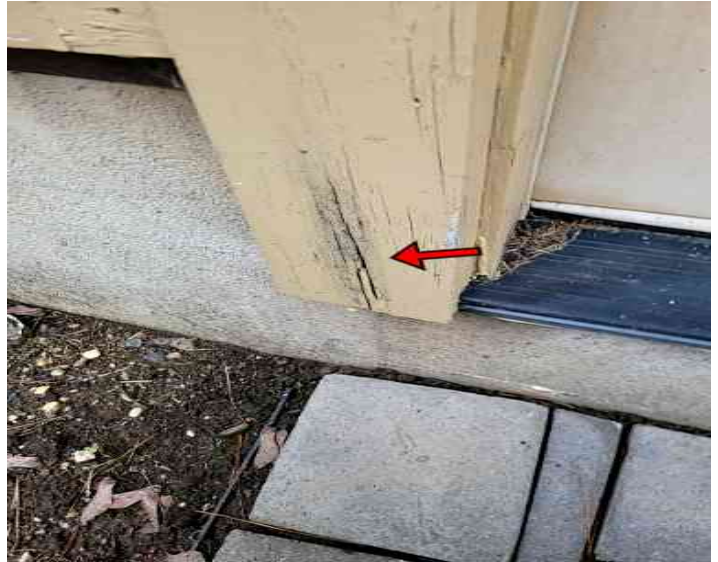
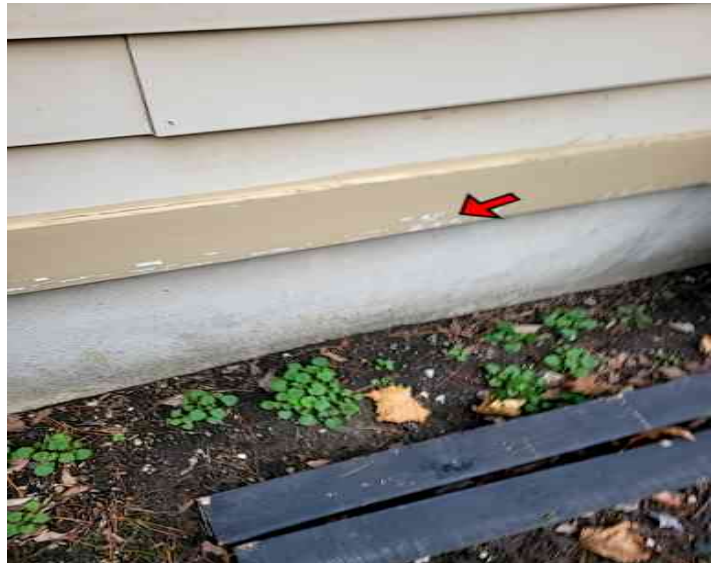
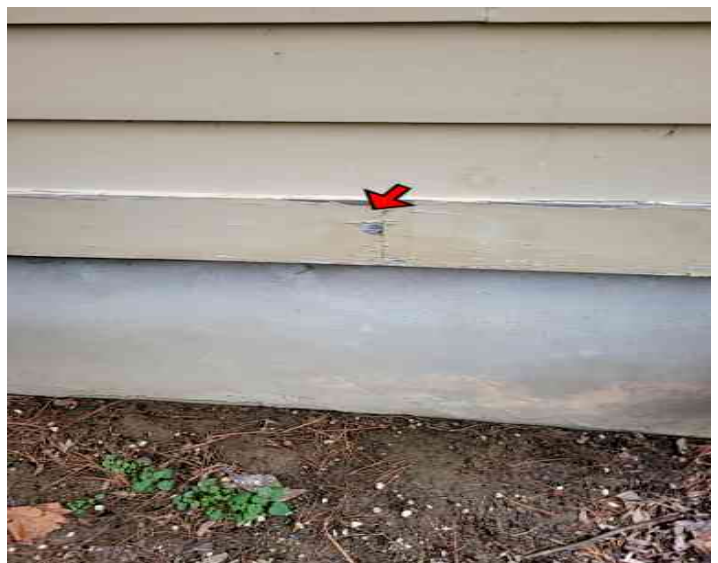
0803: Garage Exterior Walls

Rotted areas were noted.

All exterior wood should be evaluated and all needed repairs should be made.

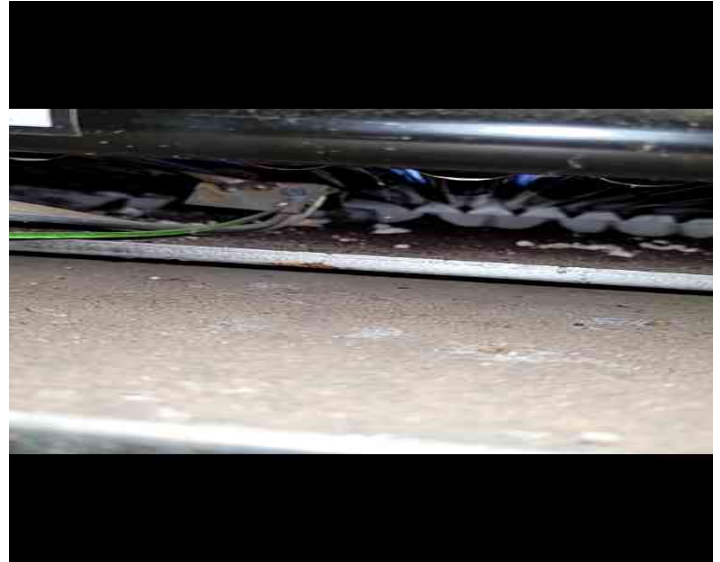
It appears the unit is short cycling at the time of inspection and the entire system should be evaluated and repaired.

Unit should be cleaned and serviced.

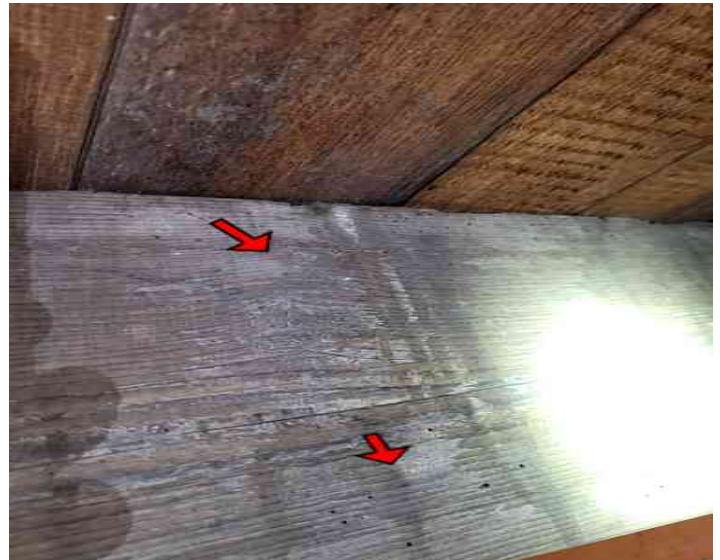
1511: Basement Ceiling Joist Visible Primary Type

Wood boring insect damage was evident. It should be evaluated by a qualified pest control contractor and a structural engineer to determine extend of damage and make any repairs or treatments as required.

Some mold/mildew was noted and should be cleaned by qualified personnel. As mold and mildew are not part of the home inspection the client may decide to do further evaluation to determine the extent of the problem and cost of cleanup/repair.

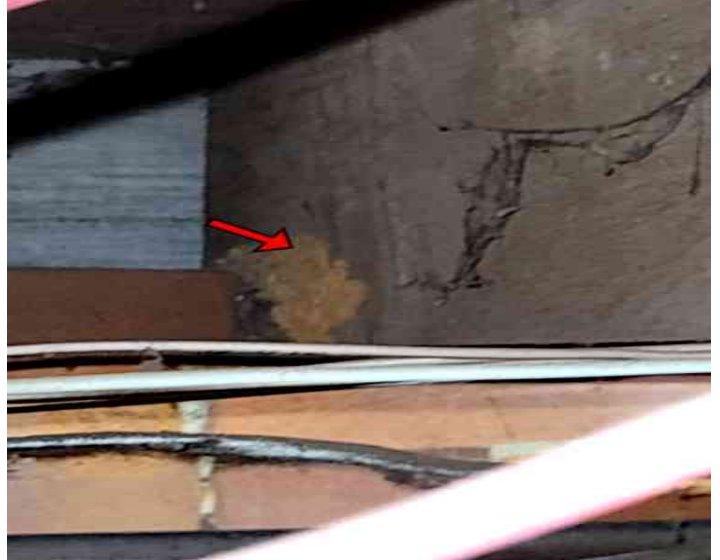
1609: Crawl Space Ceiling Joist

Termite tubes and some termite damage were noted and should be evaluated by structural contractor or engineer and all needed repairs should be made. Some mold/mildew was noted in the crawl space and should be evaluated and cleaned by qualified personnel. As mold and mildew are not part of the home inspection the client may decide to do further evaluation to determine the extent of the problem and cost to cleanup/repair. Wood boring insect damage was evident. It should be evaluated by a qualified pest control contractor and a structural engineer to determine extend of damage and make any repairs or treatments as required.

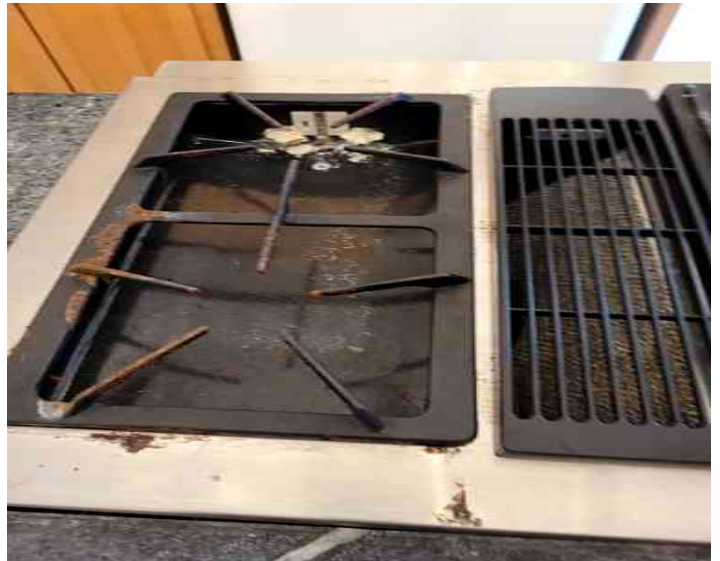
1719: Surface Cooktop

Stove was not not tested due to breaker being off. It appears the unit is not functional due to corrosion. Burns have been removed. The built in vent system vents into the basement and should be to the exterior.

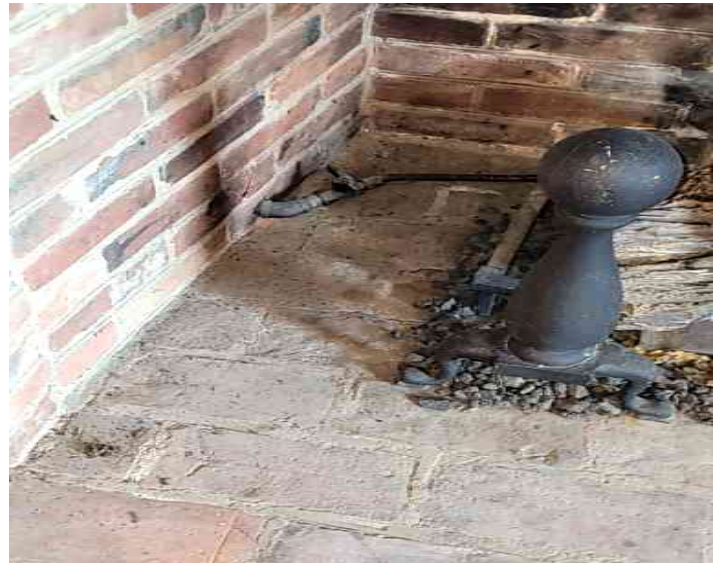
2113: Interior Fire Place 1

Gas valve was off and the fireplace was not tested. Operation should be demonstrated before settlement. All fireplaces.

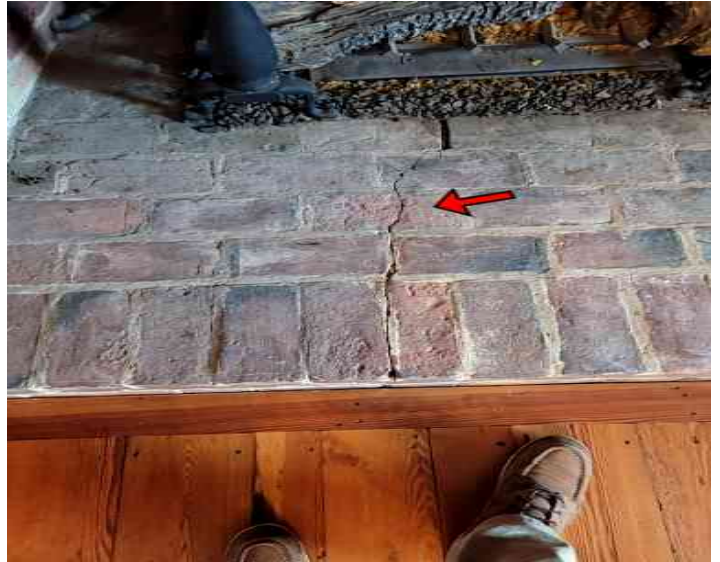
Cracks at the hearth was noted.

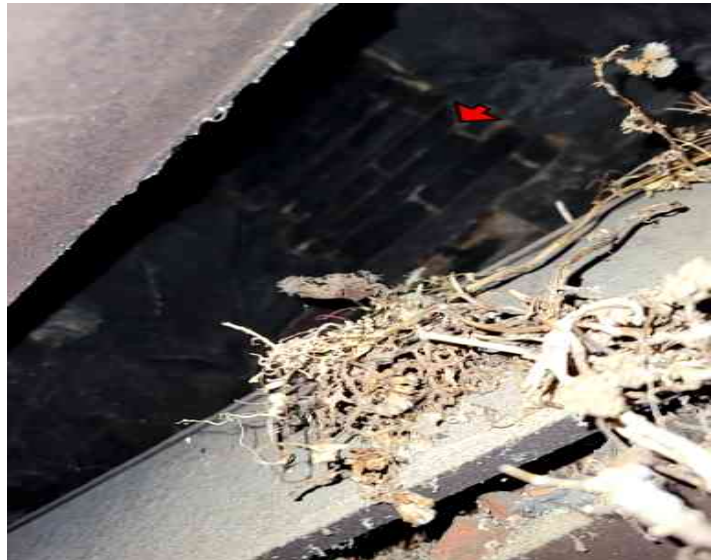
2114: Interior Fire Place 2

Cracks and missing areas of parging was noted at the front left room and the chimney system should be evaluated and all needed repairs should be made. Damper is damaged and would not close and should be repaired.

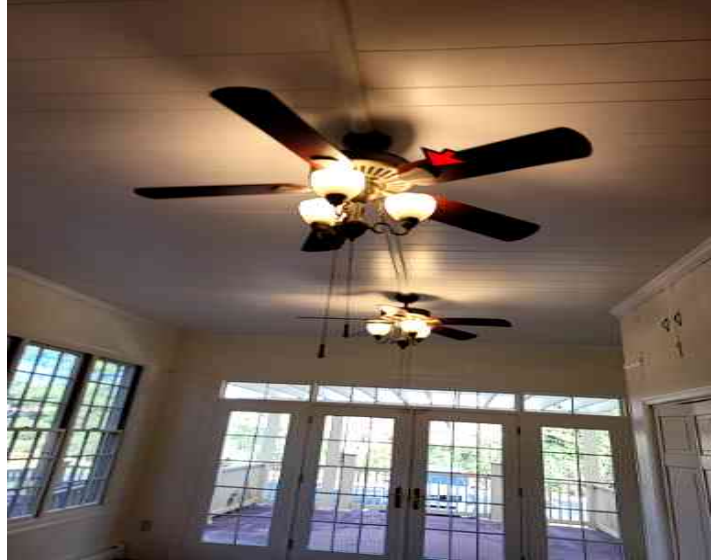
2120: Ceiling Fan

Middle ceiling fan wobbles at the rear great room and should be repaired.

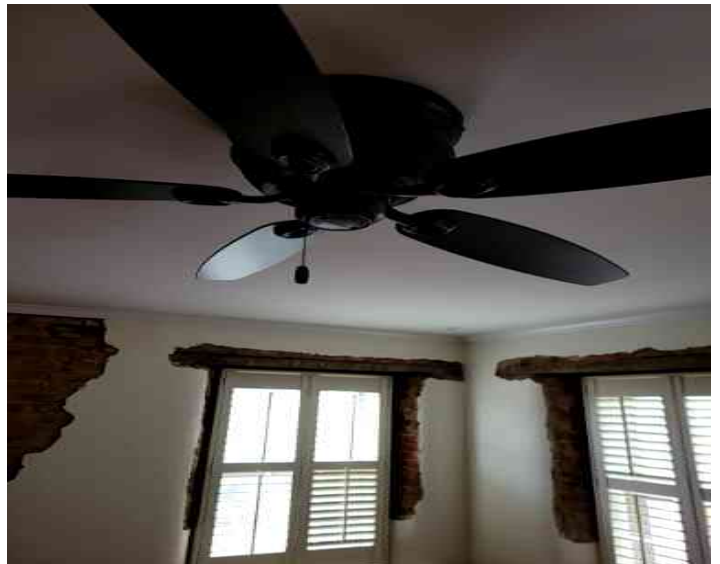
3rd floor front left bedroom front ceiling fan did not work and should be evaluated and repaired.

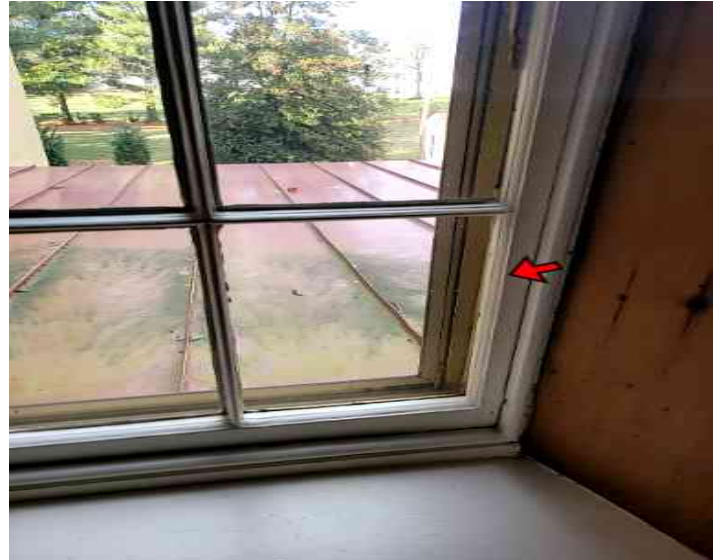
Damaged balances were noted to the windows that were operational.

Damaged balance stairway of the kitchen 2nd floor.

All windows should be evaluated and operational prior to settlement.

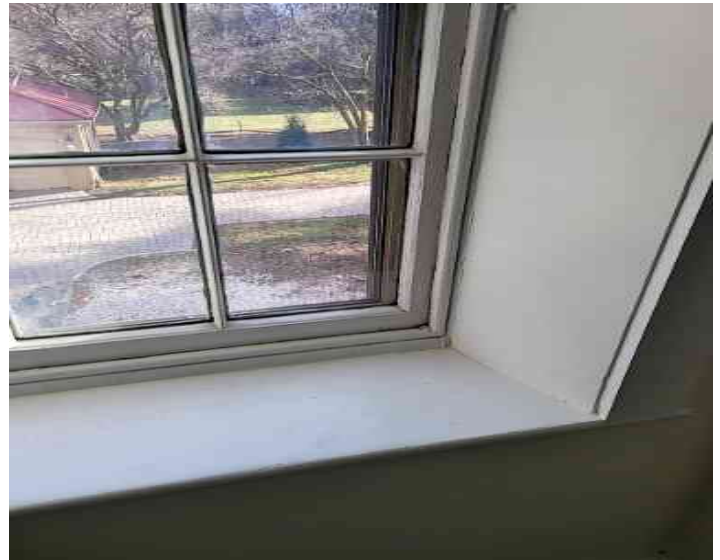
3rd floor front bedroom left window has cracked glass and does not close properly and should be repaired.

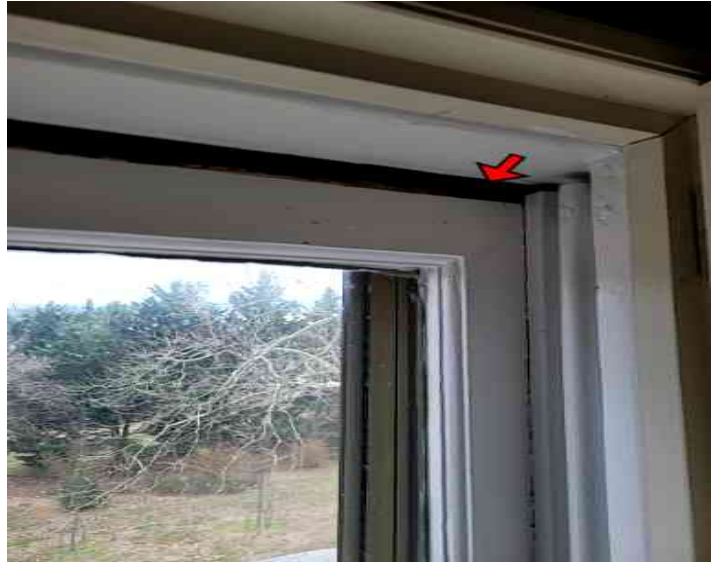
3rd floor front left bedroom side window does not close and should be repaired.

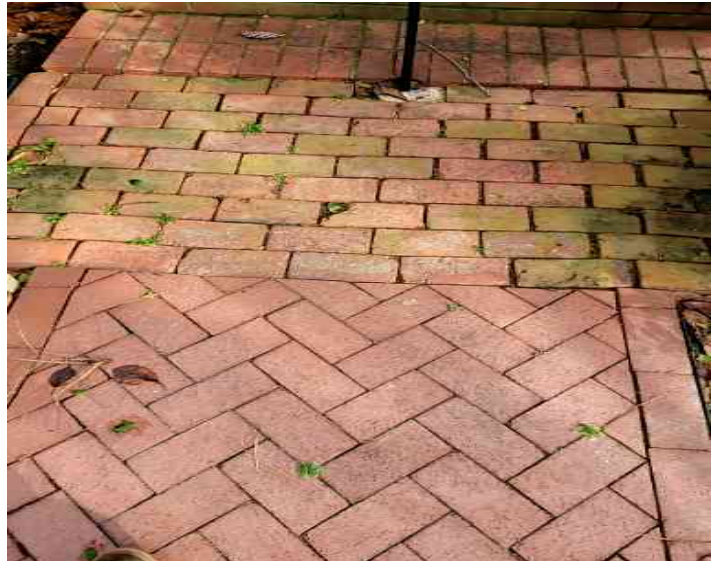
0203: Walks

Missing mortar was noted and should be repaired.
Other = Ramp.
Loose fitting deck boards were noted and should be repaired.

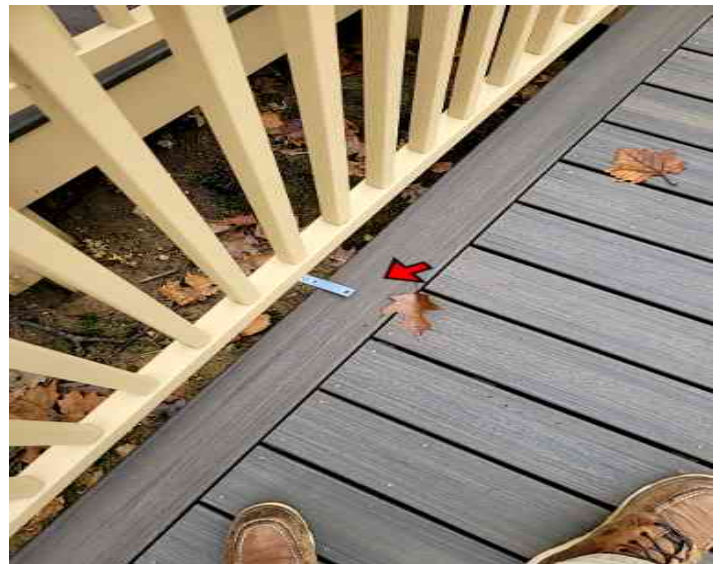
Missing screws at the railing bracket and should be repaired.

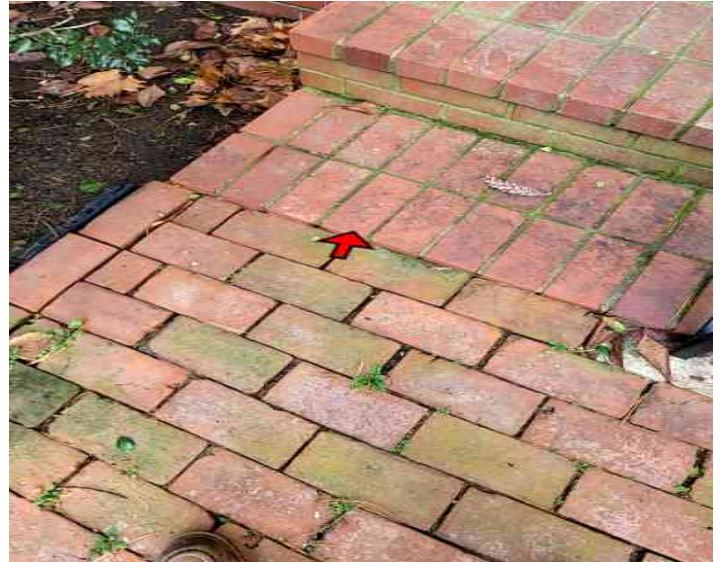
0204: Steps

Uneven areas present a tripping hazard and should be repaired.

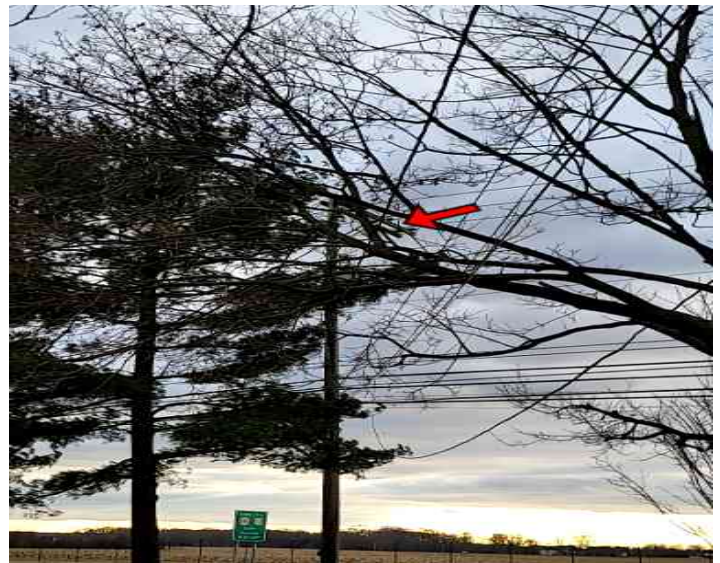
0902: Main Electrical Service

Tree limbs should be cut back from service cable line by a qualified contractor.

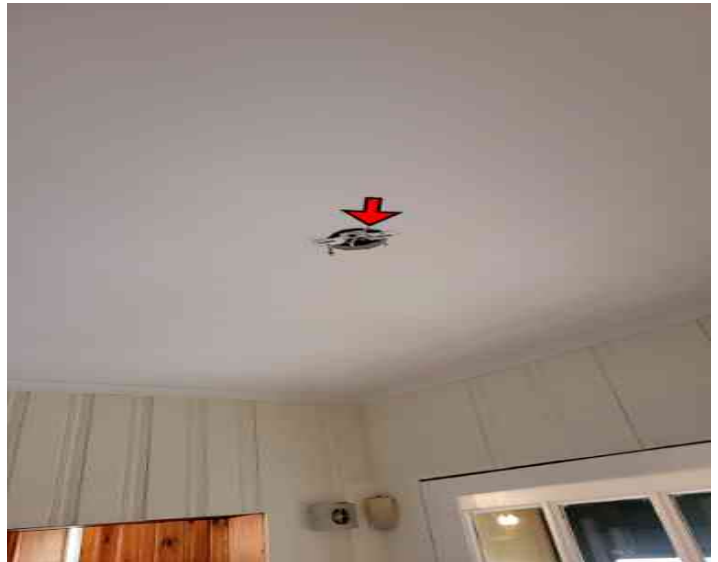
Missing light fixture at the 2nd floor hallway and should be repaired.

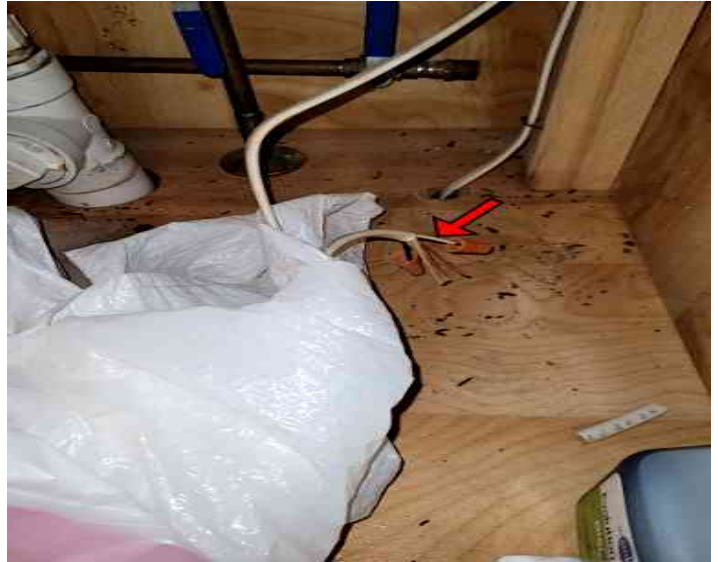
1713: Garbage Disposal

Other = There was a hot, unused wire noted under cabinet which should be made safe.

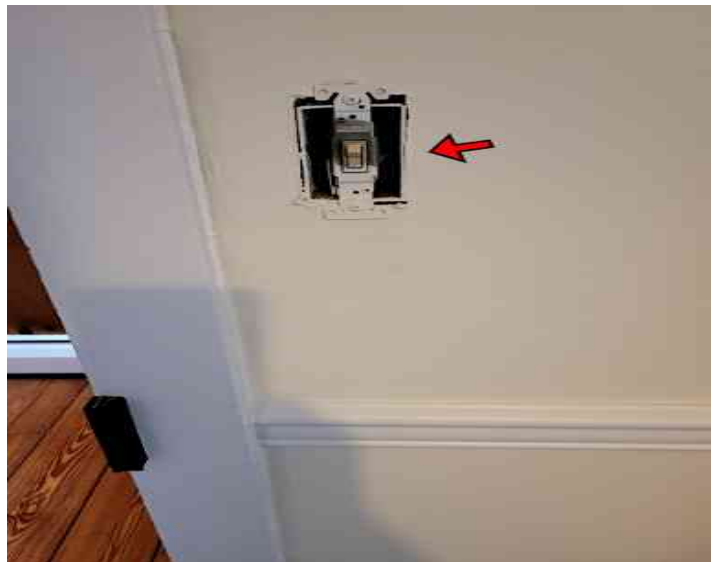
1903: Bathroom Electric Switches and Fixtures

Missing cover plate at the 2nd floor hallway bathroom.

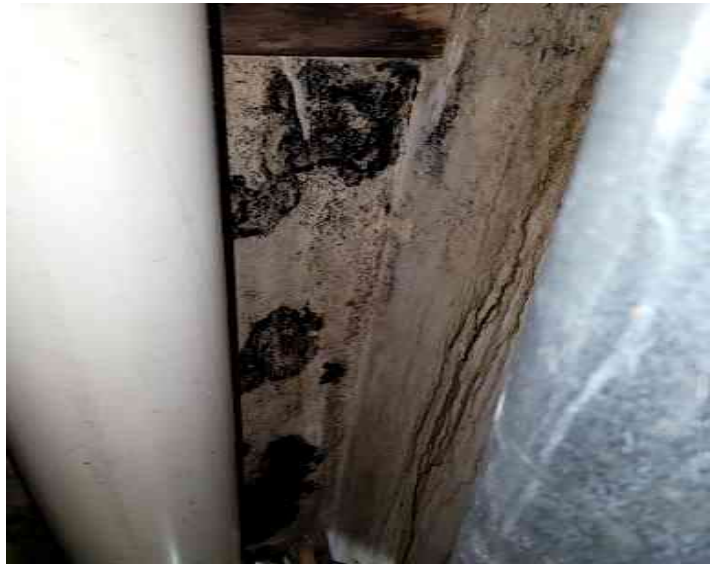
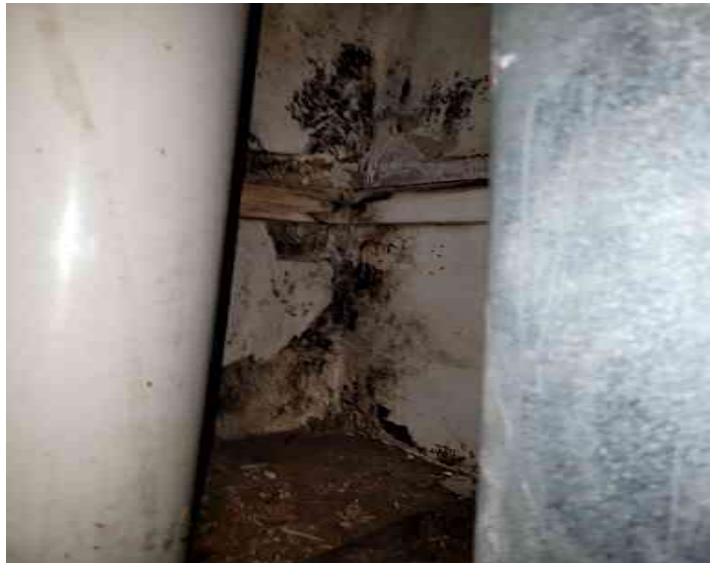
Typical plaster/ drywall flaws noted.

Some mold/mildew was noted on lower level of wall and should be cleaned by qualified personnel. As mold and mildew are not part of the home inspection the client may decide to do further evaluation to determine the extent of the problem and cost of cleanup/repair.

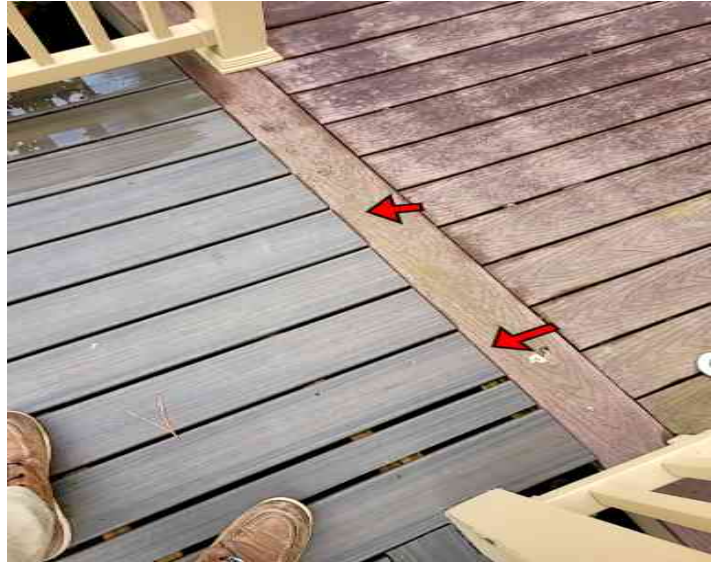
0207: Decks

Loose boards at the transition from ramp to deck and should be repaired.

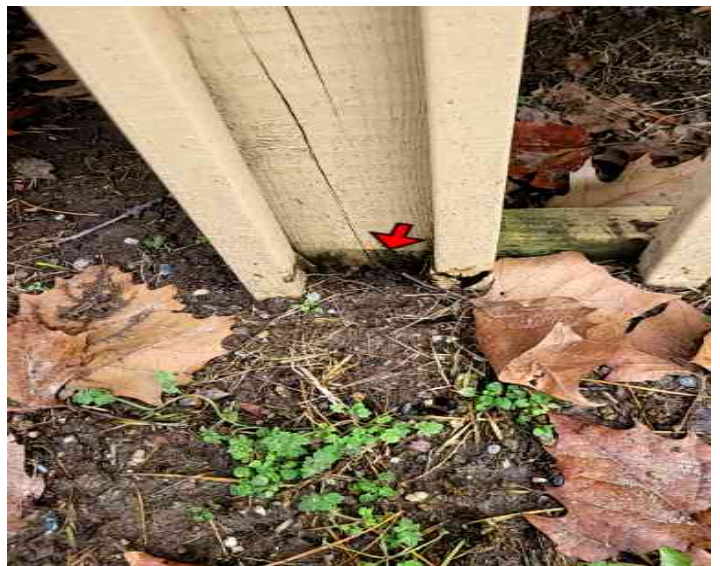
Some rot was noted at the support post and should be repaired.

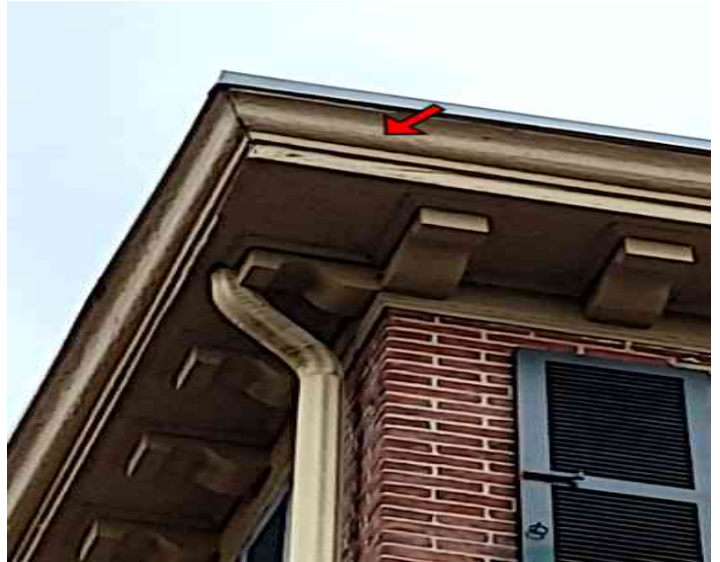
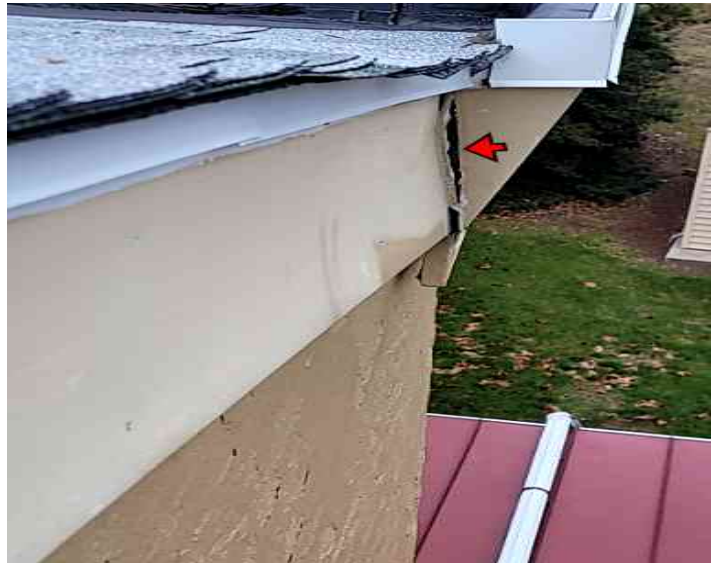
0306: Soffit\Fascia

Some loose paint and wood rot noted.

Loose fitting metal at the roof line and should be repaired.

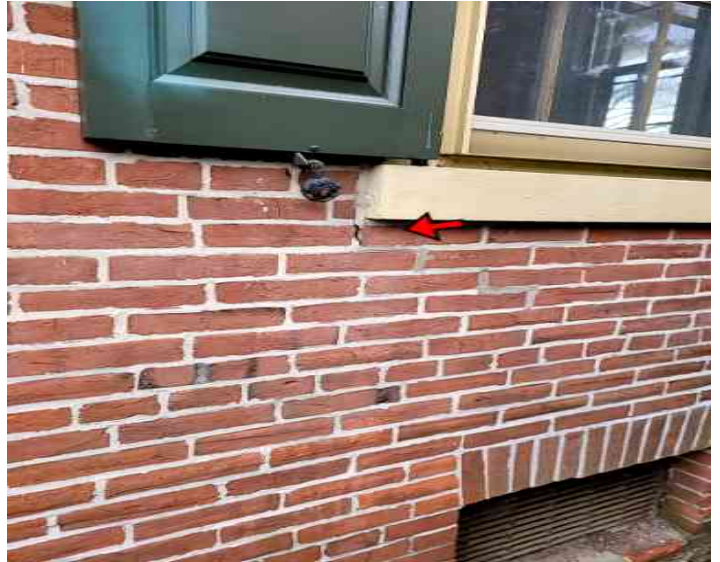
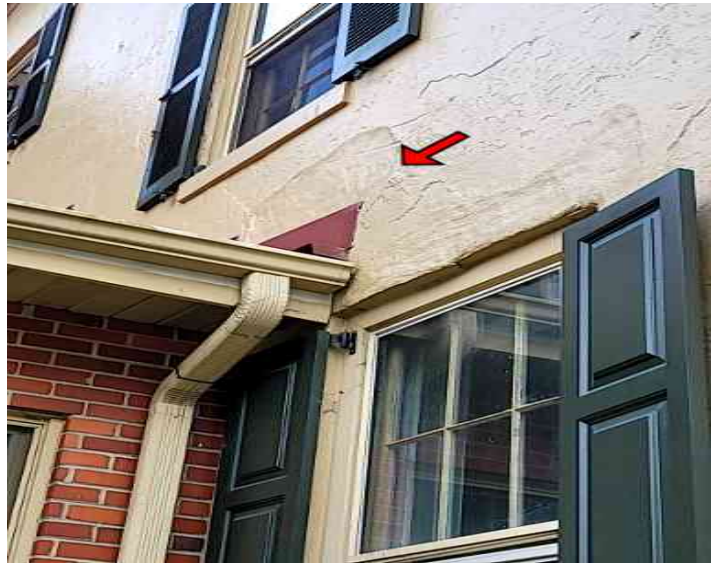
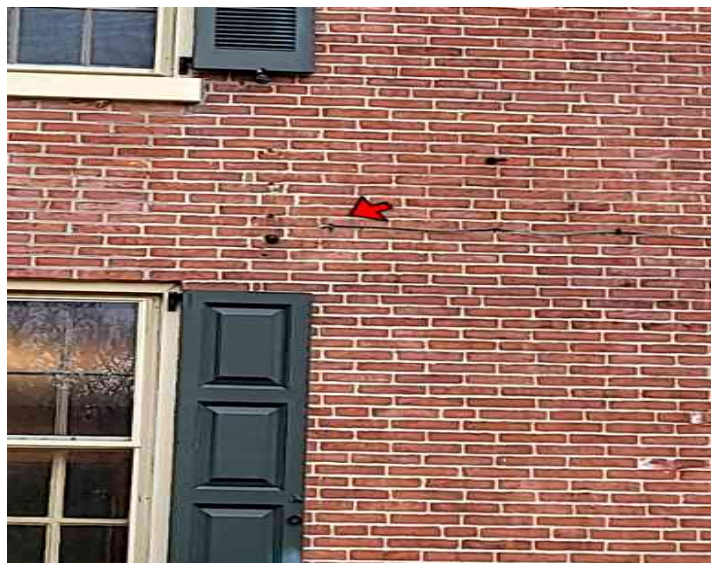
Some cracks and missing mortar was noted and should be repaired.

Cracks were noted at the rear wall of stucco and should be repaired.

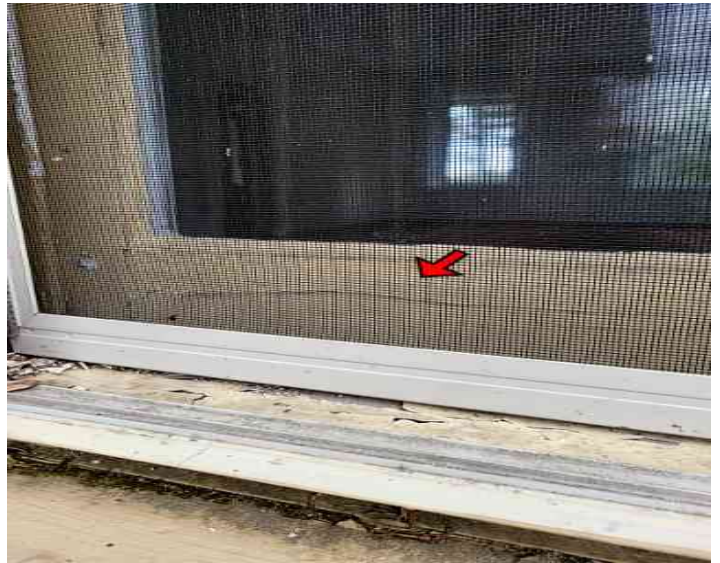
0314: Window Character Material

Some loose paint and wood rot noted.

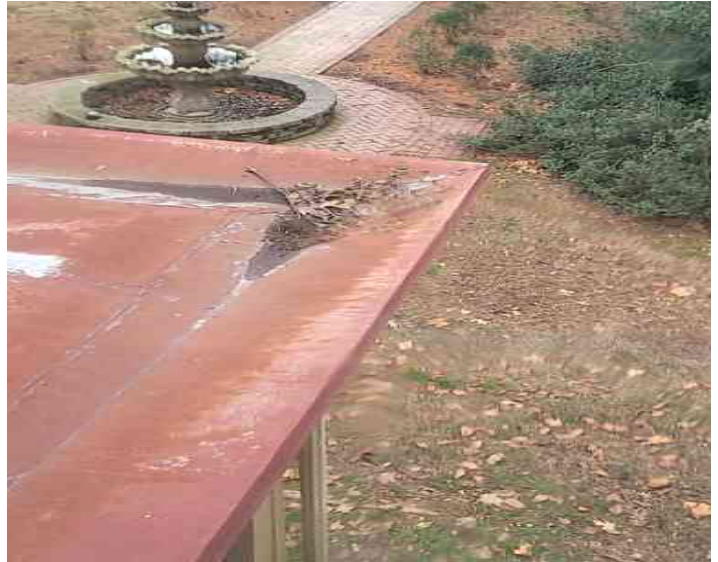
Gutters should be cleaned regularly to prevent rot and roof damage. Often wood rot will be inside framing in this type of system and may not be visible and should be monitored for leakage.

The gutters have debris in them and should be cleaned.

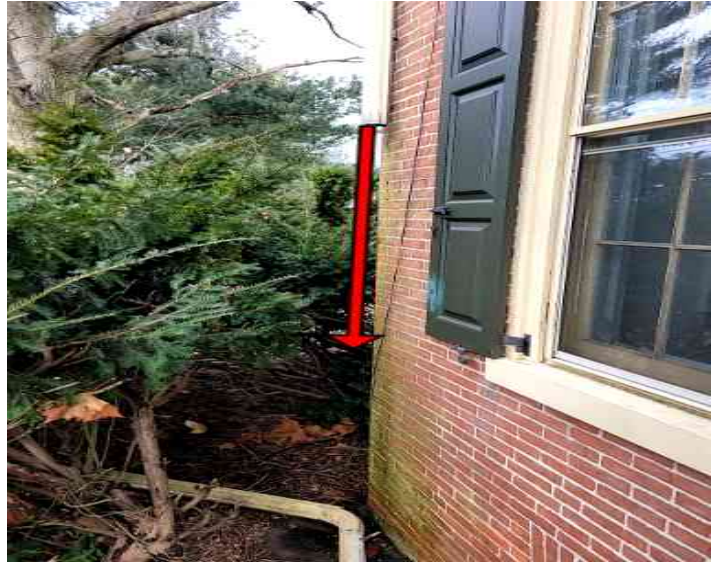
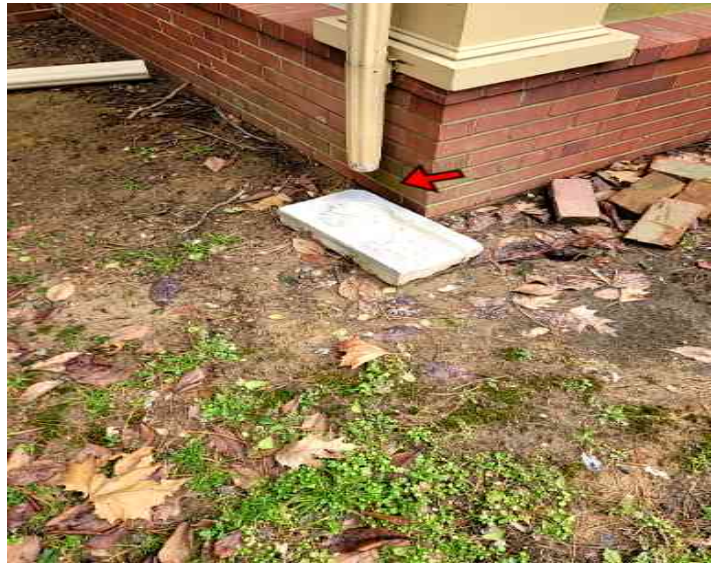
0405: Downspout Type

Disconnected down spout noted and should be repaired.

A missing downspout shoe was noted and should be installed.

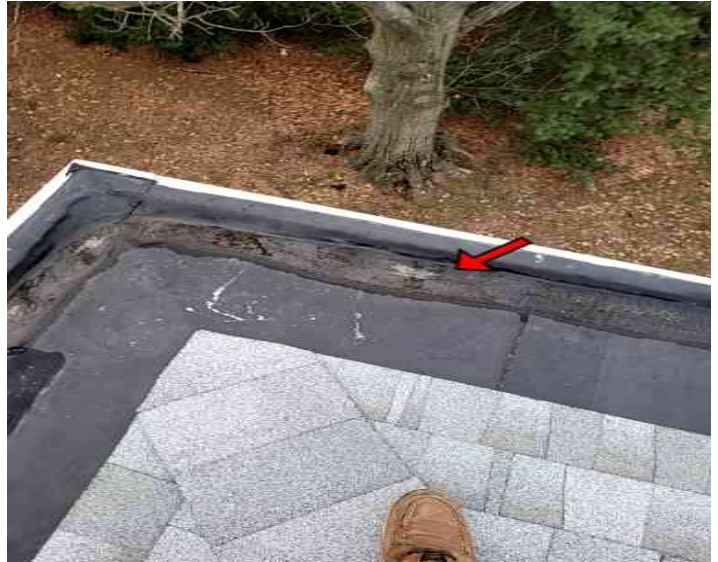
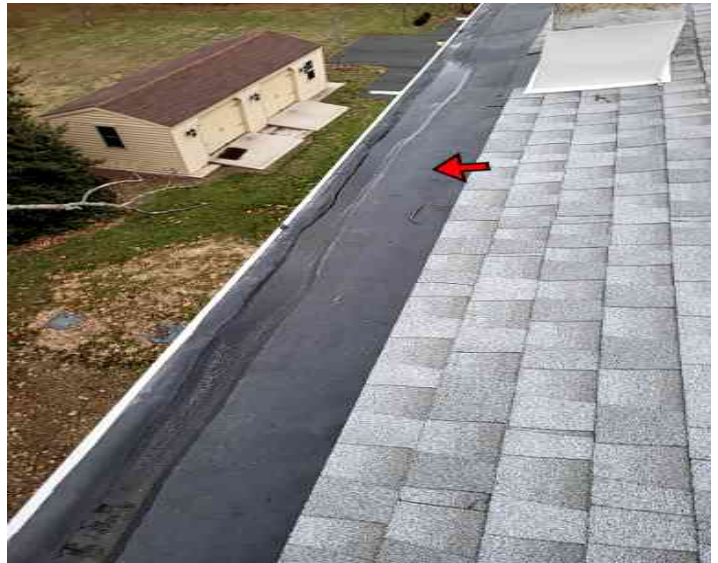
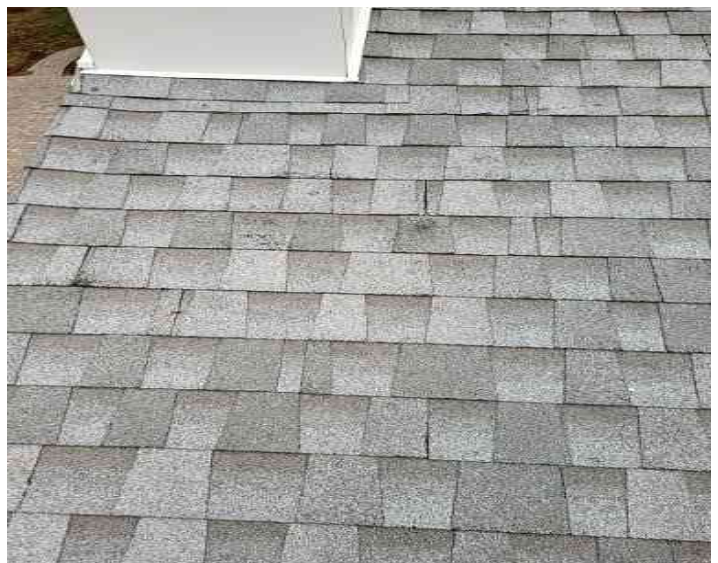
0505: Roof Covering Primary Type

Low or ponding areas on flat roofs shorten the life of the roofing felt and can cause rot to the underlying structure. Ideally, ponding roofs should be rebuilt to avoid the concentration of water.

Some scuffing and aggregate loss noted and should be monitored.

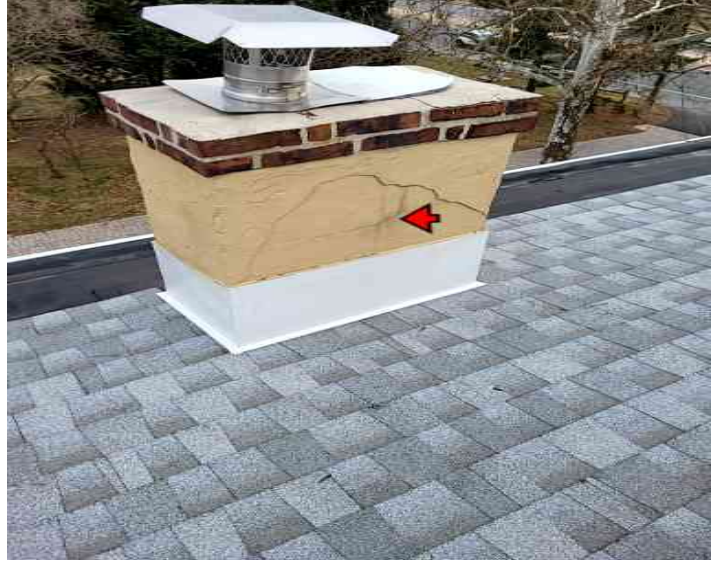
0604: Chimney 1 Type

Some cracks were noted and should be repaired.

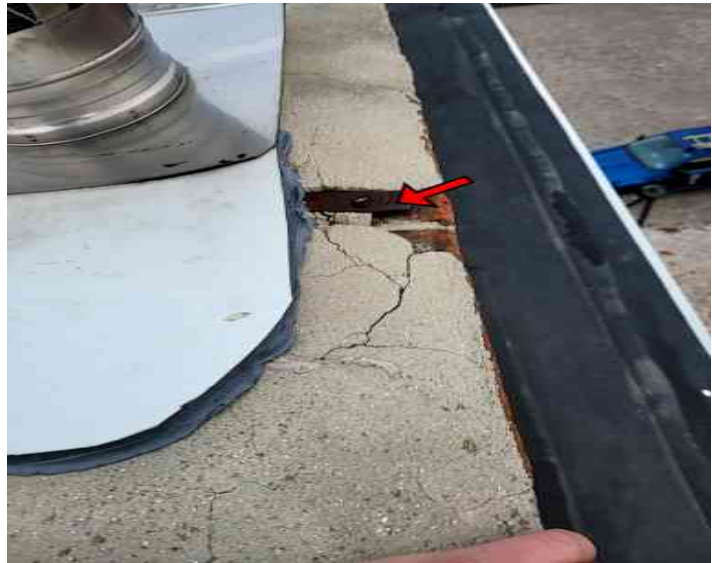
0609: Chimney Top

Some cracks noted in chimney top.

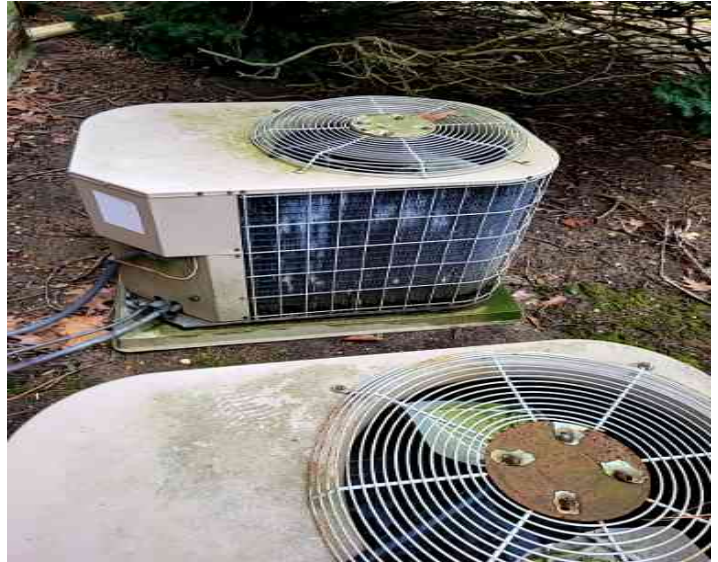
0706: Cooling System Coils and Fins

Damaged fins noted.
Some rust was noted on casings.

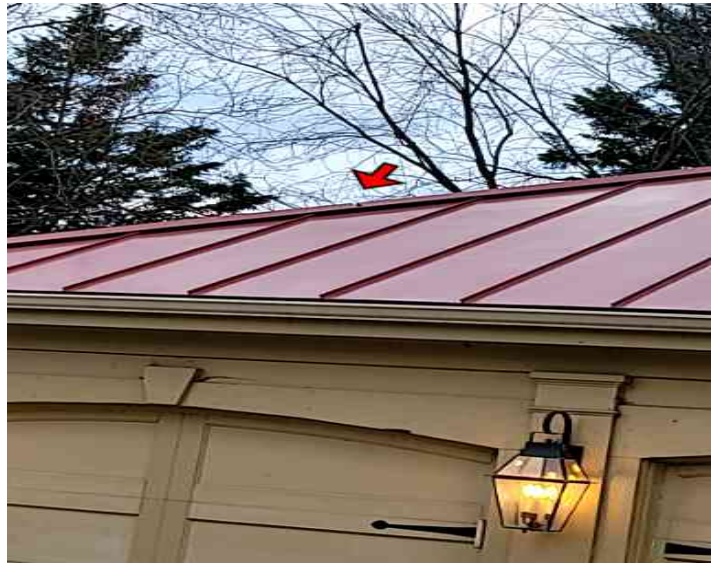
0807: Garage Roof Framing Style

Poorly fitting section was noted at the left hip and should be repaired.

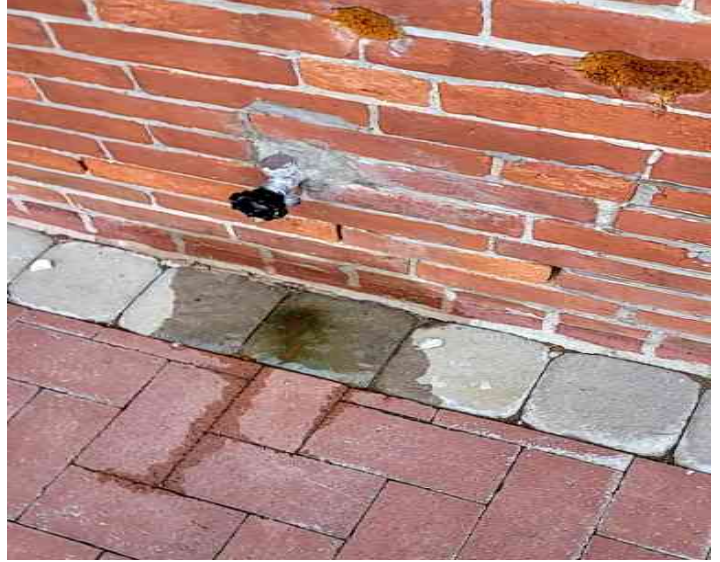
1011: Type of Outside Spigots

Unprotected hose connections should be shut off and drained before first freeze each year. Leakage was noted at the right side hose and should be repaired.

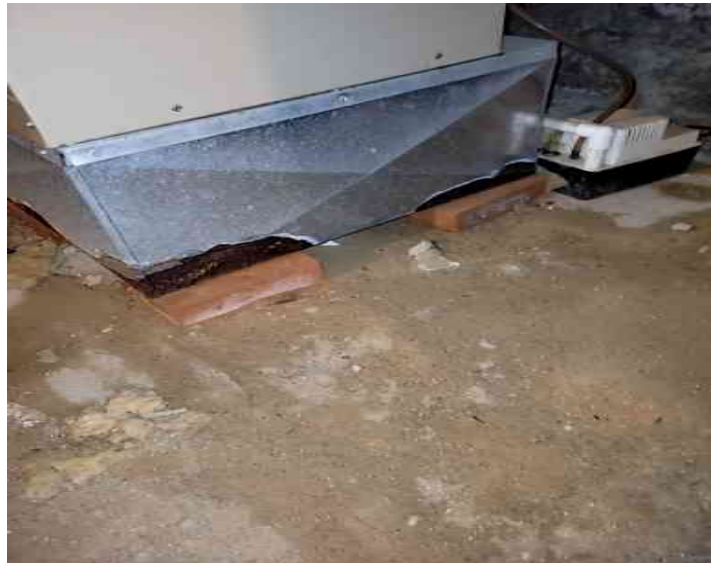
1311: Distribution System Material

Rust noted at the basement unit bottom cabinet.

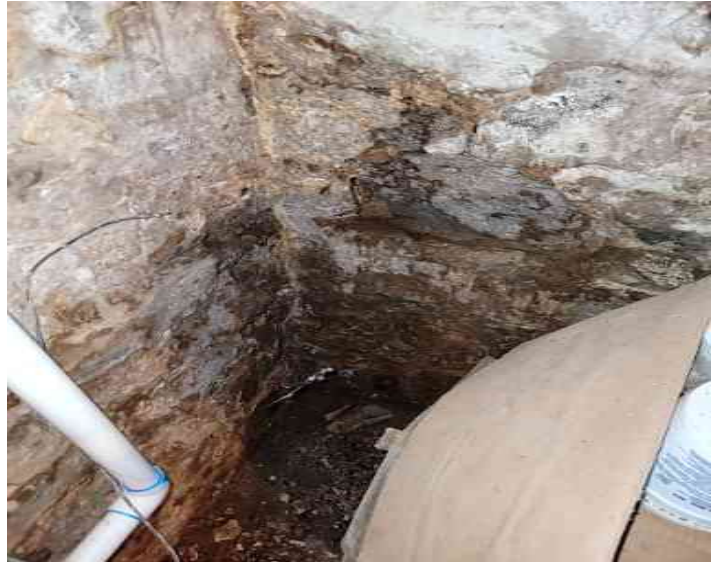
1504: Basement Foundation Walls Primary Visable type

Some cracks and water penetration noted. Older style foundation and should be monitored.
There was efflorescence on the walls.
There were some areas of loose parging and water penetration.

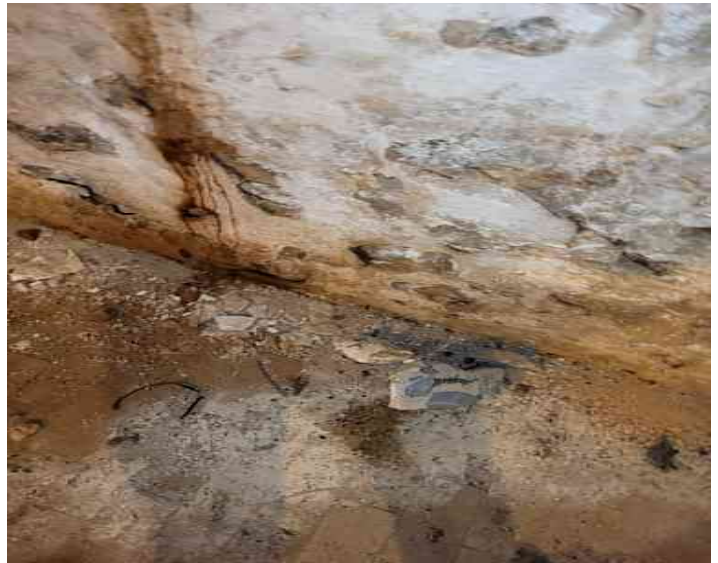
Missing mortar was noted and should be repaired.

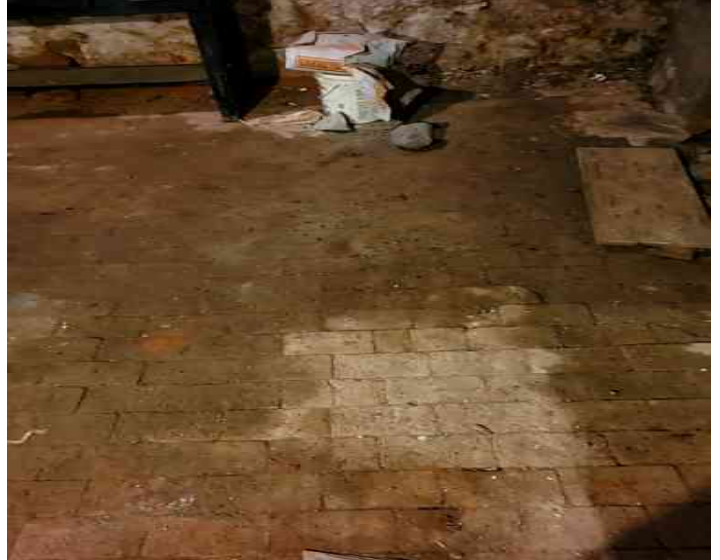
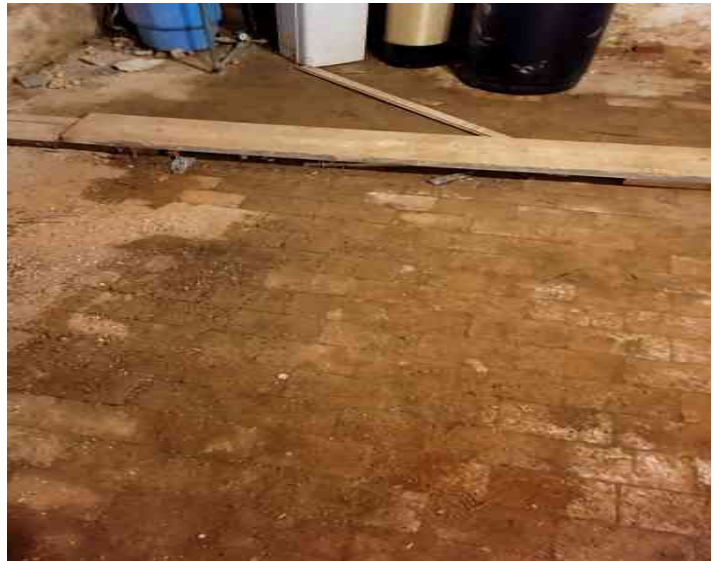
1506: Basement Floor

Some mud stains were noted and indicate water entry.

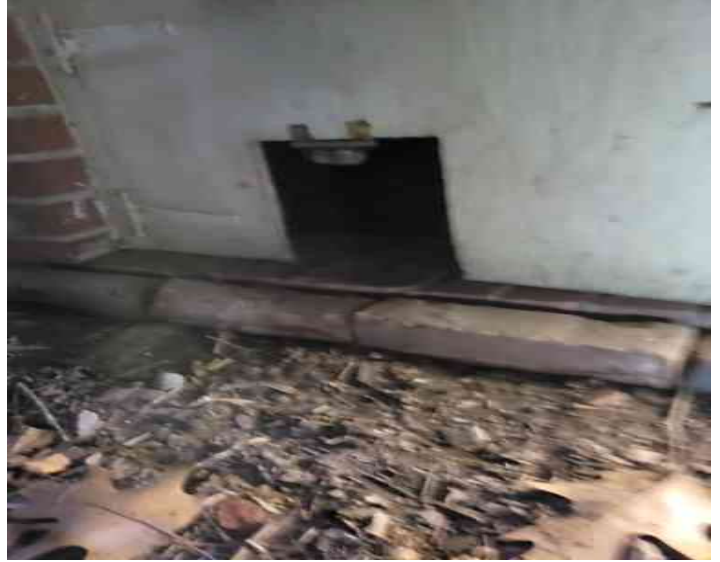
1603: Crawl Space Access

Opening at the hatch under the deck should be sealed to prevent rodents from entering.
