Reliable Home Inspection Service
100 Old Kennett Rd
Wilmington, DE 19807
302-993-9100
<https://www.reliablehomeinspectionsservice.com/>

Inspected By:
Francis Glynn H4-0000078 ASHI #253366 MD# 33646

Inspection Summary

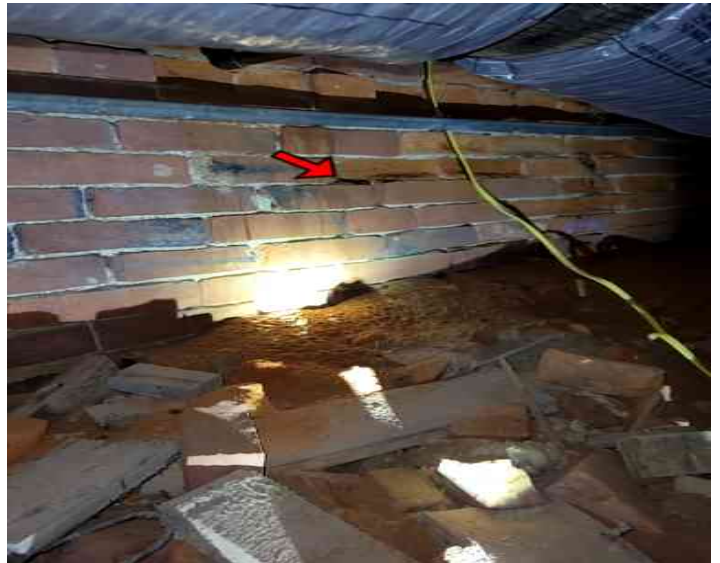
1604: Crawl Space Foundation Walls

Some cracks and water penetration noted.
Missing mortar was noted and should be repaired.

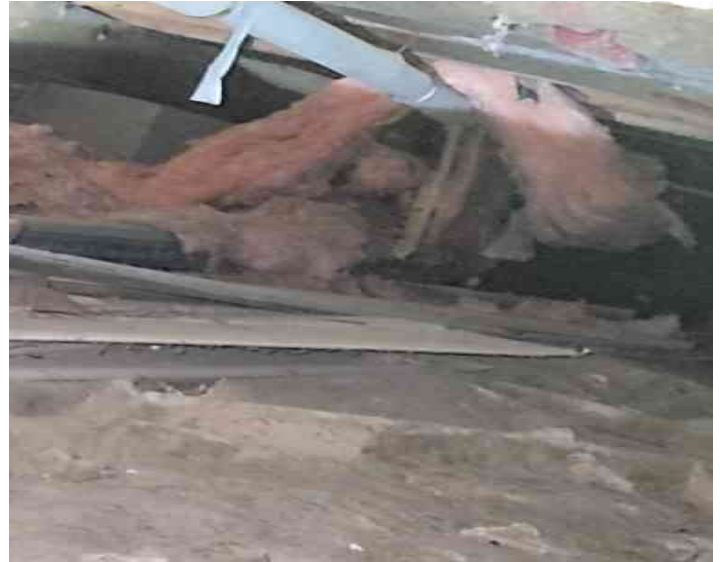
1610: Crawl Space Insulation

Insulation limits inspection.
Some insulation has fallen and should be replaced.
Insulation is installed upside down and should be repaired.

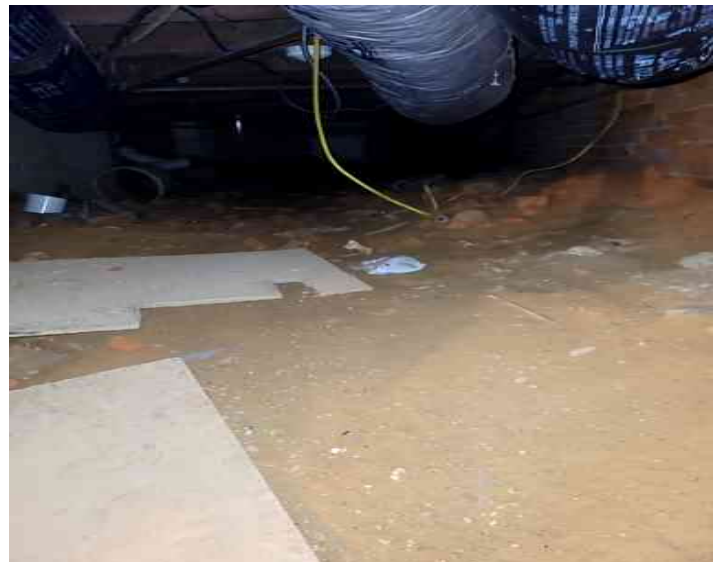
1612: Crawl Space Floor Vapor Barrier

Recommend vapor Barrier Be installed.

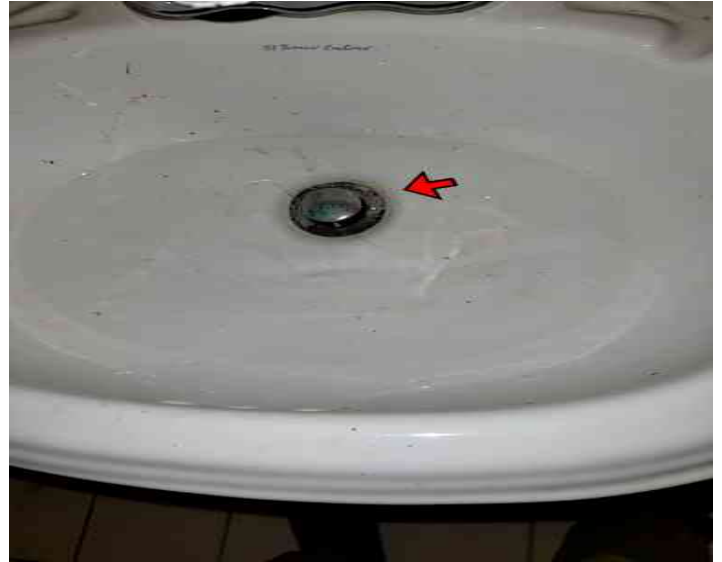
1811: Half Bath Sink Drain and Trap

The drain is slow and should be repaired.

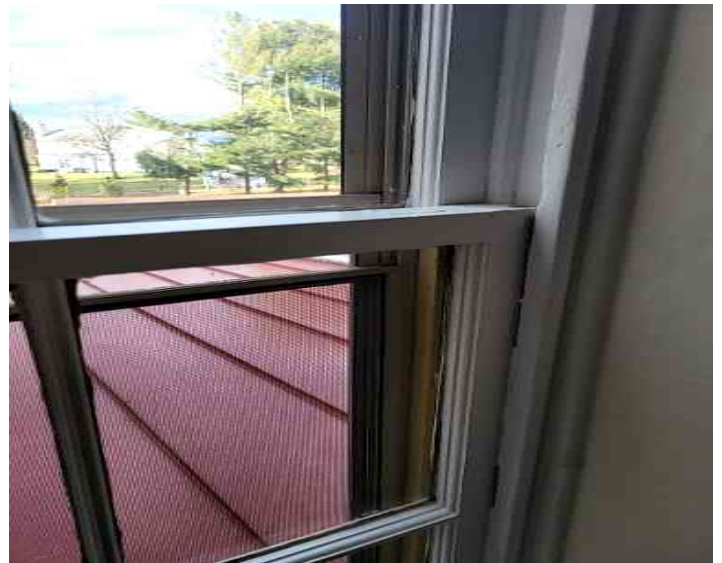
1902: Bathroom Doors, Windows

2nd floor hallway bathroom window is painted shut and missing the lock and should be repaired.

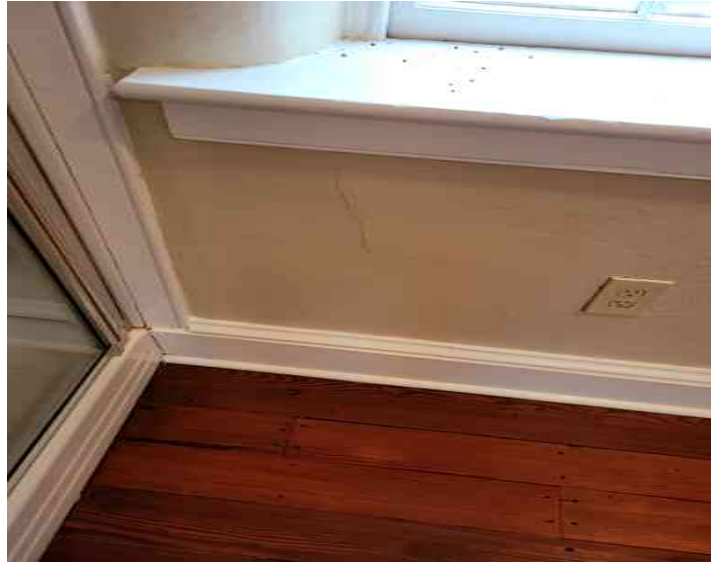
1905: Bathroom Walls and Ceilings

Some cracks were noted.

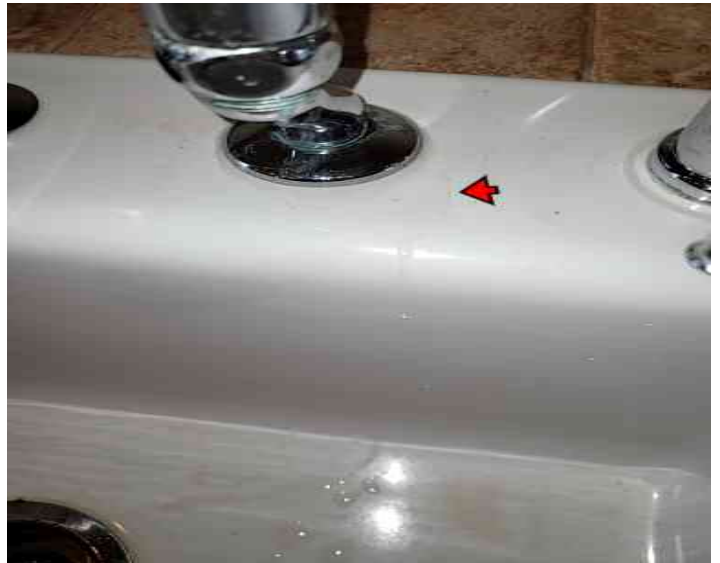
1908: Bathroom Sink Faucets

Cold valve leaks at the master bathroom sink and should be repaired.

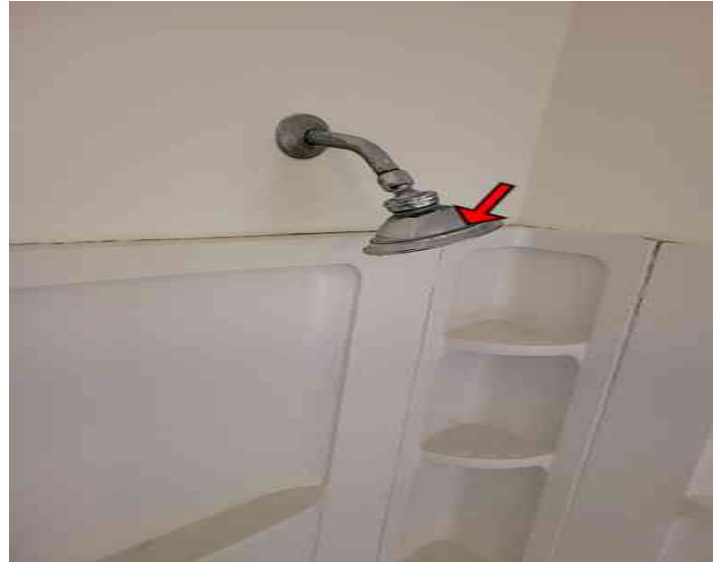
1916: Bath Showerhead

Low water pressure was noted at the 2nd floor hallway bathroom shower and should be repaired.

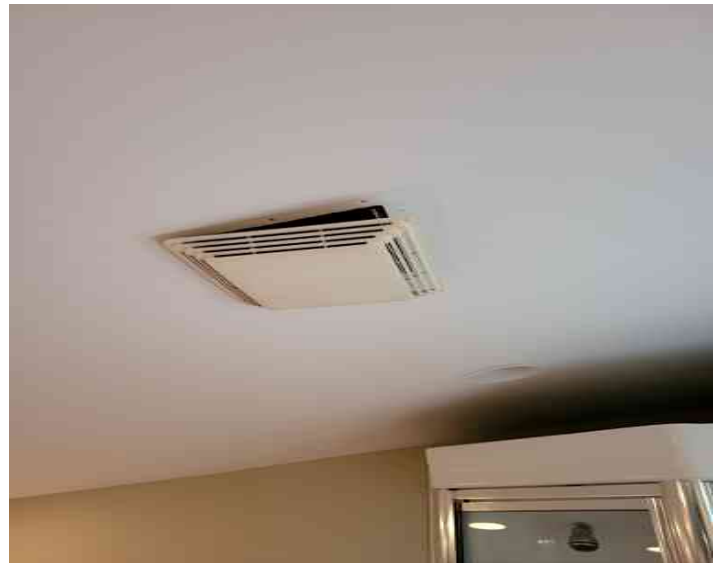
1919: Bathroom Ventilation

Fan is loose from the ceiling at the master bathroom and should be repaired.

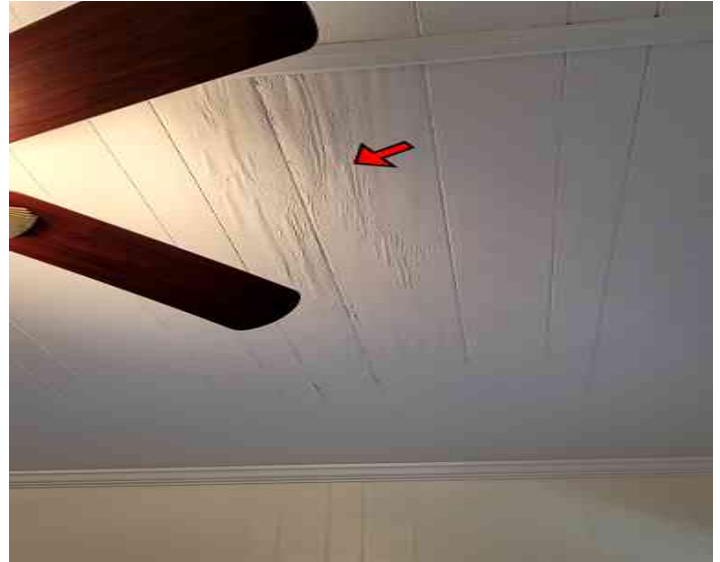
2105: Interior Ceilings

Typical plaster/ drywall flaws noted.
Loose paint was noted at the rear 1st floor great room.

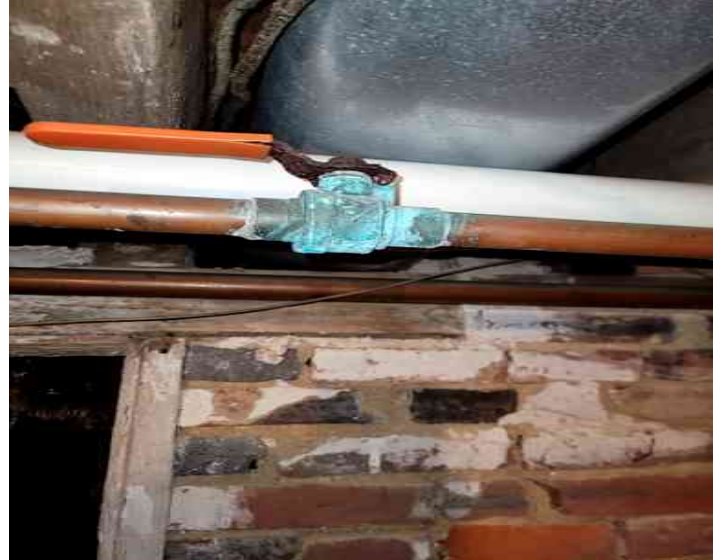
1007: Interior Water Pipes Primaray Visible Type

Some discoloration was noted.

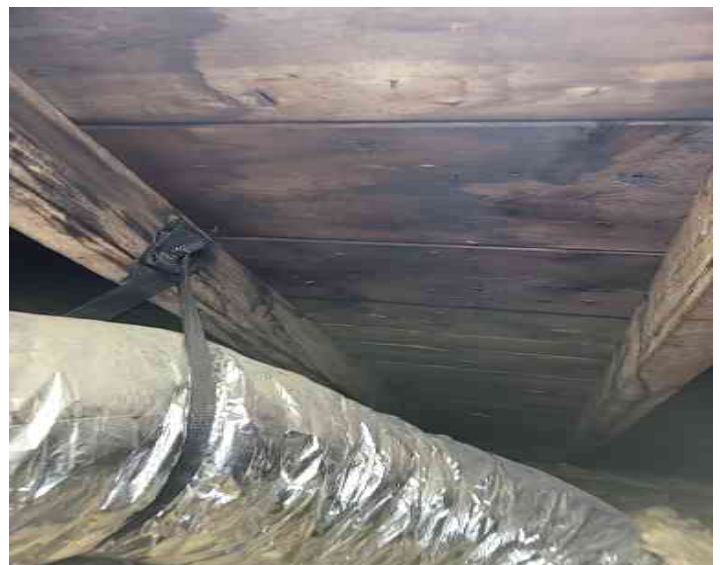
2007: Attic Sheathing

Some evidence of leakage but not wet at the time of the inspection.

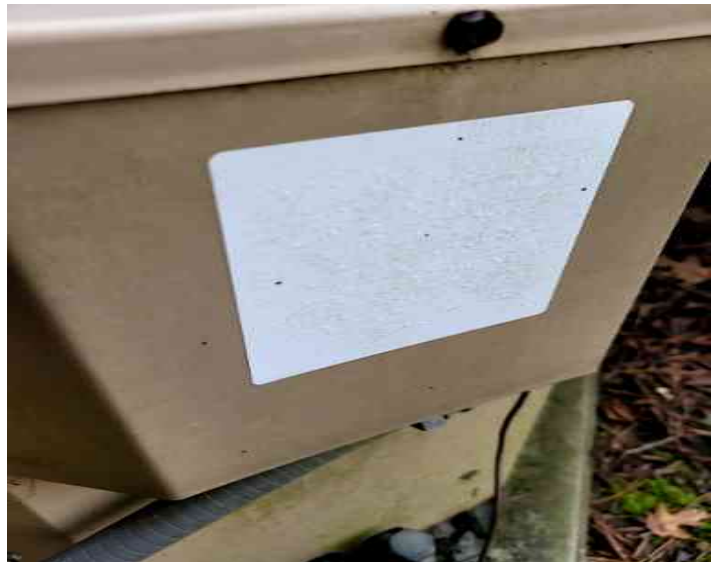
0702: Cooling System 1 Brand

Tag on unit either damaged or missing. All information in this section assumed.

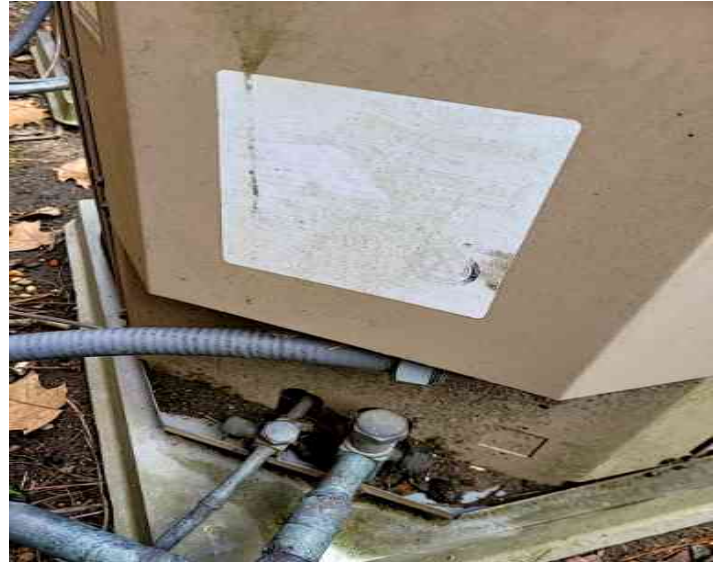
0713: Cooling System 2 Brand

Damaged tag and information is unknown.
