Reliable Home Inspection Service
100 Old Kennet Rd
Wilmington, DE 19807
302-993-9100
<https://www.reliablehomeinspectionsservice.com/>

FRONT VIEW

Inspection Summary

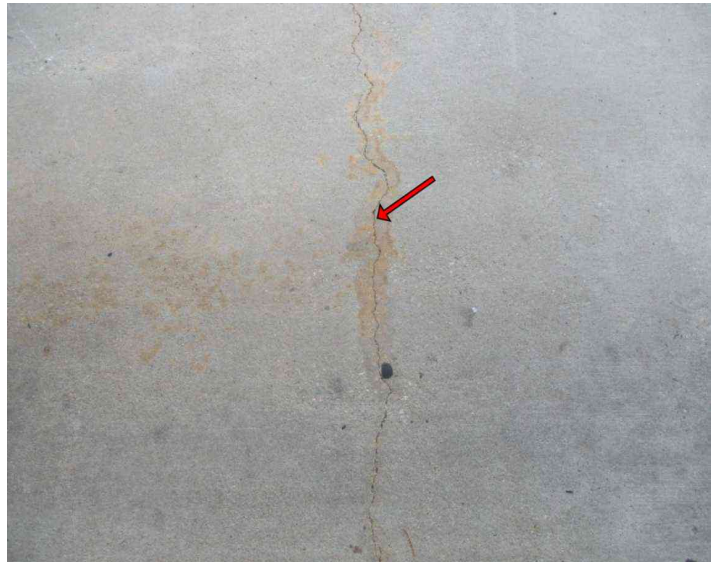
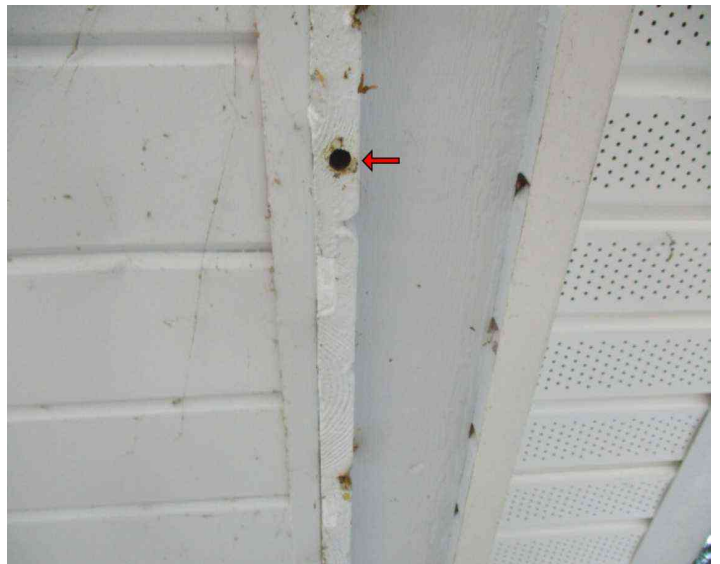
0205: Porches

Some loose paint and rot noted
Wood boring insect damage was noted.
All exterior wood products should be evaluated by
qualified contractor and all needed repairs should be
made.
Cracks and settlement were noted.

Some loose paint and rot noted Wood boring insect damage was noted. All exterior wood products should be evaluated by qualified contractor and all needed repairs should be made. Cracks and settlement were noted.

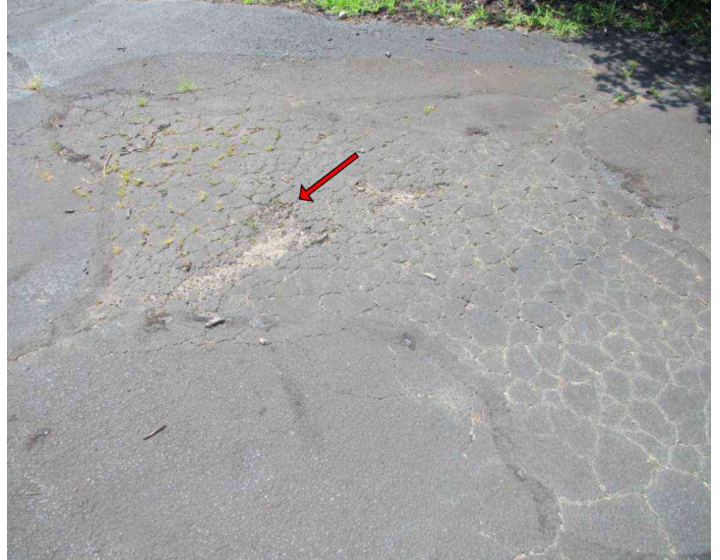
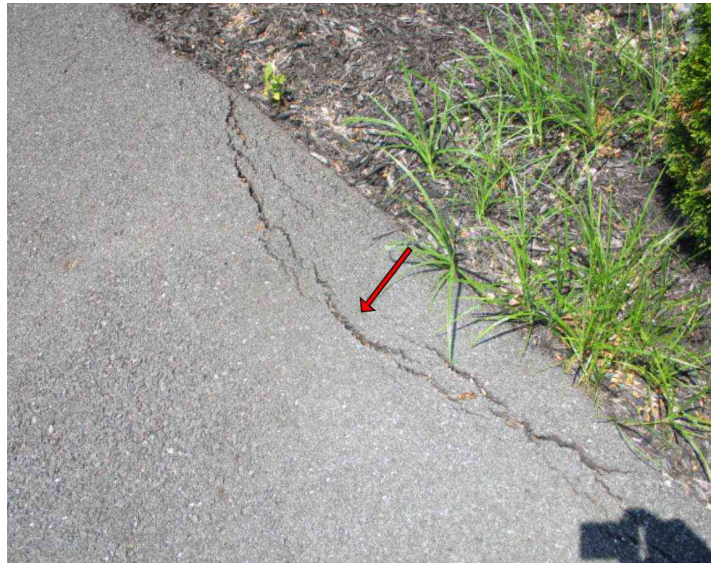
0207: Driveway/Parking Lot

Some cracks noted.
Deterioration of the parking was noted and should be evaluated by a qualified contractor and all needed repairs should be made.

Some cracks noted. Deterioration of the parking was noted and should be evaluated by a qualified contractor and all needed repairs should be made.

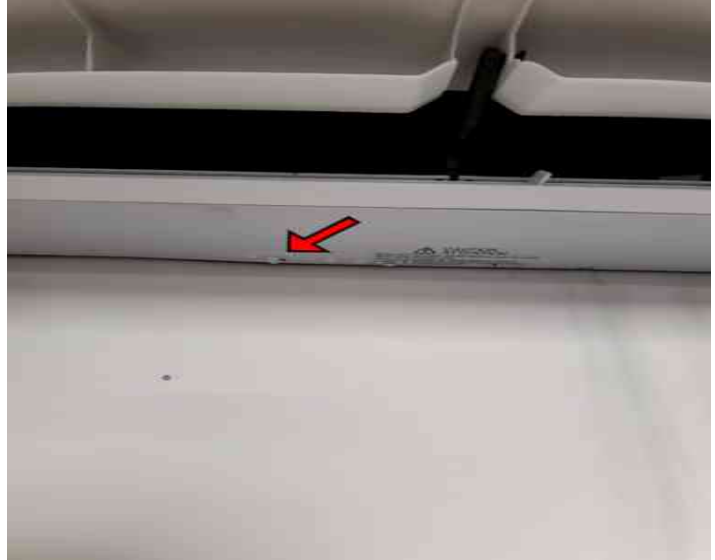
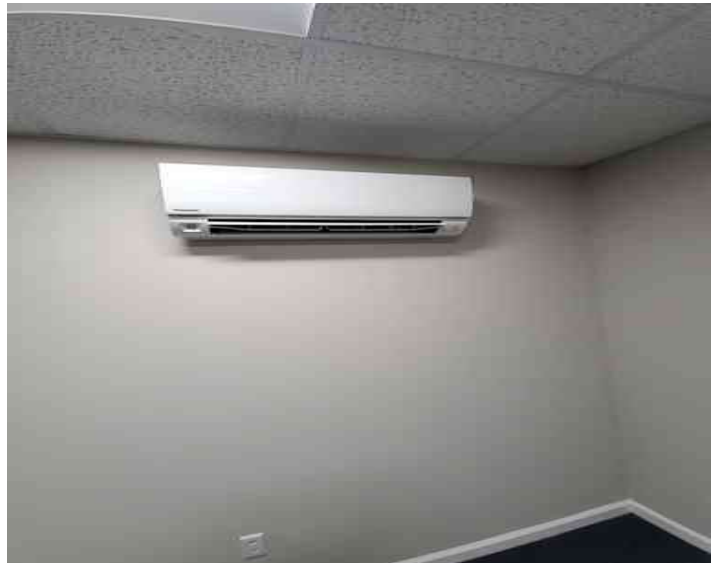
0701: COOLING SYSTEM

Panasonic mini split systems (4) systems at unit 3
Improperly installed systems were noted.
Condensation dripping from units at the time of the inspection The entire HVAC should be evaluated and all needed repairs should be made
Carrier mini split Unit 1

4 Panasonic units 3yrs old Mini split
1 Carrier unit 3yrs old Mini split

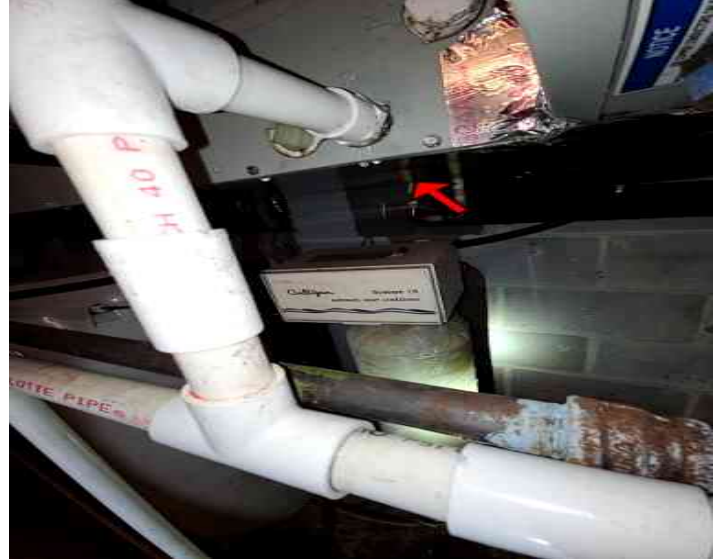
0709: Condensate Drain

Condensate line is currently leaking at the basement unit and should be evaluated and repaired.

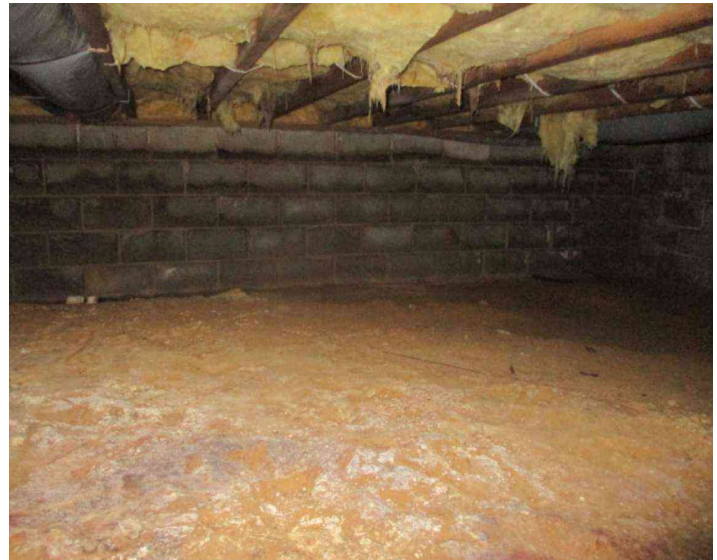
1601: CRAWL SPACE

There appears to be a moisture issue in the crawlspace. The entire crawlspace should be evaluated by a qualified contractor and all needed repairs should be made.

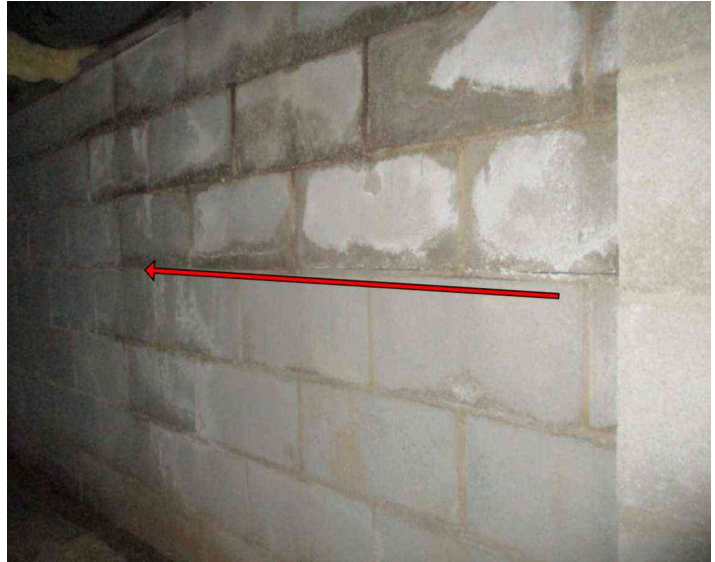
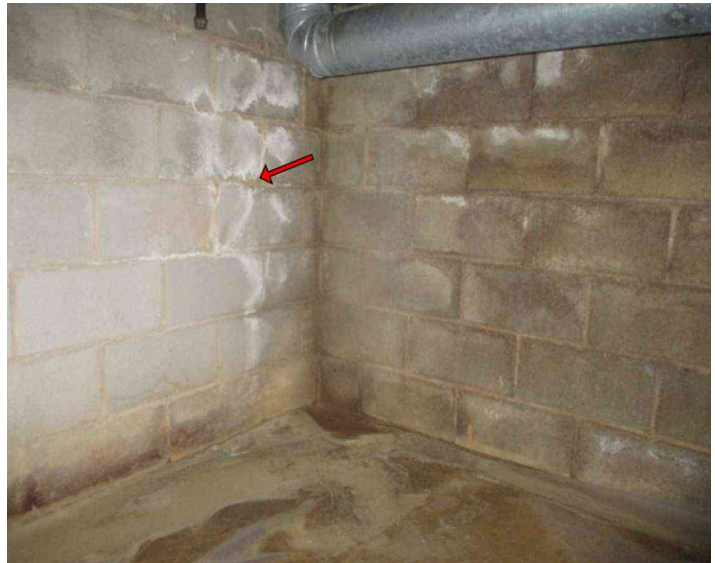
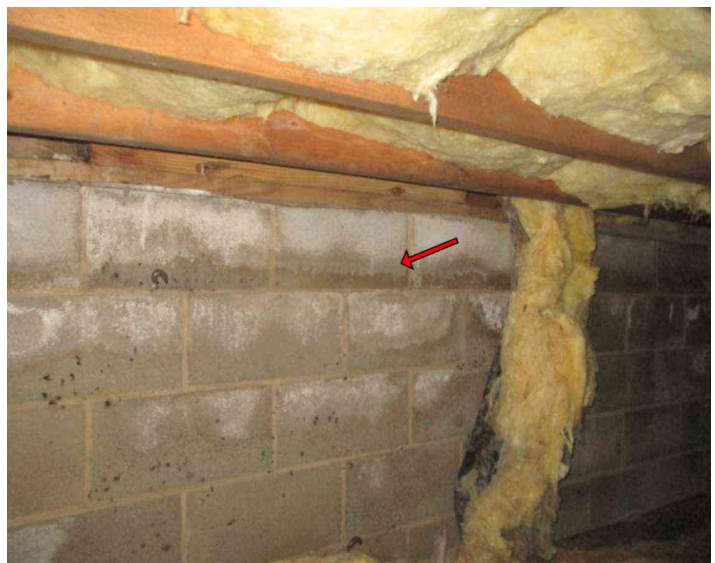
1604: Crawl Space Foundation Walls

Some cracks and water penetration noted. There was efflorescence on the walls. Some horizontal cracks were noted and should be evaluated by a structural contractor and any needed repairs should be made.

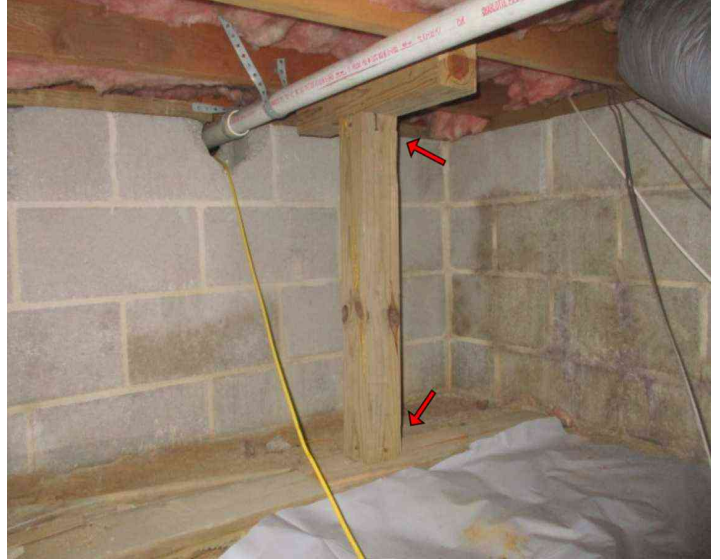
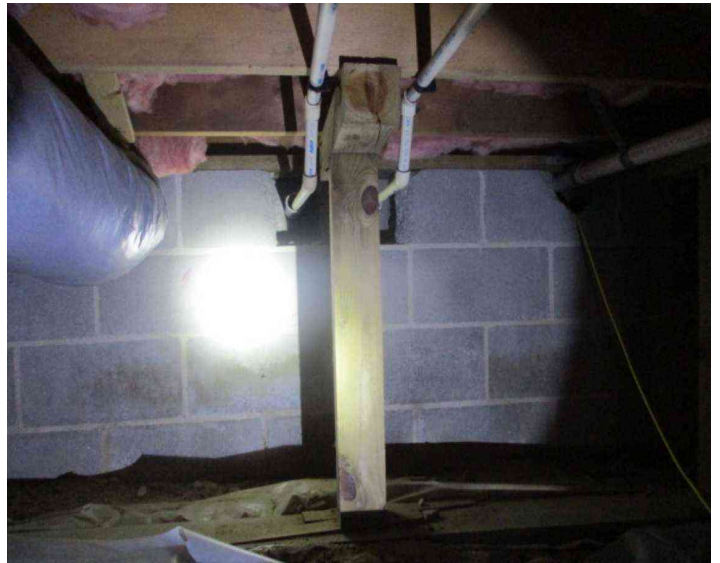
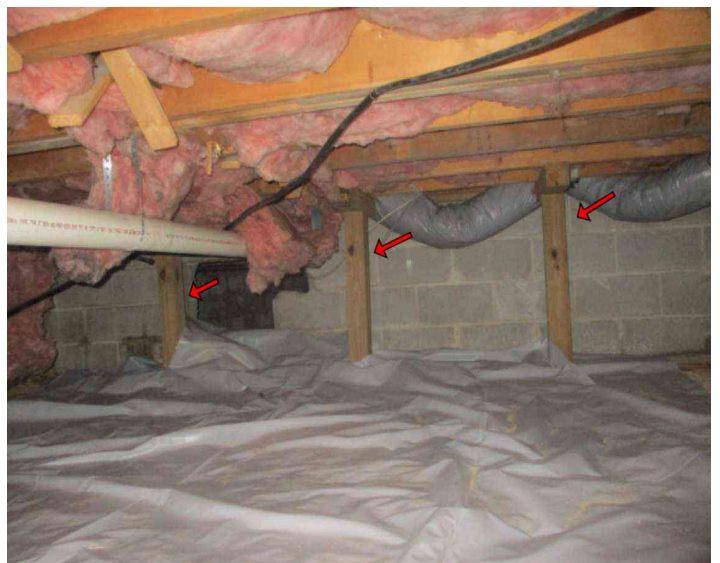
1606: Crawl Space Structural Columns

The column is a temporary makeshift support and not properly footed. The entire structural condition should be evaluated by structural contractor or engineer and all needed repairs should be made

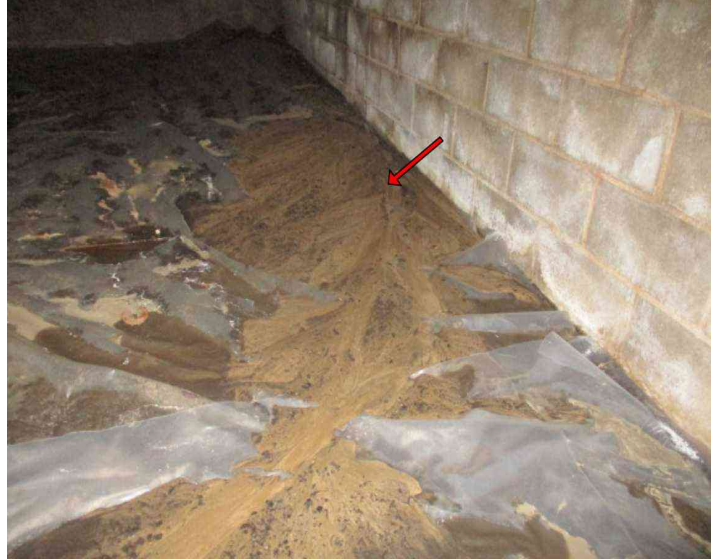
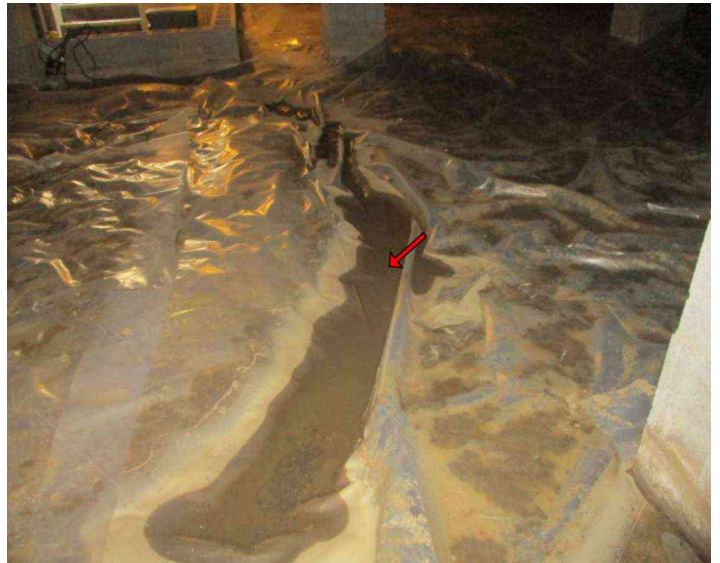
1613: Crawl Space Floor Type

There was standing water on floor of crawl space at time of inspection, source of moisture should be identified and all need repairs to improve drainage and prevent further water intrusion should be made.

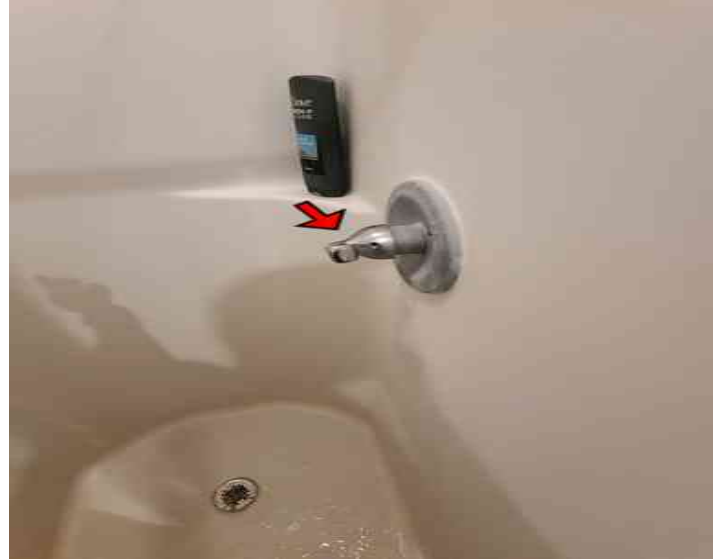
1923: Shower Faucets

Shower faucet handle does not work properly nor does it get cold and should be evaluated and repaired. Unit 2

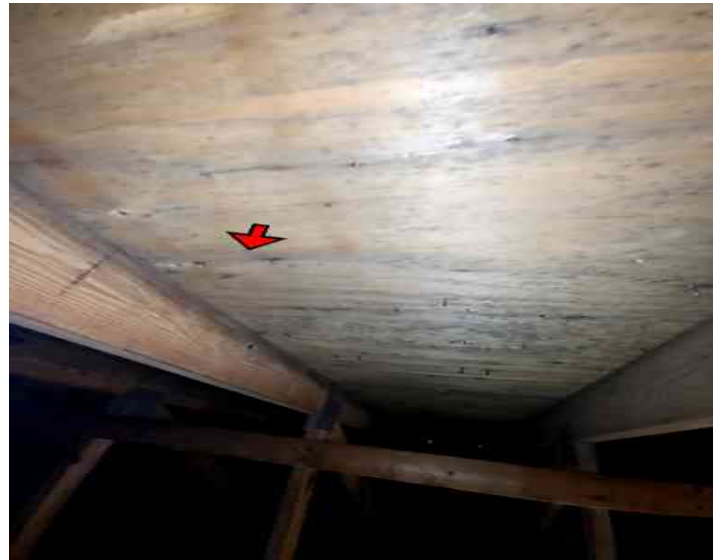
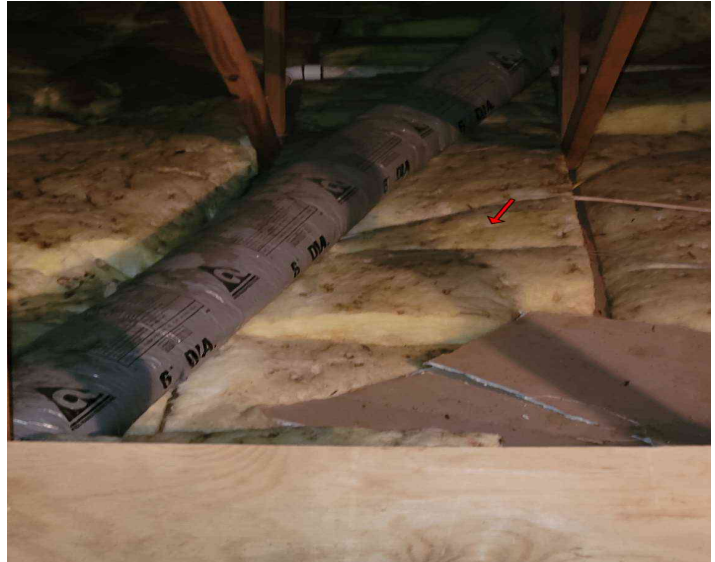
2011: Attic Ventilation

Inadequate ventilation was noted in the attic. The entire attic/roofing system should be evaluated by a qualified contractor and all needed repairs should be made. Rust was noted at the nail heads.

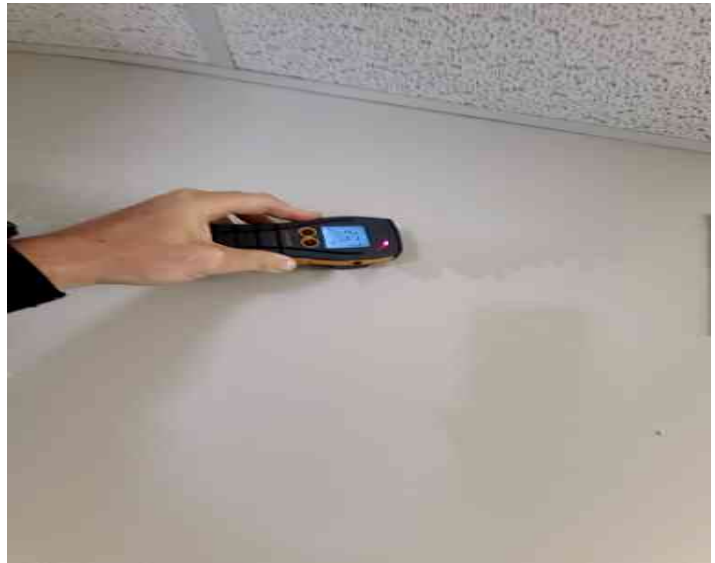
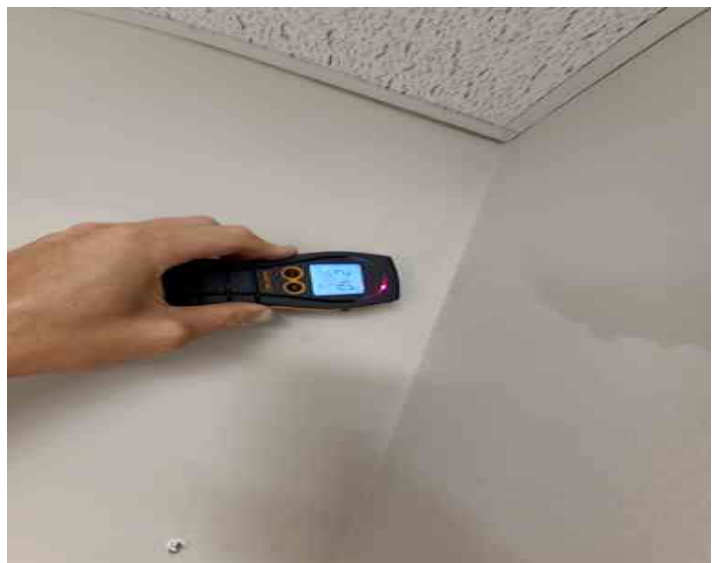
2104: Interior Walls

Typical drywall flaws were noted. Currently wet areas were noted at unit 3 hallway upper walls, unit 2 and the source should be identified and all needed repairs should be made.

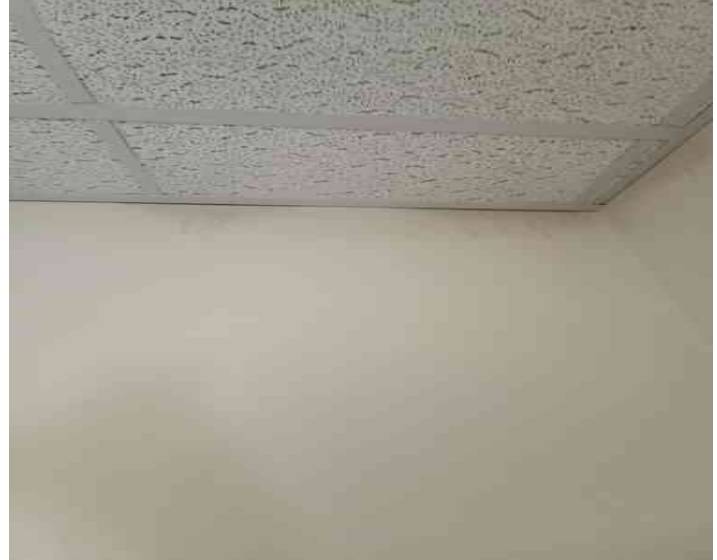
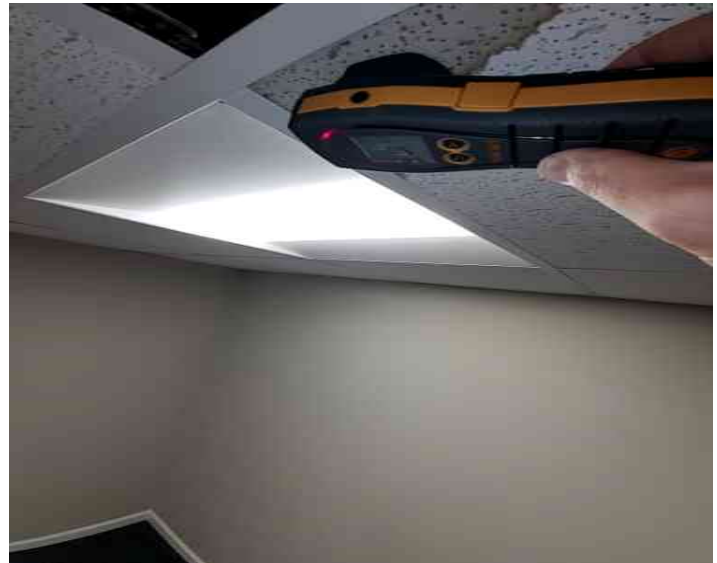
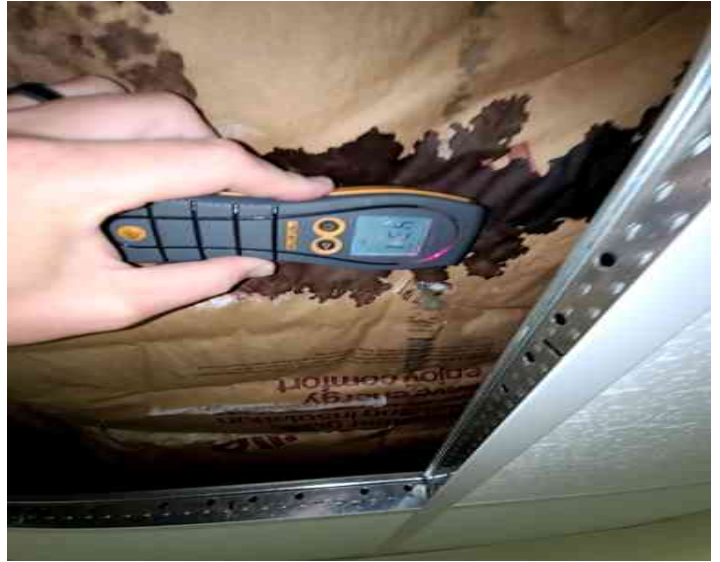
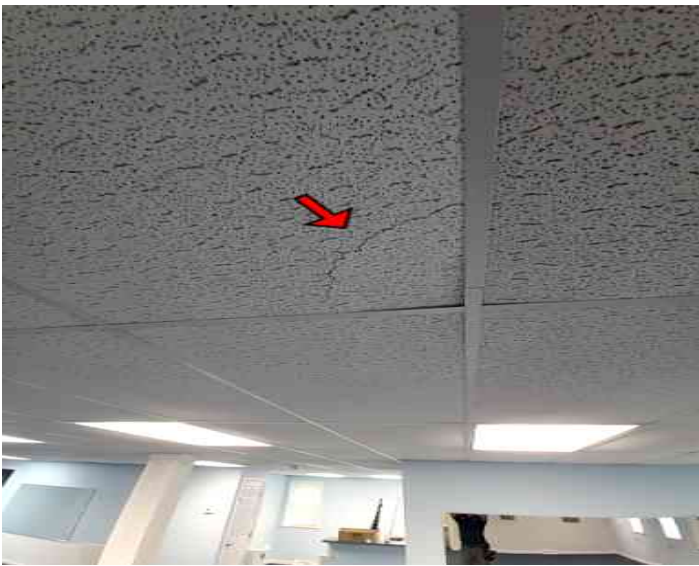
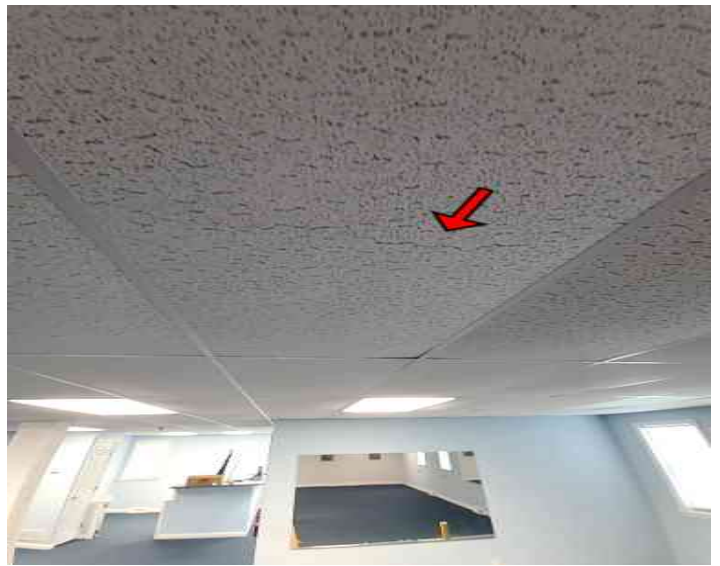
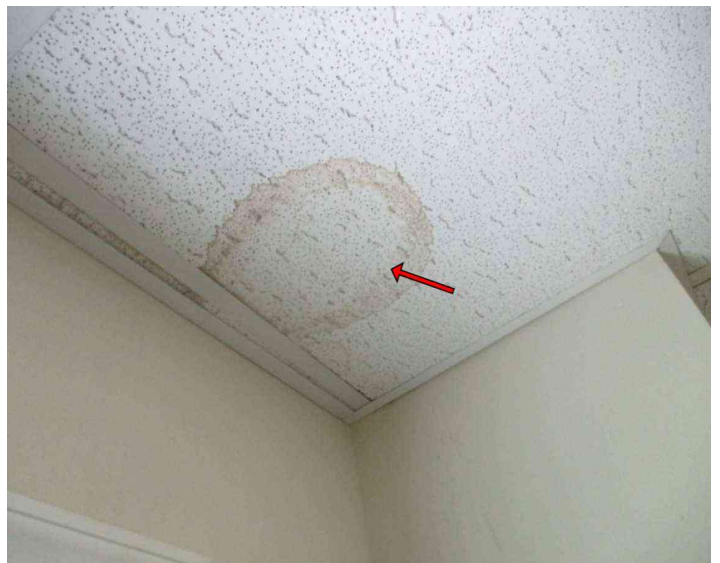
2105: Interior Ceilings

Other = Drop ceilings limit inspection. Some sagging areas were noted and should be repaired. Unit 2
Some stains were noted and were dry at inspection. unit 1

Currently wet areas of the drop ceiling was noted. The source should be identified and all needed repairs should be made. Unit 3

Wet insulation was noted above the drop ceiling and should be replaced as needed.

Some mold/mildew was noted and should be evaluated and cleaned by qualified personnel. As mold and mildew are not part of the home inspection the client may decide to do further evaluation to determine the extent of the problem and cost to cleanup/repair.

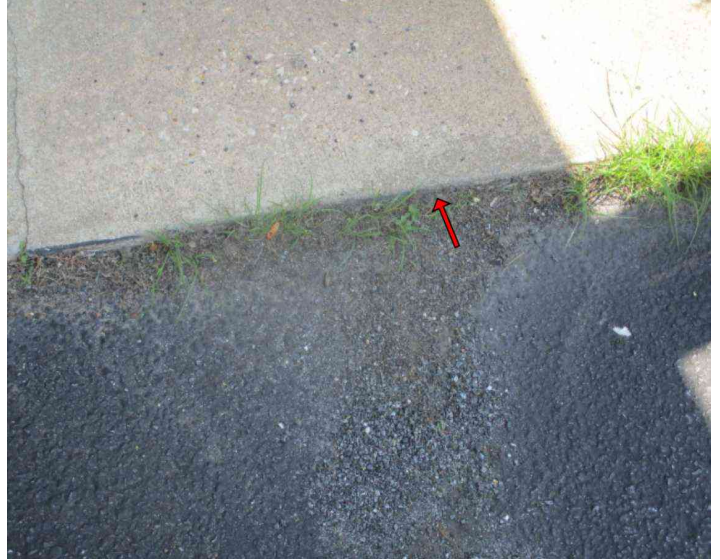
0202: Walks

Cracks and some settlement noted.
Uneven areas present tripping hazard and should be repaired.

Cracks and some settlement noted. Uneven areas present tripping hazard and should be repaired.

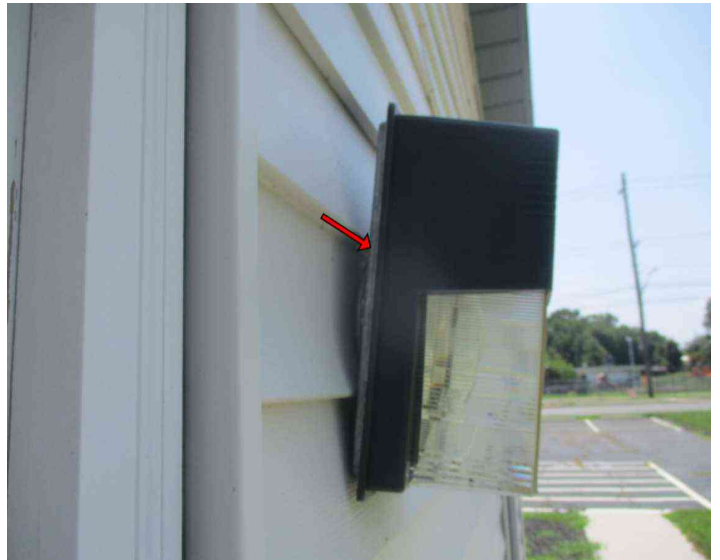
0302: Outside Outlets

Loose fitting light fixture was noted and should be repaired. Unit 3

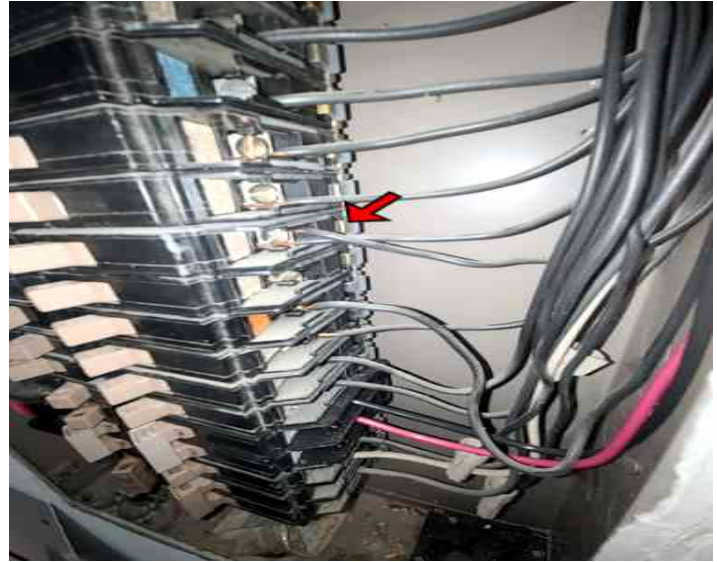
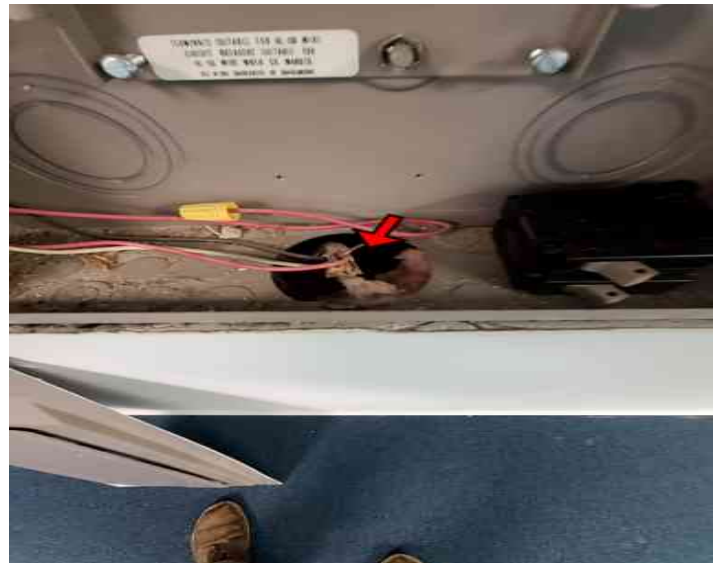
0919: Electrical Defaults

Double tapping was noted and should be repaired. Left panel.

The missing panel cover knock out seals should be replaced. Right panel.

Unused wiring in the right panel and should be made safe.

Metal boxes mounted on foundation walls should have blocking behind them. Some rust was noted and should be repaired.

Extension cords feeding devices in basement should be removed and replaced with permanent wiring.

Some lights at unit 2 did not work and should be evaluated and repaired.

Some lights did not work at unit 1 and should be evaluated and repaired.

Condensation was noted at the light fixtures above the drop ceiling at unit 3. Source should be identified and all needed repairs should be made. Light fixtures should be further evaluated to ensure no damage to the fixtures.

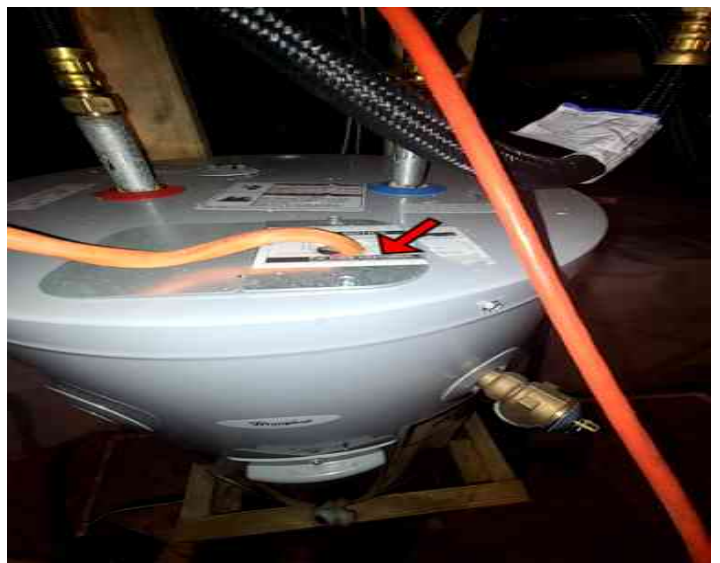
1107: Water Heater Fuel

An electrical connector was missing at the water heater and should be replaced.

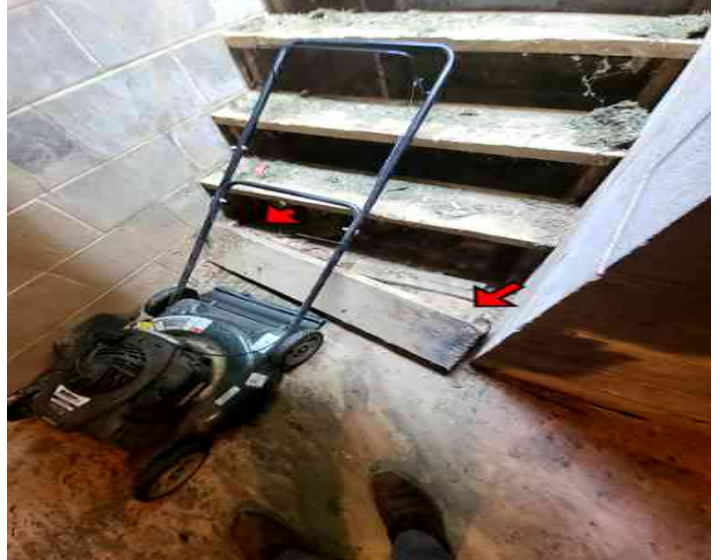
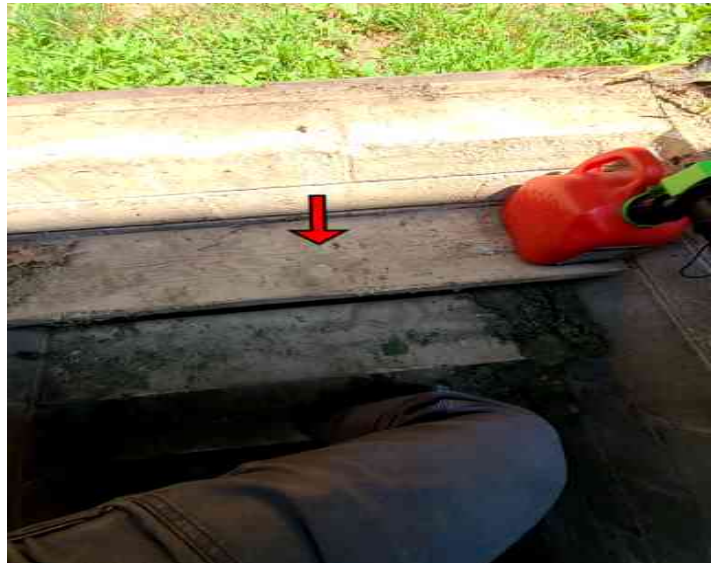
1503: Basement Access

Other = Bilco doors.

Damage and loose steps were noted and should be repaired.

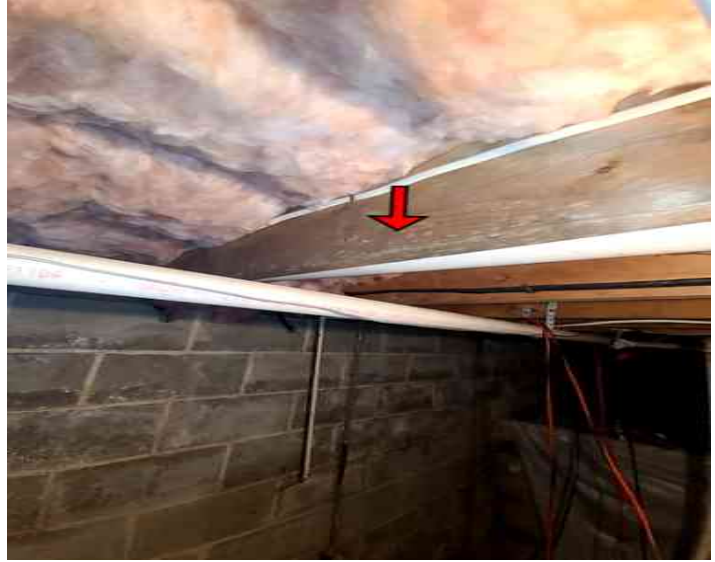
1511: Basement Ceiling Joist Visible Primary Type

Some mold/mildew was noted in the in framing and should be evaluated and cleaned by qualified personnel. As mold and mildew are not part of the home inspection the client may decide to do further evaluation to determine the extent of the problem and cost to cleanup/repair.

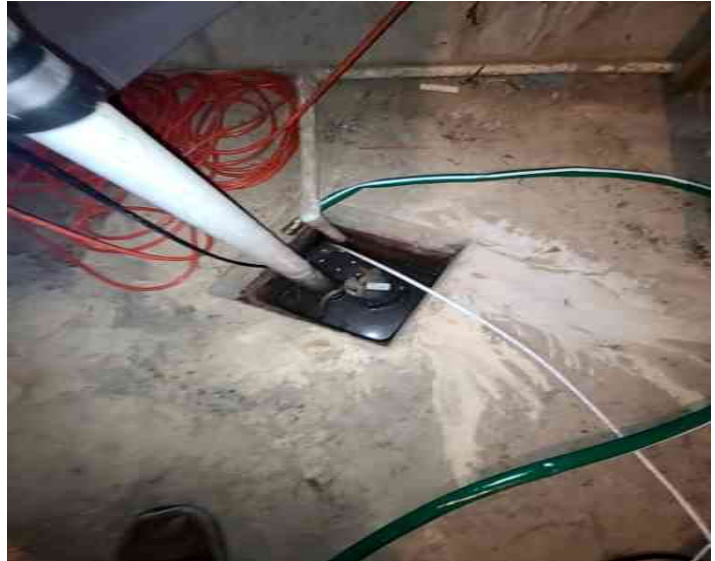
1514: Basement Drainage

Recommend adding cover.

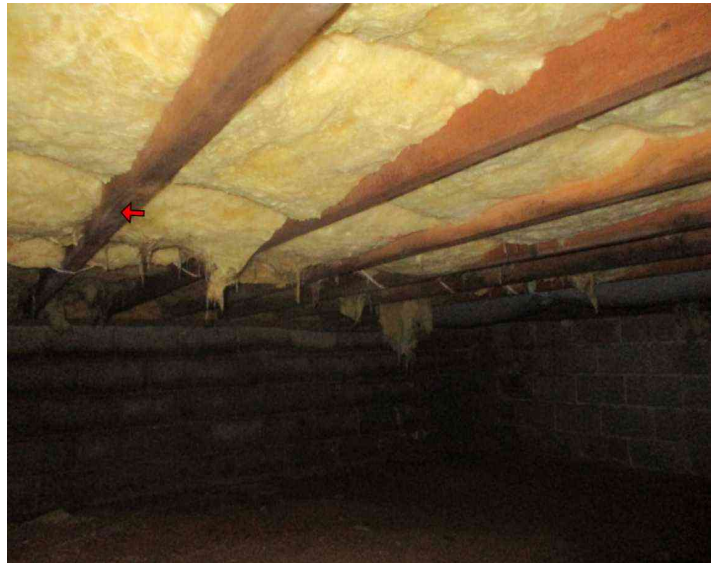
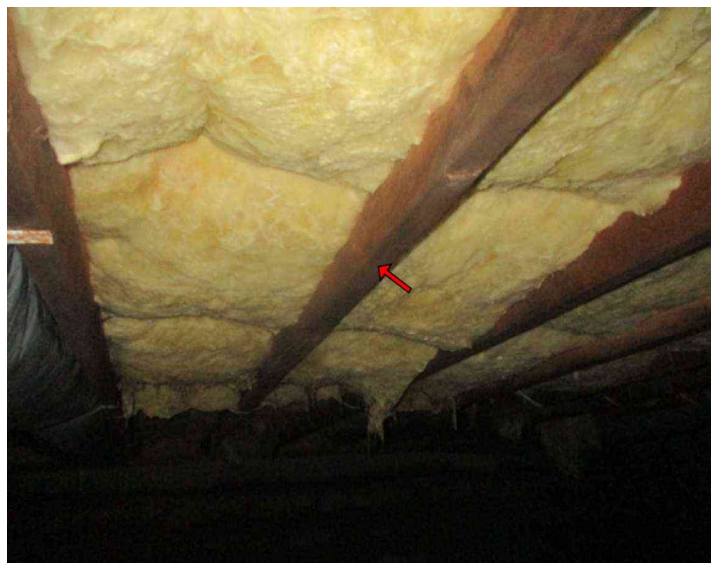
1609: Crawl Space Ceiling Joist

Some mold/mildew was noted in the crawl space and should be evaluated and cleaned by qualified personnel. As mold and mildew are not part of the home inspection the client may decide to do further evaluation to determine the extent of the problem and cost to cleanup/repair.

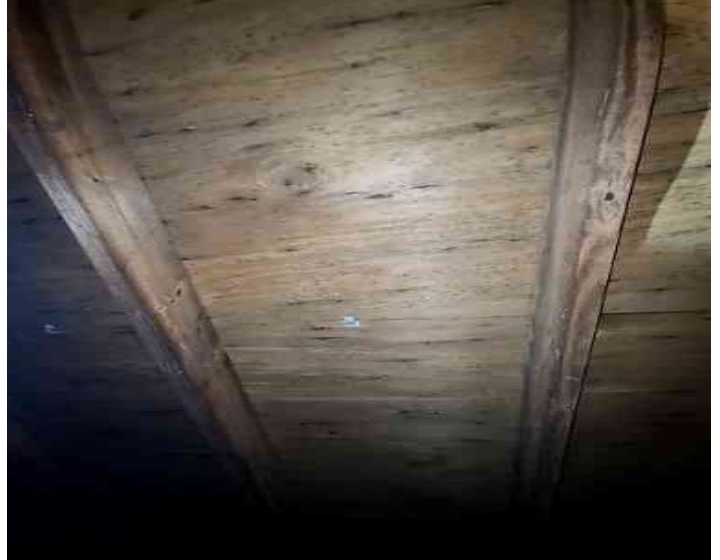
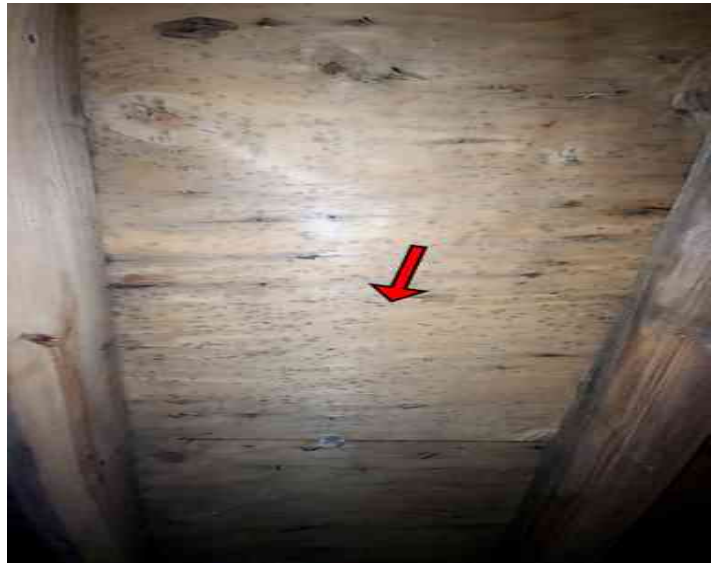
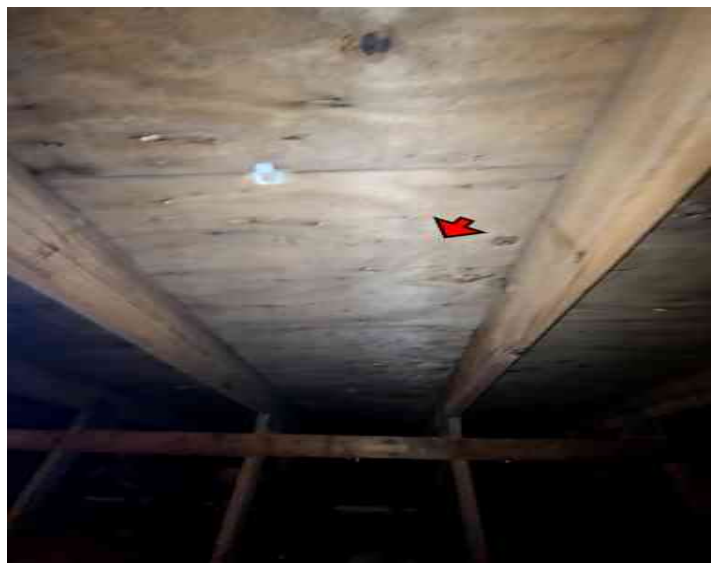
2007: Attic Sheathing

Some mold/mildew was noted in the attic and should be evaluated and cleaned by qualified personnel. As mold and mildew are not part of the home inspection the client may decide to do further evaluation to determine the extent of the problem and cost to cleanup/repair.

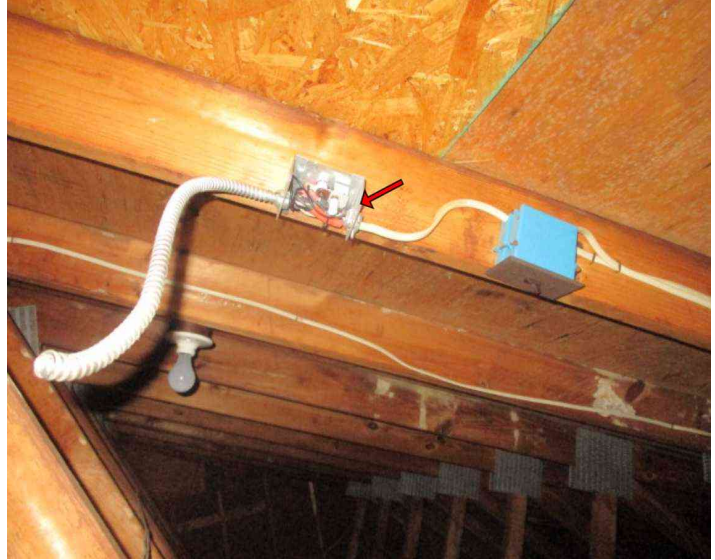
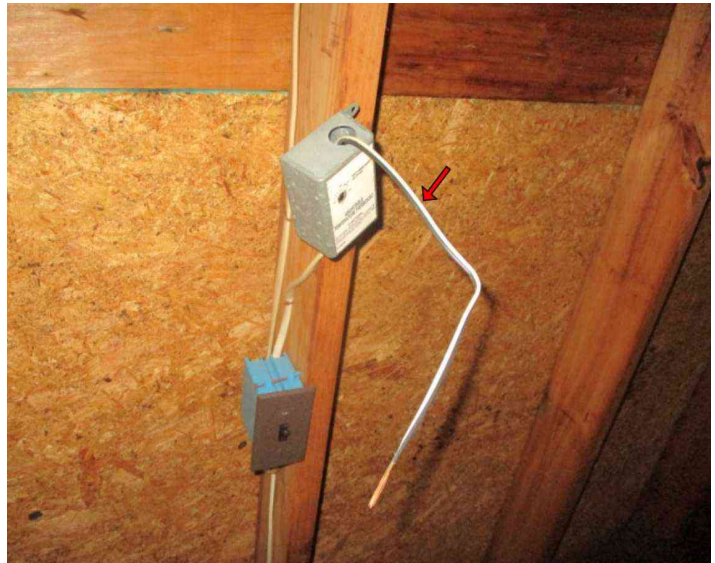
2012: Attic Wiring

Hot exposed wiring was noted and should be repaired.

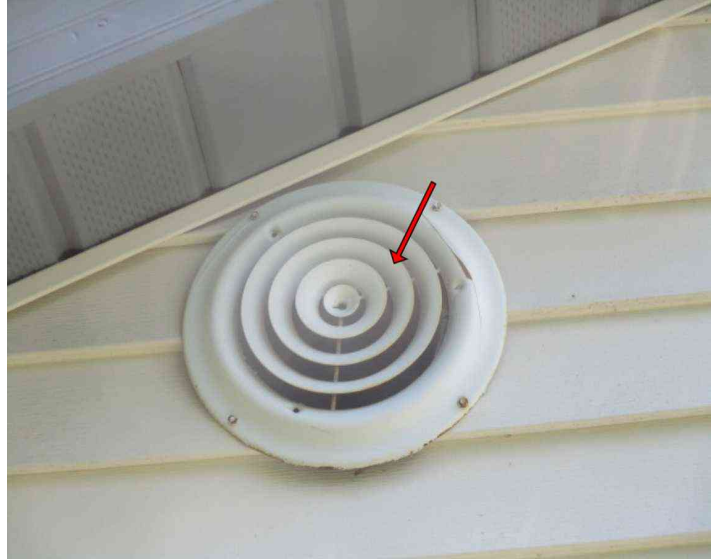
0301: EXTERIOR

Missing screen was noted at the exterior vent and should be repaired.

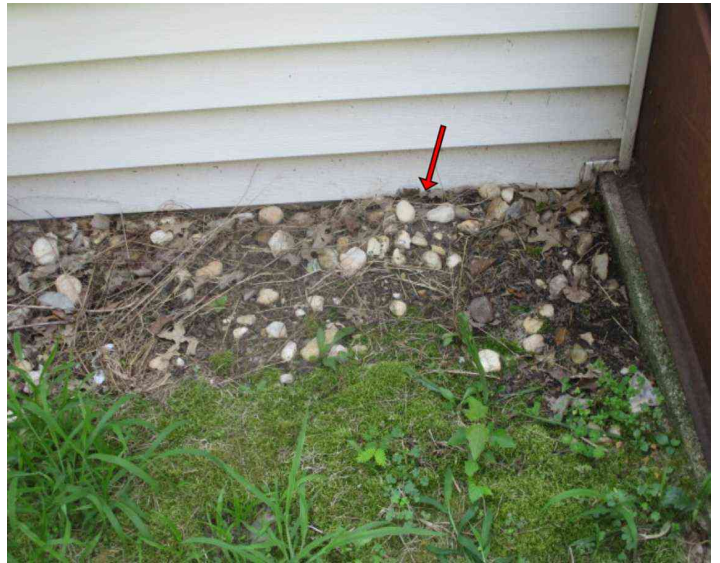
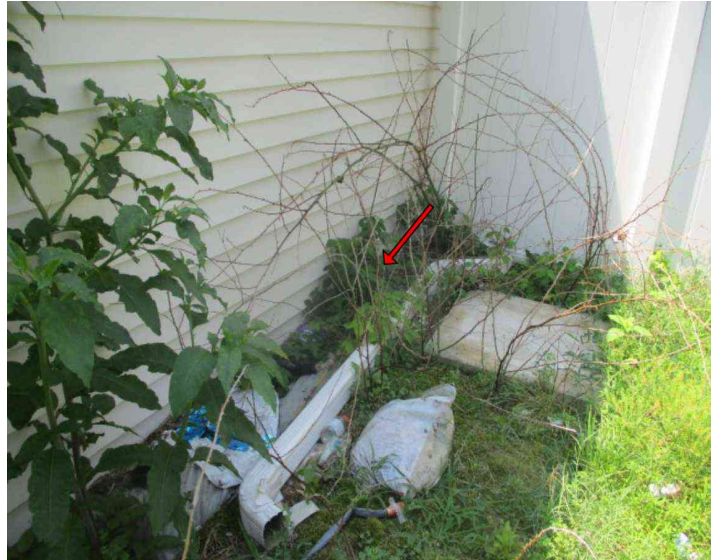
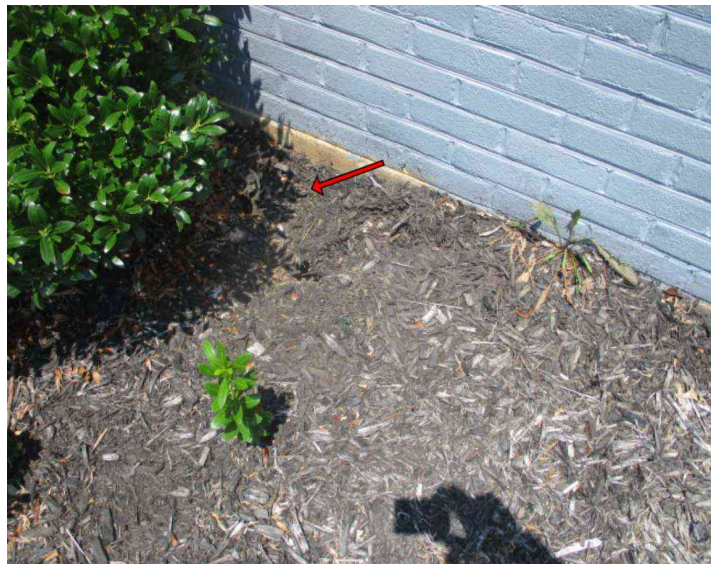
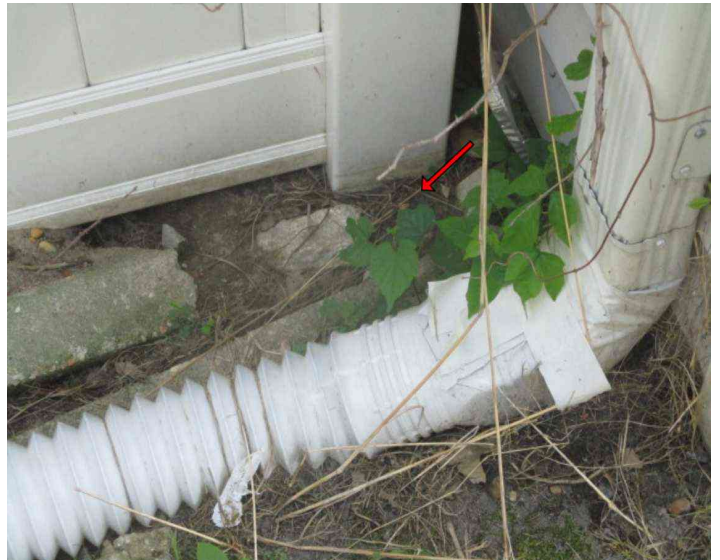
0307: Grading

Soil should be sloped away from house to improve drainage.
Siding makes soil contact and soil should be redressed to allow 6" to 8" of clearance below siding .
Some erosion was noted and should be repaired.

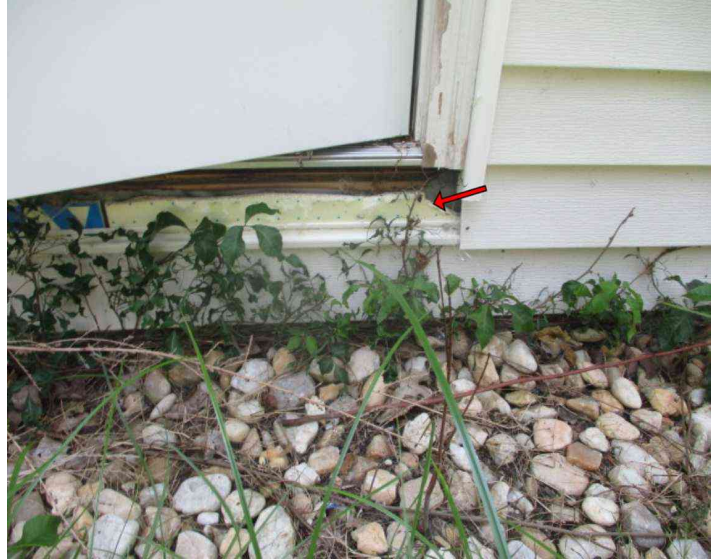
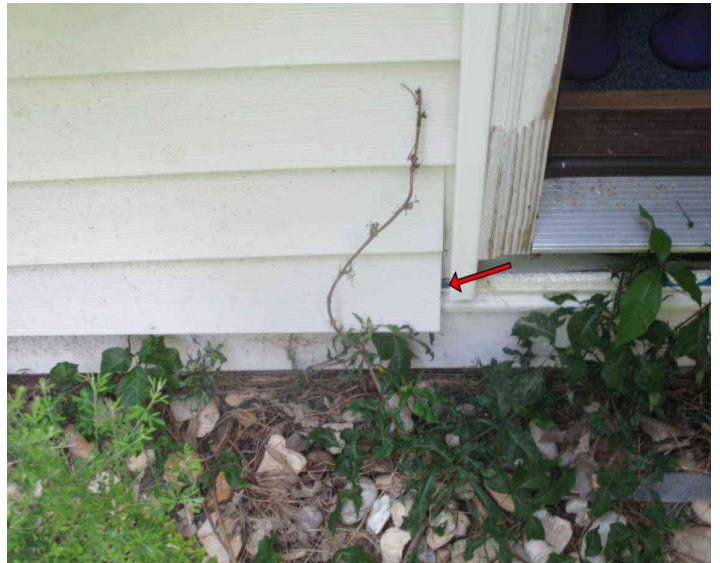
0308: Siding

Loose fitting and missing section was noted and should be repaired.
Some damage was noted and should be repaired.

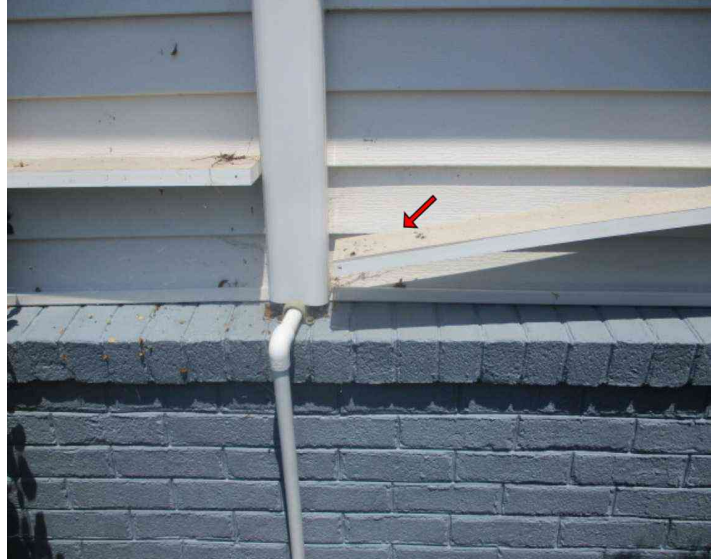
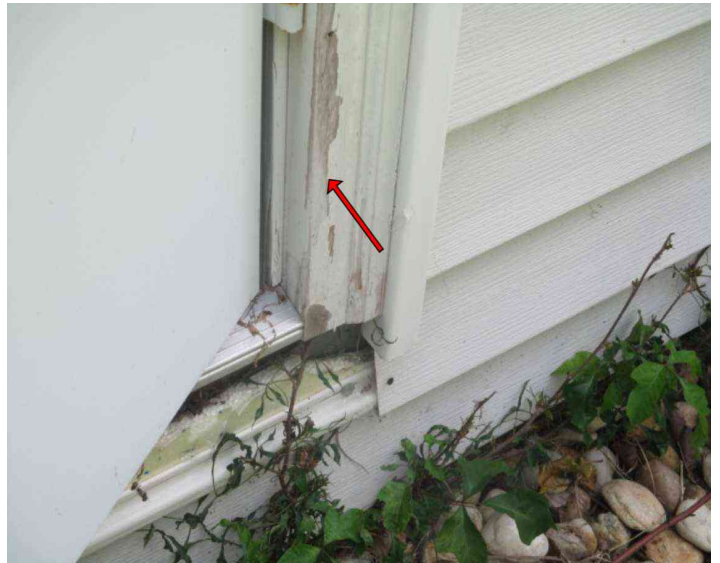
0310: Trim Work

Some loose paint and wood rot noted.
Loose fitting areas were noted and should be repaired.

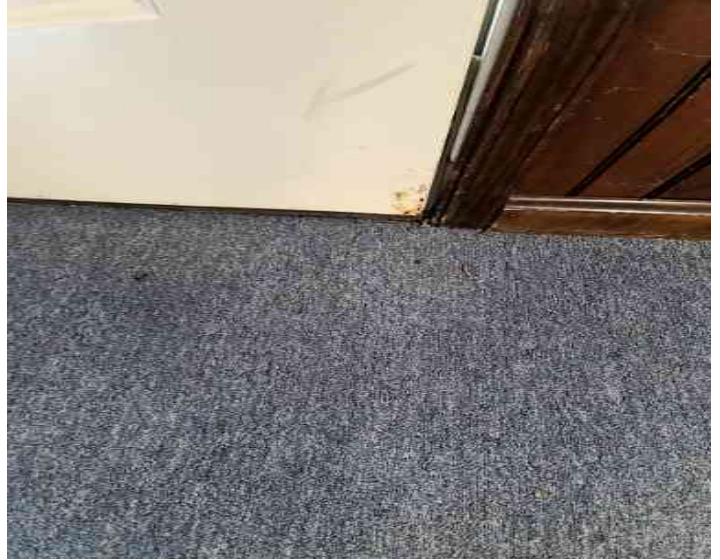
0311: Entry Doors

Rust was noted at the front entry door at unit 3.
