Reliable Home Inspection Service
100 Old Kennet Rd
Wilmington, DE 19807
302-993-9100
<https://www.reliablehomeinspectionsservice.com/>

FRONT VIEW

Inspection Summary

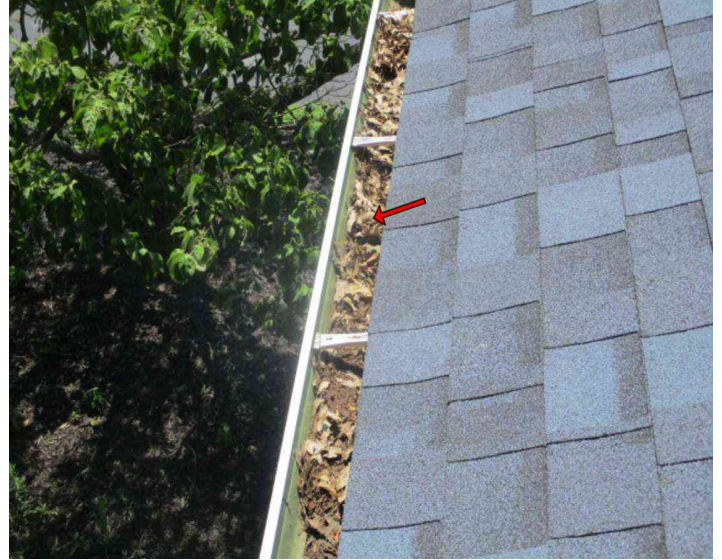
0404: Gutter Type

Gutters should be cleaned regularly to prevent rot and roof damage.

The gutters have debris in them and should be cleaned.

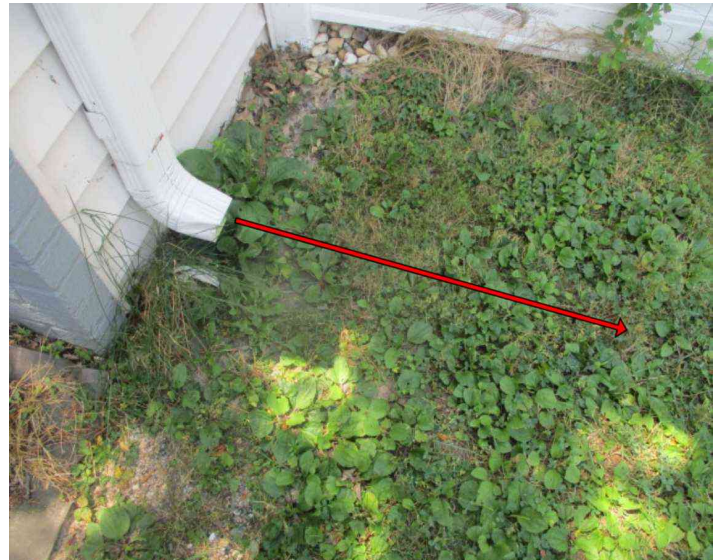
0408: Splash Blocks

Run off drains should be added. Run-off drains would carry water further away from foundation than splash blocks, and are recommended.

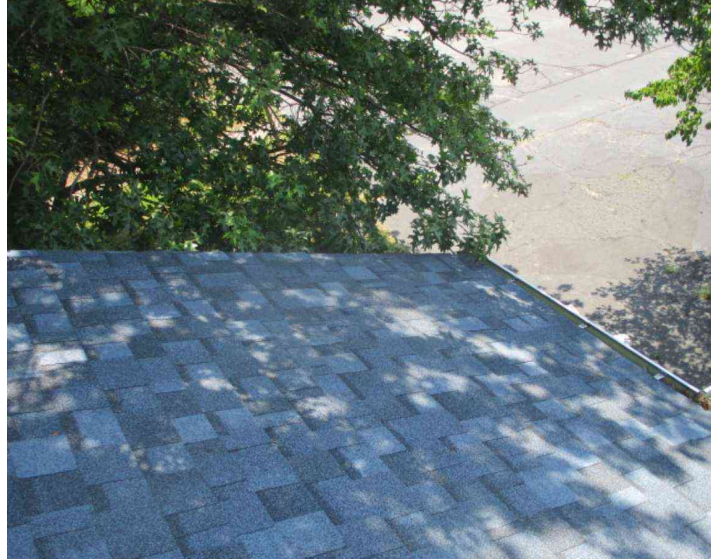
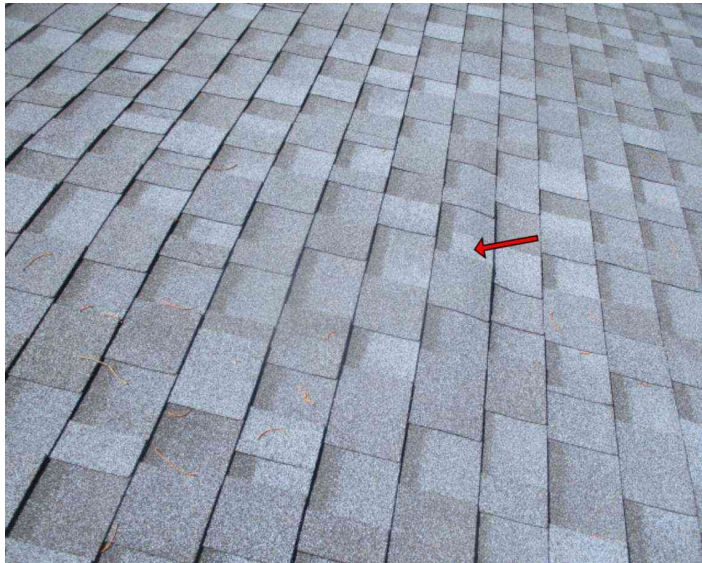
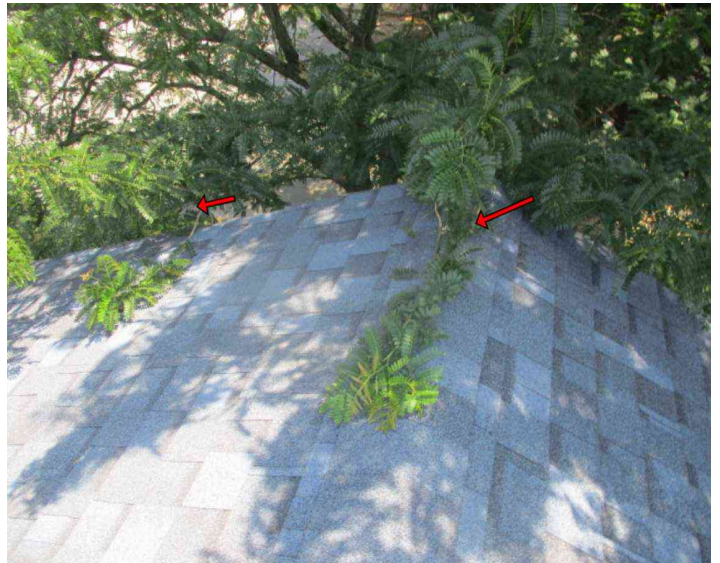
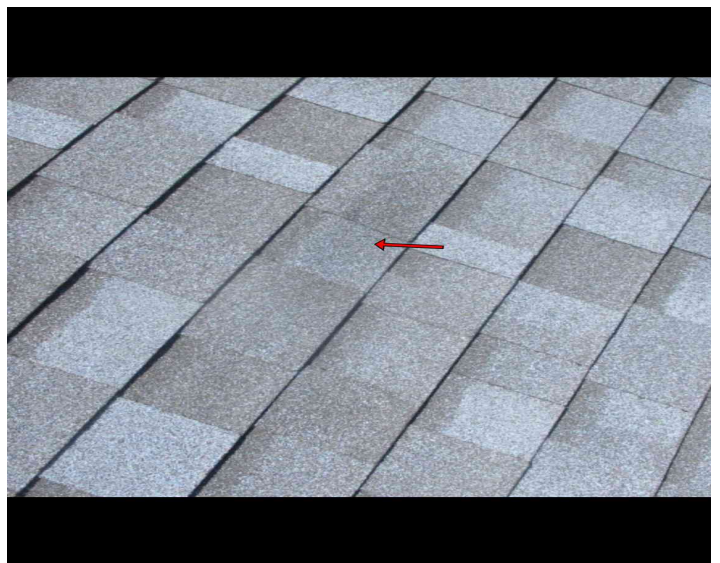
0505: Roof Covering Primary Type

Tree limbs should be cut back from the roof.
Raised areas of the sheathing was noted and should be repaired.
Some waviness was noted.

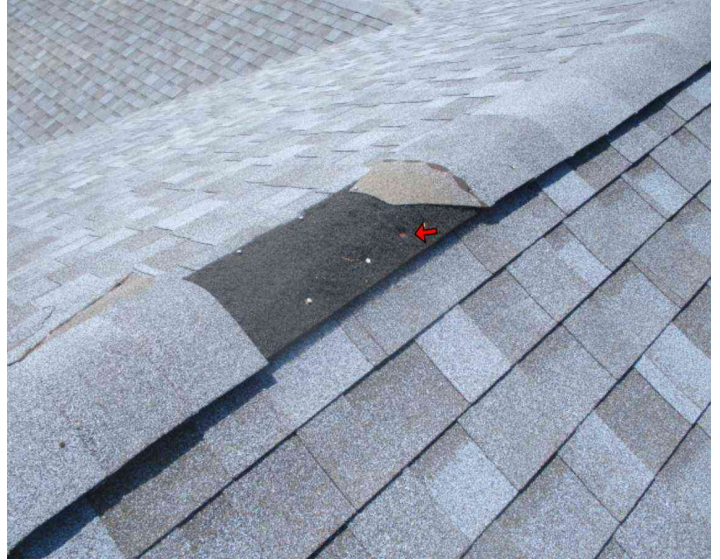
0508: Roof Ventilation System

Missing sections of shingles were noted at the ridge vent and should be repaired.

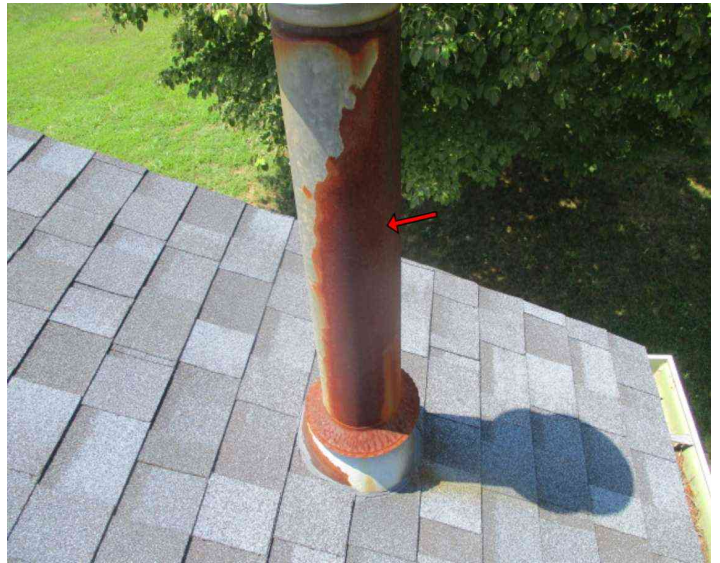
0604: Chimney 1 Type

Some rust was noted. Paint with `Rustoleum` or a similar product.

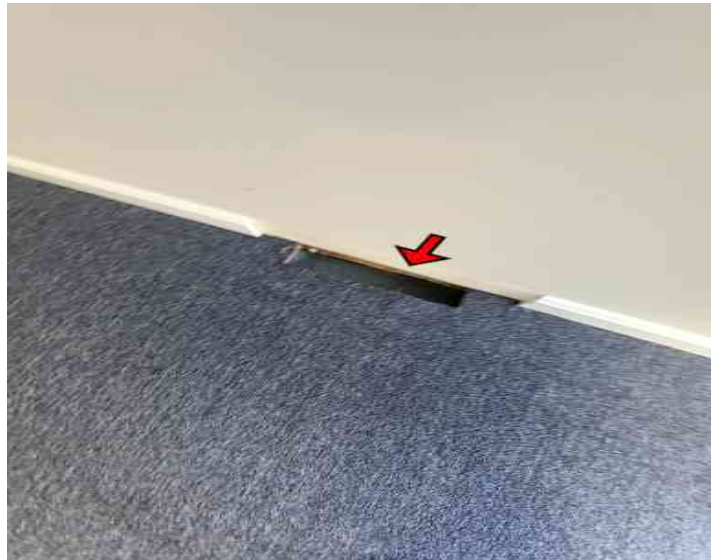
1311: Distribution System Material

Missing vent cover was noted and should be repaired.
Unit 3

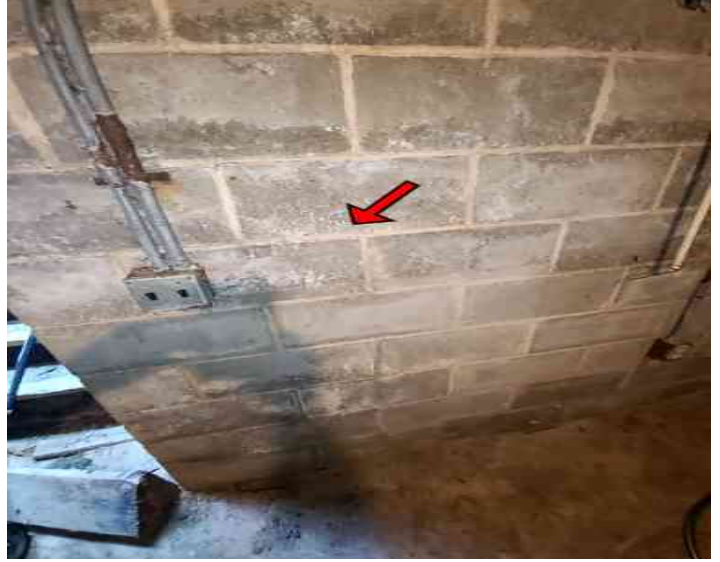
1504: Basement Foundation Walls Primary Visible type

Some cracks and water penetration noted.
There was efflorescence on the walls.

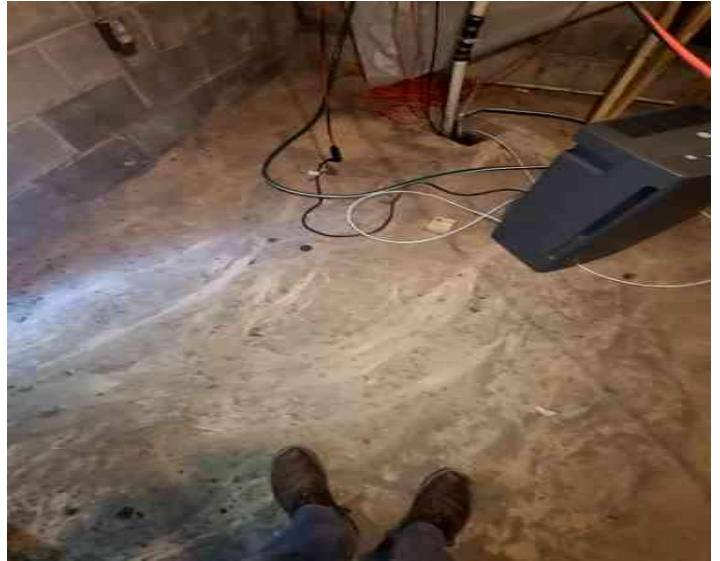
1506: Basement Floor

Some mud stains were noted and indicate water entry.

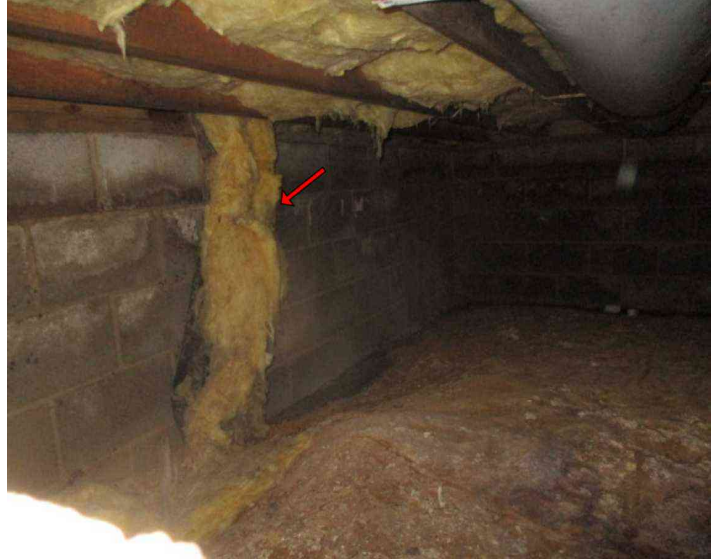
1610: Crawl Space Insulation

Insulation limits inspection.
Some insulation has fallen and should be replaced.

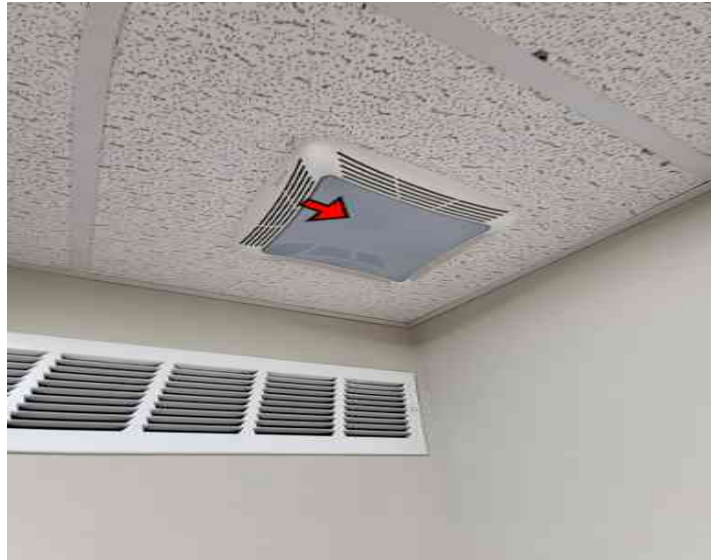
1803: Half Bath Electric Switches and Fixtures

Light was out at the fan light combo at unit 3 and
should be repaired.

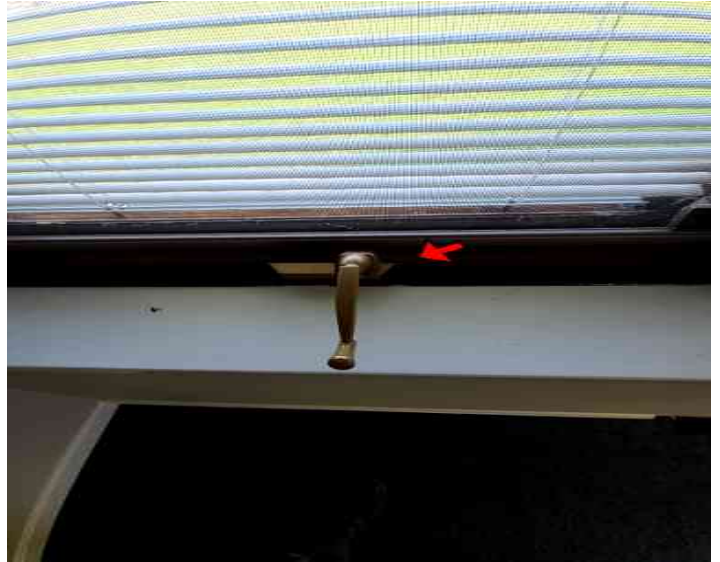
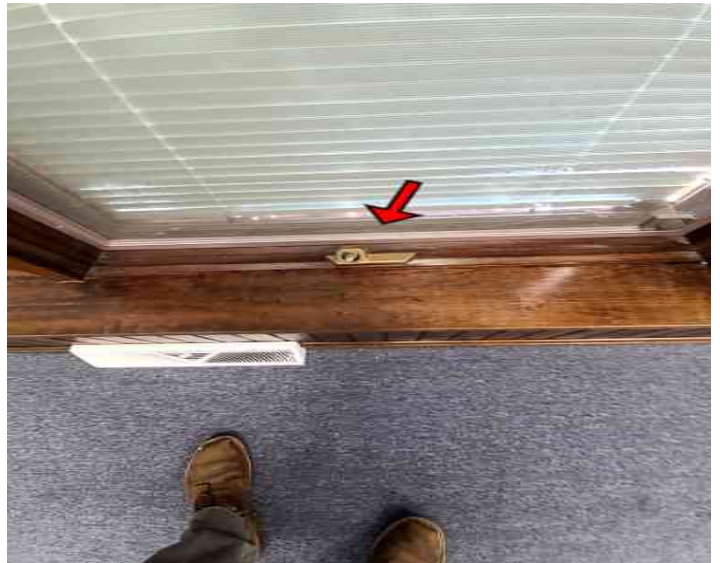
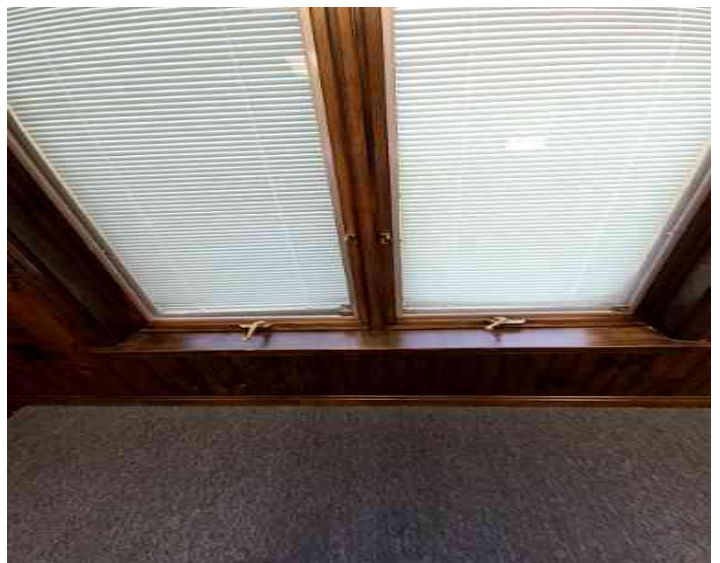
2122: Windows

Stripped crank at unit 3 window and should be repaired.

Some missing cranks were noted and should be repaired. Unit 3

Some casement windows were difficult to open. Unit 3

Both side casement windows did not close properly and should be repaired. Unit 3.

Right front window at unit 2 did not open and should be repaired.

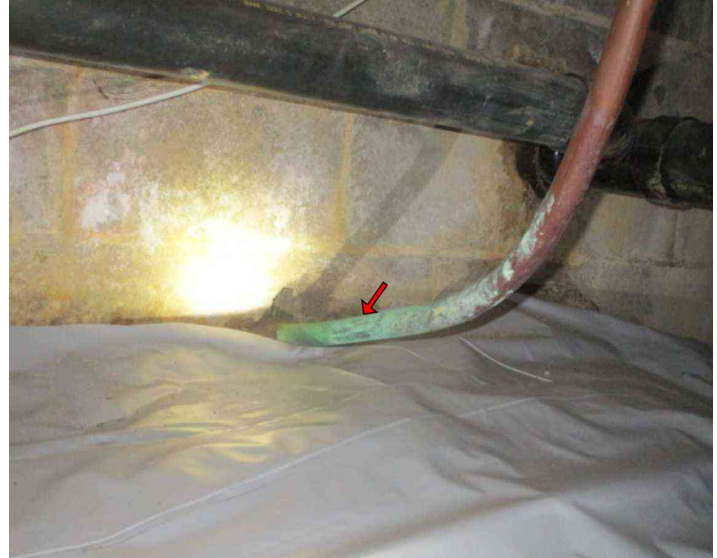
1004: Municipal Main Supply Type

Some discoloration was noted.
