RELIABLE HOME INSPECTION SERVICE

REHOBOTH BEACH, DE 19971

Inspected 4/25/18 9:00 AM

Inspection Summary

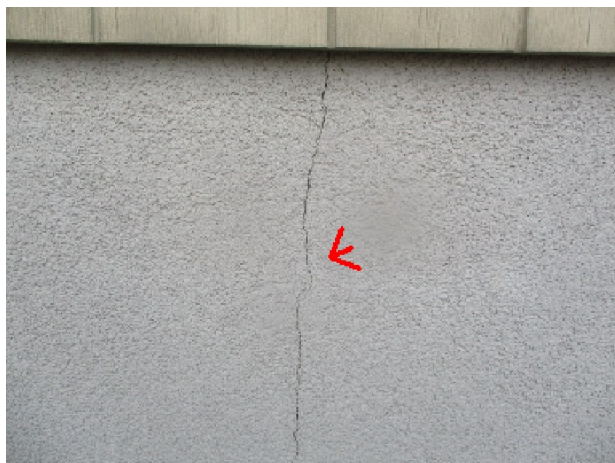
Type of Home

Some cracks were noted. Open area was noted. Open caulk joints were noted.

Exterior walls should be evaluated by a qualified contractor and all needed repairs should be made.

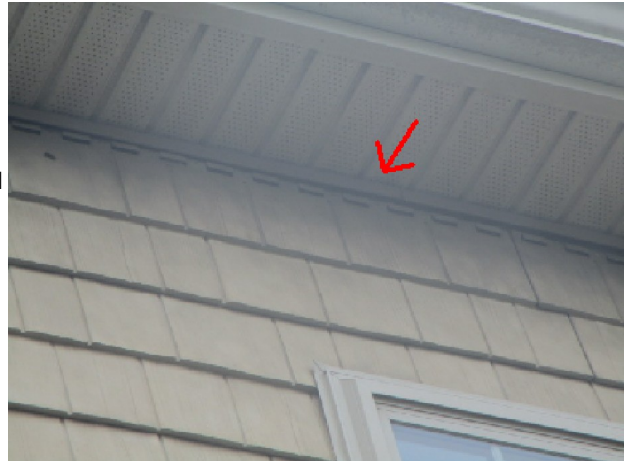
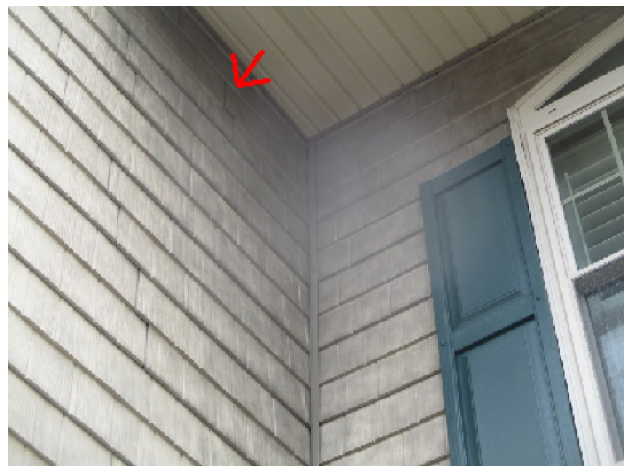
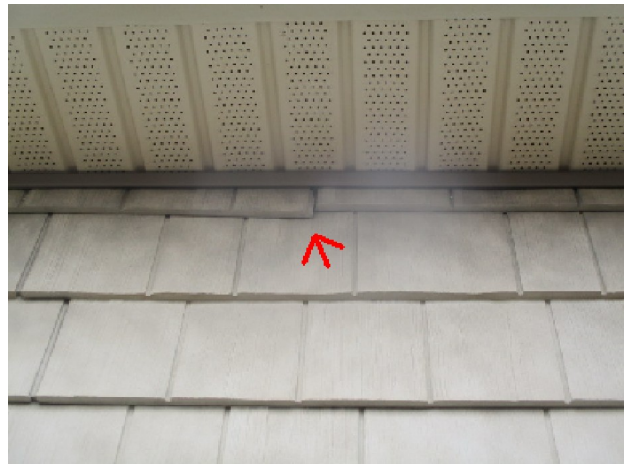
Siding

Some loose and poorly fitting areas were noted.
Some missing sections were noted.
Some staining was noted.
Mismatched section was noted.
Evidence of leakage was noted at multiple locations at the interior of the home.
All exterior walls should be evaluated by a qualified contractor and all needed repairs should be made.

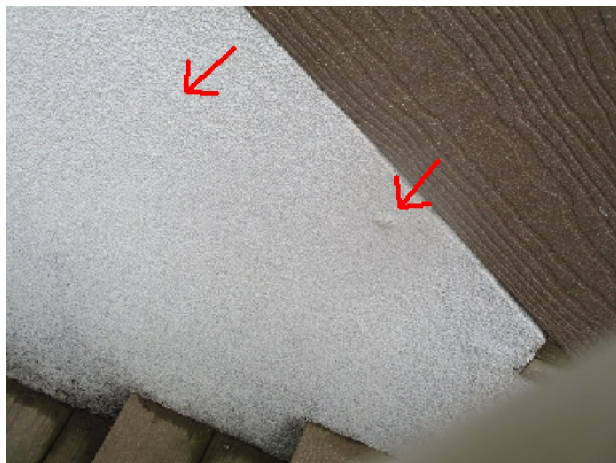
Masonry Walls

Some cracks were noted. Open area was noted. Open caulk joints were noted.

Exterior walls should be evaluated by a qualified contractor and all needed repairs should be made.

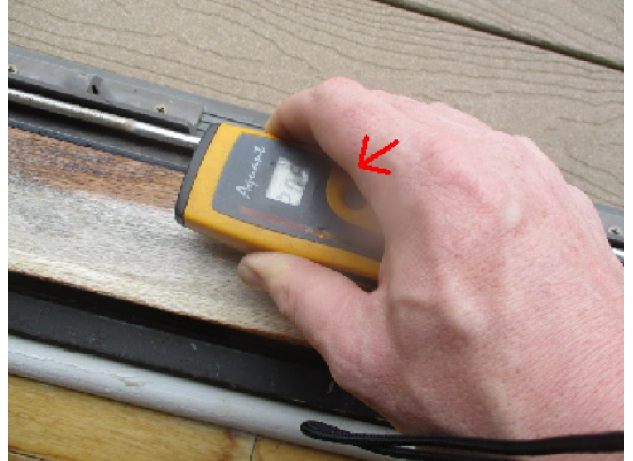
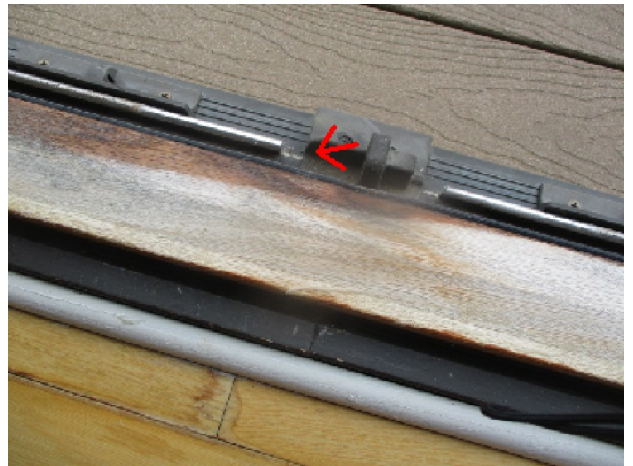
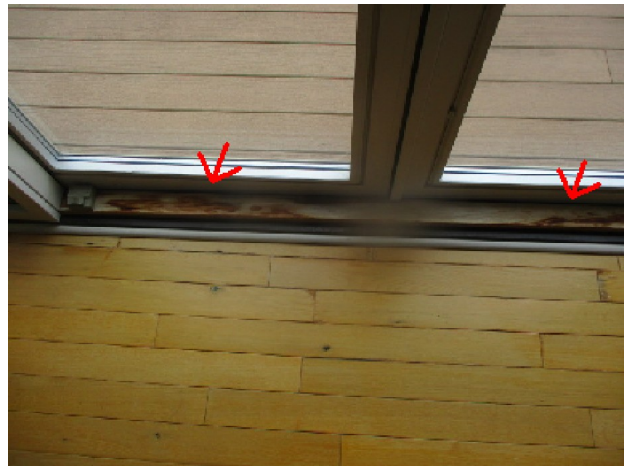
Patio Doors

Currently wet areas were noted at the dinning room sliding door. The door does not lock properly. Condensation was noted between insulated glass. The entire door system should be evaluated by a qualified contractor and all needed repairs should be made. Evidence of past leakage was noted to the slider in the family room. Recommend further evaluation by a qualified contractor and all needed repairs should be made. All sliding doors should be evaluated and all needed repairs should be made.

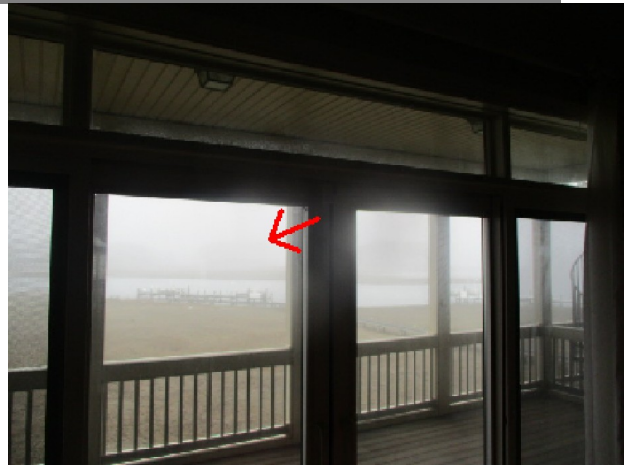
Evidence of past leakage was noted to the slider in the family room. Recommend further evaluation by a qualified contractor and all needed repairs should be made.

All sliding doors should be evaluated and all needed repairs should be made.

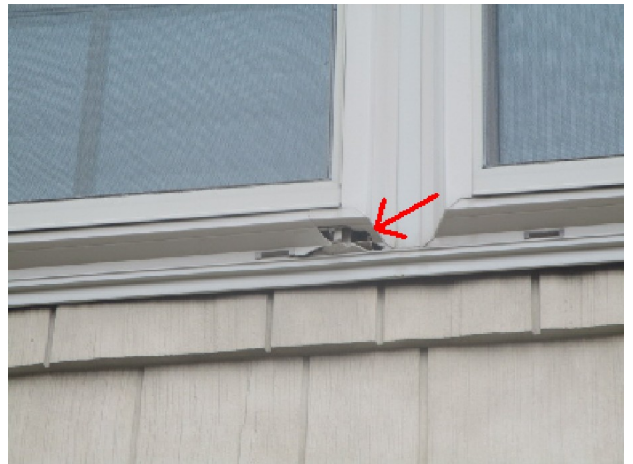
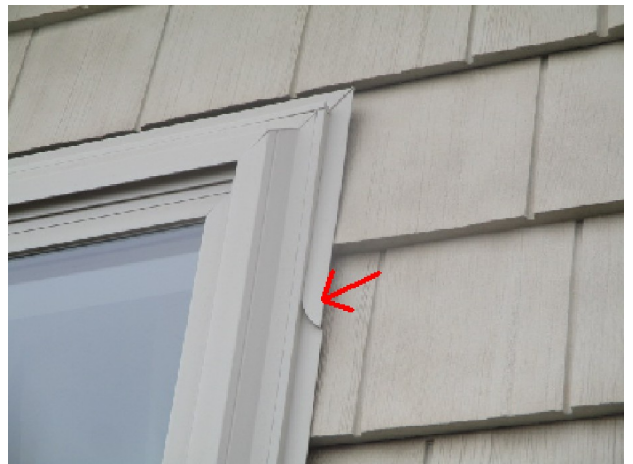
Window Character Material

Damaged front vinyl window and should be repaired or replaced.
Loose trim pieces were noted and should be repaired.

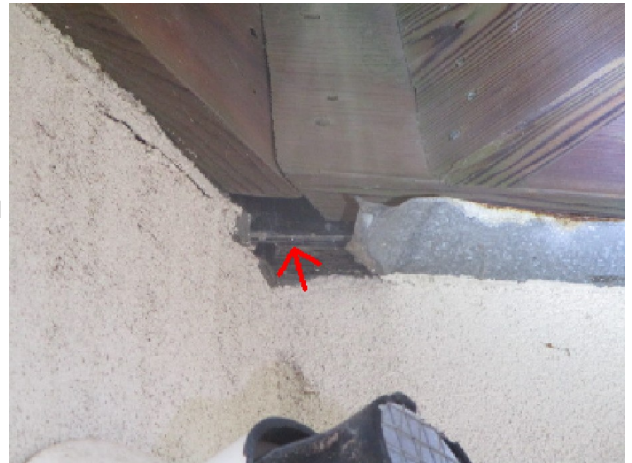
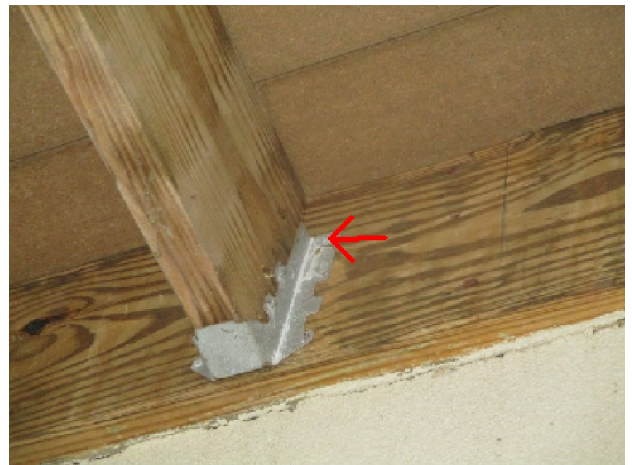
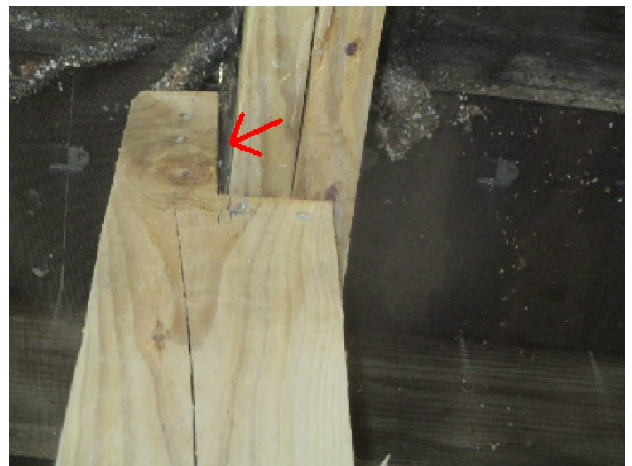
Decks

Other= Plastic decking.

Sagging areas were noted. Waviness was noted at the deck boards.

Missing lag bolts were noted at the supports under the deck.

Loose, missing and damaged lattice was noted.

The railings are leaning.

Improperly installed flashing or no flashing noted where the decks connects to the home.

Both deck systems should be evaluated by a qualified contractor and all needed repairs should be made.

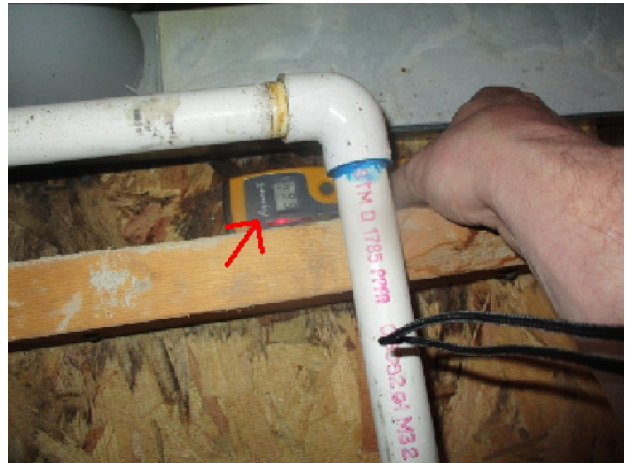
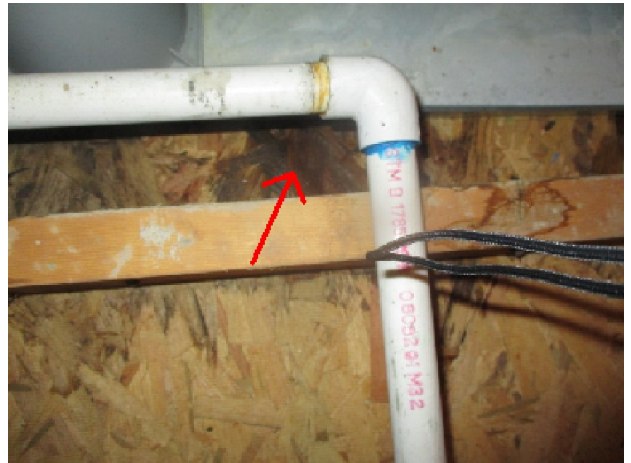
Condensate Drain

Active Leakage of the condensate in the attic drain line will cause staining and/or damage to the interior ceiling surfaces. Further evaluation by a qualified HVAC contractor is recommended and all needed repairs should be made.

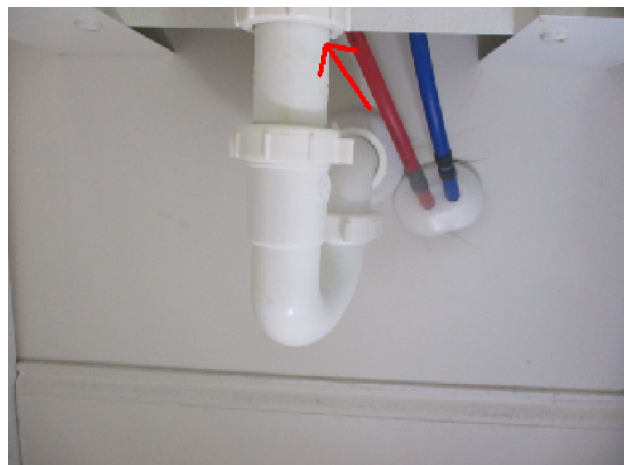
Laundry Sink Drain Trap

The drain pipe leaked when tested and should be evaluated and repaired. Lower level laundry tub.

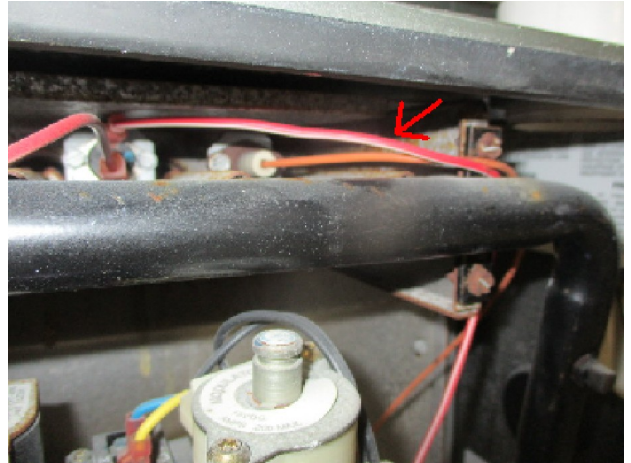
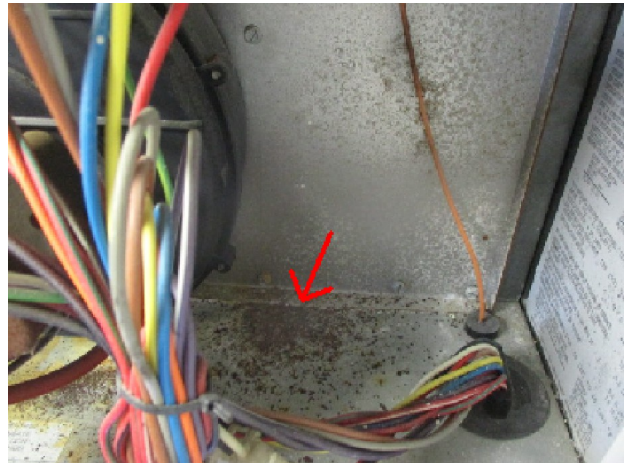
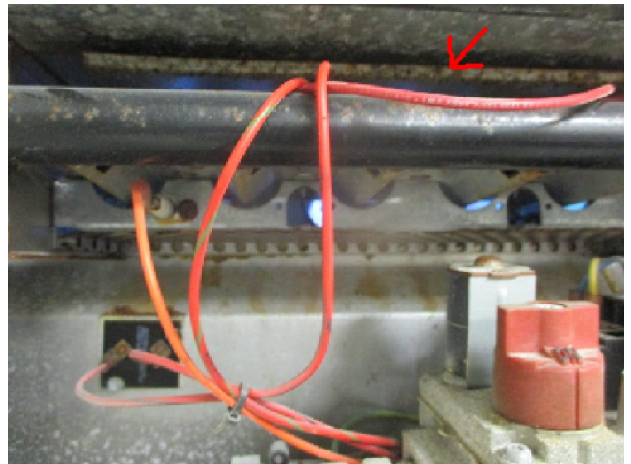
Heat Exchanger Visual

Large amounts of rust was noted at the heat exchanger. Both bottom units should be evaluated and serviced by a qualified heating contractor.

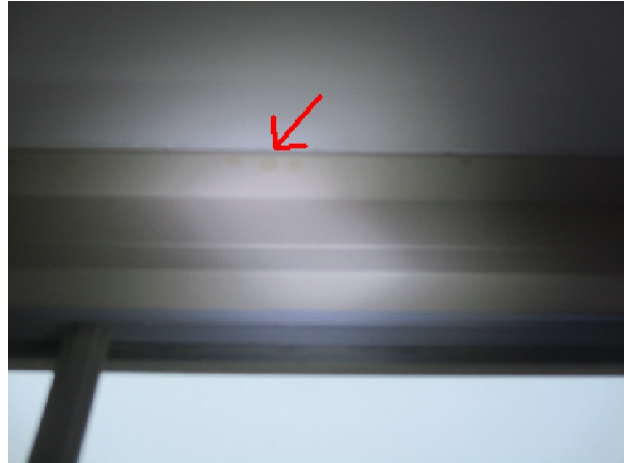
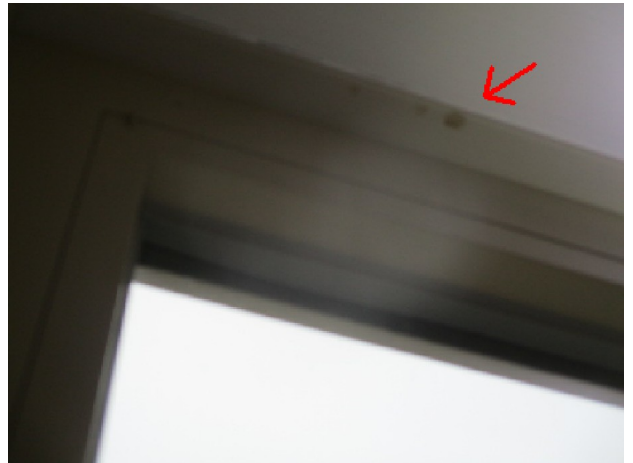
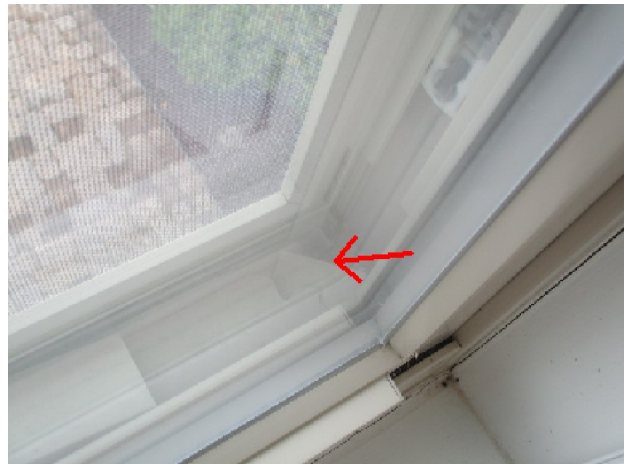
Bathroom Doors, Windows

Pocket door does not lock.

Condensation was noted between panes of insulated glass and the window should be replaced. Master bathroom.

Damage balance was noted. Damage to the vinyl sash was noted. Refer to major defect at interior windows.

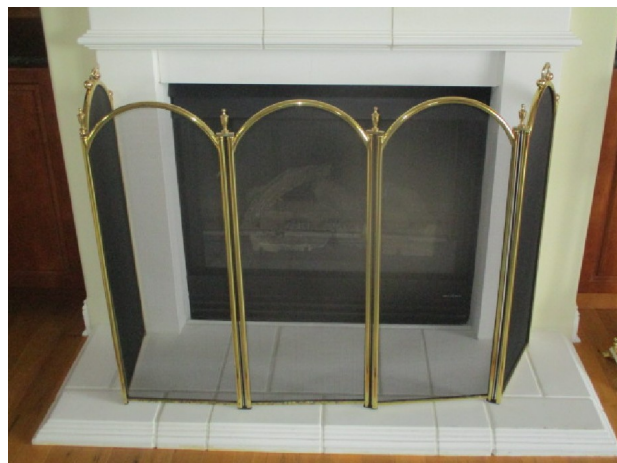
Interior Fire Place 1

The pilot was not lit and the fireplace was not tested. Operation should be demonstrated before settlement.

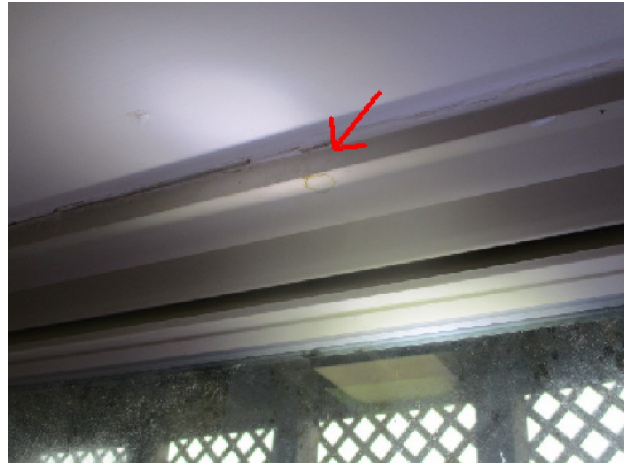
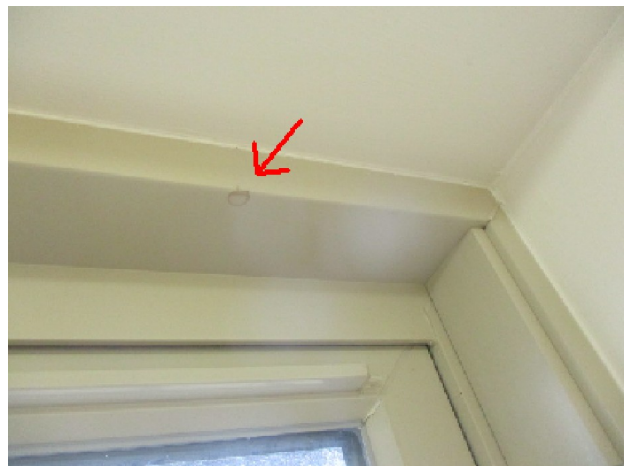
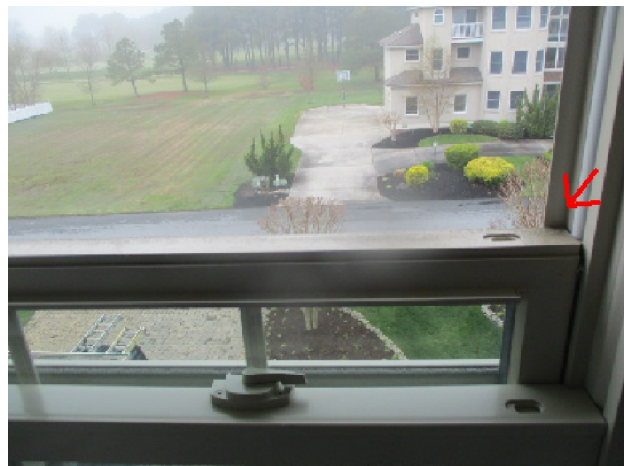
Windows

Damage balances were noted.
Condensation was noted between insulated multiple window panes.
Evidence of leakage was noted at multiple windows.
Damage safety clip was noted.
All windows should be evaluated by a qualified contractor and all needed repairs should be made.

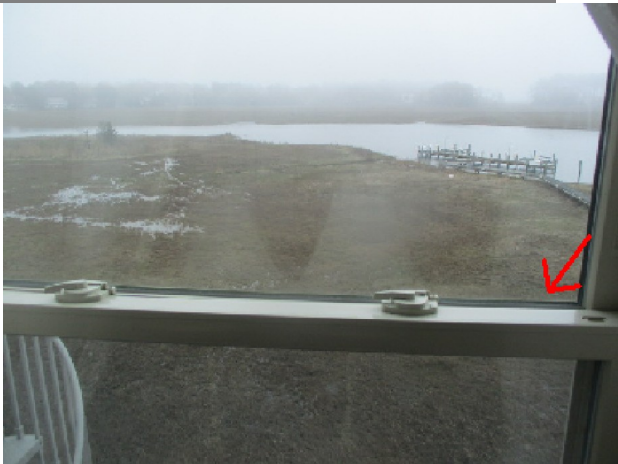
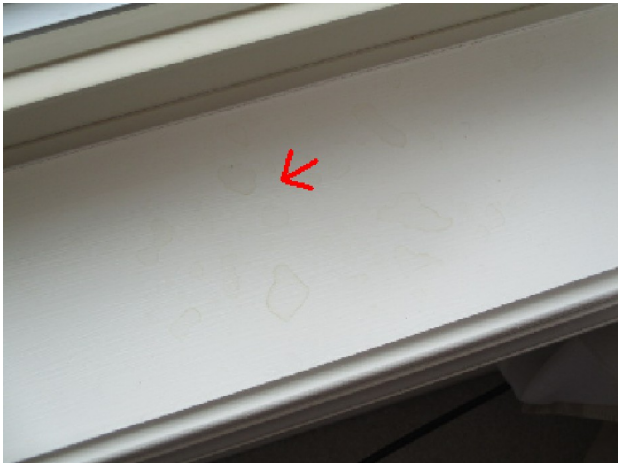
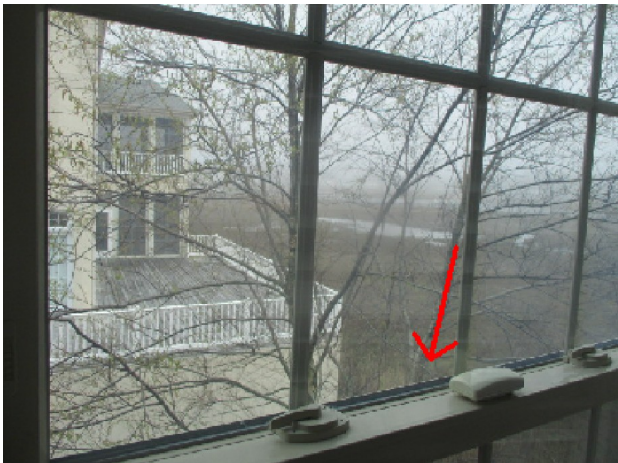
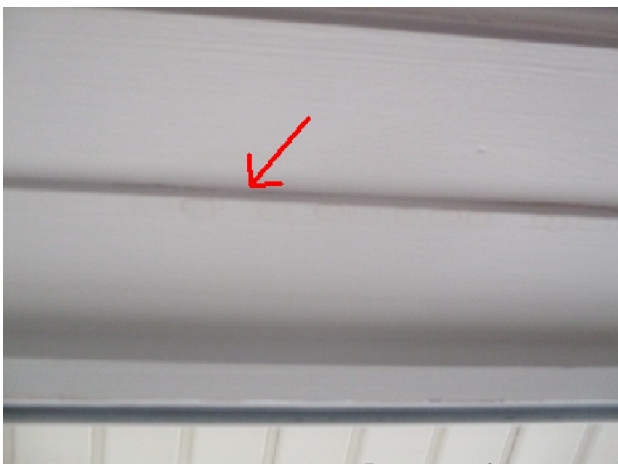
Damage balances were noted.
Condensation was noted between insulated multiple window panes.
Evidence of leakage was noted at multiple windows.
Damage safety clip was noted.
All windows should be evaluated by a qualified contractor and all needed repairs should be made.

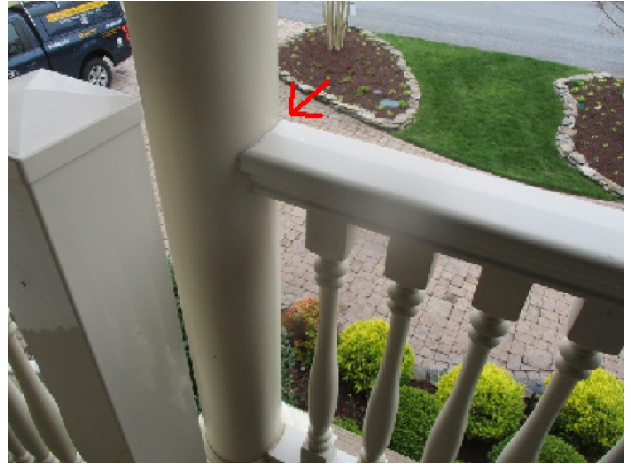
Hand Rail

Loose railings were noted at the front and should be repaired.

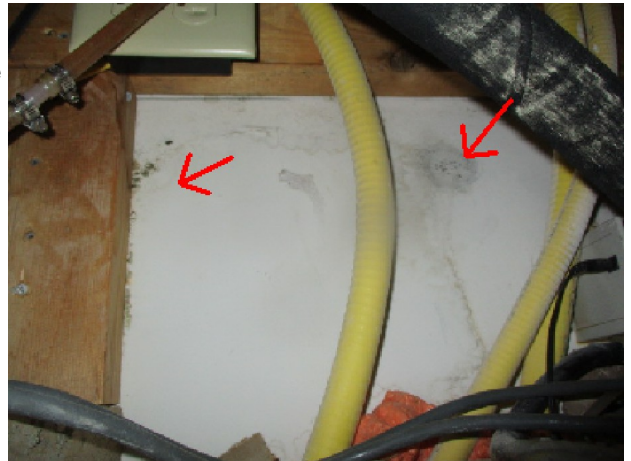
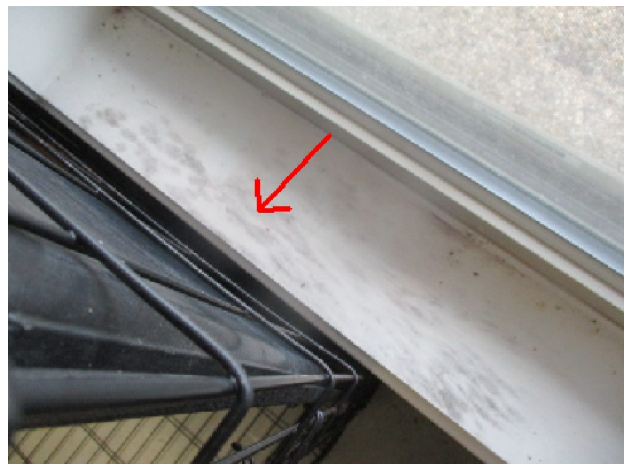
Garage Interior Walls

Some mold/mildew was noted on walls and should be cleaned by qualified personnel. As mold and mildew are not part of the home inspection the client may decide to do further evaluation to determine the extent of the problem and cost of cleanup/repair.

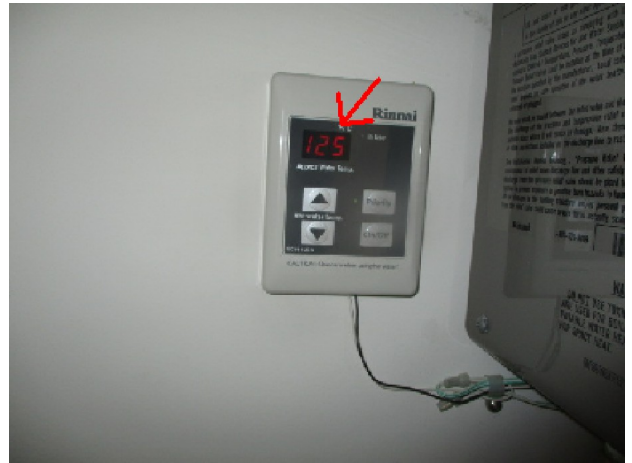
WATER HEATER

Water heater temp is above normal setting.

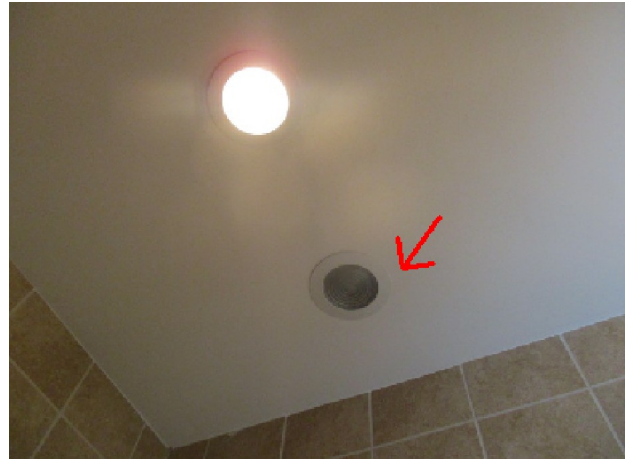
Bathroom Electric Switches and Fixtures

Light in the master shower did not work at time of inspection and should be evaluated and repaired.

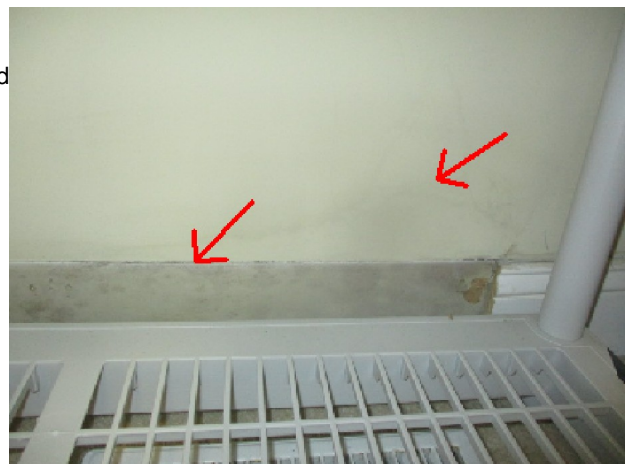
Interior Walls

Typical drywall flaws were noted.
Some mold/mildew was noted in the master closet/bathroom and should be evaluated and cleaned by qualified personnel. As mold and mildew are not part of the home inspection the client may decide to do further evaluation to determine the extent of the problem and cost to cleanup/repair.
Some stains were noted but were not wet at the time of inspection.

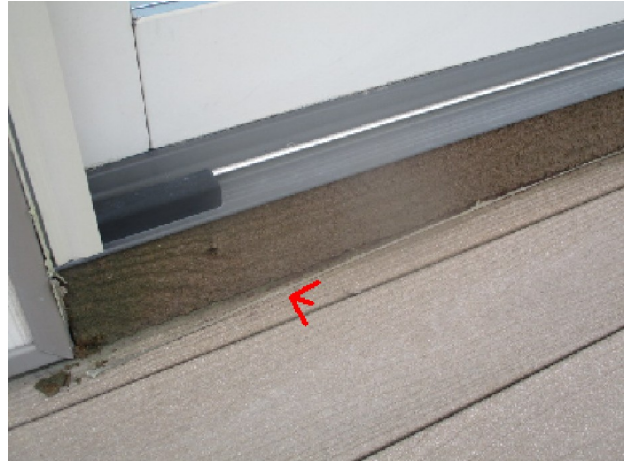
Trim Work

Rotted areas were noted under the dinning room sliding door and should be replaced.

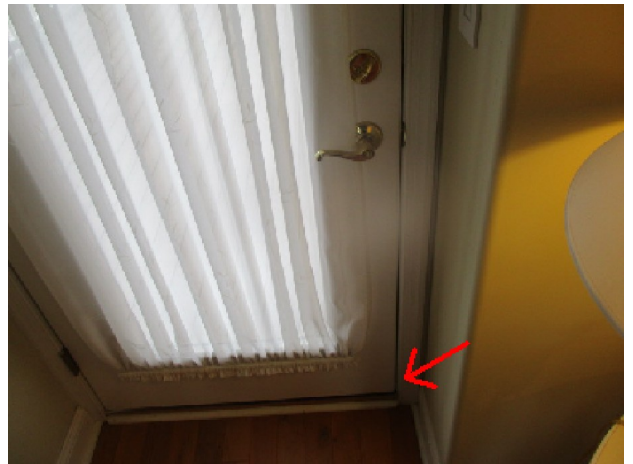
Entry Doors

Side door at the master bedroom does not close properly and should be repaired.(daylight was showing)

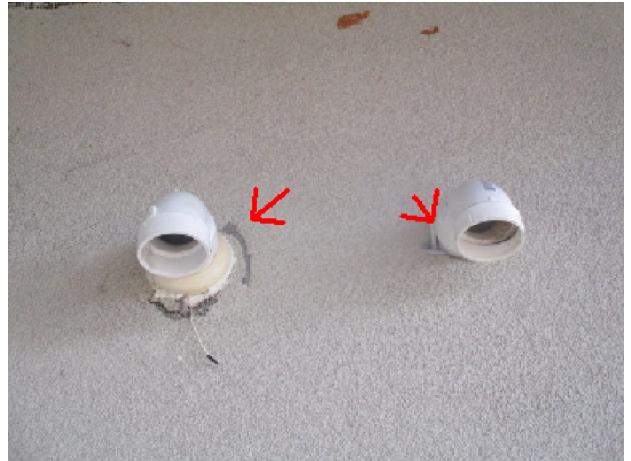
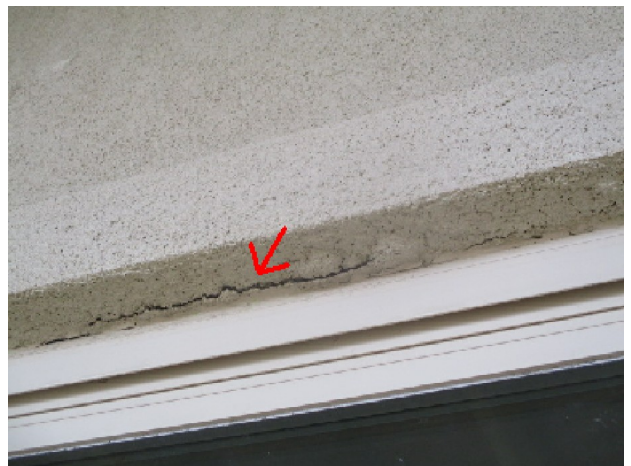
Caulking should be improved.

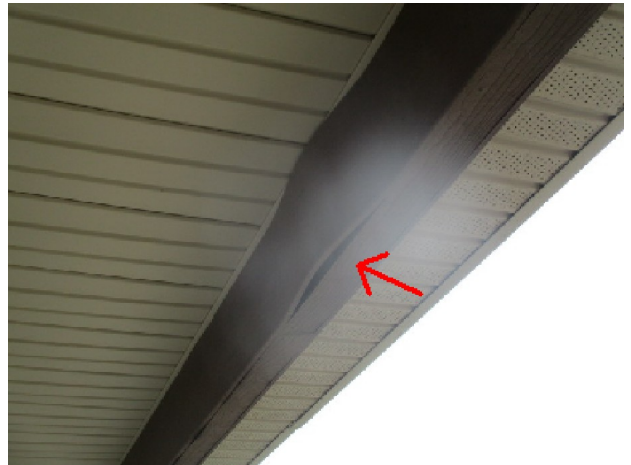
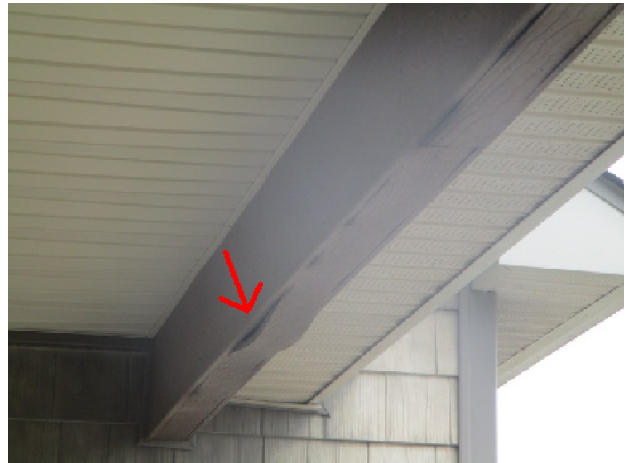
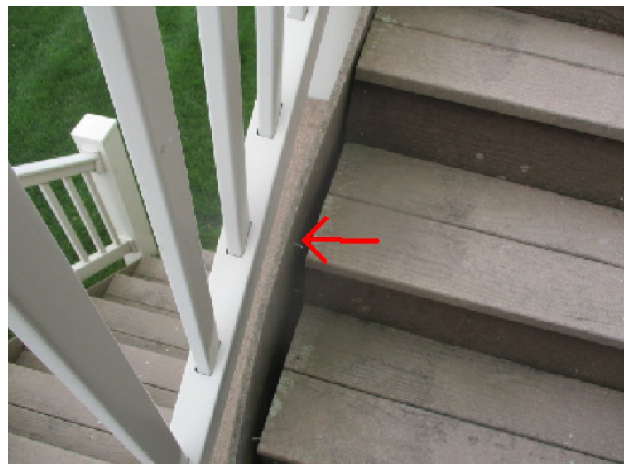
Porches

Other = Man made material with pressure treated framing.
Warped and loose fitting material was noted and should be repaired or replaced.

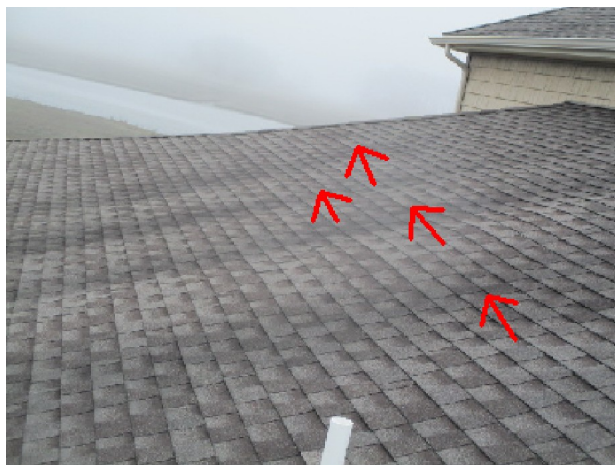
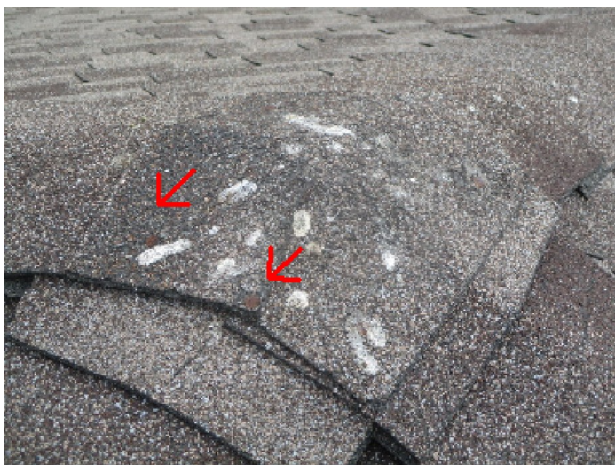
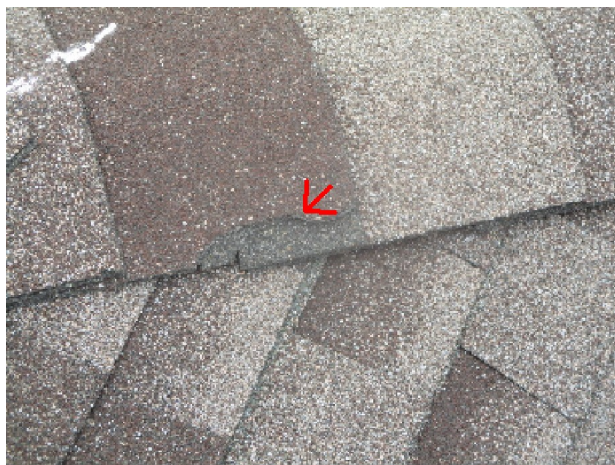
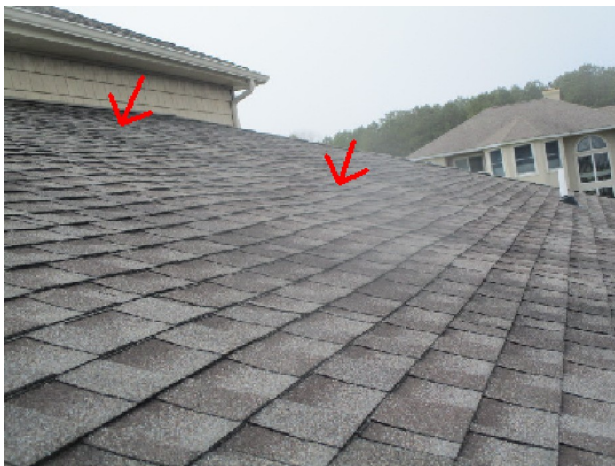
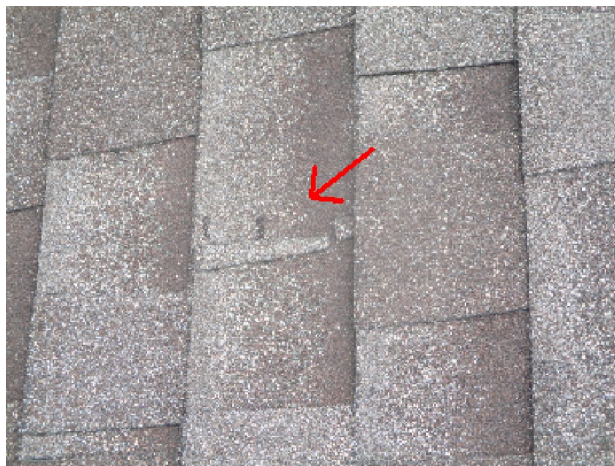
Roof Covering Primary Type

Nail heads should be sealed where exposed.
A few cracked shingles were noted and should be repaired.
Some waviness was noted.
Some staining was noted.

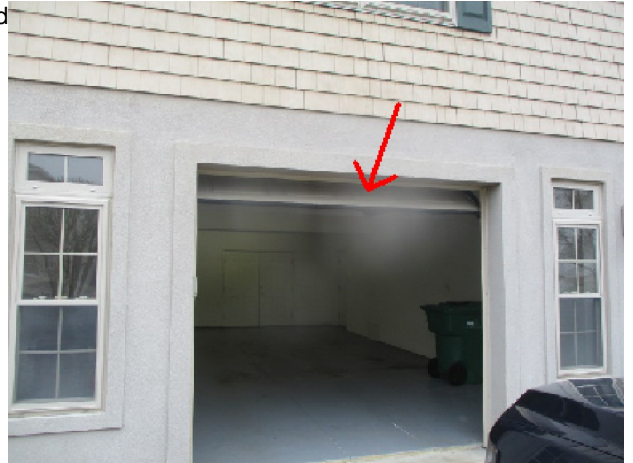
Auto Garage Door Lift Controls

Single garage door would not stay up fully up when tested and should be repaired.

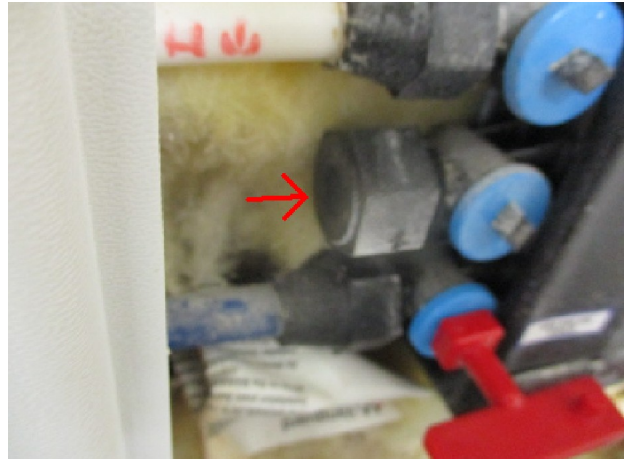
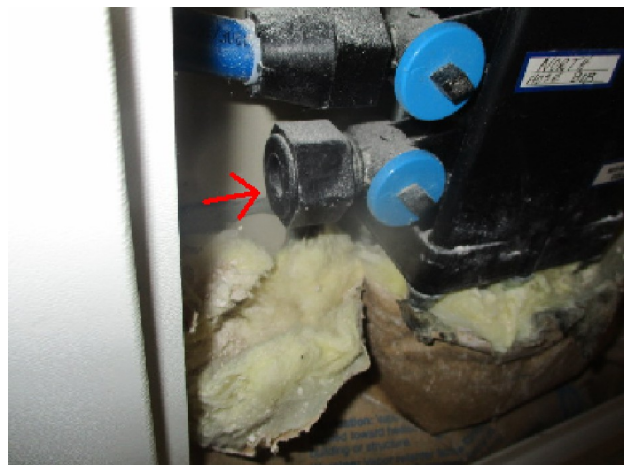
Interior Visible Water Pipes Visible Primary Type

Unused valves should be capped.

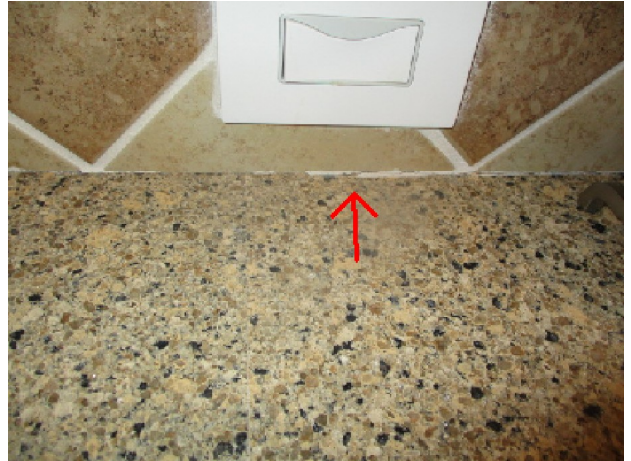
Kitchen Walls

Back splash should be better sealed.

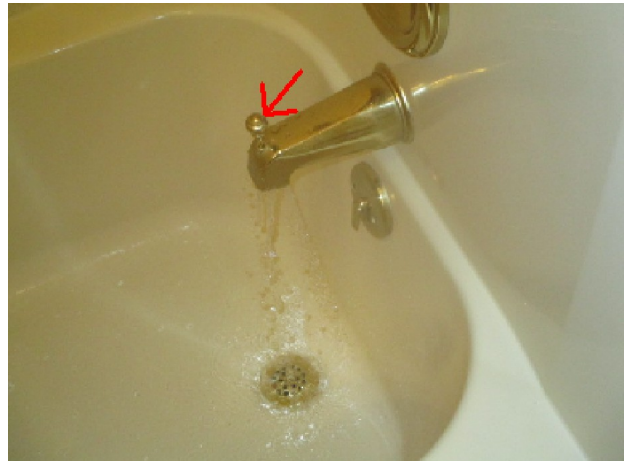
Bathtub Faucets

Diverter would not properly seal and should be repaired.

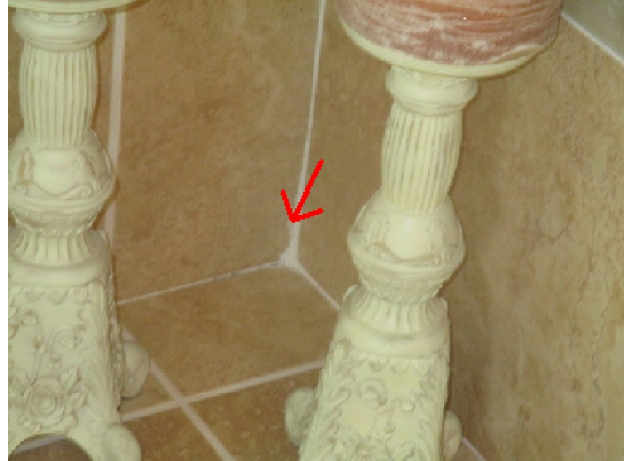
Tub Wall Encl.

The tub enclosure joints should be re-caulked. Master bathroom.

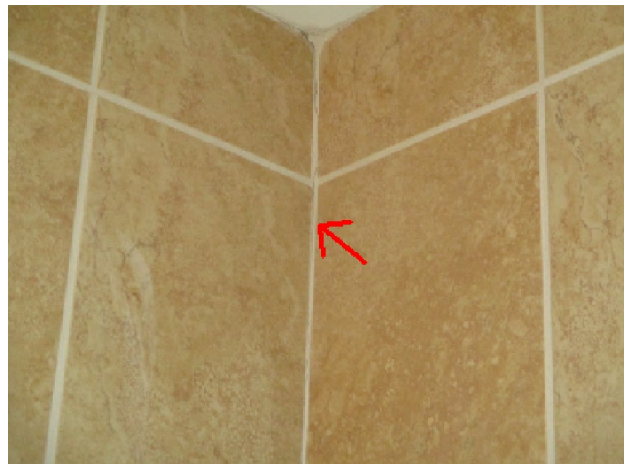
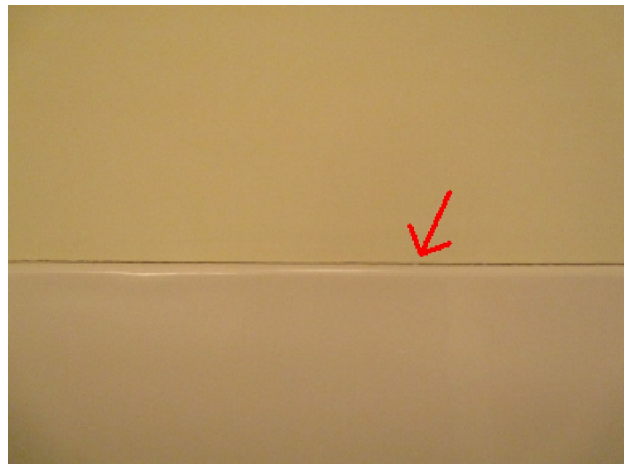
Shower Stall Walls

Ceramic tile joints need caulking.
The fiberglass surround should be better sealed.

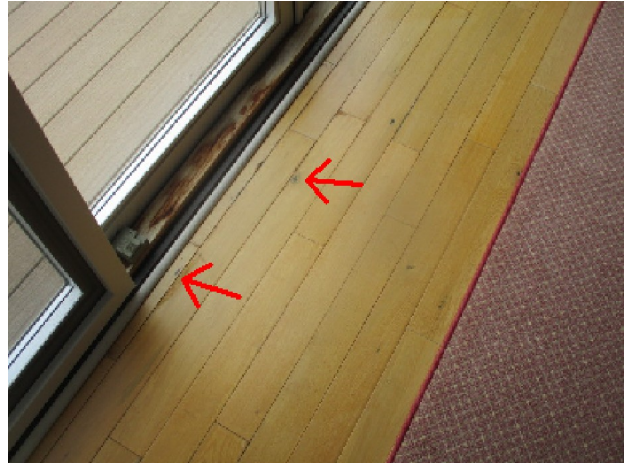
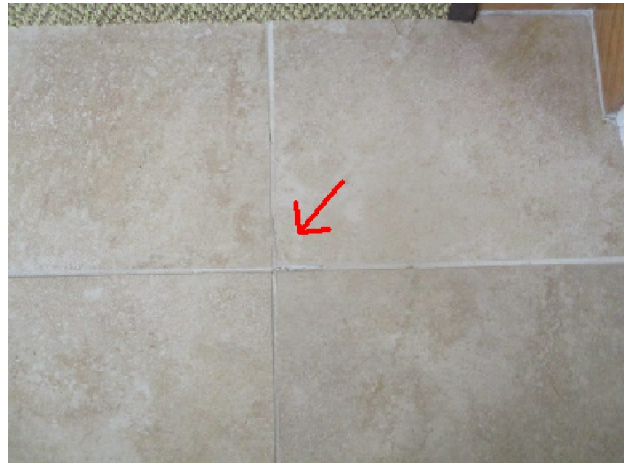
Interior Floors

Water stains were noted at the dinning room slider and were dry at time of inspection.
Some missing grout was noted at the foyer.

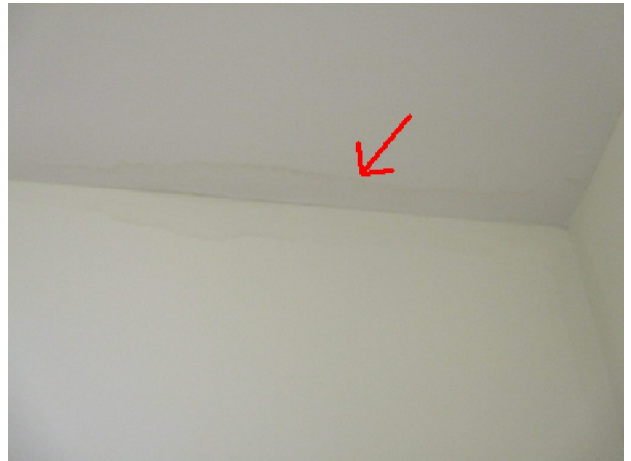
Interior Ceilings

Typical drywall flaws were noted.
Water stains were noted but were not currently wet at the time of inspection.

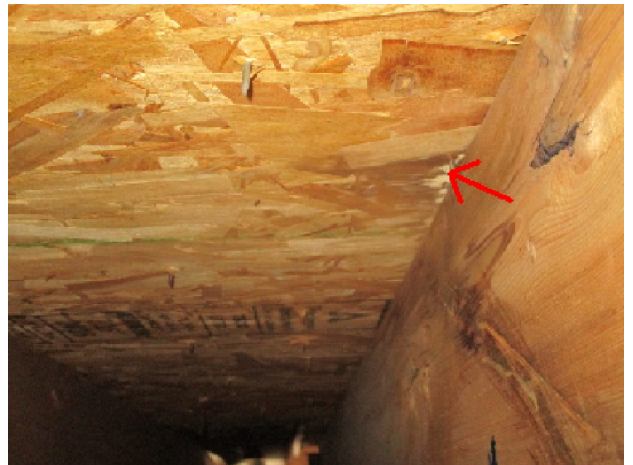
Attic Sheathing

Some stains were noted but were not currently wet.
