Reliable Home Inspection Service  
100 Old Kennett Rd  
Wilmington, DE 19807  
302-993-9100  
<https://www.reliablehomeinspectionsservice.com/>

FRONT VIEW

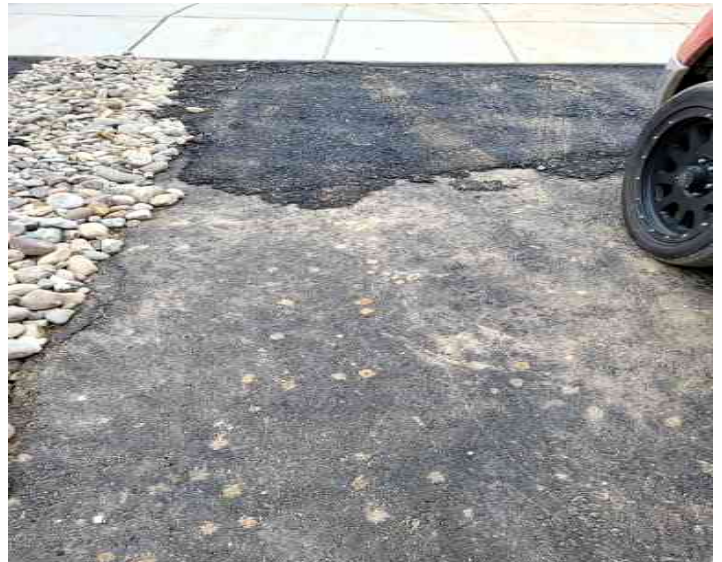
#### 0208: Driveway/Parking Lot

Some cracks noted.  
Final coat was not installed at time of inspection.  
Recommend to client to request documentation on completion date.

Some cracks noted. Final coat was not installed at time of inspection. Recommend to client to request documentation on completion date.

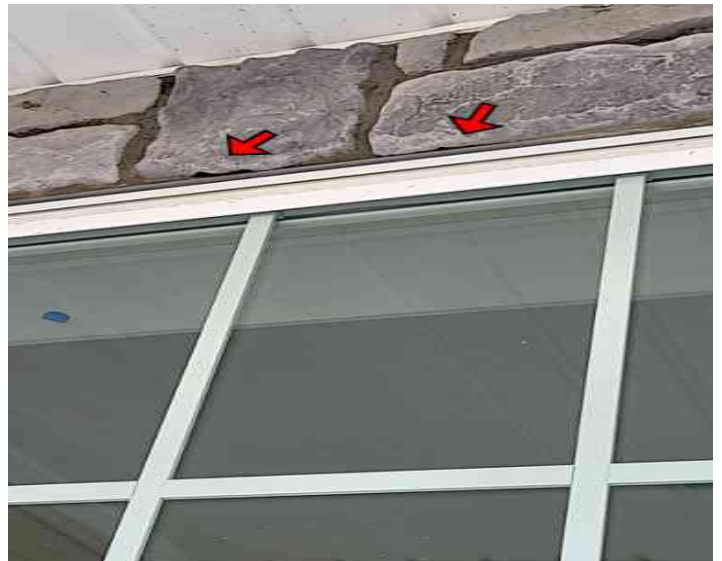
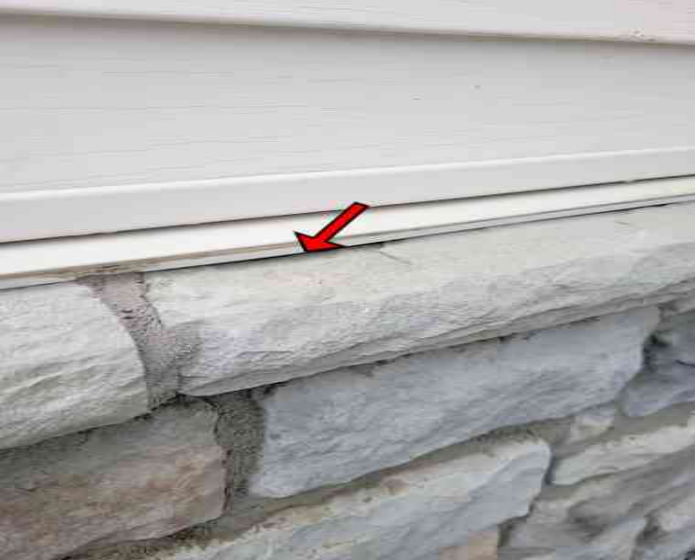
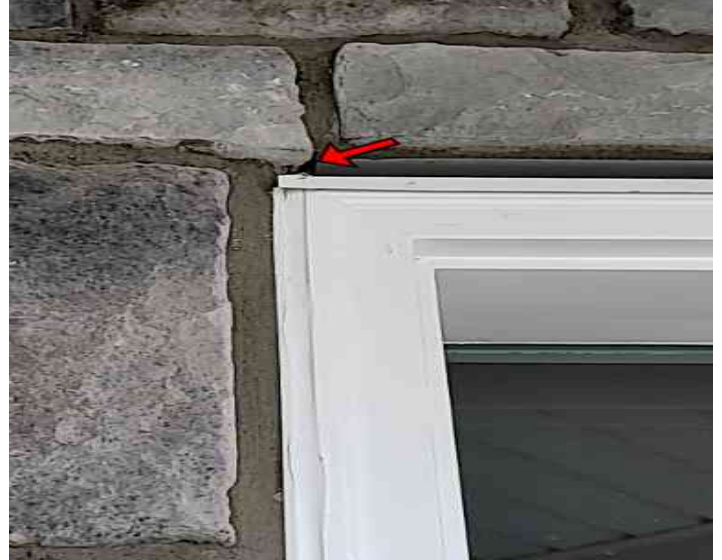
#### 0309: Masonry Walls

Other= Faux stone.  
Missing mortar and gaps noted.  
Exterior walls should be evaluated and all needed repairs should be made.

Other Faux stone Missing mortar and gaps noted Exterior walls should be evaluated and all needed repairs should be made.

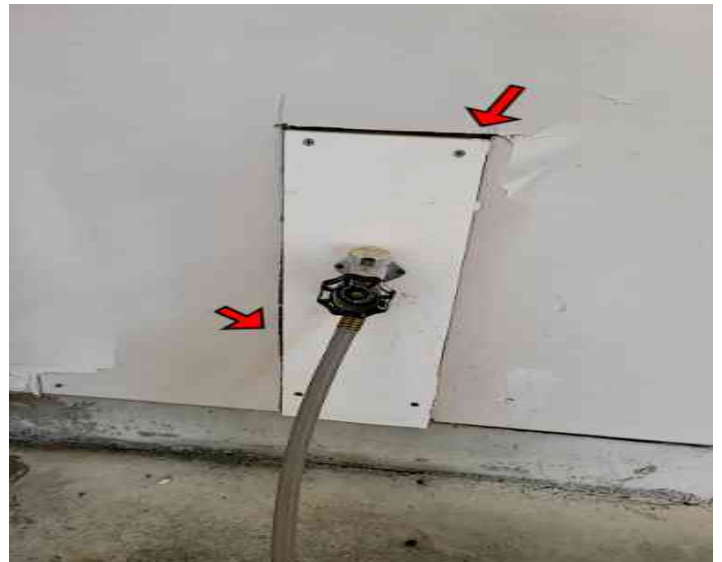
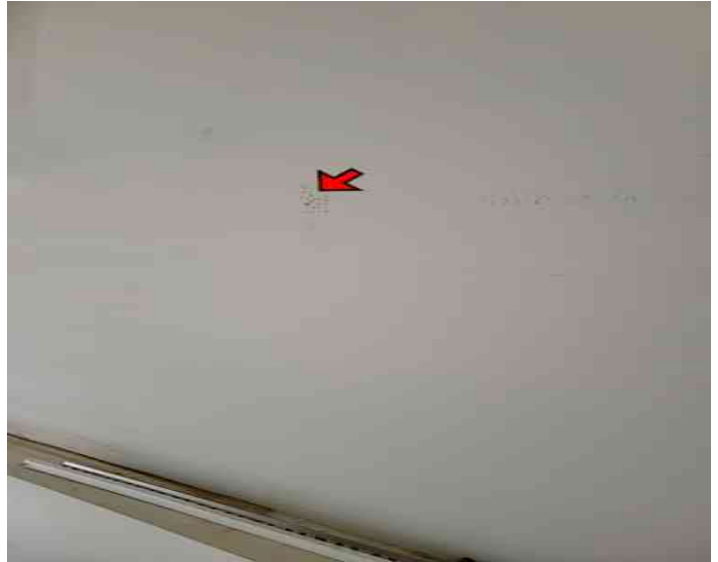
#### 0811: Garage Interior Walls

All holes in fire rated walls should be patched.  
Some loose paint was noted.

All holes in fire rated walls should be patched. Some loose paint was noted.

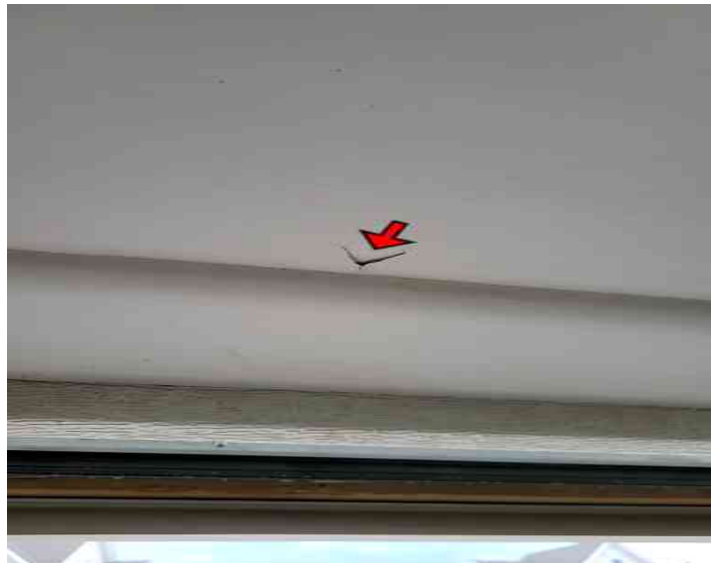
#### 0814: Garage Doors

Damage to the panel at the over head door.  
Missing weather stripping was noted at the passage door and should be repaired.

The garage passage door to house should have an automatic closer to protect the house occupants from carbon monoxide fumes from auto emissions.

Damage to the panel at the over head door. Missing weather stripping wad noted at the passage door and should be repaired. The garage passage door to house should have an automatic closer to protect the house occupants from carbon monoxide fumes from auto emissions.

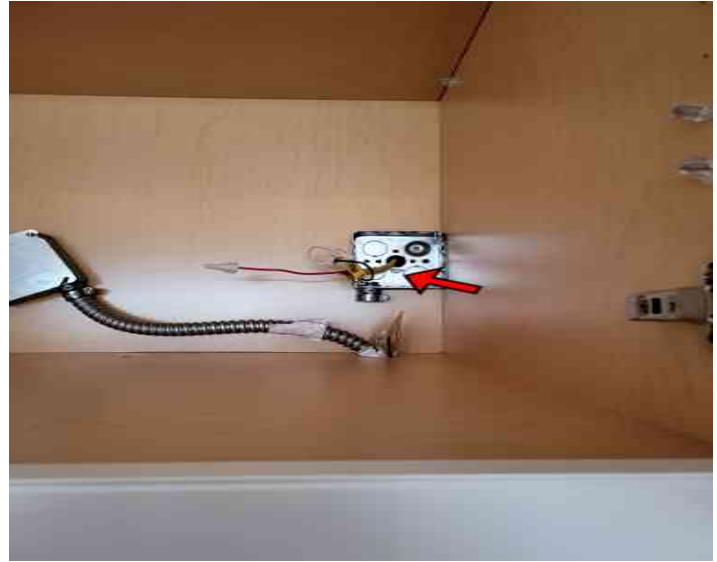
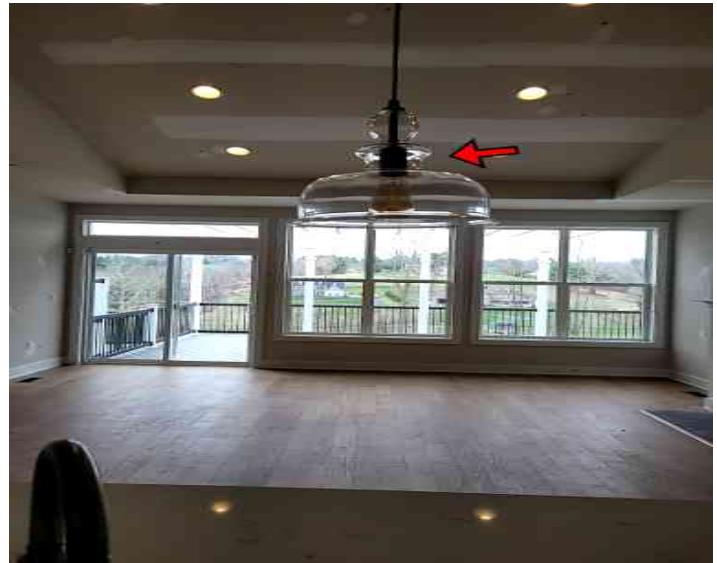
### 1720: Kitchen Wall Receptacles

GFCI reset is in the main panel.  
Exposed wiring noted in the cabinet and should be repaired.  
Light is not straight and should be repaired

GFCI reset is in the main panel. Exposed wiring noted in the cabinet and should be repaired. Light is not straight and should be repaired.

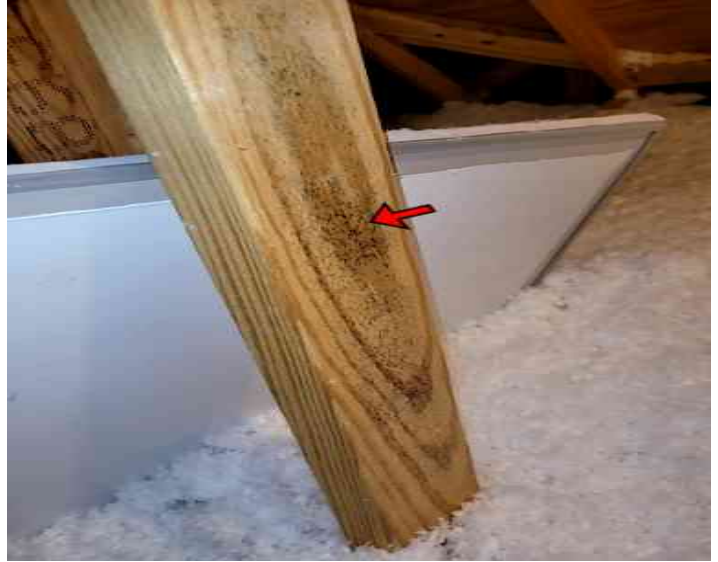
#### 2005: Attic Structural Framing Type

As is common in most home in America some possible mold/mildew was noted on some structural surfaces and sheathing and should be cleaned by qualified personnel. As mold and mildew are not part of the home inspection the client may decide to do further evaluation to determine the extent of the problem and cost of cleanup/repair.

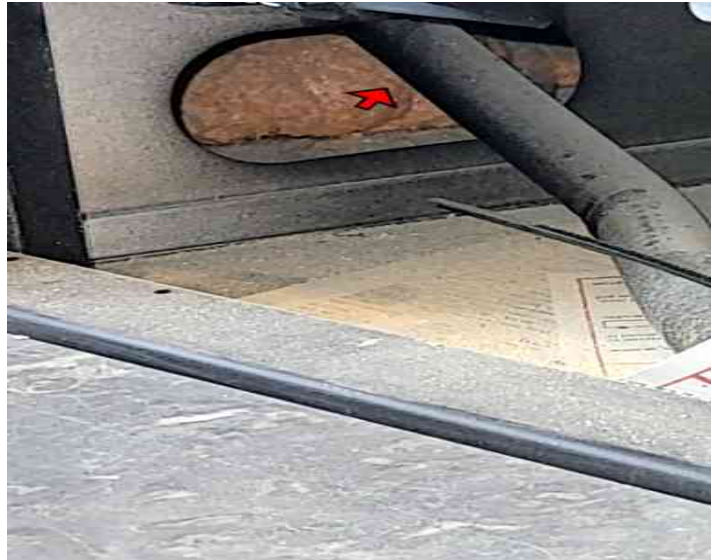
#### 2113: Interior Fire Place 1

Missing grommet noted around gas line and should be repaired.

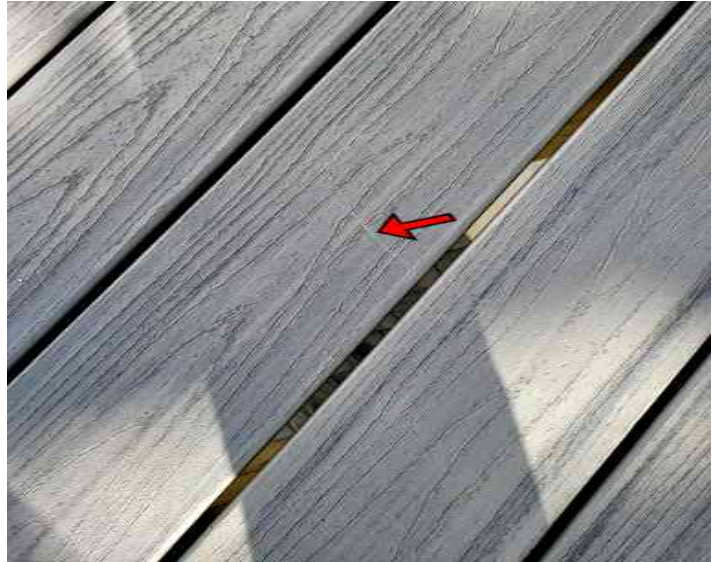
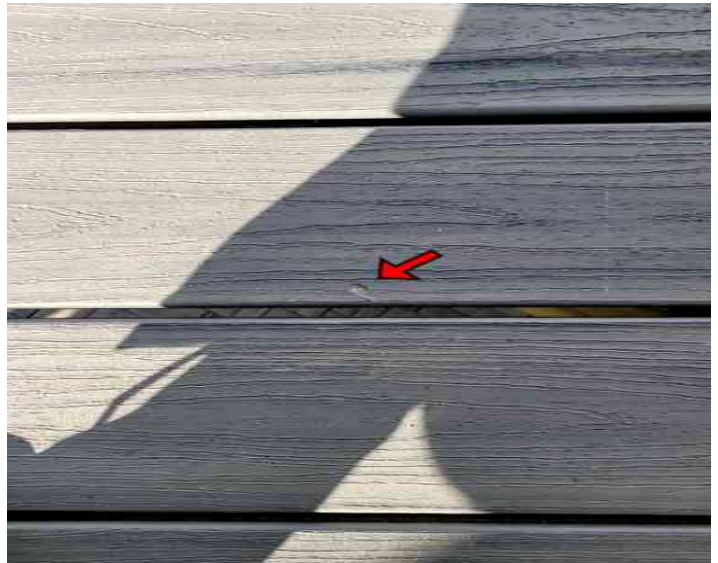
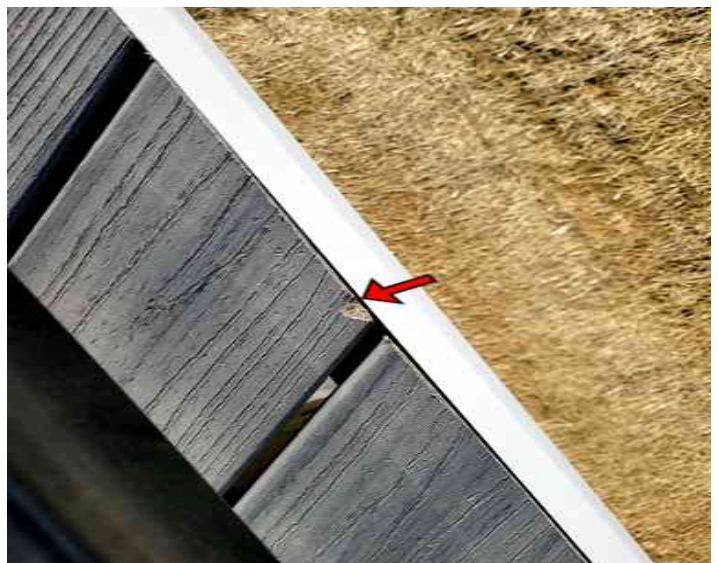
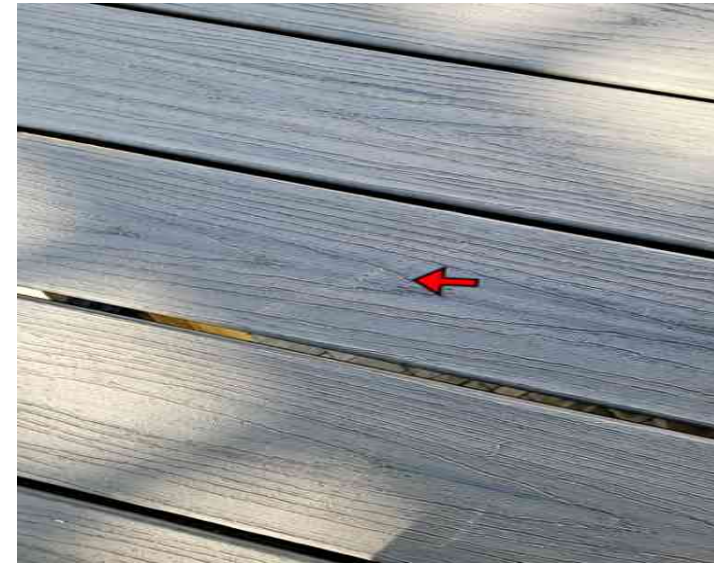
### 0207: Decks

Scratched and damaged deck boards were noted and should be repaired

Scratched and damaged deck boards were noted and should be repaired.

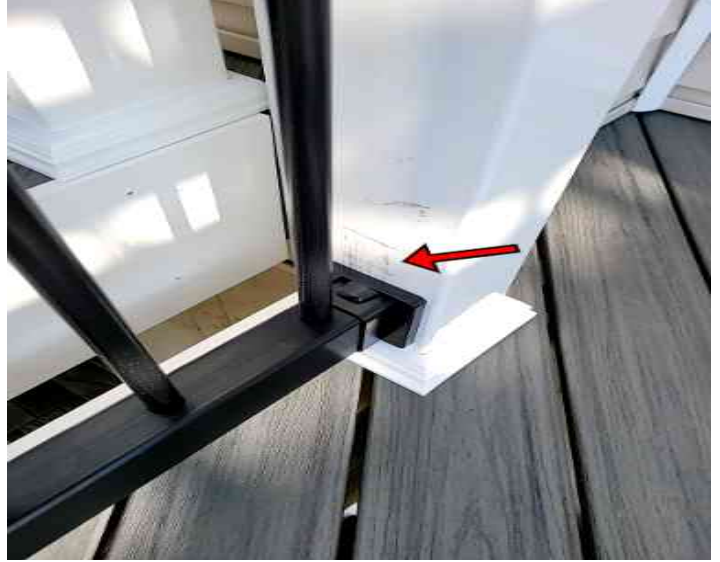
### 0210: Hand Rail

Scuffed and scratched areas were noted at the deck post and should be repaired.

Other= Vinyl Scuffed and scratched areas were noted at the deck post and should be repaired.

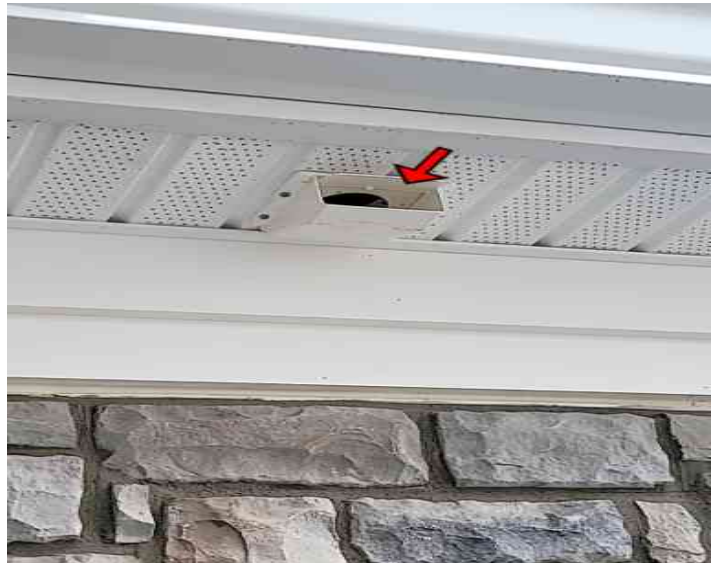
### 0301 EXTERIOR

Damaged exterior vent flap and should be repaired

Damaged exterior vent flap and should be repaired.

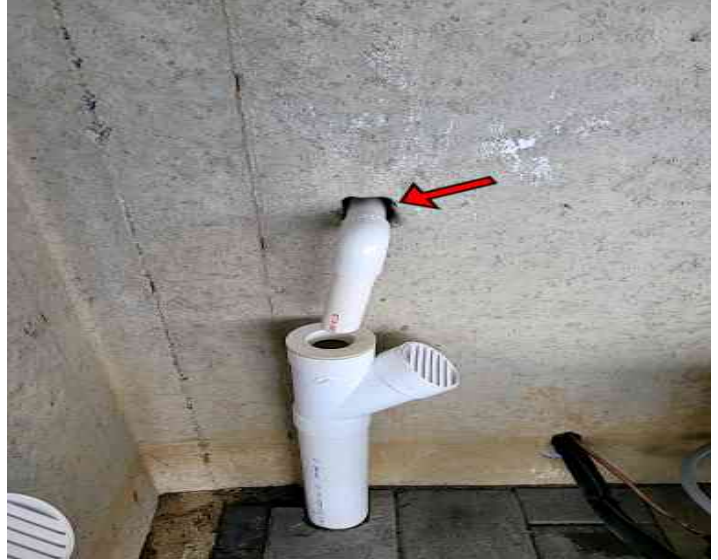
### 0304: Exposed Foundation Primary Visible Type

Some cracks noted.  
Openings should be sealed

Some cracks noted Openings should be sealed

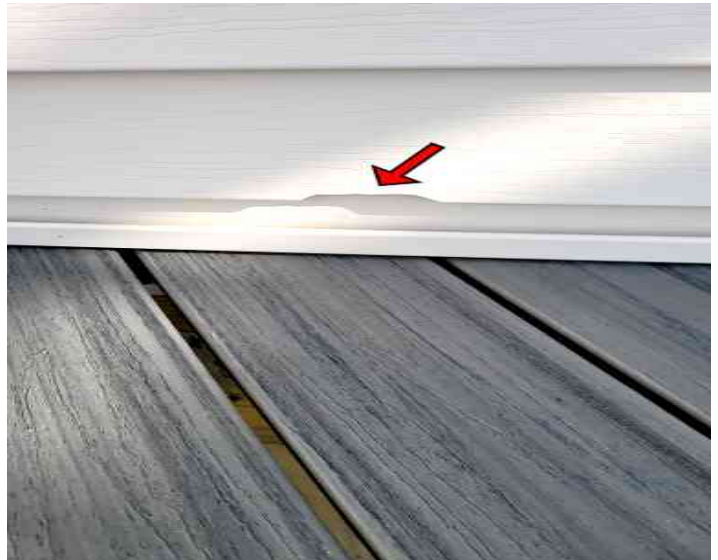
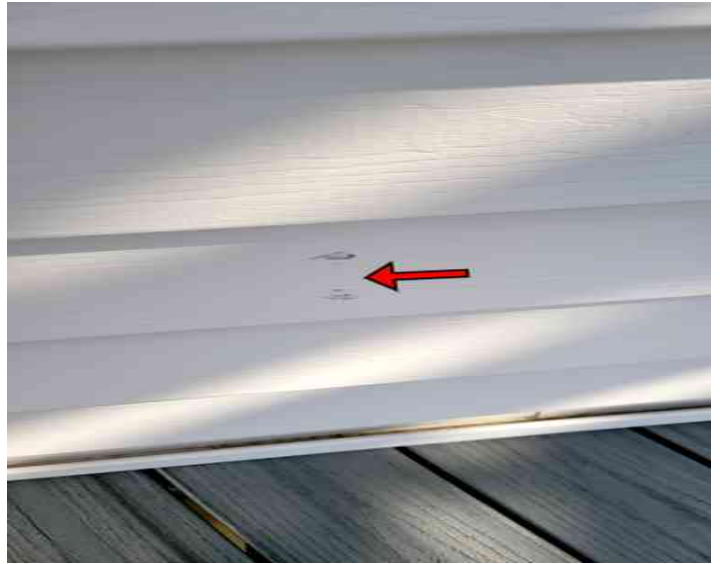
### 0308 Siding

Damaged was noted on the rear and should be repaired.  
Some scuffing was noted

Damaged was noted on the rear and should be repaired Some scuffing was noted

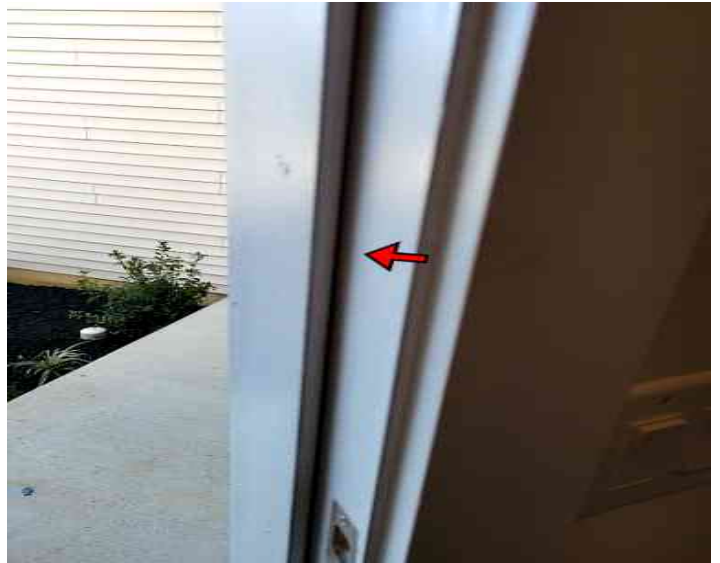
#### 0311: Entry Doors

Missing weather stripping was noted and should be repaired.

Missing weather stripping was noted and should be repaired

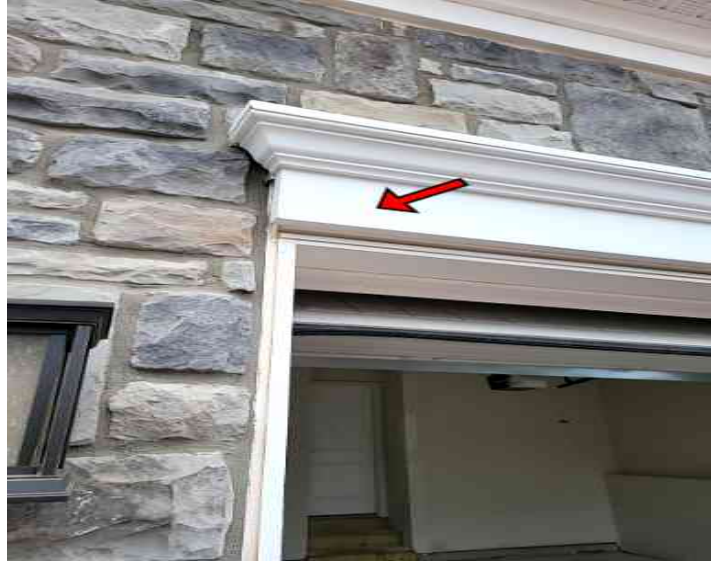
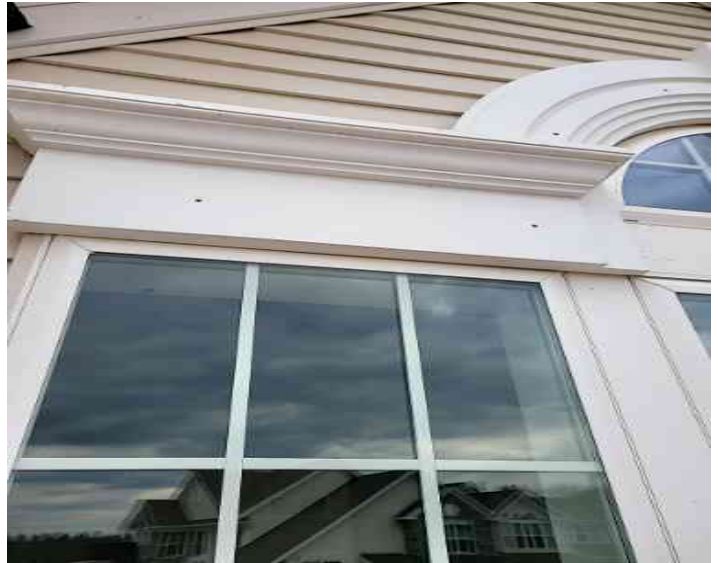
### 0320: Caulking

Caulking should be improved.  
All trim and holes should be sealed.

Caulking should be improved. All trim and holes should be sealed.

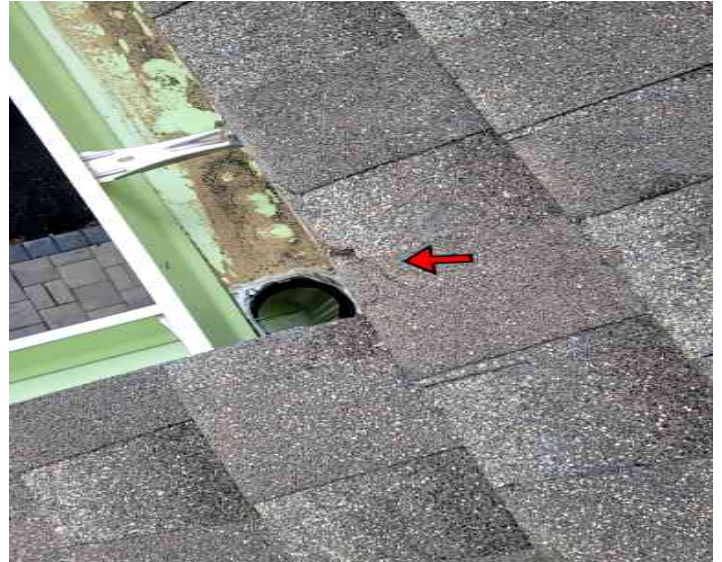
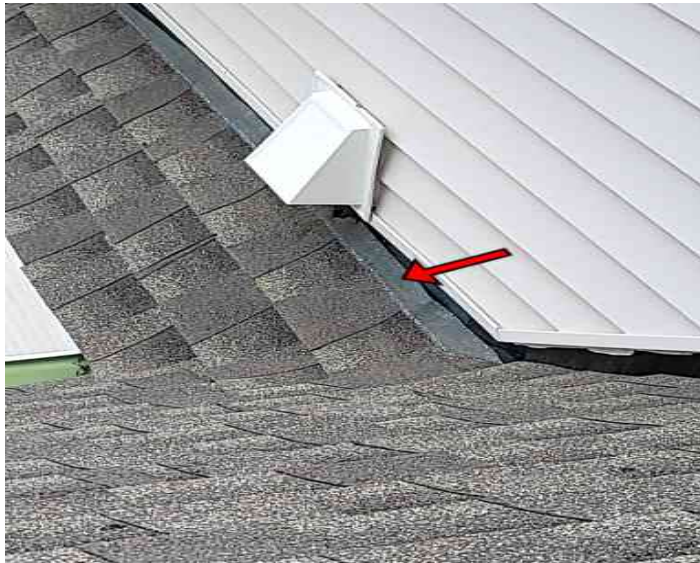
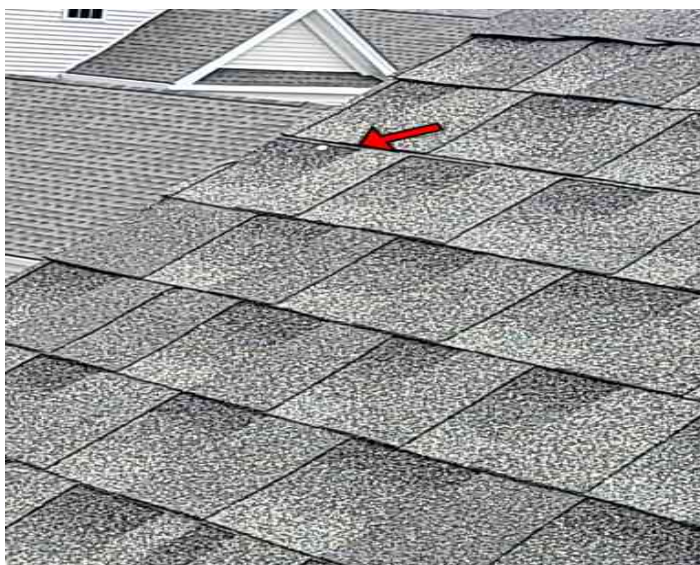
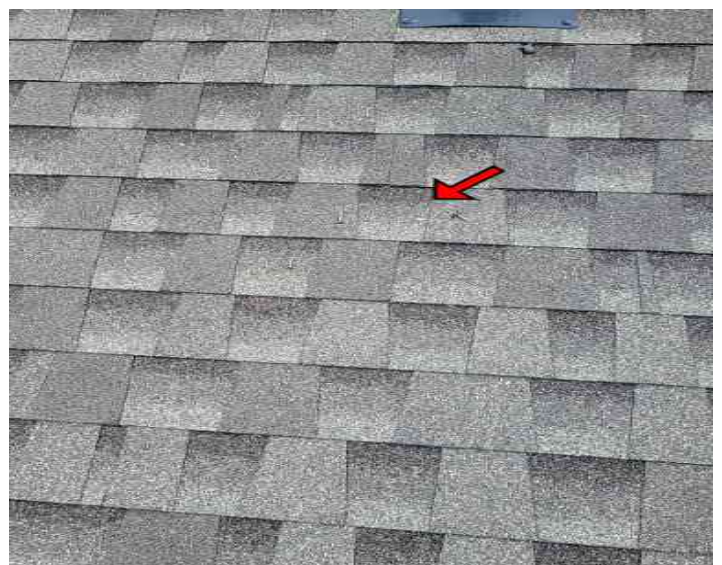
### 0505: Roof Covering Primary Type

Some scuffing and aggregate loss noted and should be monitored  
Debris should be removed from the roof surface.  
A few cracked/damaged shingles were noted and should be repaired.  
Nail heads should be sealed where exposed  
Loose fitting shingle was noted and should be repaired.

Some scuffing and aggregate loss noted and should be monitored. Debris should be removed from the roof surface. A few cracked/damaged shingles were noted and should be repaired. Nail heads should be sealed where exposed. Loose fitting shingle was noted and should be repaired.

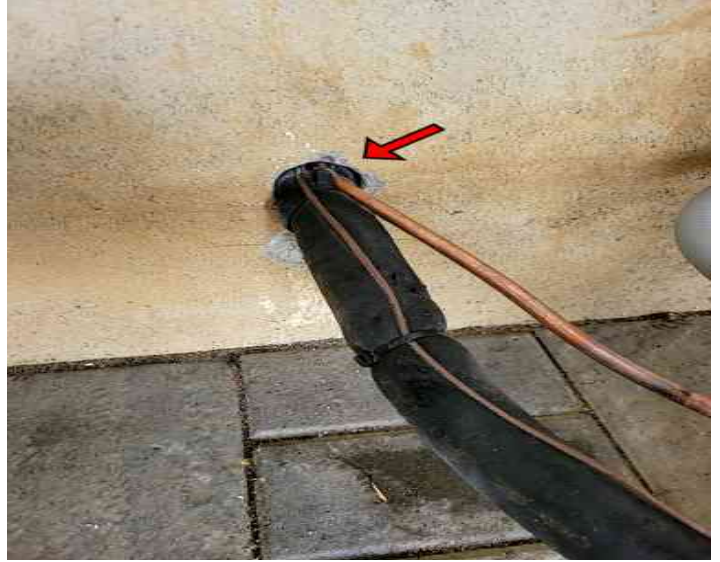
### 0708: Cooling Lines

Penetrations should be sealed.

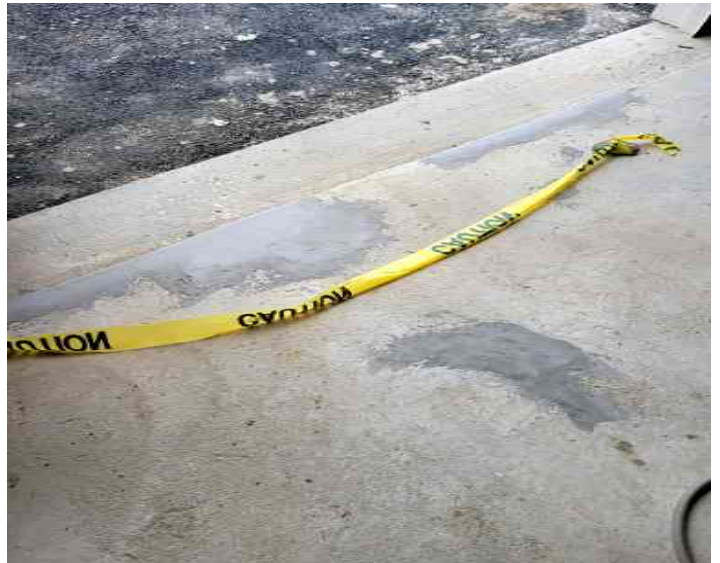
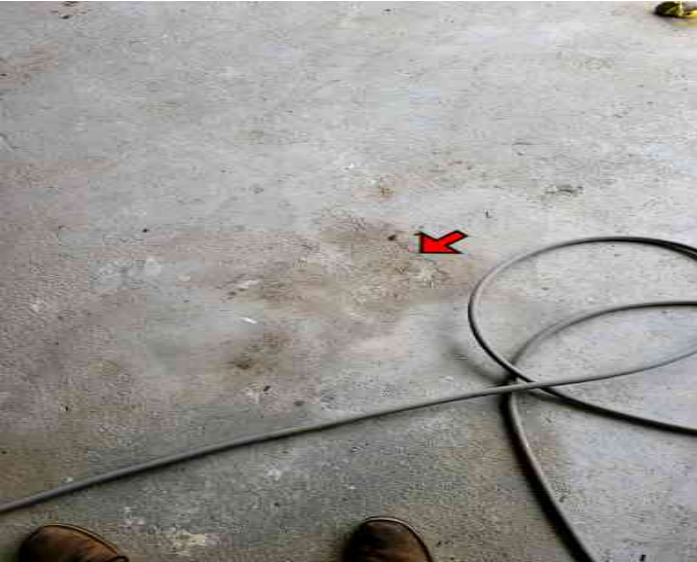
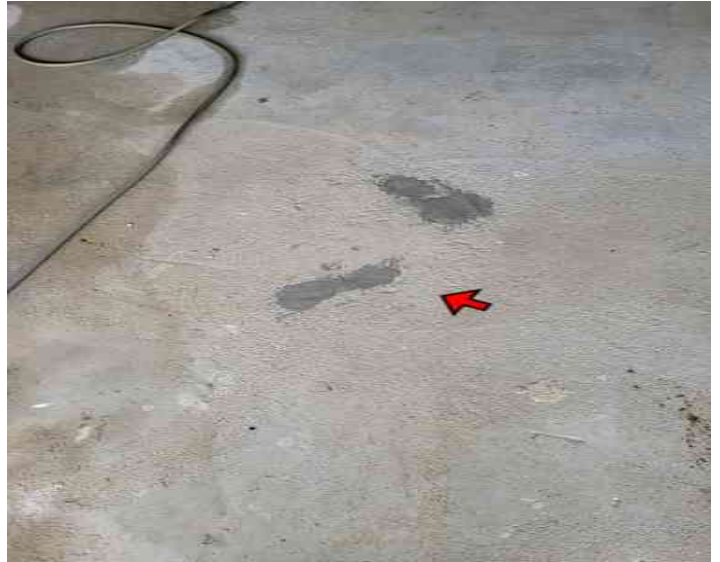
### 0813 Garage Floor

Damaged and poorly finished areas were noted and should be repaired.

Damaged and poorly finished areas were noted and should be repaired

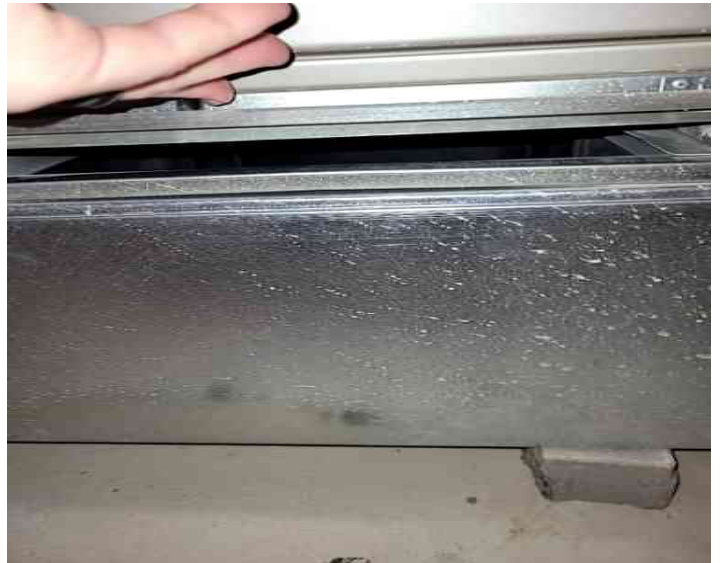
### 1317 Filter System

There was no filter installed at time of the inspection

There was no filter installed at time of the inspection.

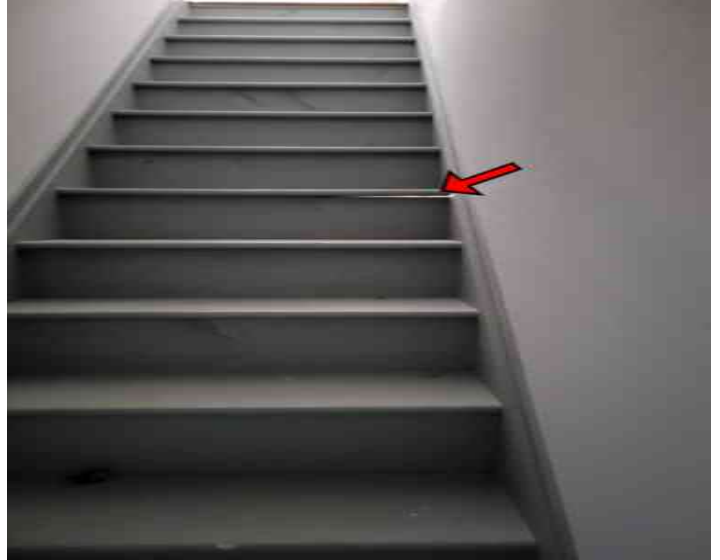
#### 1503: Basement Access

Raised stair tread was noted and should be repaired.

Raised stair tread was noted and should be repaired

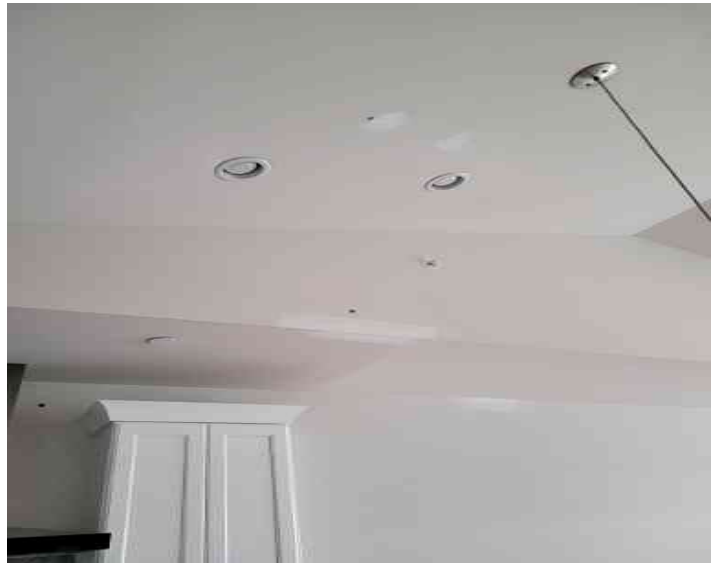
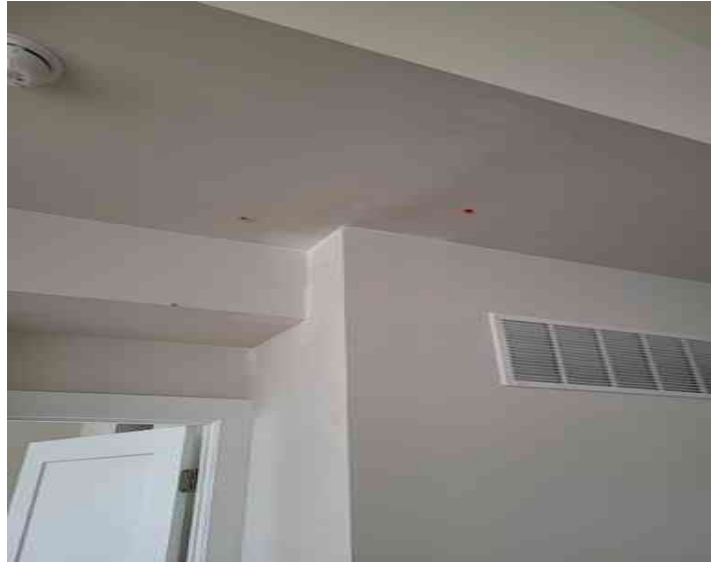
#### 1703 Kitchen Ceiling

Some poorly finished areas were noted

Some poorly finished areas were noted.

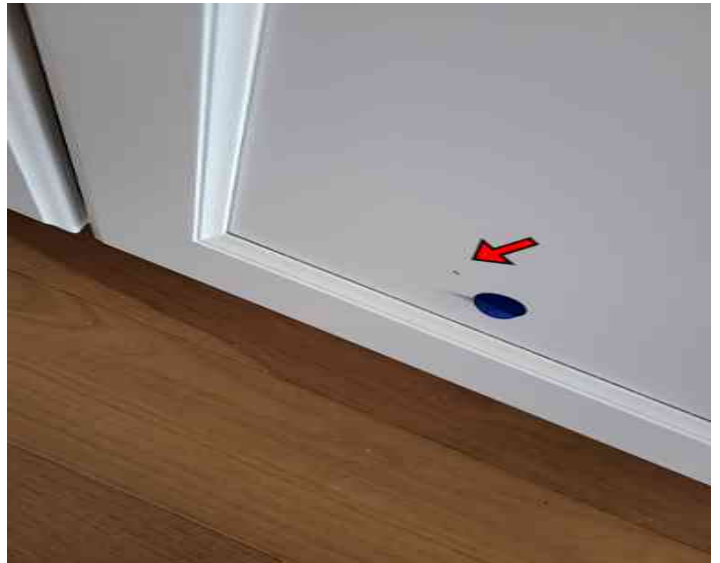
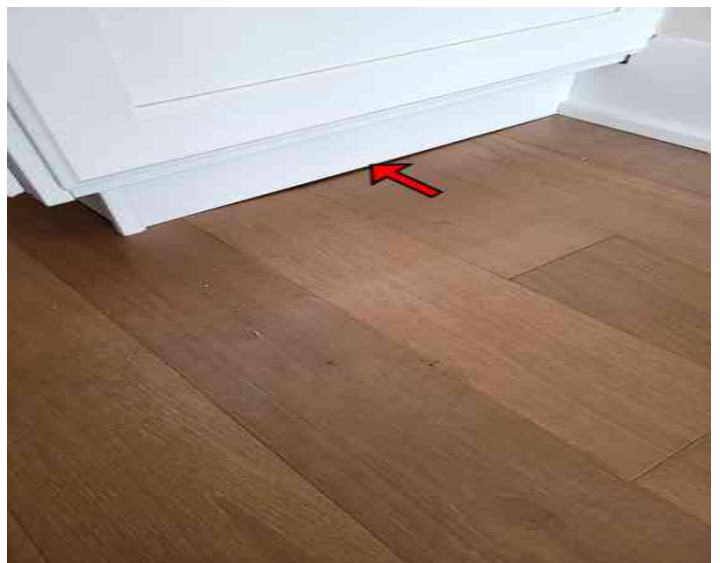
### 1708 Kitchen Cabinets

Some scratches were noted and should be repaired  
Gap noted at the base cabinet toe kick and should be repaired

Some scratches were noted and should be repaired. Gap noted at the base cabinet toe kick and should be repaired.

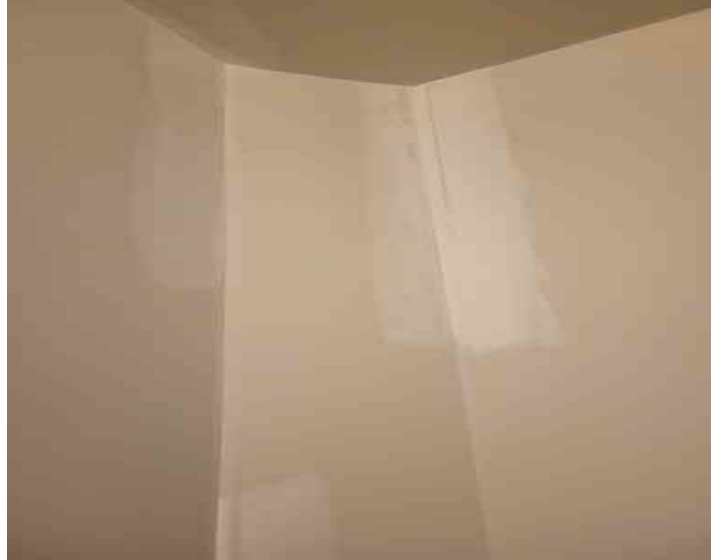
#### 1805: Half Bath Walls and Ceilings

Poorly finished areas were noted.

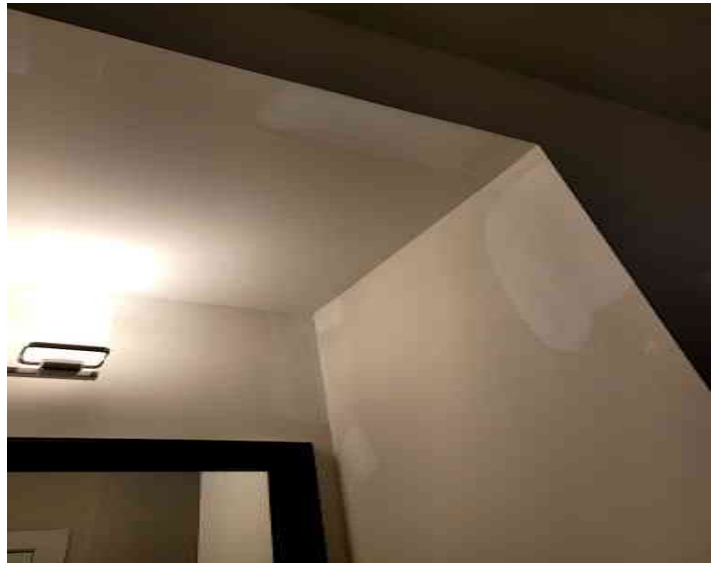
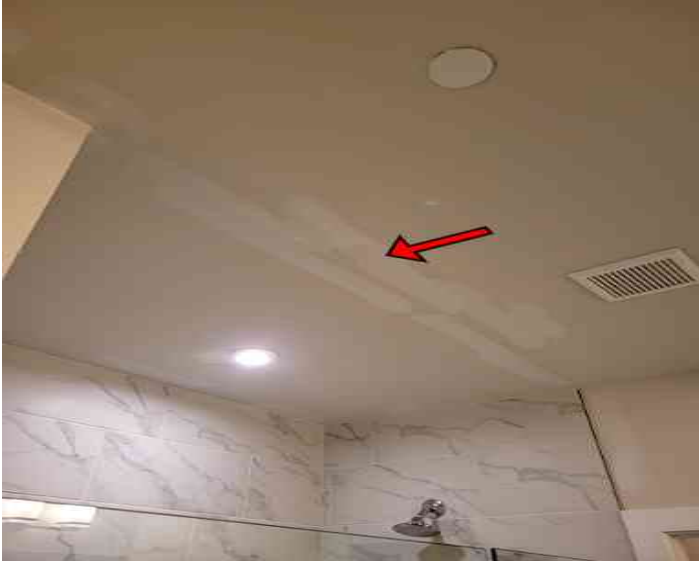
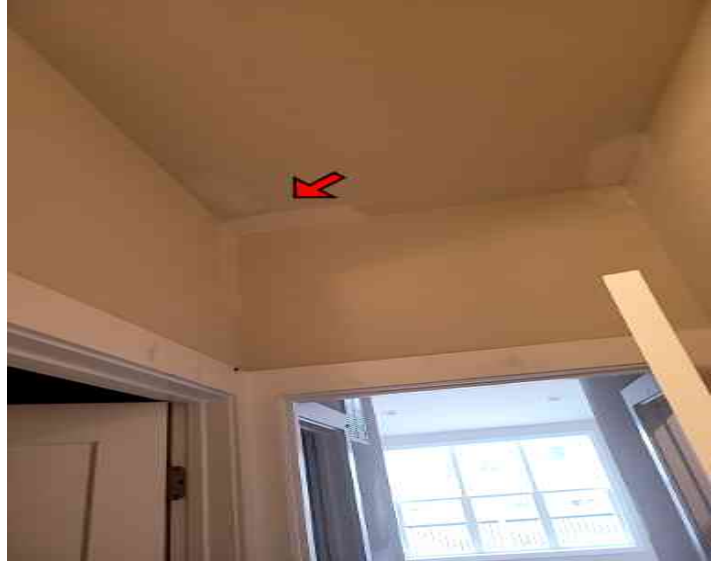
#### 1905 Bathroom Walls and Ceilings

Poorly finished areas were noted and should be repaired.

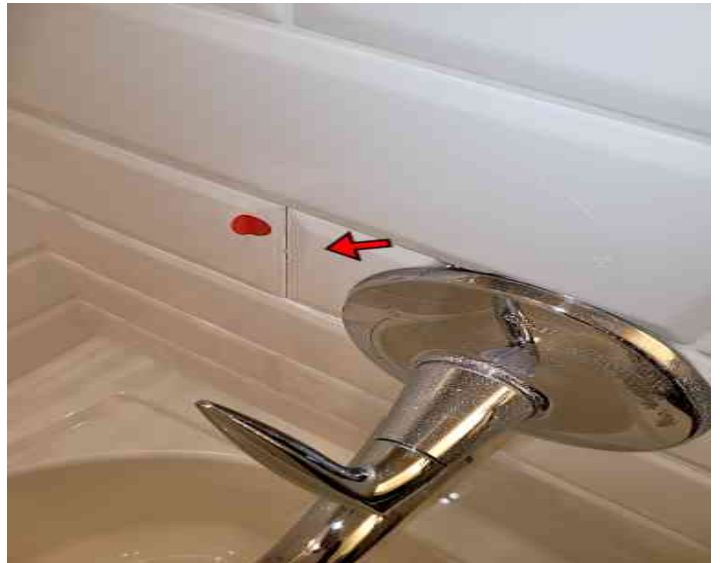
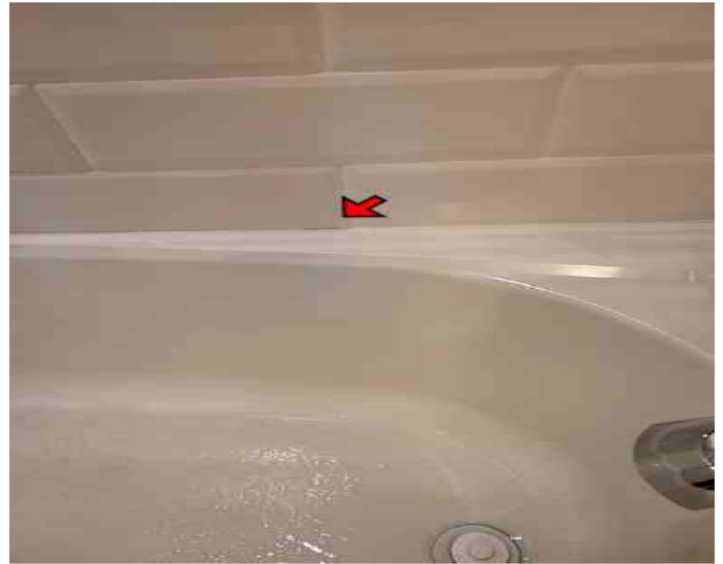
### 1918: Tub Wall Encl.

Missing grout was noted and should be repaired.  
Caulking should be improved.

Missing grout was noted and should be repaired. Caulking should be improved.

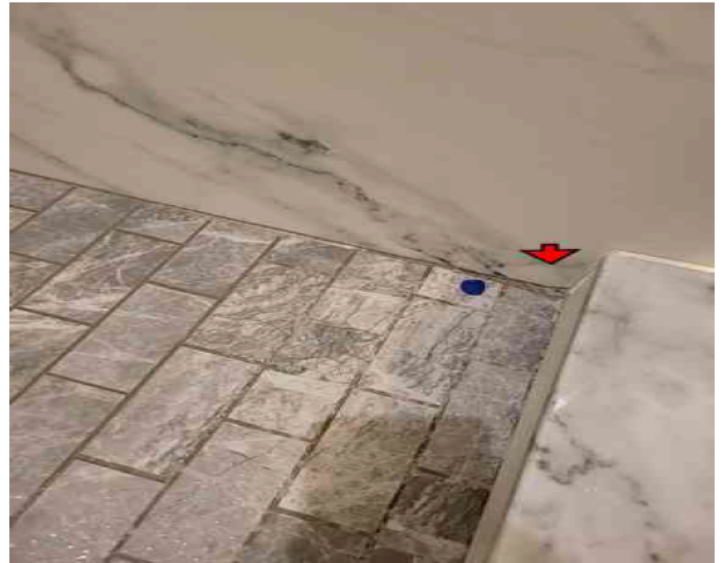
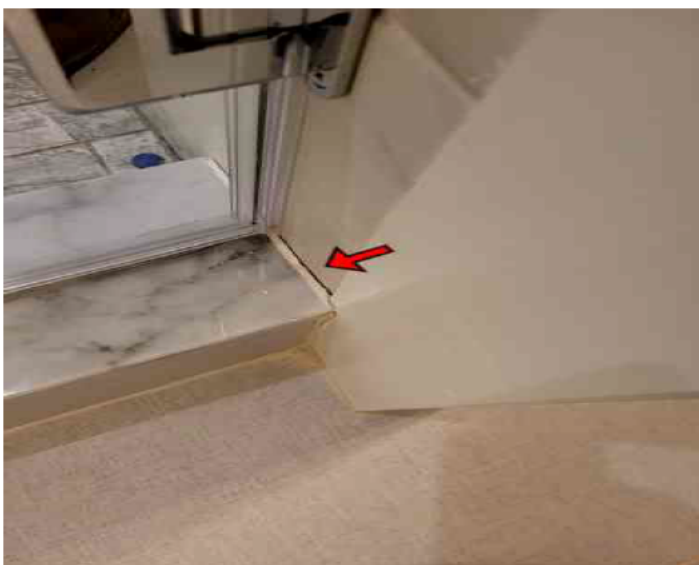
1921: Shower Stall Walls

Caulking should be improved.

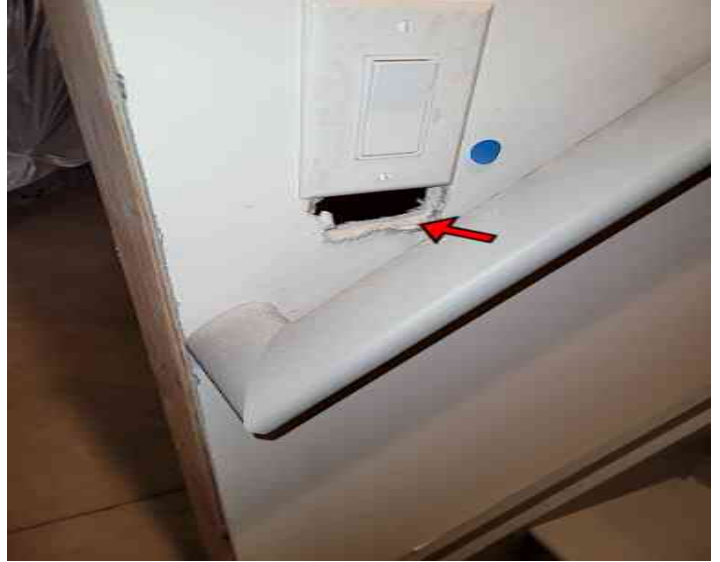
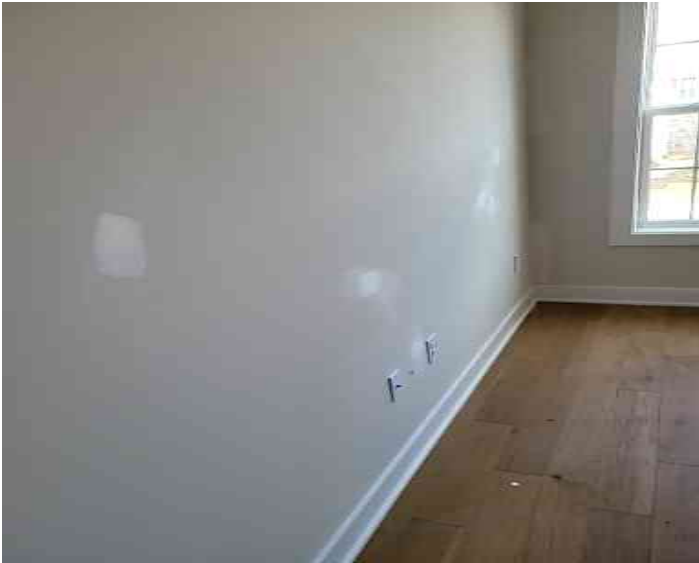
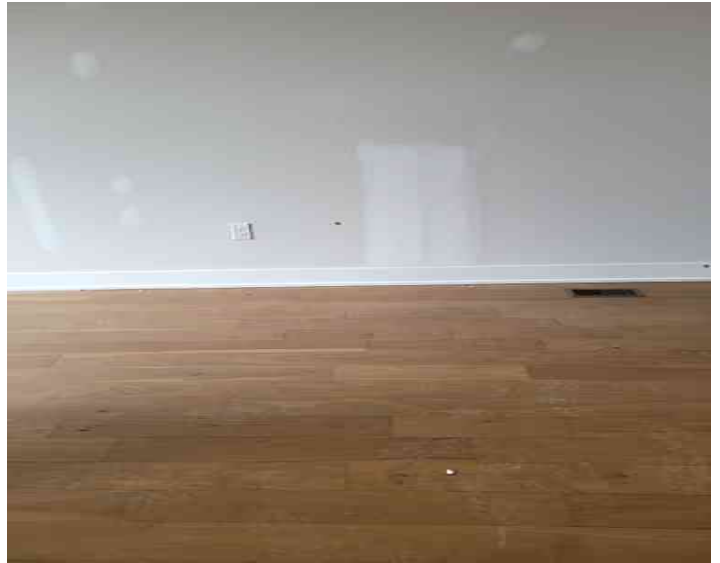
### 2104: Interior Walls

Typical drywall flaws were noted.  
Some poorly finished areas were noted.

Typical drywall flaws were noted. Some poorly finished areas were noted.

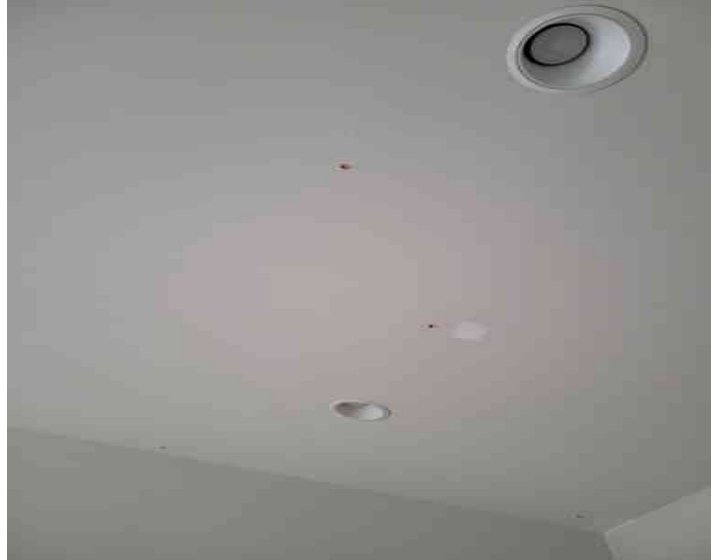
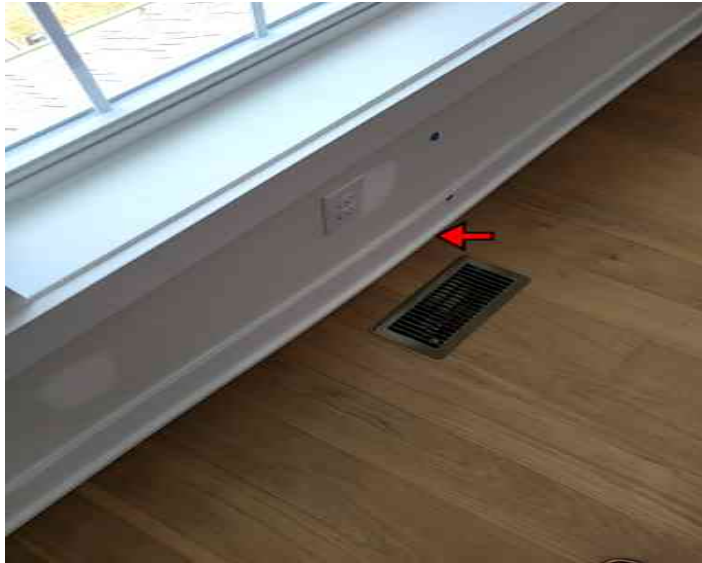
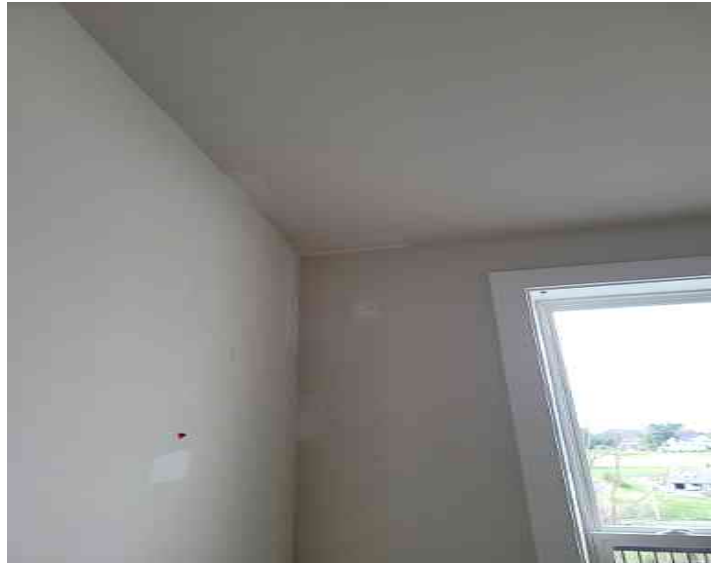
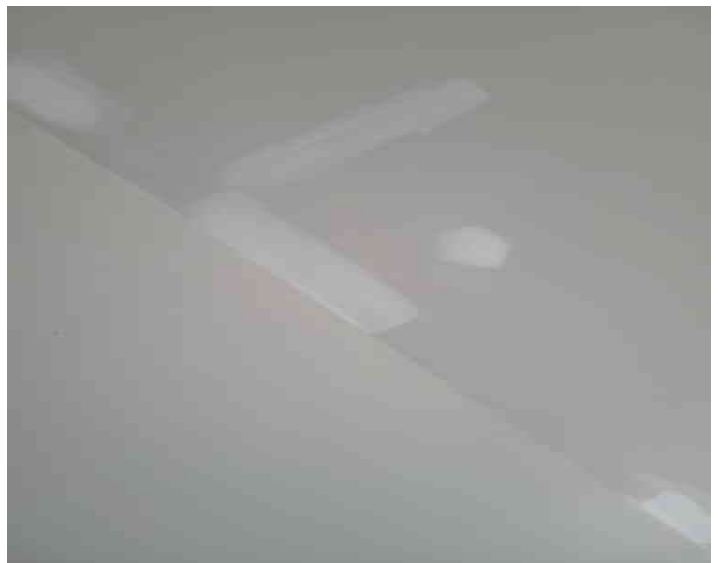
### 2105: Interior Ceilings

Typical drywall flaws were noted.  
Poorly finished areas of drywall were and should be repaired.  
Bowed section was noted at the front left bedroom.

Typical drywall flaws were noted. Poorly finished areas of drywall were and should be repaired. Bowed section was noted at the front left bedroom.

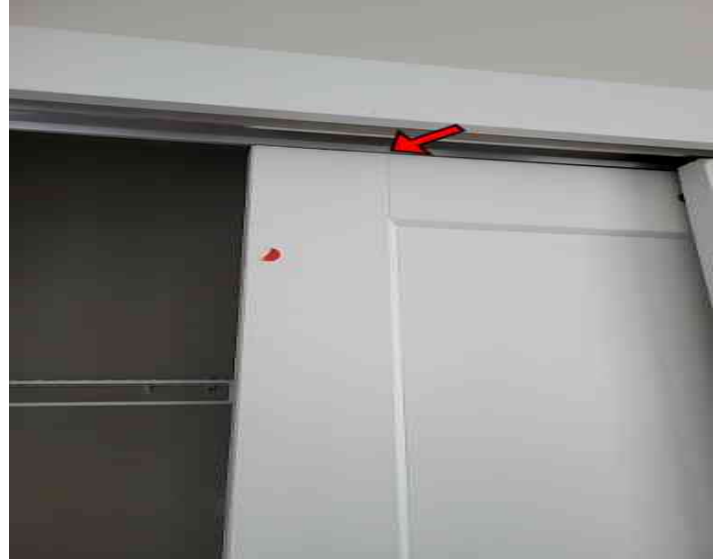
### 2116: Closets/ Interior Doors

Front right bedroom bypass closet door rubs and should be repaired

Front right bedroom bypass closet door rubs and should be repaired.
