Reliable Home Inspection Service  
100 Old Kennett Rd  
Wilmington, DE 19807  
302-993-9100  
<https://www.reliablehomeinspectionsservice.com/>

FRONT VIEW

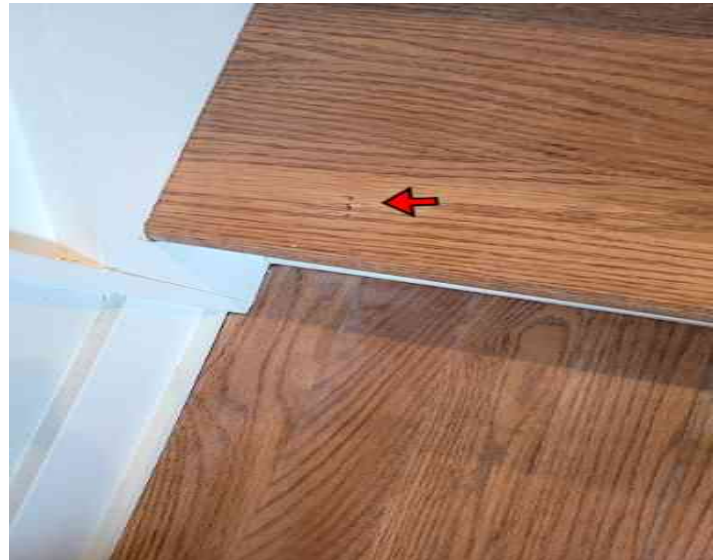
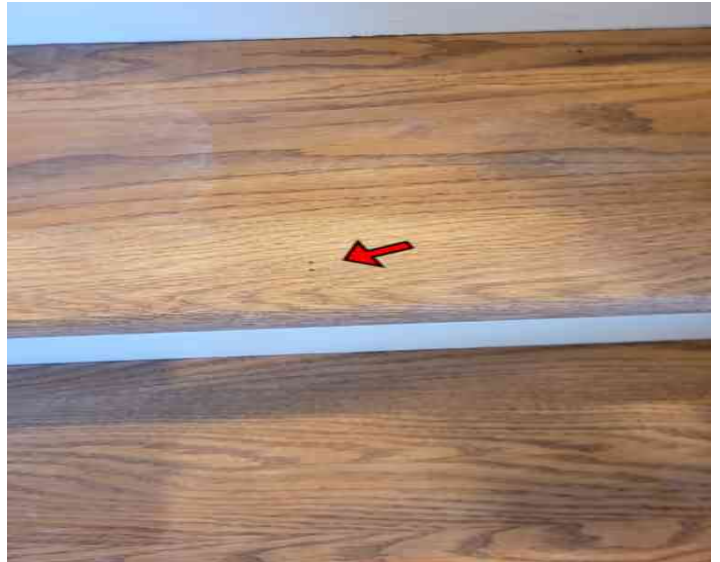
### 2119 Stairways

Staple holes were noted and should be repaired

Staple holes were noted and should be repaired.

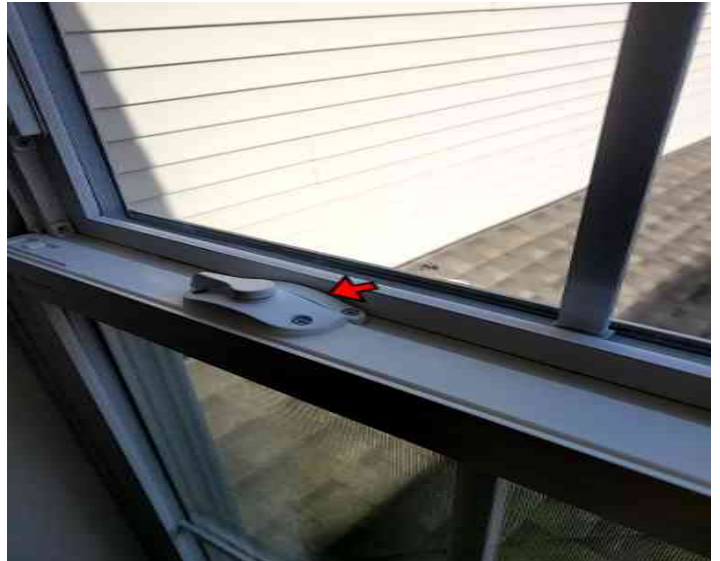
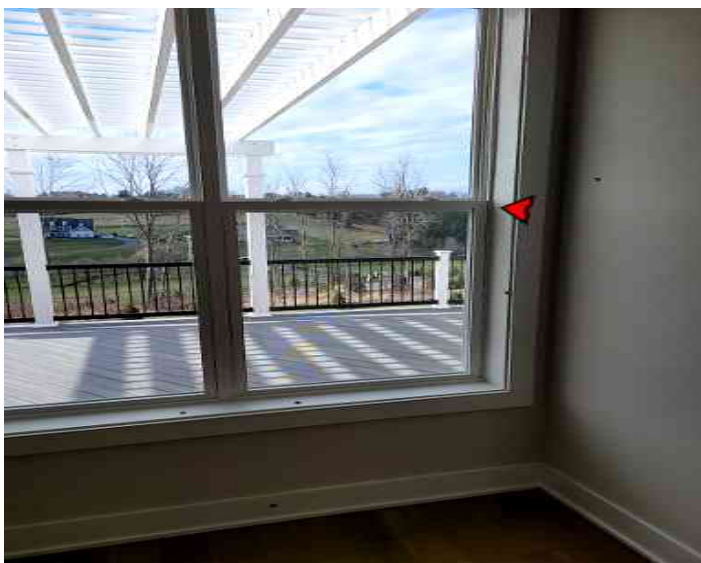
### 2122 Windows

2nd floor hallway window does not lock and should be repaired.

Right window at the dining room is tight and should be repaired.

Right window at the family room was tight and should be repaired.

2nd floor hallway window does not lock and should be repaired. Right window at the dining room is tight and should be repaired. Right window at the family room was tight and should be repaired.

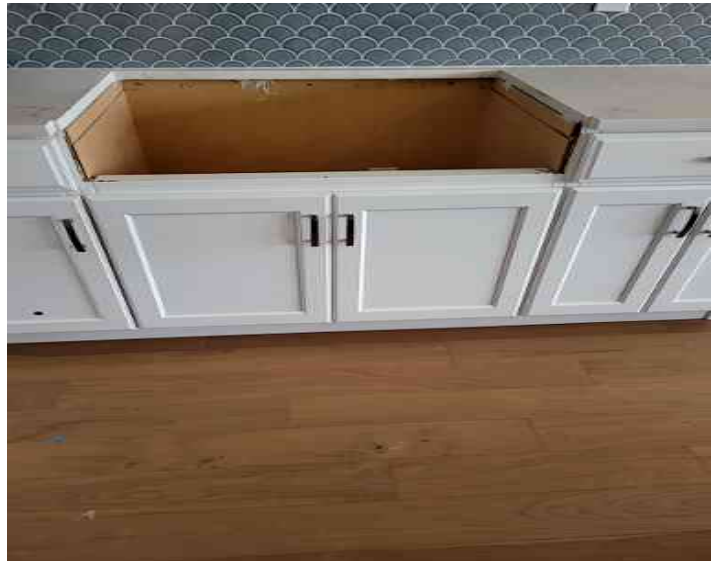
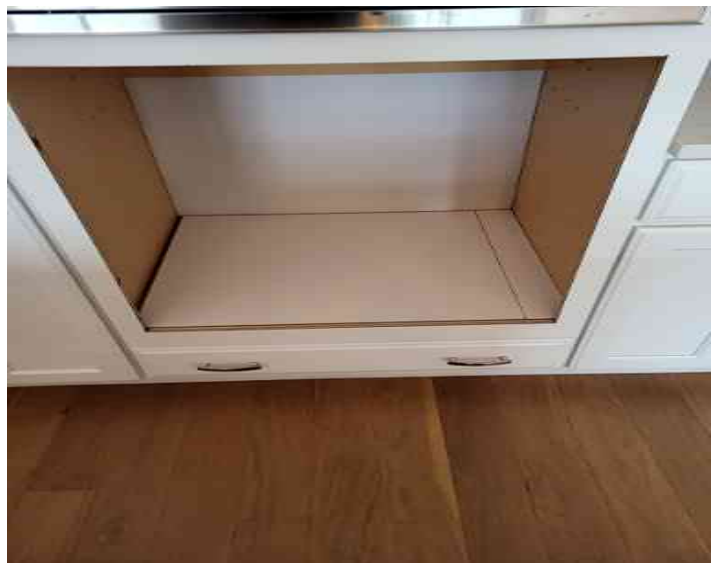
### 1718 Range Oven

There was no stove installed at time of inspection
