Reliable Home Inspection Service
100 Old Kennett Road
Wilmington, Delaware 19807
877-993-9100
www.reliablehomeinspectionsservice.com

Inspection Summary

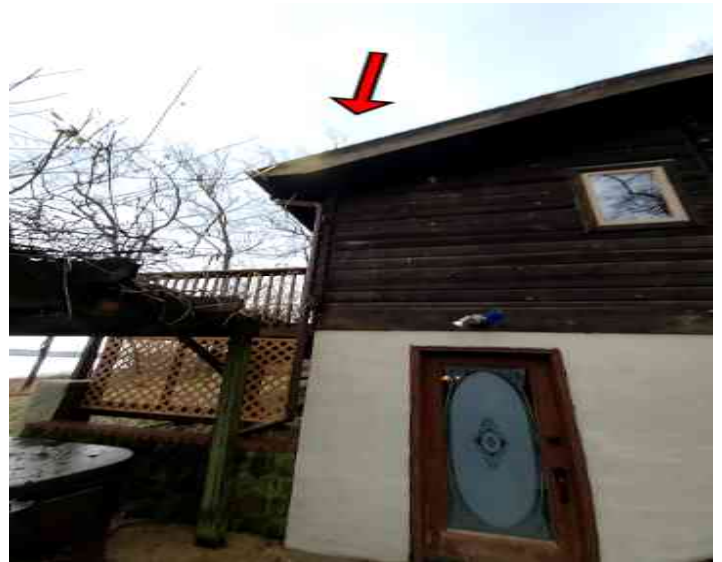
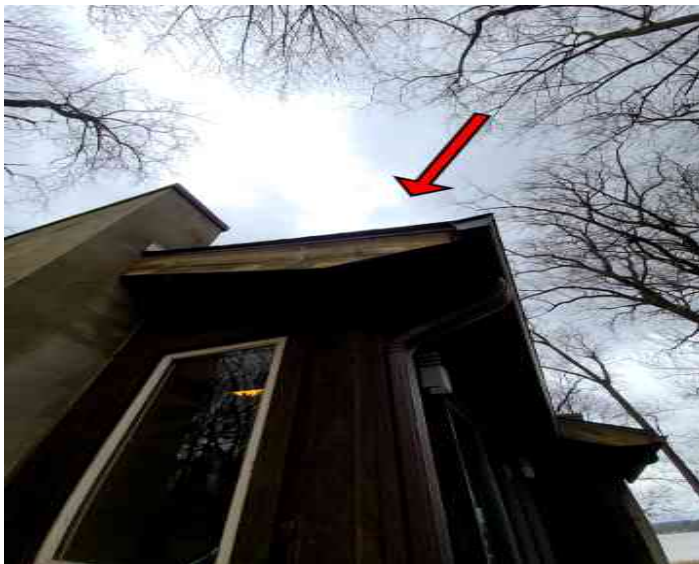
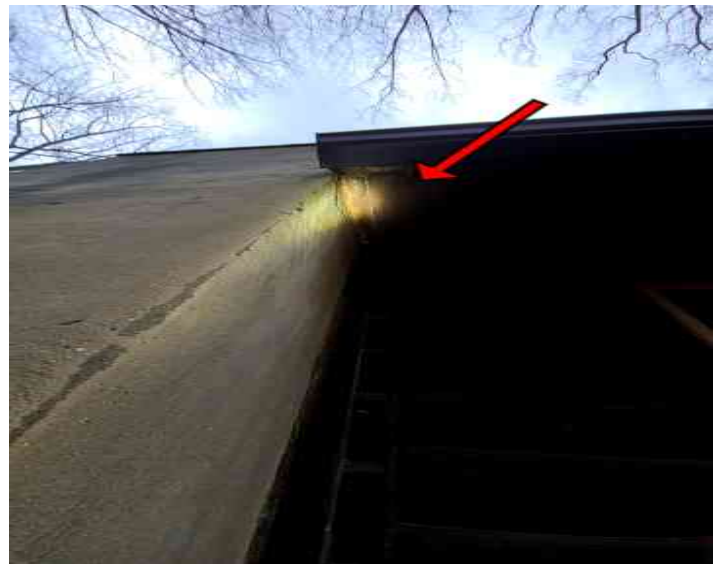
1: Soffit\Fascia

Some loose paint and wood rot noted. Carpenter bee and Bird damage noted and all exterior wood products should be evaluated and all needed repairs made. Poorly sealed area where soffit and fascia meet chimney and should be repaired

Some loose paint and wood rot noted. Carpenter bee and Bird damage noted and all exterior wood products should be evaluated and all needed repairs made. Poorly sealed area where soffit and fascia meet chimney and should be repaired

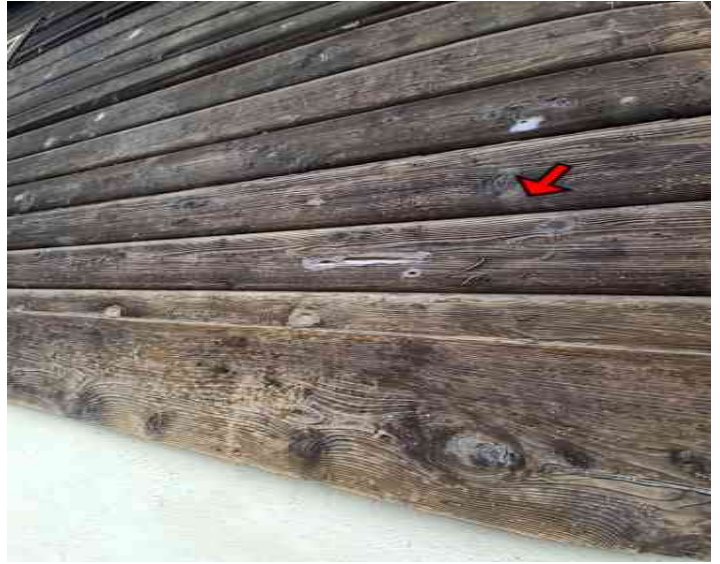
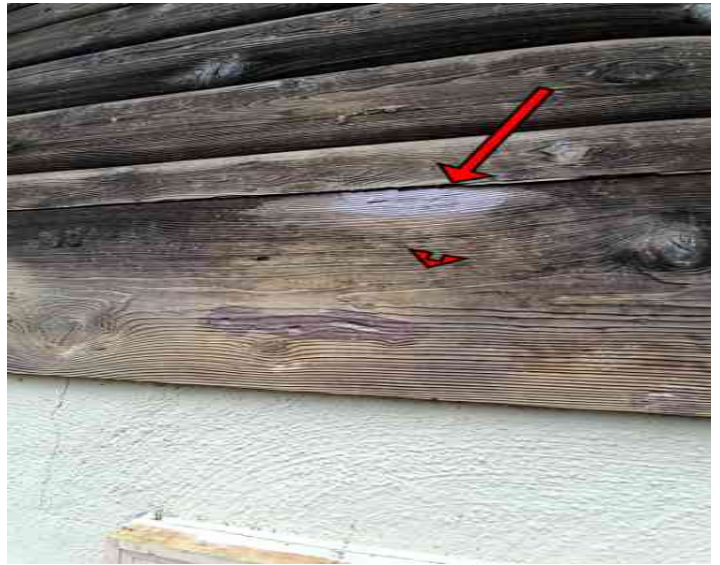
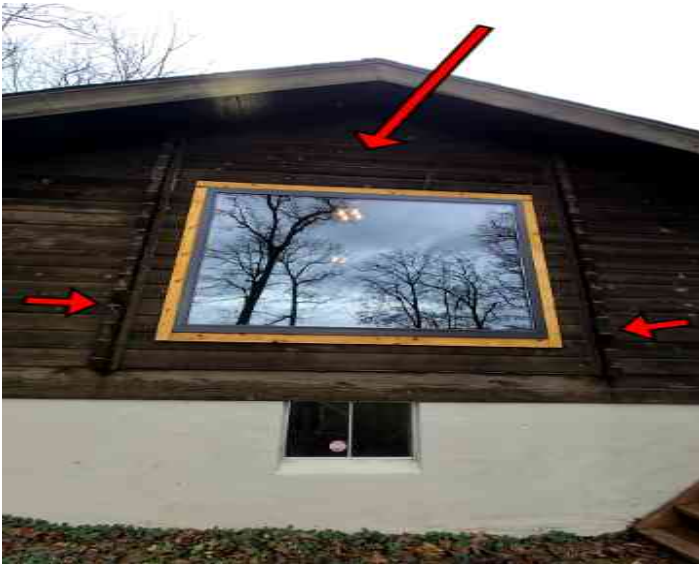
2: Siding

Carpenter bee and bird damage noted and some repairs all exterior walls should be evaluated in only repairs made and treatments Poorly installed Windows noted not flashed properly no top flashing All should be evaluated and repaired

Carpenter bee and bird damage noted and some repairs all exterior walls should be evaluated in only repairs made and treatments Poorly installed Windows noted not flashed properly no top flashing All should be evaluated and repaired

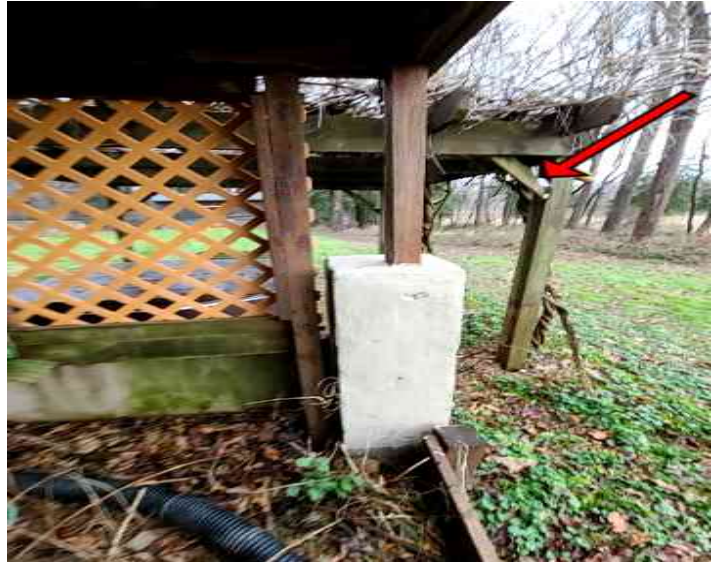
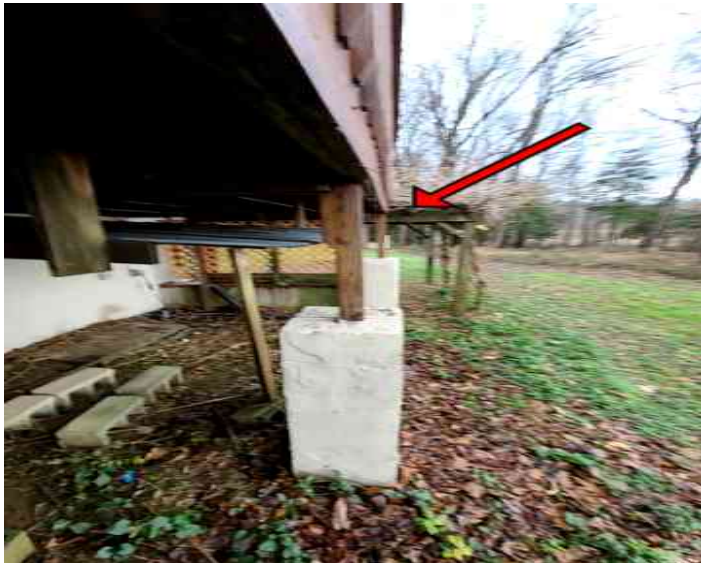
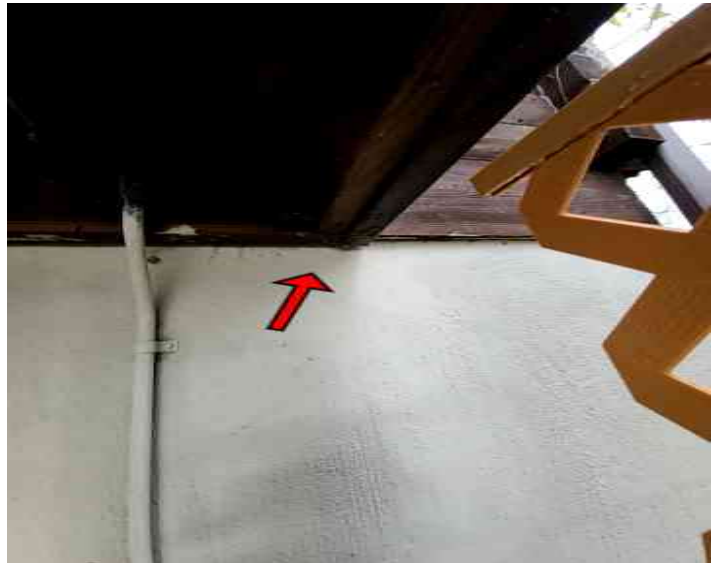
3: Decks

Deck has leaning posts/peirs and is not bolted to the house and should be evaluated and repaired Both legs do to not rest on properly posts and should be evaluated and repaired. Missing railings noted at newer deck and should be installed. Stain and some rot noted. All decks should be evaulated and repaired. beam does not fully rest on posts.

Poorly connected framing noted at deck

Deck has leaning posts/peirs and is not bolted to the house and should be evaluated and repaired Both legs do to not rest on properly posts and should be evaluated and repaired. Missing railings noted at newer deck and should be installed. Stain and some rot noted. All decks should be evaulated and repaired. beam does not fully rest on posts.

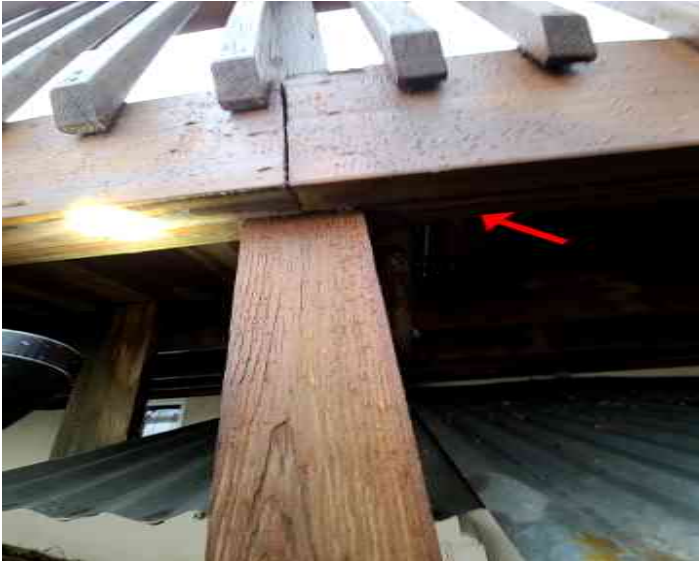
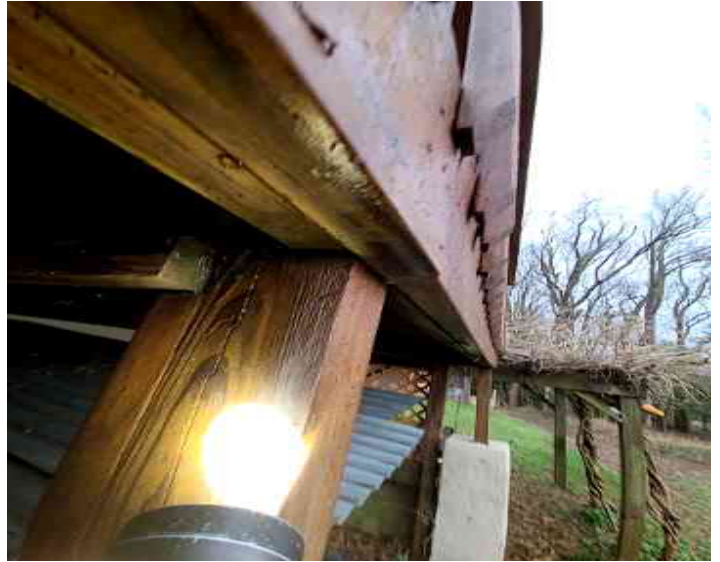
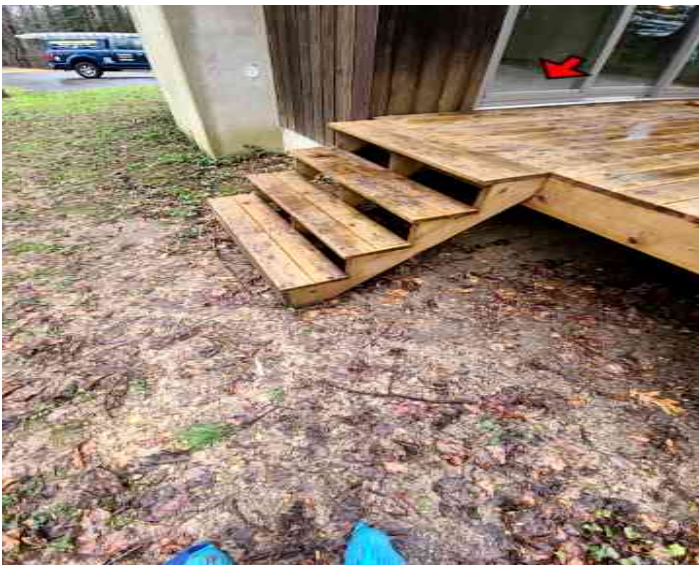
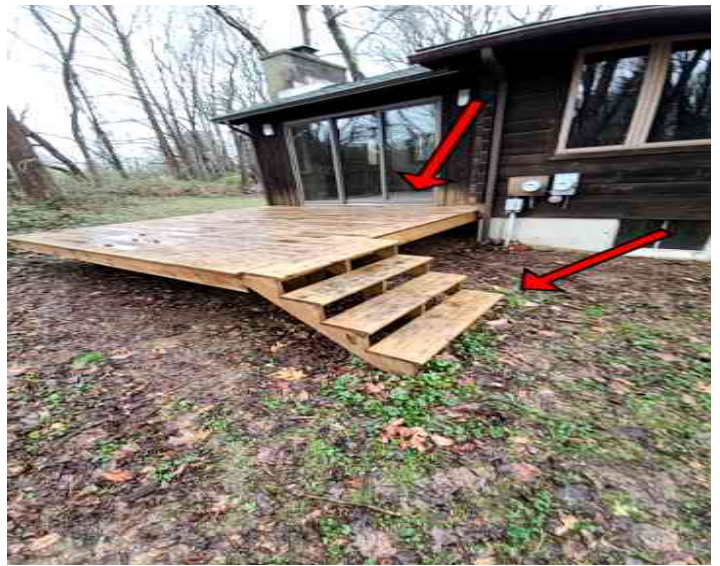
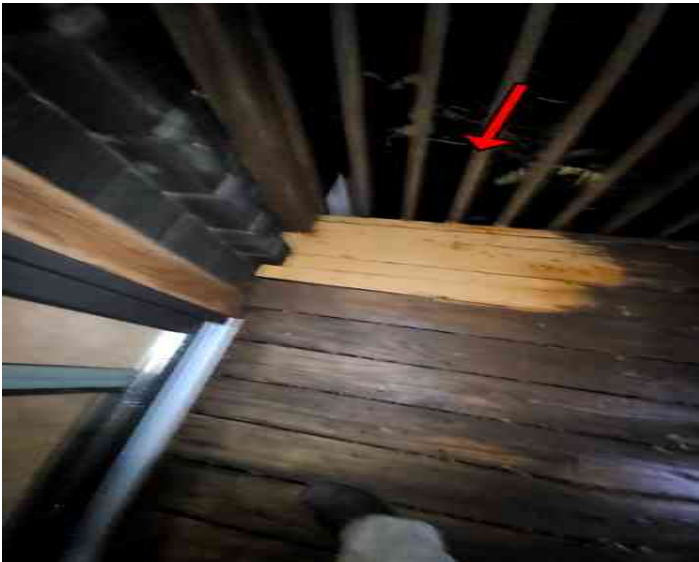
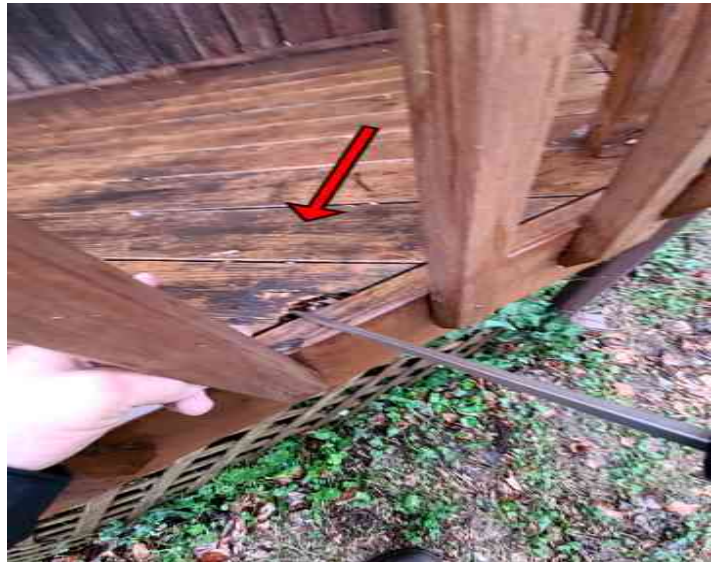
Rot at front deck should be repaired.

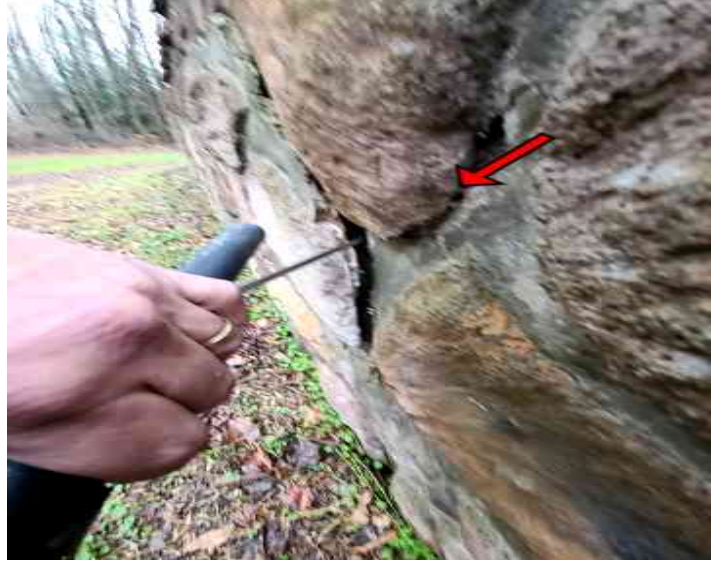
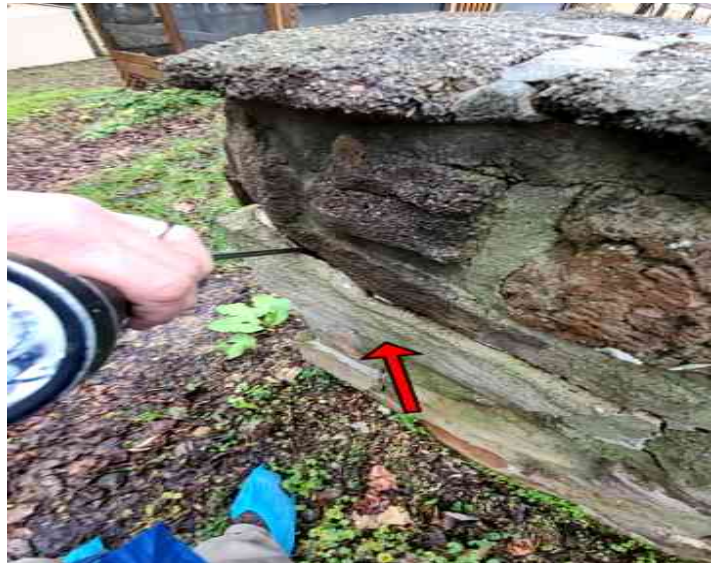
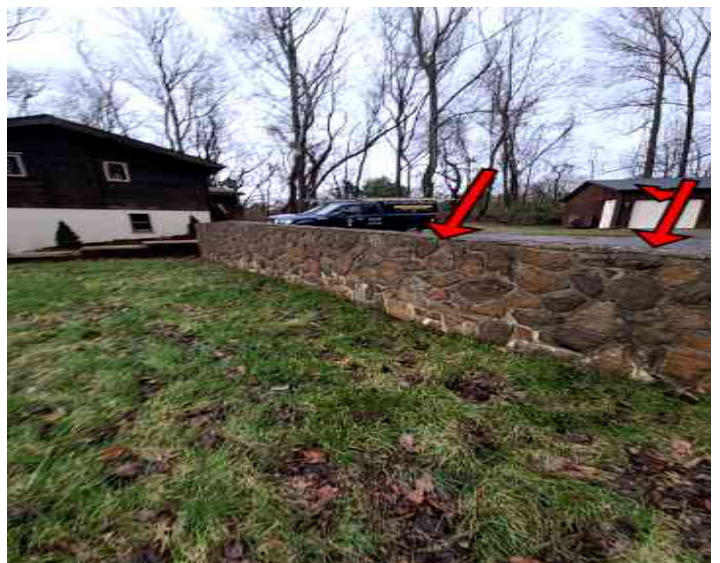
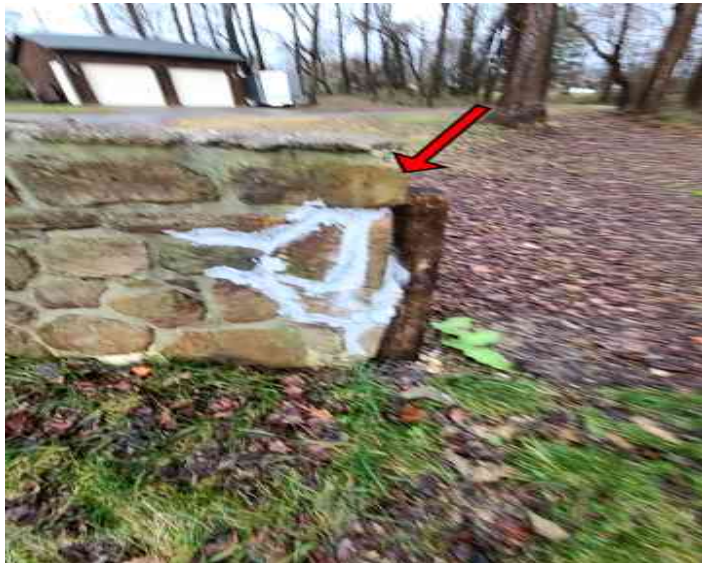
4: Retaining Wall

Cracked, loose and damaged areas of all some staining indicates water penetration and no weep holes noted and should be evaluated and repaired

Cracked, loose and damaged areas of all some staining indicates water penetration and no weep holes noted and should be evaluated and repaired

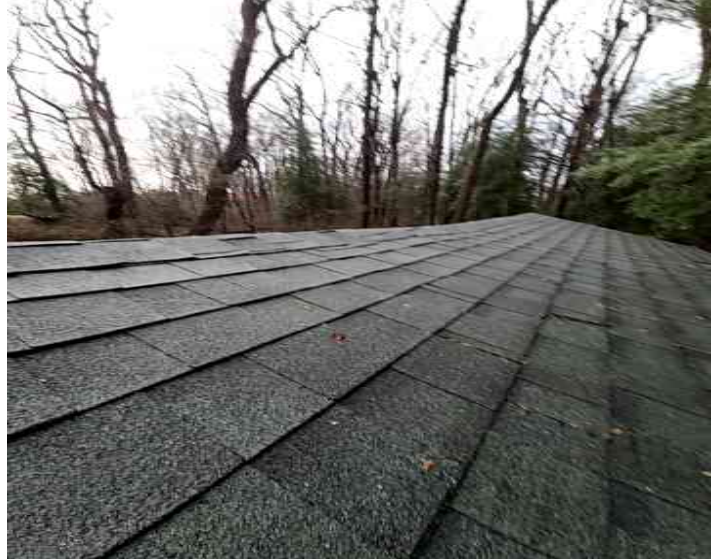
5: ROOF

Large sag and improper cap shingles noted on shed roof and should be repaired

Large sag and improper cap shingles noted on shed roof and should be repaired

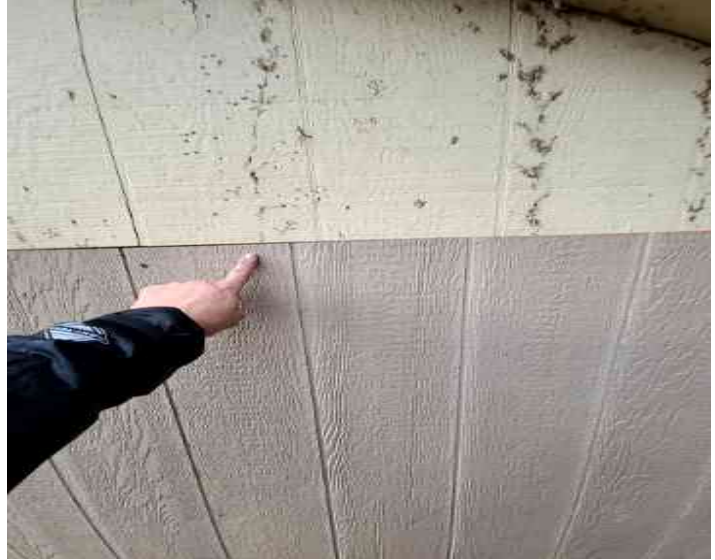
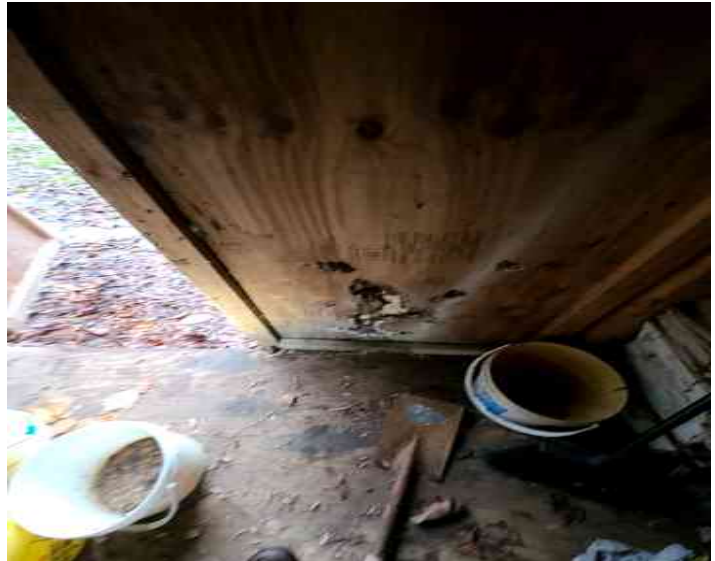
6: GARAGE

Missing shiplap flashing noted on exterior of shed and should be repaired. Rotted areas noted at shed and should be evaluated and repaired. Rot mold and mildew noted inside shed and should be repaired. Some mold/mildew was noted on some structural surfaces and sheathing and should be cleaned by qualified personnel. As mold and mildew are not part of the home inspection the client may decide to do further evaluation to determine the extent of the problem and cost of cleanup/repair. Rotted wall and floor system in shed and should be evaluated and repaired. Termite tubes and some damage were noted in the garage and should be evaluated by a qualified structural contractor or engineer and all needed repairs should be made. Rotted siding noted and siding in contact with soil also damaged soffit and fascia all exterior walls should be evaluated and repaired. Pavilion on site has some rot and should be repaired. Missing areas of latis. Both shed pavilion should be evaluated and all needed repairs made.

Missing shiplap flashing noted on exterior of shed and should be repaired. Rotted areas noted at shed and should be evaluated and repaired. Rot mold and mildew noted inside shed and should be repaired. Some mold/mildew was noted on some structural surfaces and sheathing and should be cleaned by qualified personnel. As mold and mildew are not part of the home inspection the client may decide to do further evaluation to determine the extent of the problem and cost of cleanup/repair. Rotted wall and floor system in shed and should be evaluated and repaired. Termite tubes and some damage were noted in the garage and should be evaluated by a qualified structural contractor or engineer and all needed repairs should be made. Rotted siding noted and siding in contact with soil also damaged soffit and fascia all exterior walls should be evaluated and repaired. Pavilion on site has some rot and should be repaired. Missing areas of latis. Both shed pavilion should be evaluated and all needed repairs made.

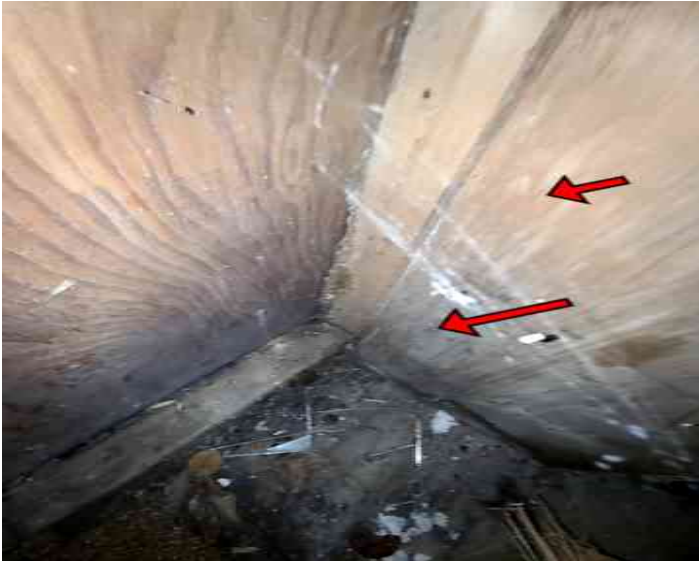
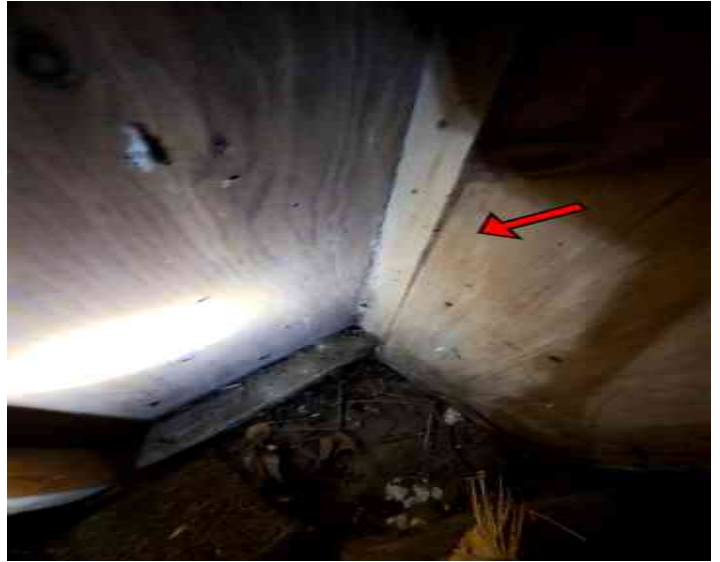
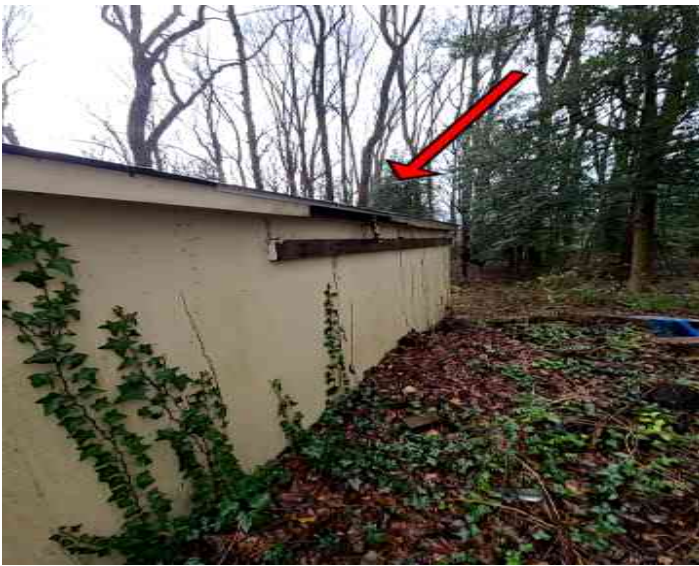
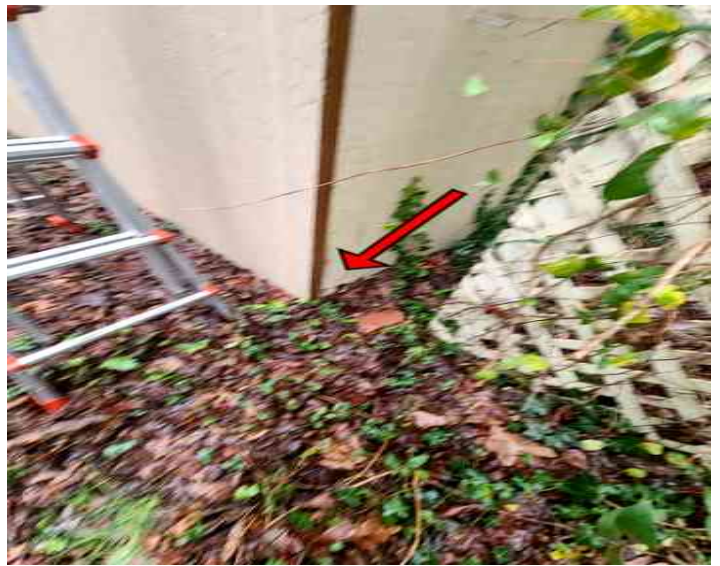
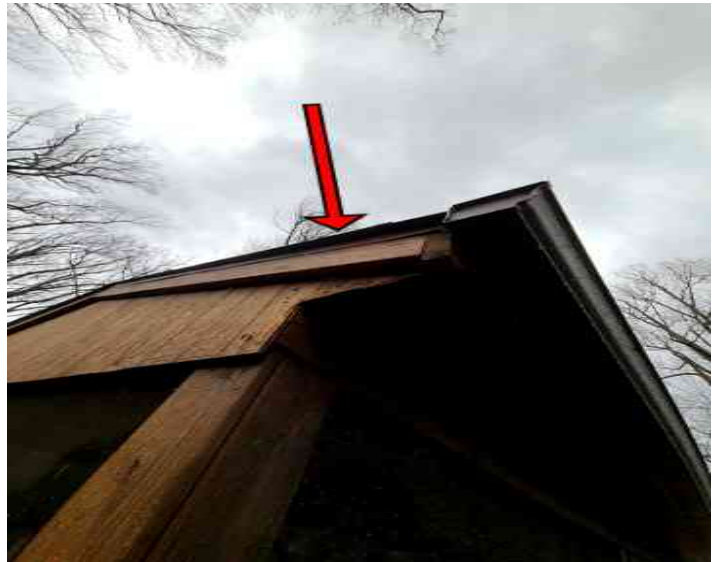
Delamination noted in pavilion ceiling and should be repaired

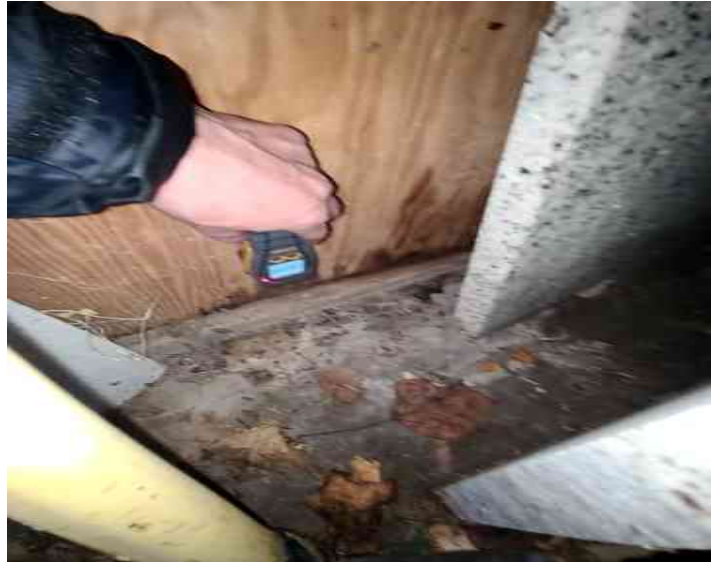
7: Garage Interior Walls

Wet areas noted inside garage and should be evaluated and repaired. Some mold/mildew was noted on walls and should be cleaned by qualified personnel. As mold and mildew are not part of the home inspection the client may decide to do further evaluation to determine the extent of the problem and cost of cleanup/repair.

Wet areas noted inside garage and should be evaluated and repaired. Some mold/mildew was noted on walls and should be cleaned by qualified personnel. As mold and mildew are not part of the home inspection the client may decide to do further evaluation to determine the extent of the problem and cost of cleanup/repair.

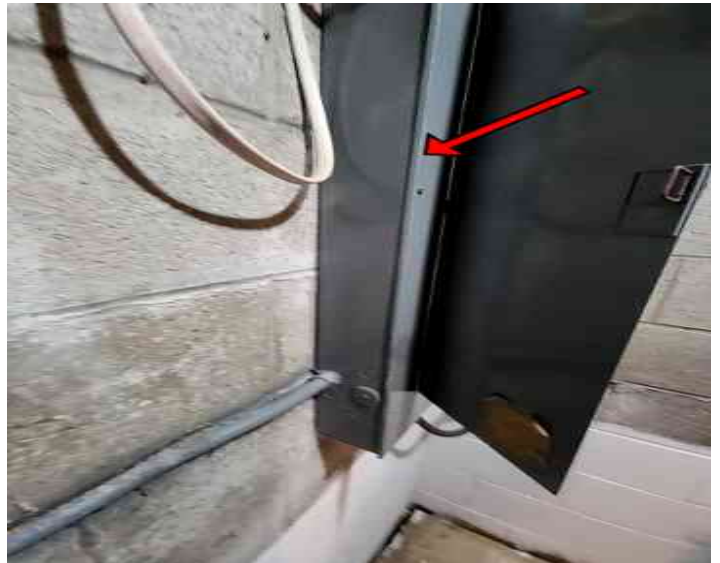
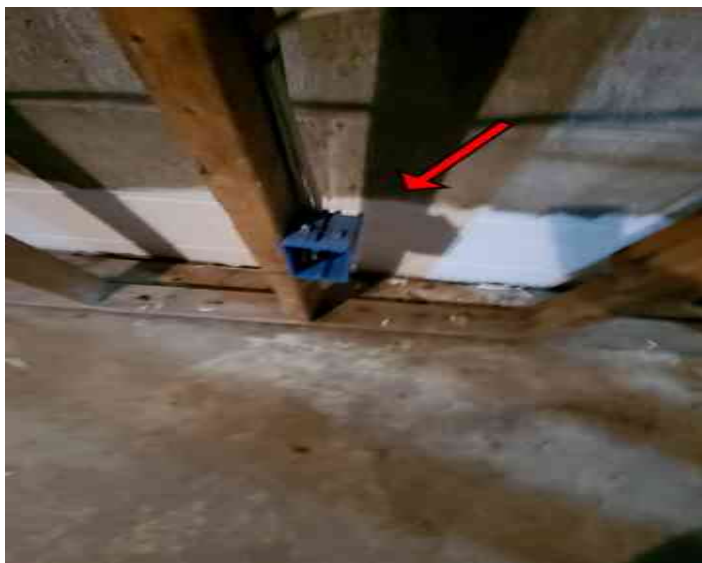
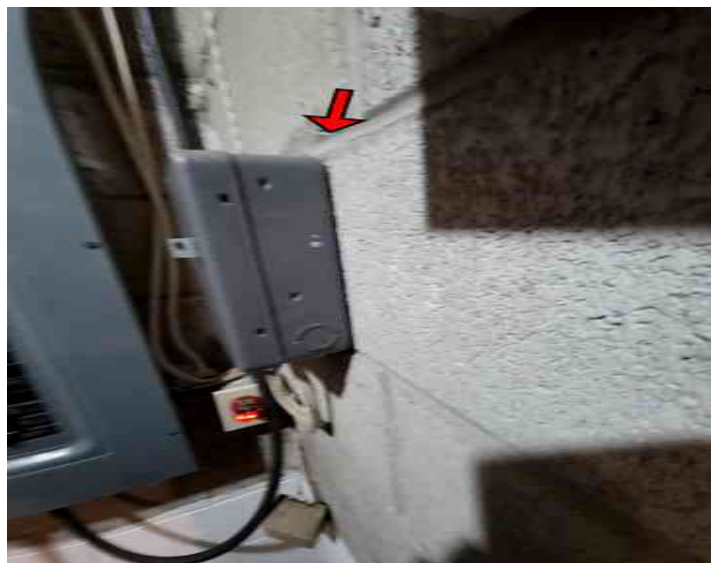
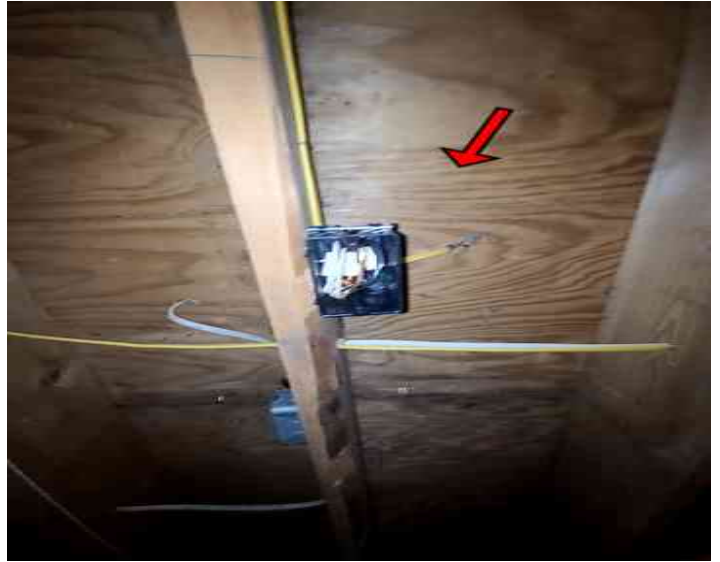
8: ELECTRICAL SYSTEM

Basement outlets should be GFCI outlets Boxes on walls should be on blocks to prevent rust Incomplete basement wiring noted expose live wires missing box covers All electrical items were noted as safety concerns shall be considered part of this major defect Multiple electrical defects were noted The entire electrical system should be evaluated by a qualified electrical contractor and all needed repairs should be made

Basement outlets should be GFCI outlets Boxes on walls should be on blocks to prevent rust Incomplete basement wiring noted expose live wires missing box covers All electrical items were noted as safety concerns shall be considered part of this major defect Multiple electrical defects were noted The entire electrical system should be evaluated by a qualified electrical contractor and all needed repairs should be made

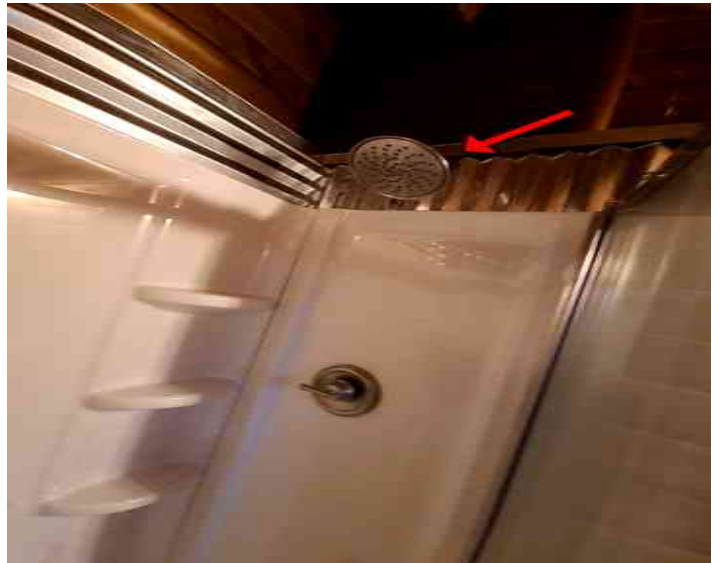
9: PLUMBING

Low-flow noted Plumbing should be repaired

Low-flow noted Plumbing should be repaired

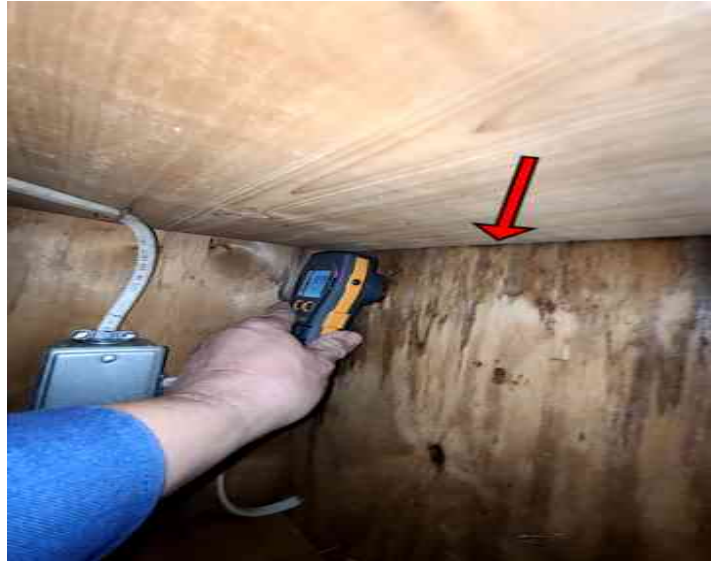
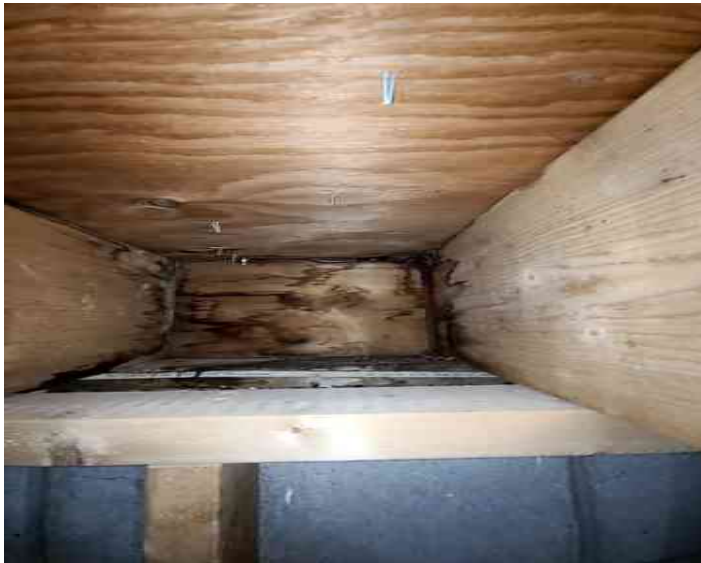
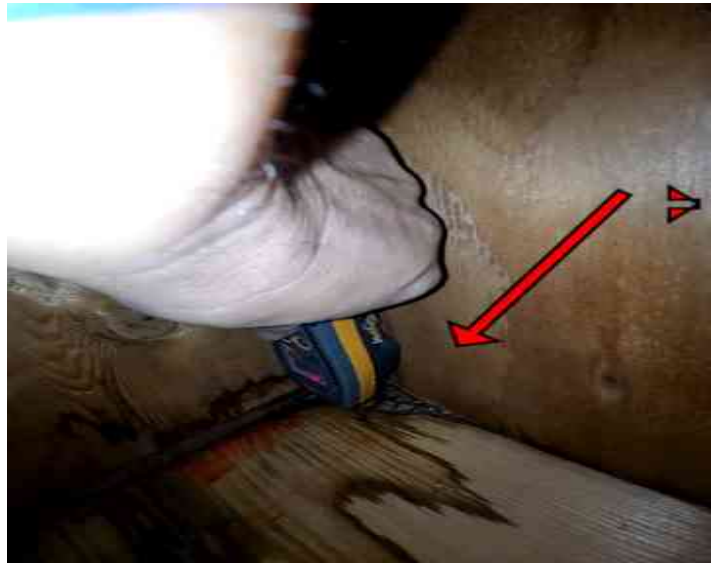
10: Basement Ceiling Sub Floor Visible Primary Type

Currently wet stain noted at the rear right corner
Source should be identified and all needed repairs
made. Other Wet stains noted center of rear wall
should be evaluated in repair Some mold/mildew was
noted in the lowest level and should be evaluated and
cleaned by qualified personnel. As mold and mildew
are not part of the home inspection the client may
decide to do further evaluation to determine the extent
of the problem and cost to cleanup/repair.

Center of rear wall

Currently wet stain noted at the rear right corner Source should be identified and all needed repairs made. Other Wet stains noted center of rear wall should be evaluated in repair Some mold/mildew was noted in the lowest level and should be evaluated and cleaned by qualified personnel. As mold and mildew are not part of the home inspection the client may decide to do further evaluation to determine the extent of the problem and cost to cleanup/repair.

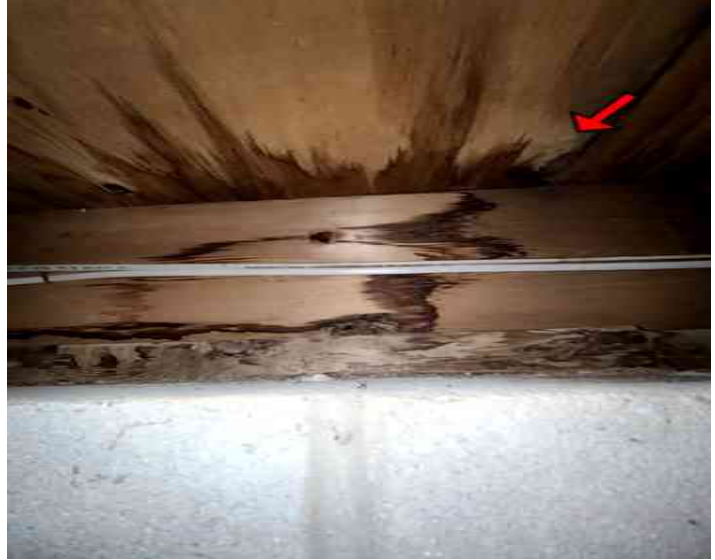
11: Basement Ceiling Joist Visible Primary Type

Some stains that were not wet at the time of inspection and should be monitored. Wet stains and some dry stains noted in basement and all should be evaluated and repaired.

Some stains that were not wet at the time of inspection and should be monitored. Wet stains and some dry stains noted in basement and all should be evaluated and repaired.

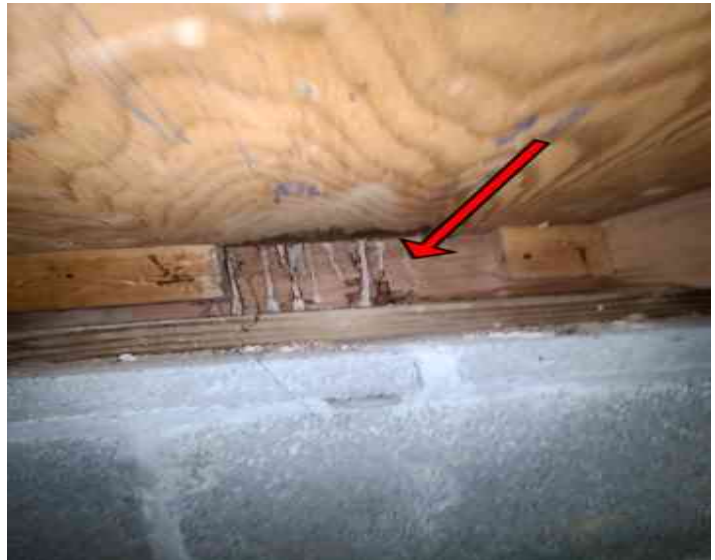
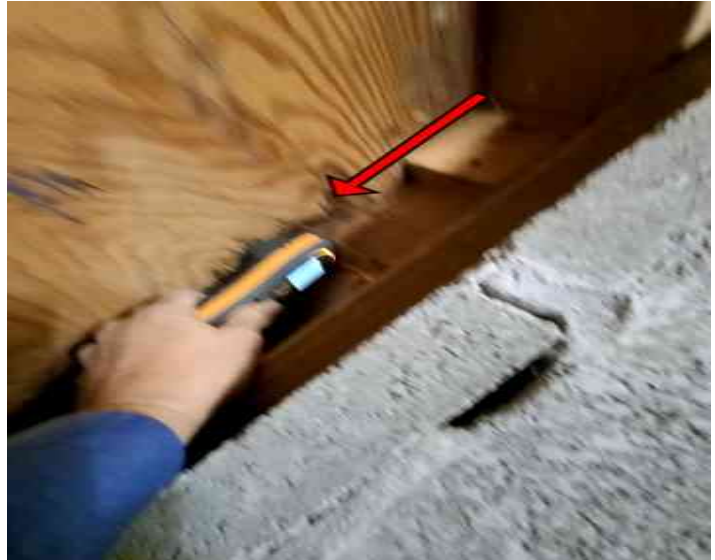
12: Crawl Space Ceiling Sub Floor

Current leak noted at the framing under fireplace and source of wetness should be identified and repaired

Current leak noted at the framing under fireplace and source of wetness should be identified and repaired

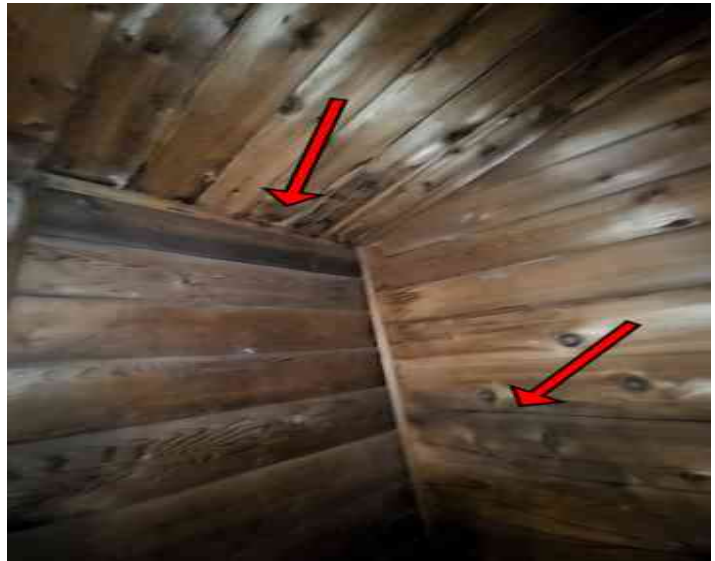
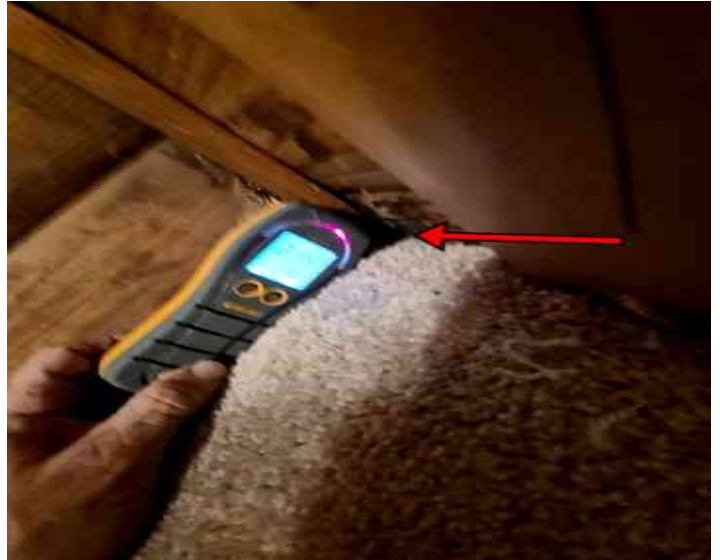
13: Interior Walls

Stains rot and discoloration noted on all interior walls and should be evaluated and repaired some stains did not check wet. Some mold/mildew was noted on lower level of wall and should be cleaned by qualified personnel. As mold and mildew are not part of the home inspection the client may decide to do further evaluation to determine the extent of the problem and cost of cleanup/repair. Wet stain noted in the middle rear bedroom and should be evaluated and repaired

Wet stain noted middle rear bedroom

Stains rot and discoloration noted on all interior walls and should be evaluated and repaired some stains did not check wet. Some mold/mildew was noted on lower level of wall and should be cleaned by qualified personnel. As mold and mildew are not part of the home inspection the client may decide to do further evaluation to determine the extent of the problem and cost of cleanup/repair. Wet stain noted in the middle rear bedroom and should be evaluated and repaired

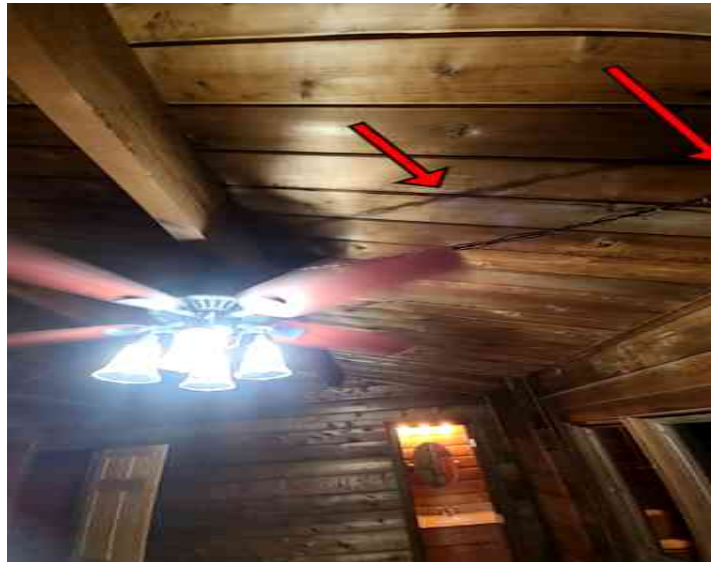
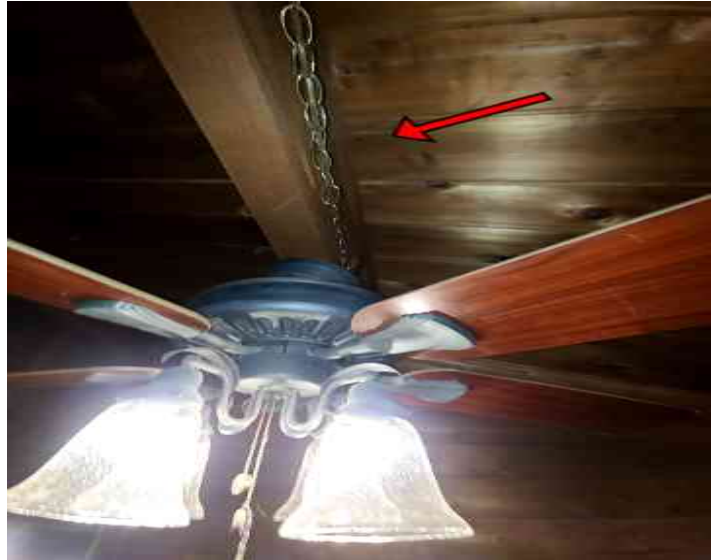
14: Ceiling Fan

Improper wiring to Fans swag connections have no ground and should be permanently wired

Improper wiring to Fans swag connections have no ground and should be permanently wired

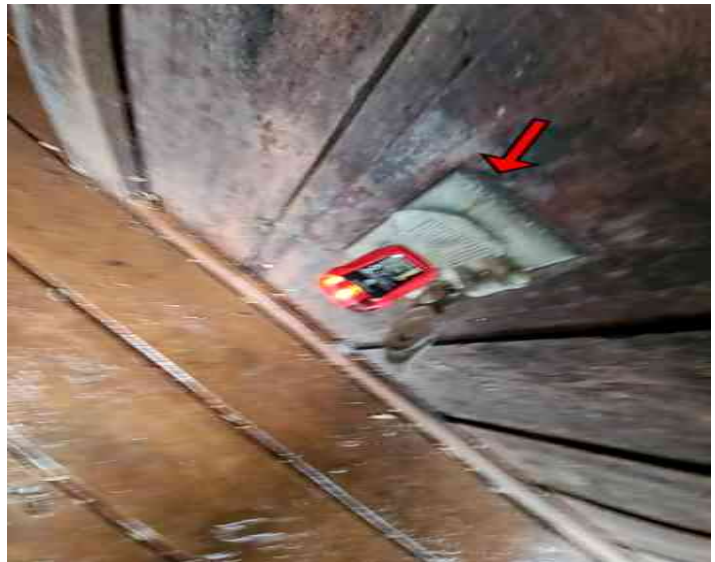
15: Outside Outlets

The GFCI on the garage would not trip when tested and should be repaired.

The GFCI on the garage would not trip when tested and should be repaired.

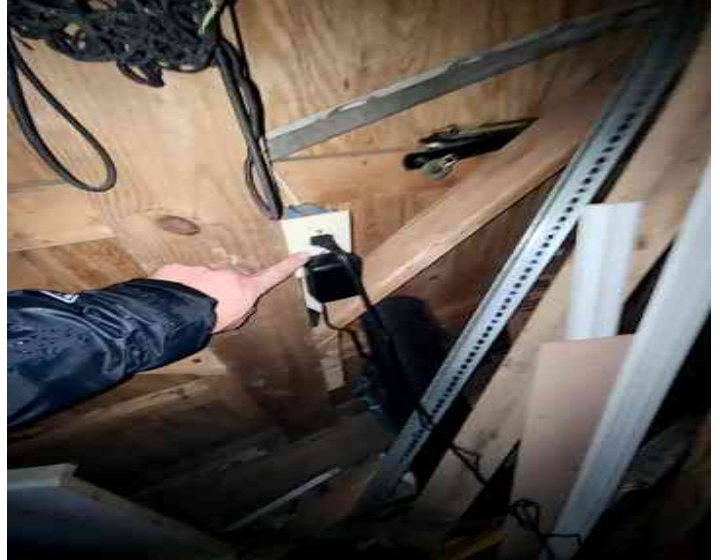
18: Garage Electrical System

Recommend GFCI protection.

Recommend GFCI protection.

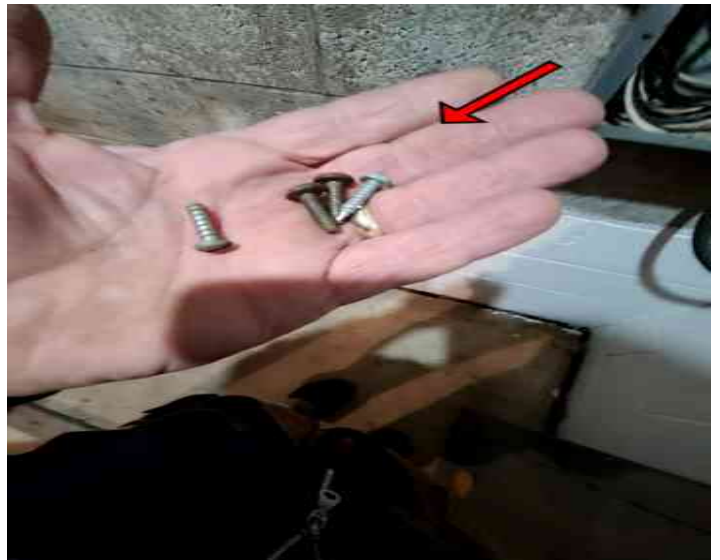
21: Electrical Defaults

Missing panel cover screws were noted and should be replaced. Pointed panel cover screws should be replaced with blunt screws.

Missing panel cover screws were noted and should be replaced. Pointed panel cover screws should be replaced with blunt screws.

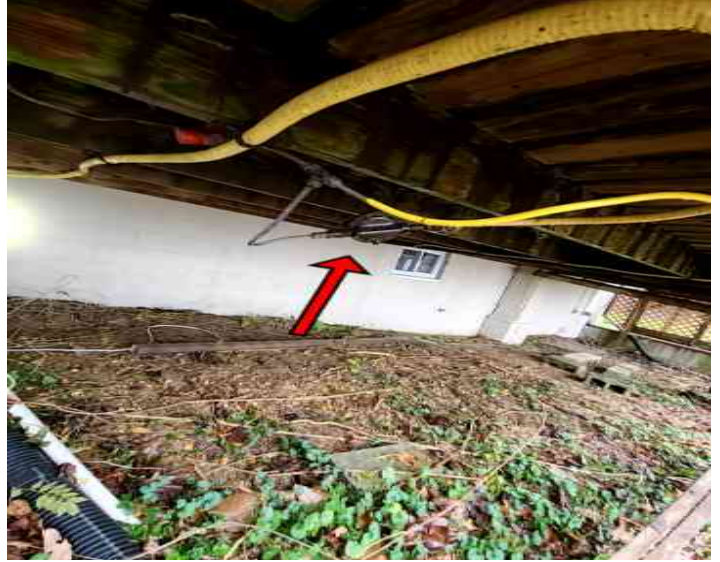
22: Main Gas Valve

Poorly installed and supported gas piping noted under deck and should be repaired

Poorly installed and supported gas piping noted under deck and should be repaired

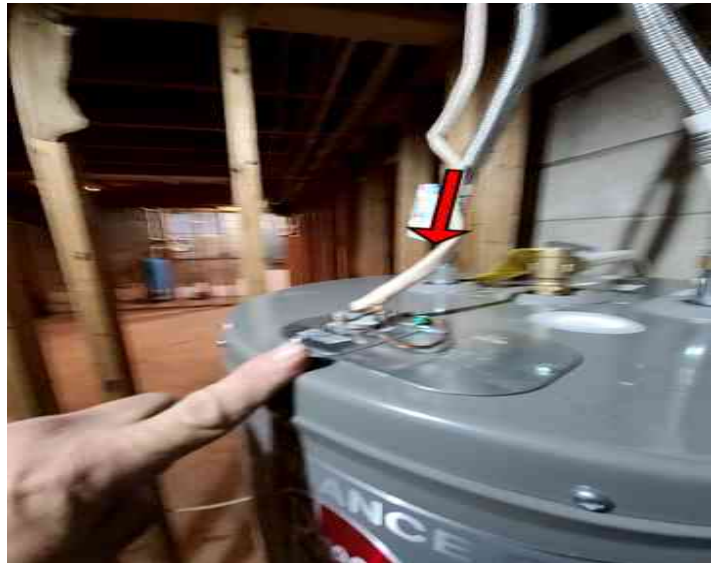
23: Water Heater Fuel

There is an improper electrical connection at the top of the unit which should be repaired by a qualified electrician.

There is an improper electrical connection at the top of the unit which should be repaired by a qualified electrician.

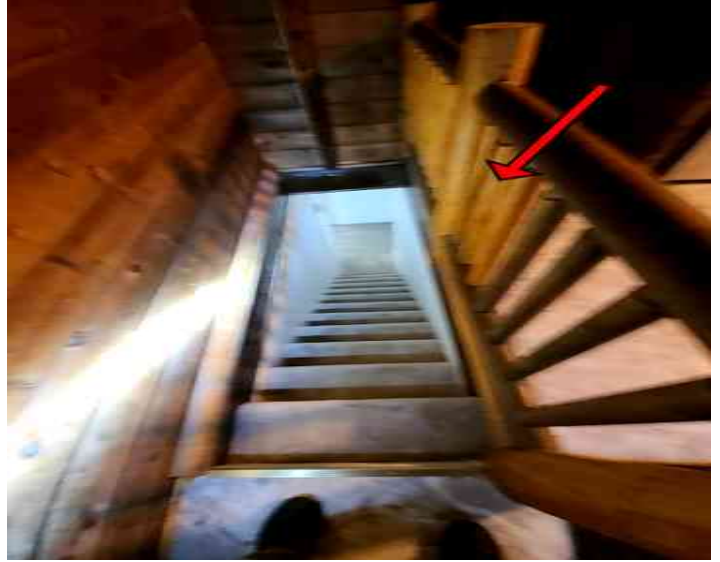
24: Basement Access

There was no hand rail noted in basement and one should be installed.

There was no hand rail noted in basement and one should be installed.

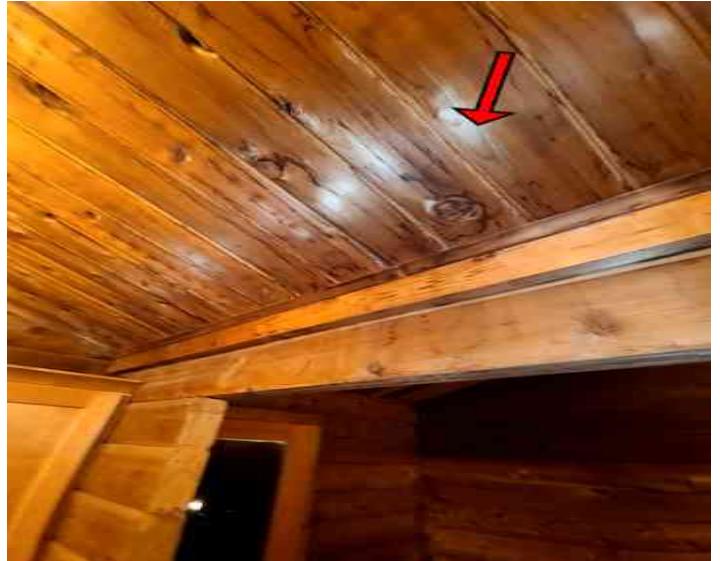
25: Kitchen Ceiling

Some water stains not wet at time of inspection. Some mold/mildew were noted in the kitchen and should be evaluated and cleaned by qualified personnel. As mold and mildew are not part of the home inspection, the client may decide to do further evaluation to determine the extent of the problem and cost to cleanup/repair.

Some water stains not wet at time of inspection Some mold/mildew were noted in the kitchen and should be evaluated and cleaned by qualified personnel. As mold and mildew are not part of the home inspection the client may decide to do further evaluation to determine the extent of the problem and cost to cleanup/repair.
