Reliable Home Inspection Service
100 Old Kennett Road
Wilmington, Delaware 19807
877-993-9100
www.reliablehomeinspectionsservice.com

Inspection Summary

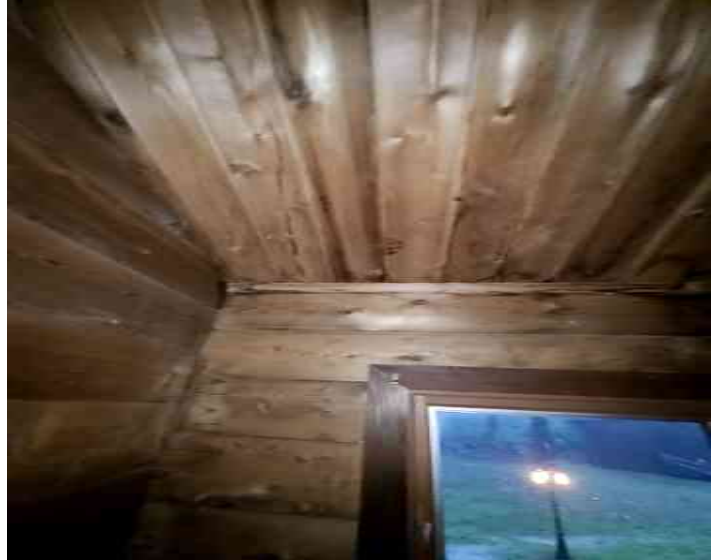
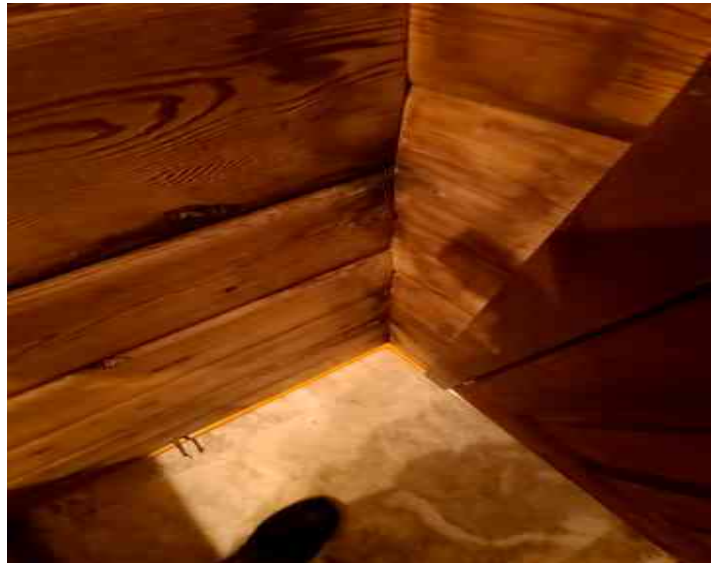
26: Bathroom Walls and Ceilings

Other = Some evidence of past leakage some staining but not wet Some mold/mildew was noted on walls behind access panel and should be cleaned by qualified personnel. As mold and mildew are not part of the home inspection the client may decide to do further evaluation to determine the extent of the problem and cost of cleanup/repair.

Stains in master bath not wet at time of inspection

Other = Some evidence of past leakage some staining but not wet Some mold/mildew was noted on walls behind access panel and should be cleaned by qualified personnel. As mold and mildew are not part of the home inspection the client may decide to do further evaluation to determine the extent of the problem and cost of cleanup/repair.

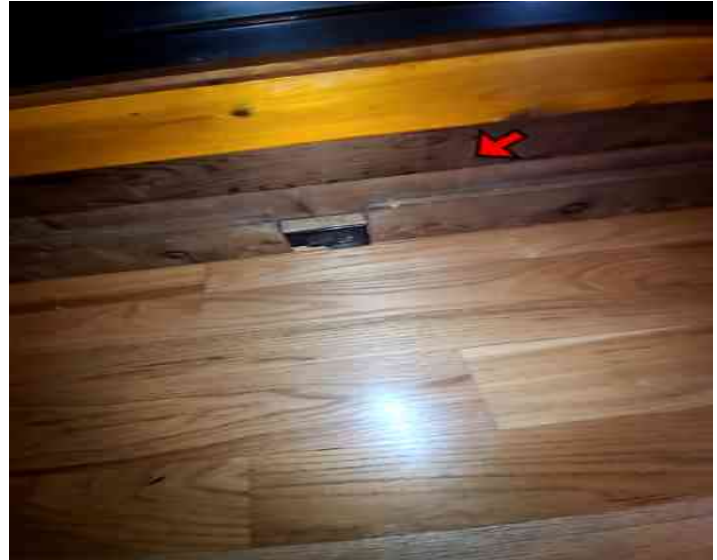
28: Interior Outlets

Damaged Outlet noted in the family room and should be replaced

Damaged Outlet noted in the family room and should be replaced

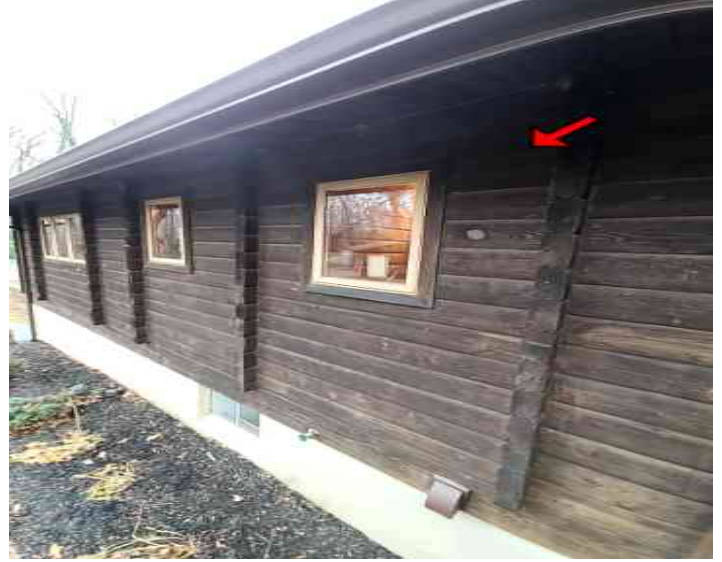
32: Windows Storm\Screen

Some missing screens were noted.

Some missing screens were noted.

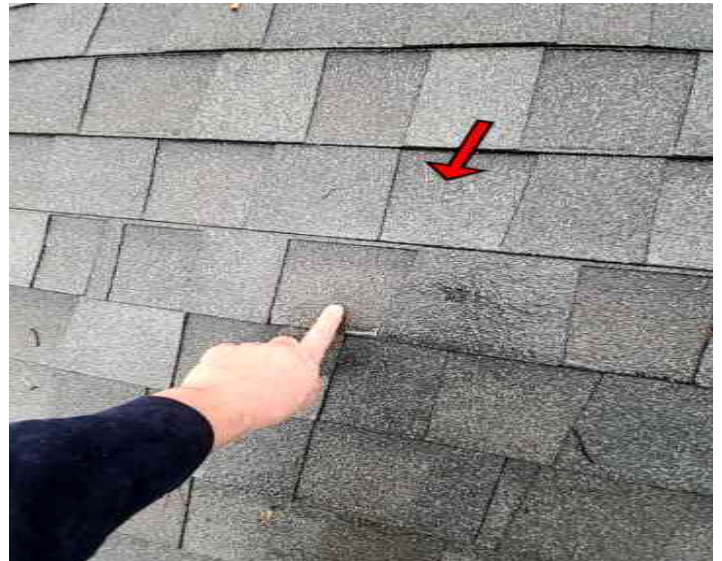
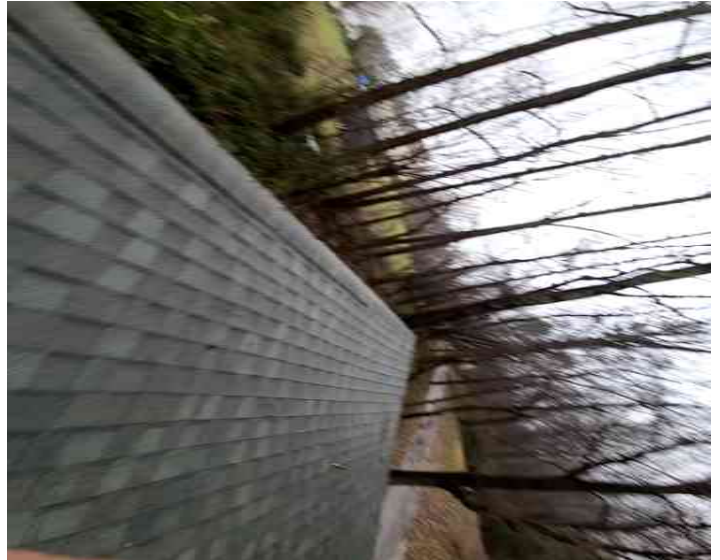
34: Garage Roof

Approx age of roof covering 1 to 5 Number of layers =1 Some shingles ran long Too much exposure

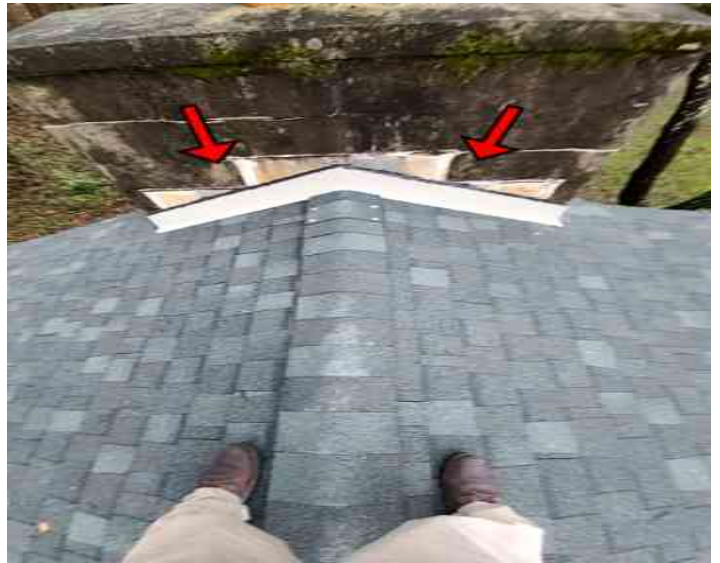
35: Chimney 1 Type

Cut out and cracks in chimneys should be sealed

Cut out and cracks in chimneys should be sealed

Some cracks noted in chimney top.

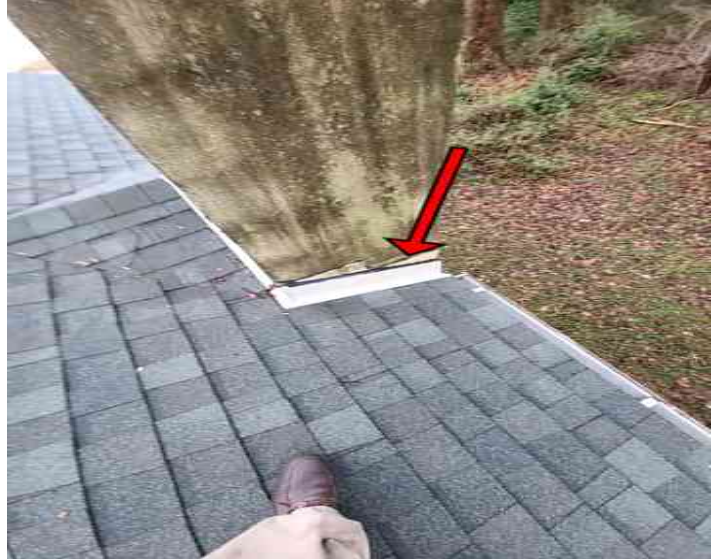
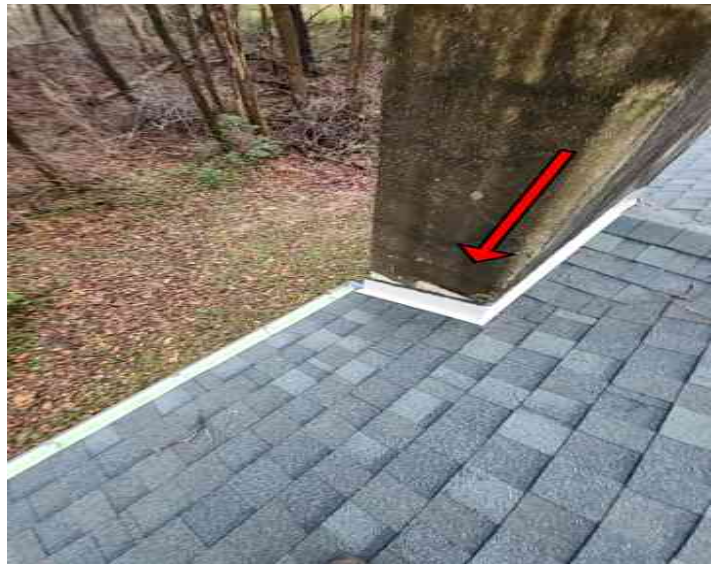
36: Chimney 2 Location

Areas where flashing for cutting into chimneys should be sealed.

Some sealant noted and should be monitored and maintained

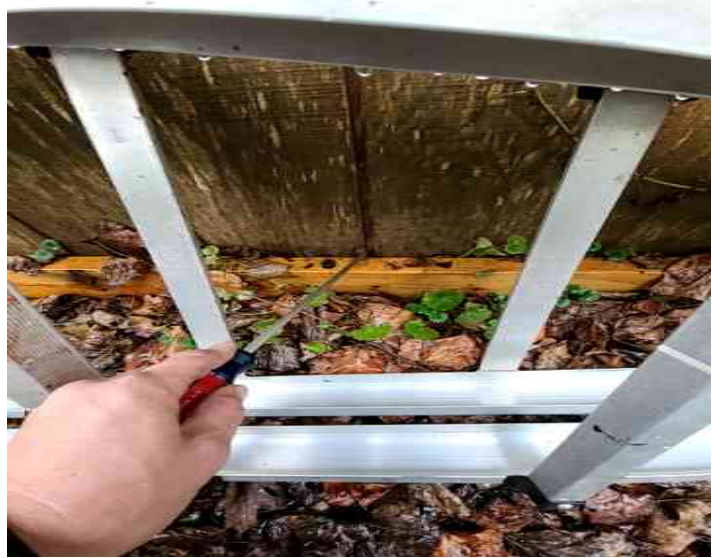
37: Garage Exterior Walls

Added trim board at rear may cover rot

Some visible rot above trim board..

Added trim board at rear may cover rot

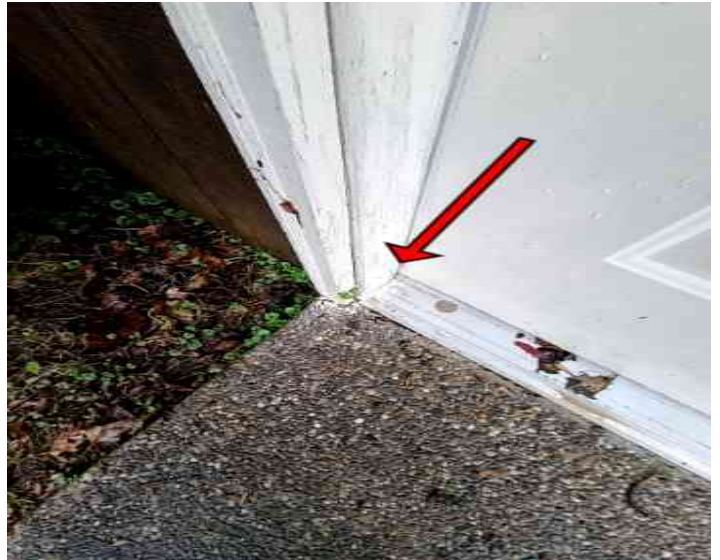
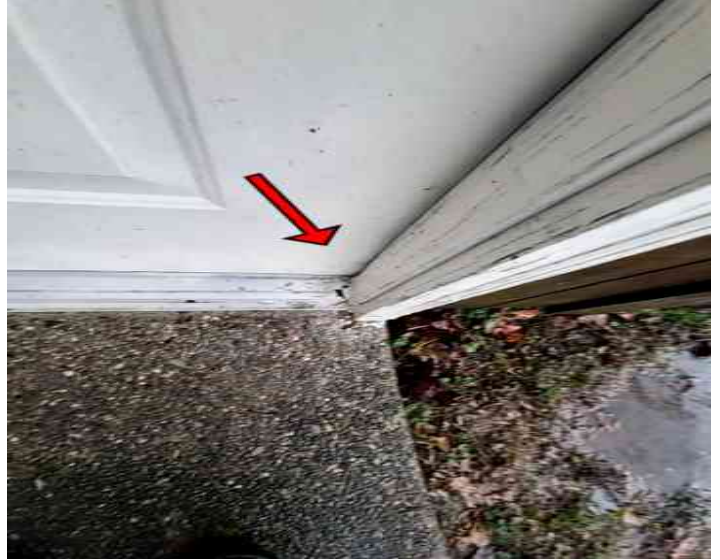
39: Garage Doors

Some dents in garage doors rot noted in garage door trim and should be repaired.

Some dents in garage doors rot noted in garage door trim and should be repaired.

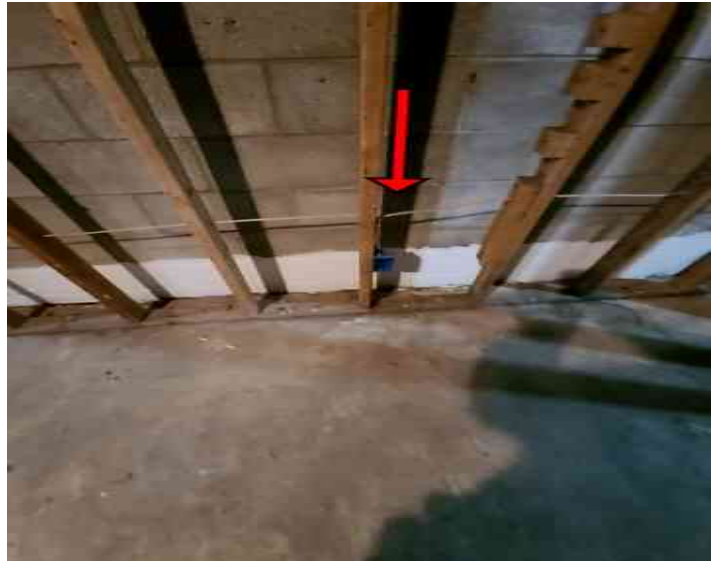
41: Basement Foundation Walls Primary Visible type

Some cracks and water penetration noted. White paint on walls indicate possible environmental clean up.

Some cracks and water penetration noted. White paint on walls indicate possible environmental clean up.

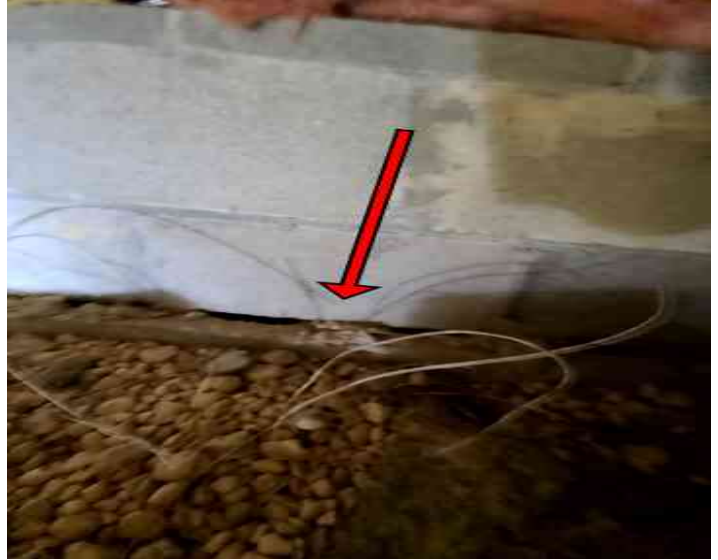
42: Crawl Space Foundation Walls

Some cracks and water penetration noted Smaller block installed over larger block and should be monitored

Some cracks and water penetration noted Smaller block installed over larger block and should be monitored

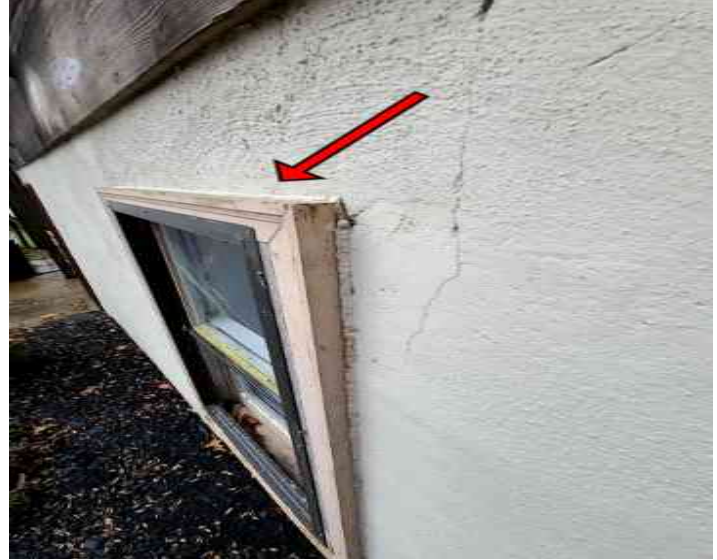
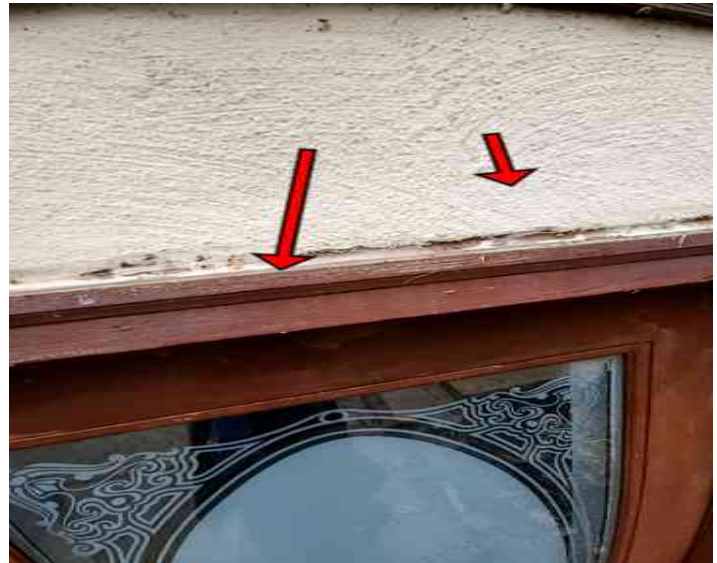
49: Window Character Material

Some loose paint and wood rot. Some poorly sealed areas where doors and windows meet masonry wall

Some loose paint and wood rot. Some poorly sealed areas where doors and windows meet masonry wall

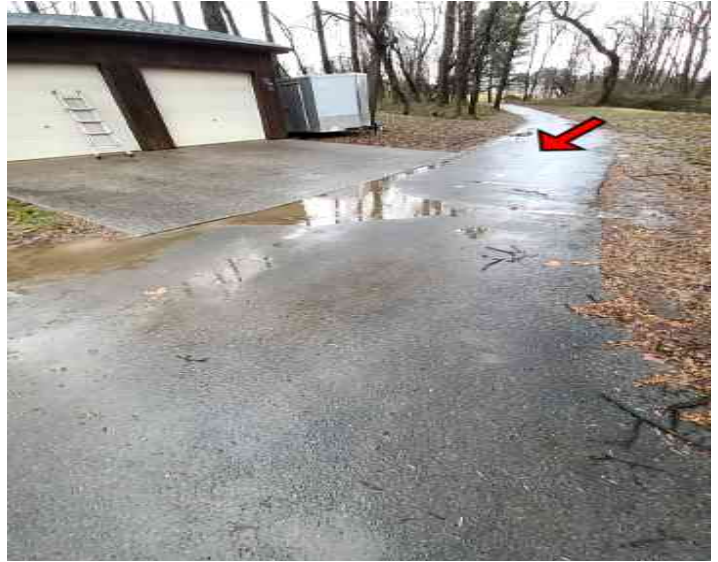
52: Driveway/Parking Lot

Some cracks noted. Water standing in areas of the driveway and should be repaired to drain

Some cracks noted. Water standing in areas of the driveway and should be repaired to drain
