Reliable Home Inspection Service
100 Old Kennett Rd
Wilmington, DE 19807
302-993-9100
<https://www.reliablehomeinspectionsservice.com/>

Client Information: [REDACTED]
HABITAT FOR HUMANITY

Inspection Summary

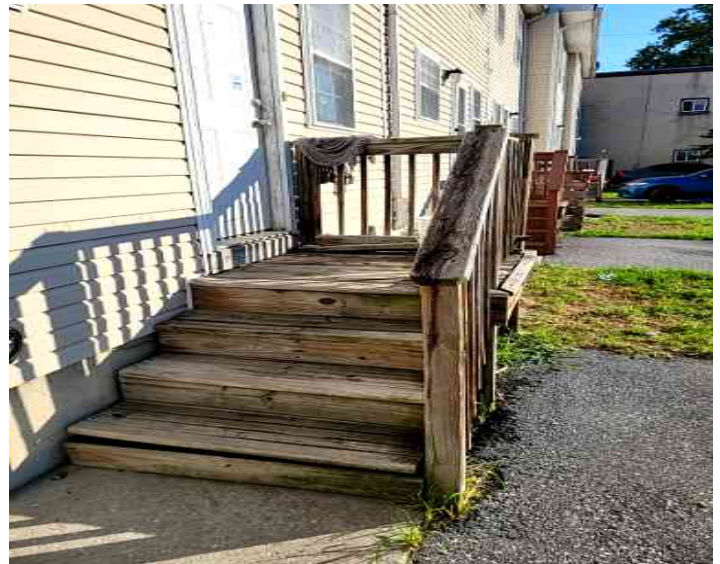
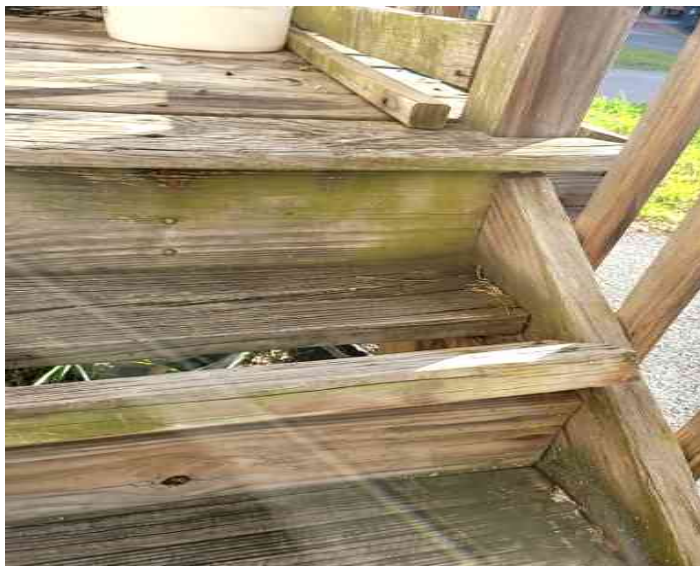
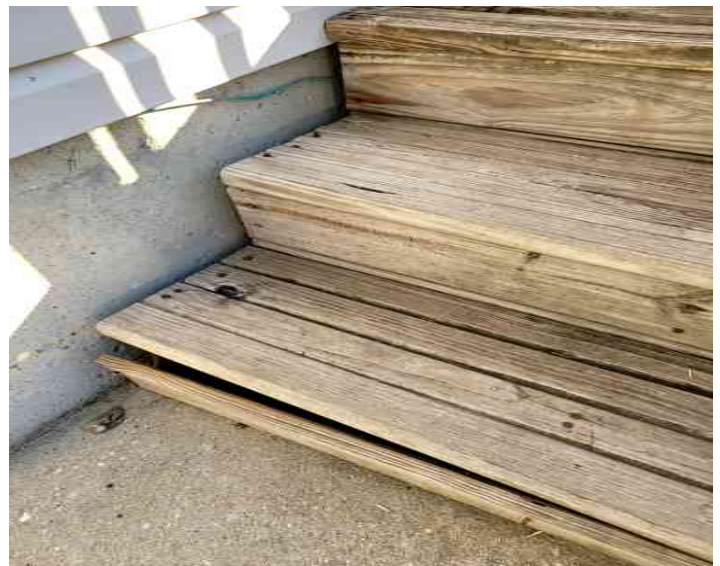
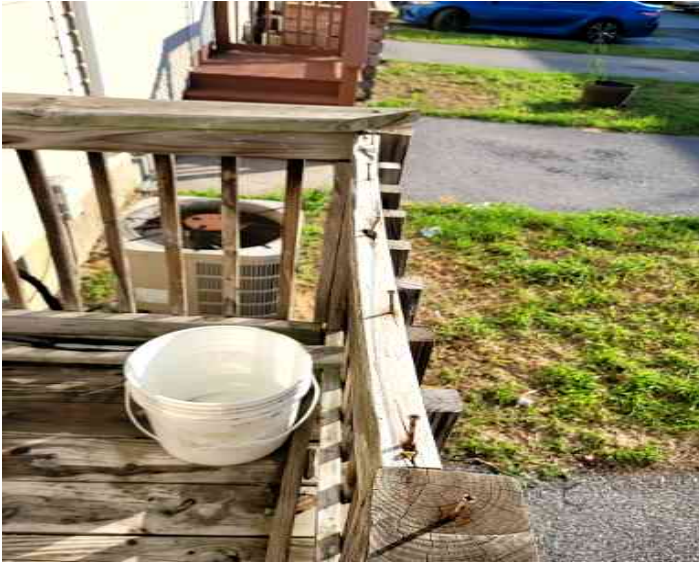
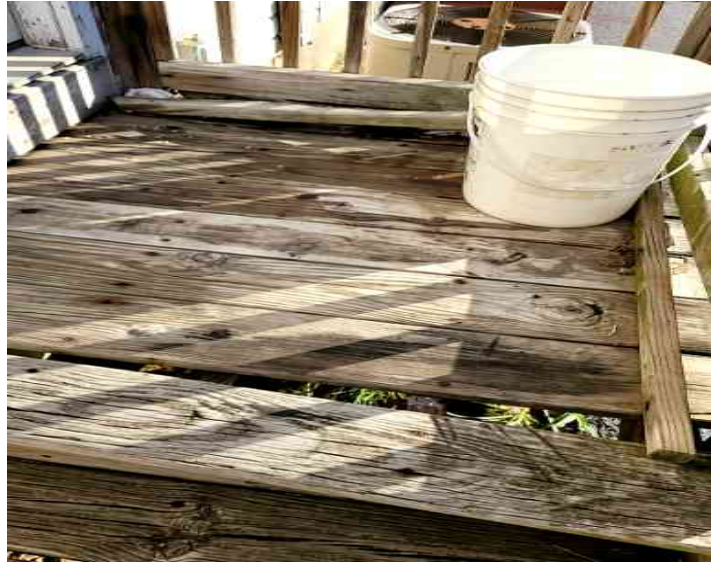
0203: Walks

Cracks and some settlement noted.
Some damaged and uneven steps and boards were noted.
Rear steps are rotted and deteriorated and should be evaluated by a qualified contractor and all needed repairs be made

Cracks and some settlement noted. Some damaged and uneven steps and boards were noted. Rear steps are rotted and deteriorated and should be evaluated by a qualified contractor and all needed repairs be made

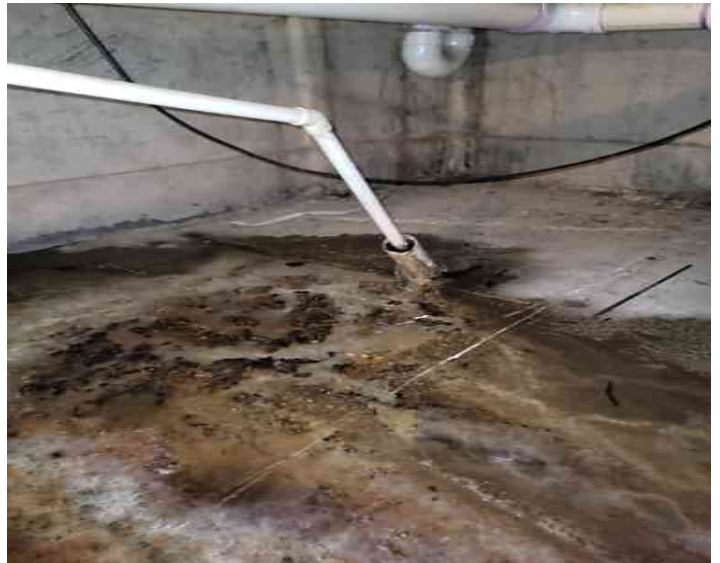
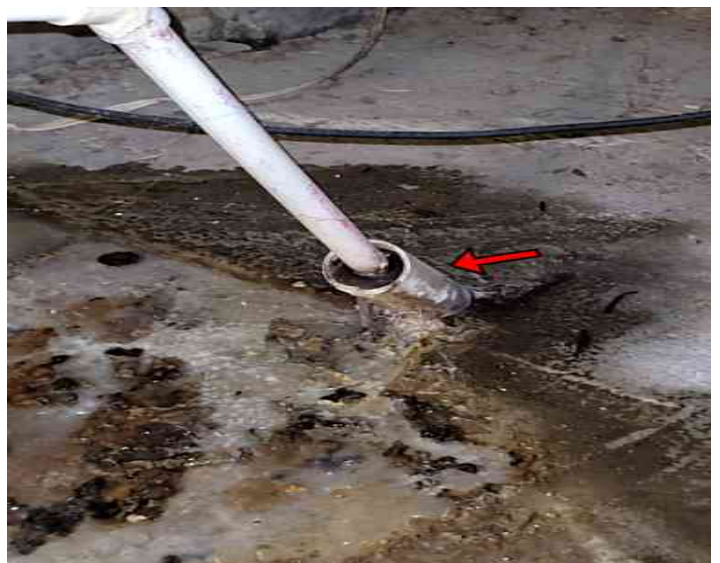
0709: Condensate Drain

Clogged and active leak from condensate drain in crawlspace was noted and should be evaluated and repaired.

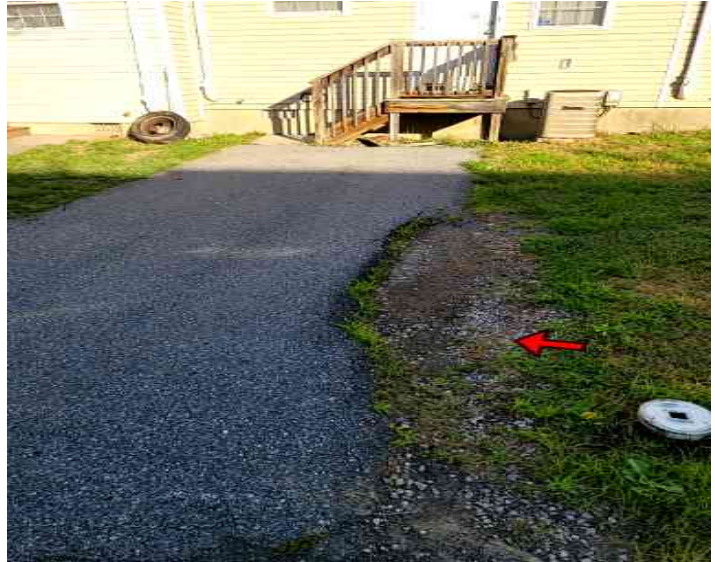
0208: Driveway/Parking Lot

Some cracks noted.

Uneven areas may present a tripping hazard and should be repaired to prevent injury.

Some cracks noted. Uneven areas may present a tripping hazard and should be repaired to prevent injury.

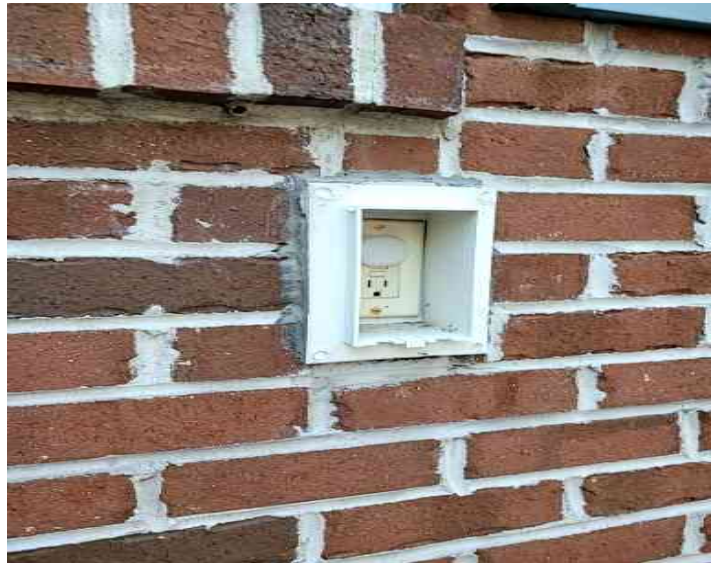
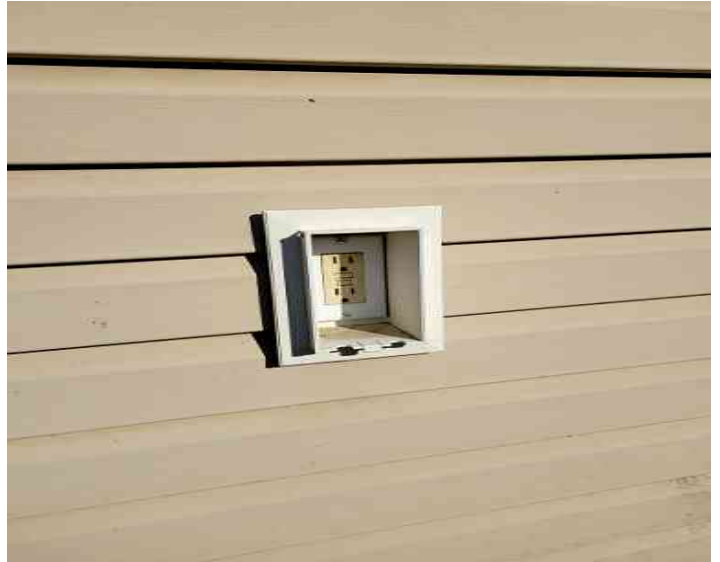
0302: Outside Outlets

Damaged or missing water proof covers were noted and should be repaired or replaced.

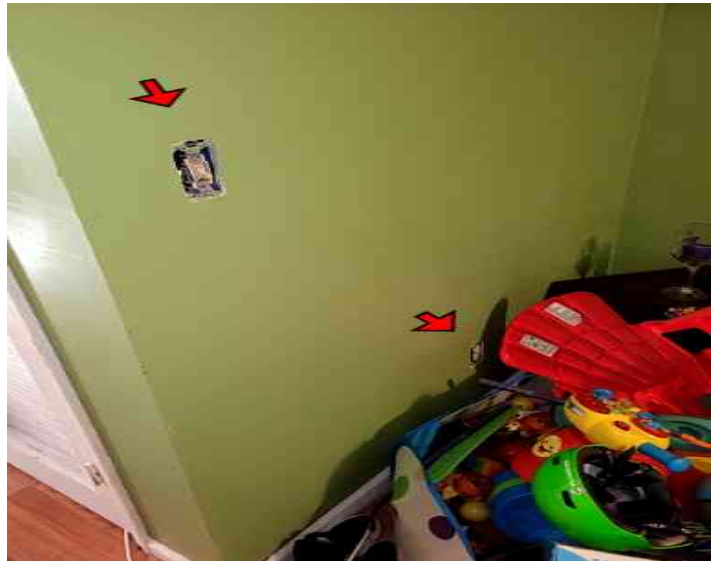
0919: Electrical Defaults

Some missing outlet and switch covers were noted and should be replaced.

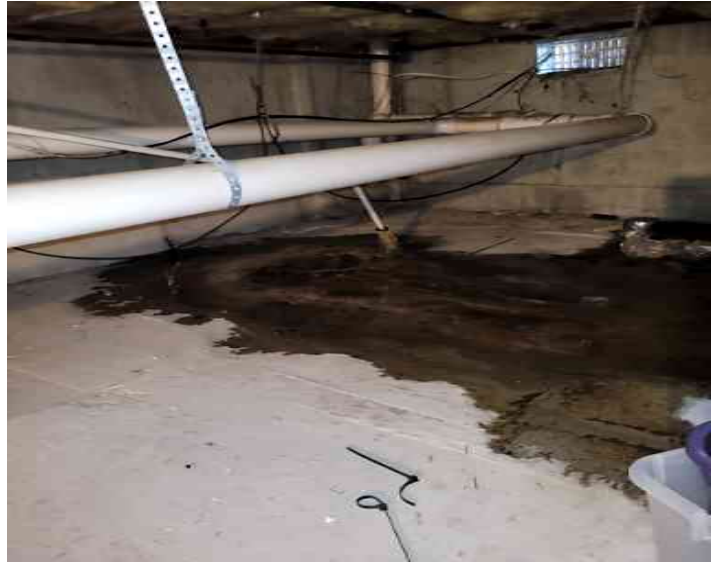
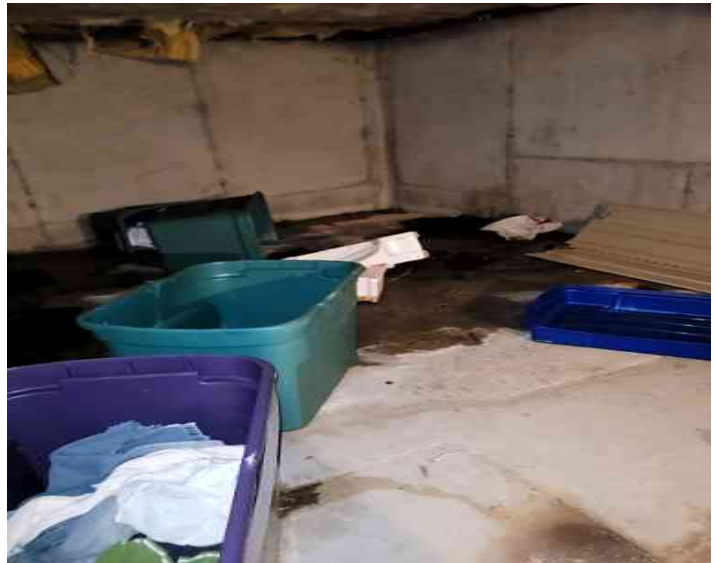
1613: Crawl Space Floor Type

Clogged/current leak from condensate drain was noted and should be cleaned and any damage repaired. Some mold/mildew was noted and should be evaluated and cleaned by qualified personnel. As mold and mildew are not part of the home inspection the client may decide to do further evaluation to determine the extent of the problem and cost to cleanup/repair.

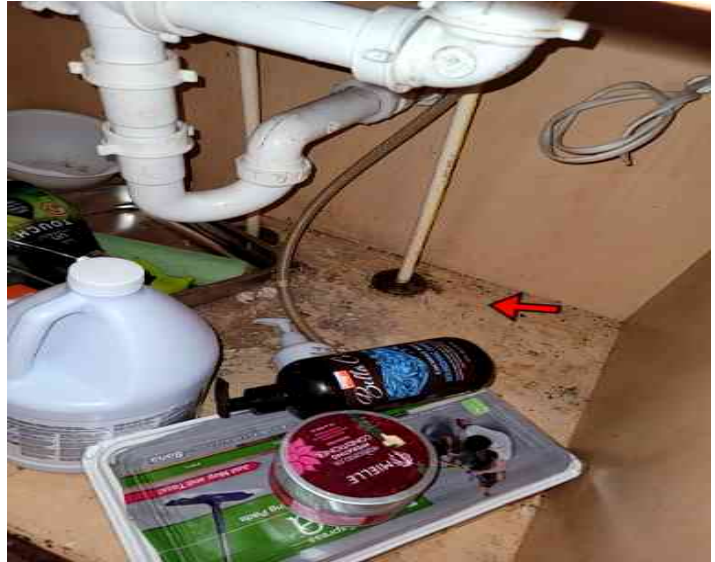
1708: Kitchen Cabinets

Some water damage under sink was noted but was dry at time of the inspection.

Some mold/mildew was noted and should be cleaned by qualified personnel. As mold and mildew are not part of the home inspection the client may decide to do further evaluation to determine the extent of the problem and cost of cleanup/repair.

Some water damage under sink was noted but was dry at time of the inspection. Some mold/mildew was noted and should be cleaned by qualified personnel. As mold and mildew are not part of the home inspection the client may decide to do further evaluation to determine the extent of the problem and cost of cleanup/repair.

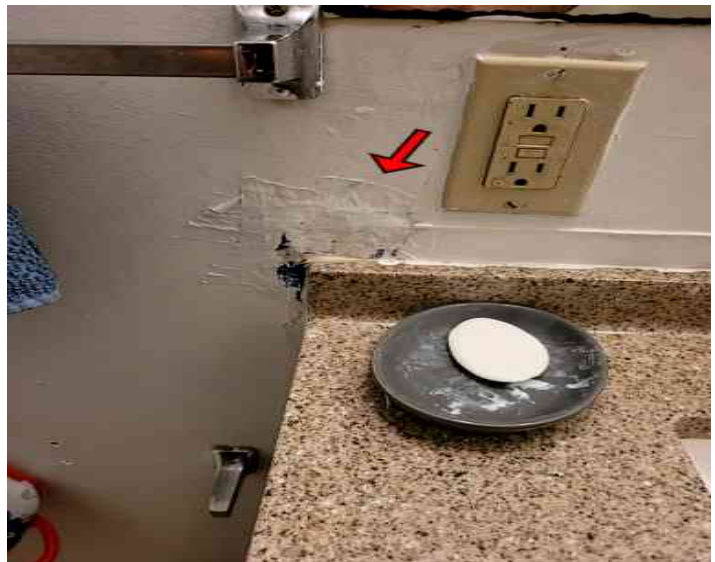
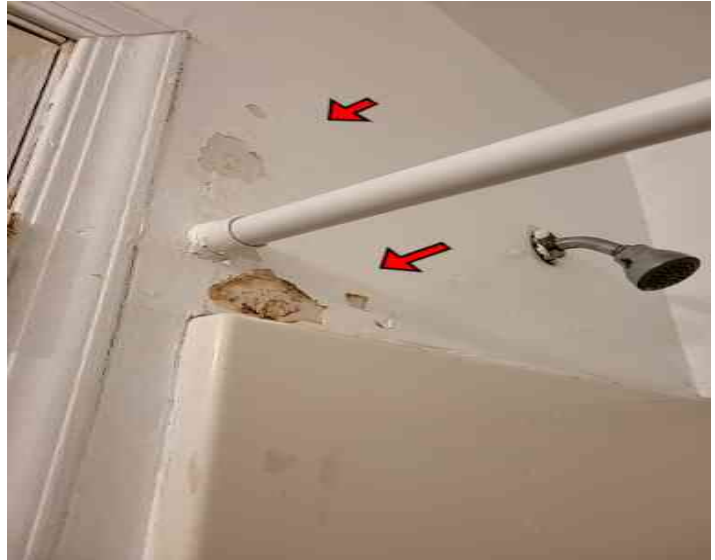
1905: Bathroom Walls and Ceilings

Some damage noted above tub/shower and vanity.

Some mold/mildew was noted on walls/ceiling and should be cleaned by qualified personnel. As mold and mildew are not part of the home inspection the client may decide to do further evaluation to determine the extent of the problem and cost of cleanup/repair.

Some damage noted above tub/shower and vanity. Some mold/mildew was noted on walls/ceiling and should be cleaned by qualified personnel. As mold and mildew are not part of the home inspection the client may decide to do further evaluation to determine the extent of the problem and cost of cleanup/repair.

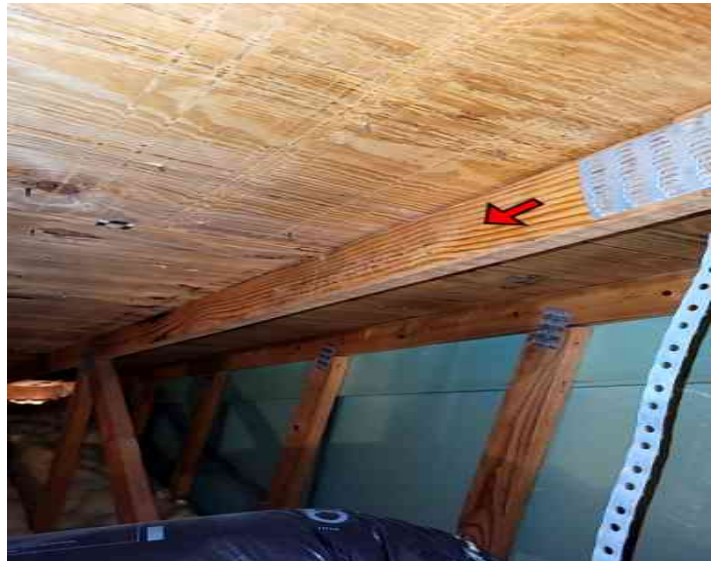
2005: Attic Structural Framing Type

Some mold/mildew was noted in the attic and should be evaluated and cleaned by qualified personnel. As mold and mildew are not part of the home inspection the client may decide to do further evaluation to determine the extent of the problem and cost to cleanup/repair.

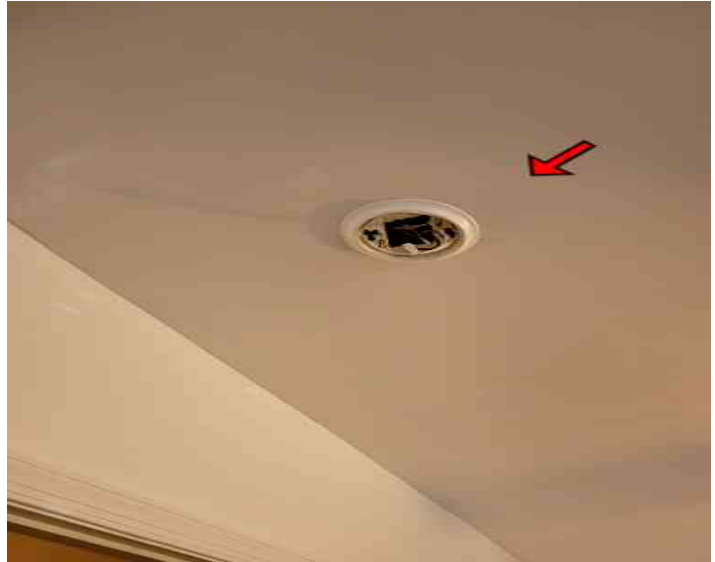
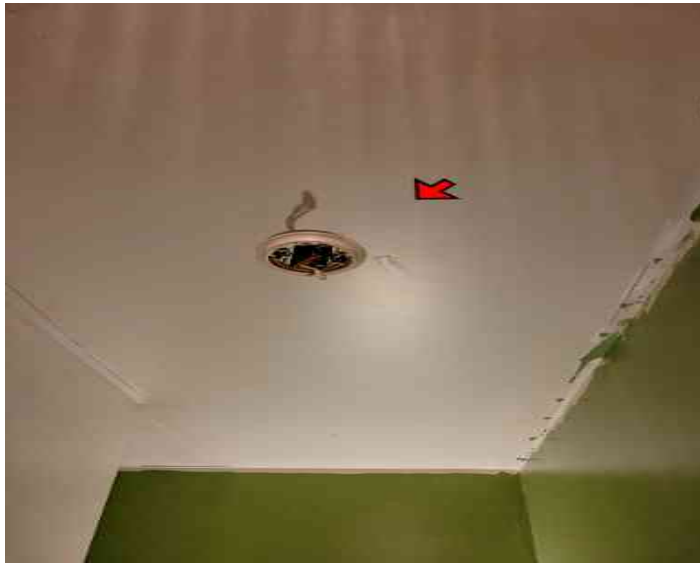
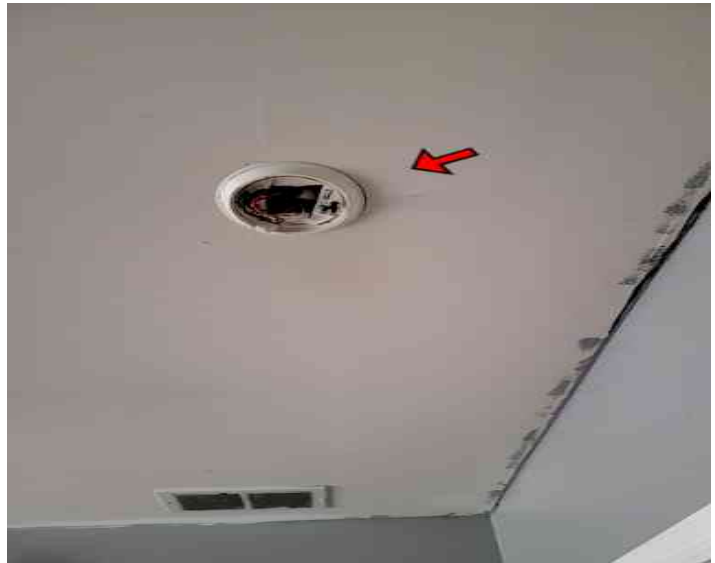
2117: Smoke Detectors

Missing or too few noted. Smoke detectors should be checked the day the home is occupied, recommended and required in some areas to have one smoke detector in each bedroom and one in hall with in 15 feet of the bedroom doors and one on each of the remaining floors including basement. A CO detector should be installed on the bedroom floor these are minimums.

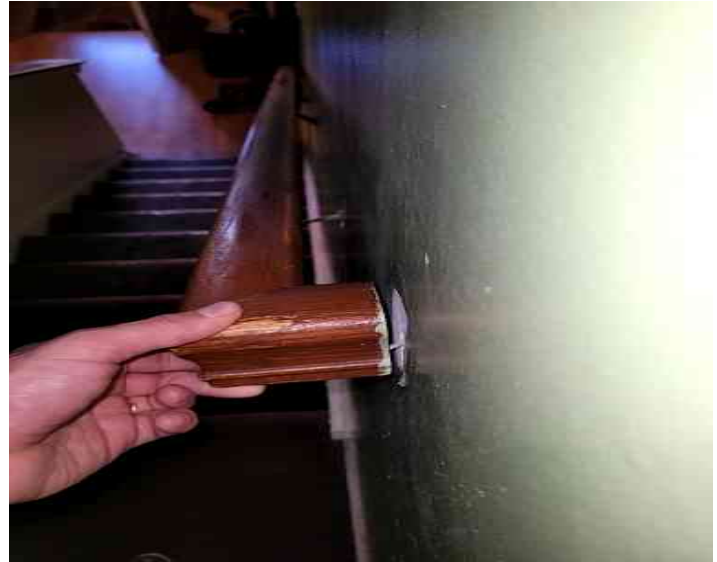
2119: Stairways

Loose railing was noted and should be repaired.

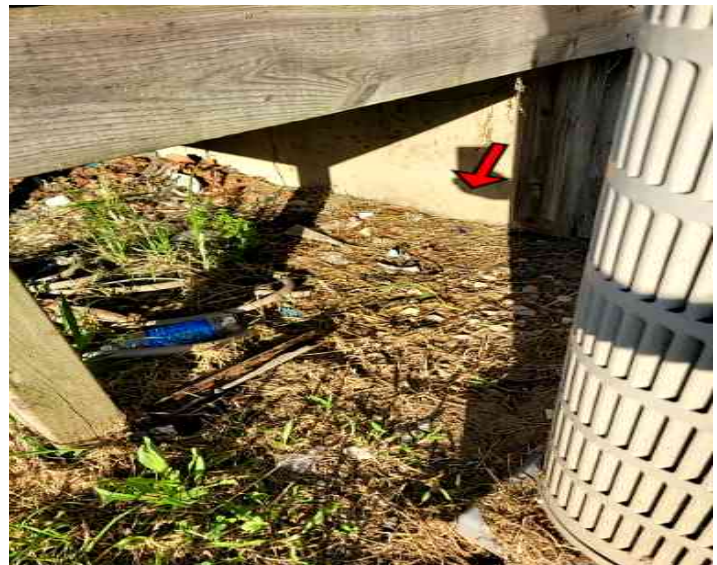
0307: Grading

Soil should be sloped away from house to improve drainage.

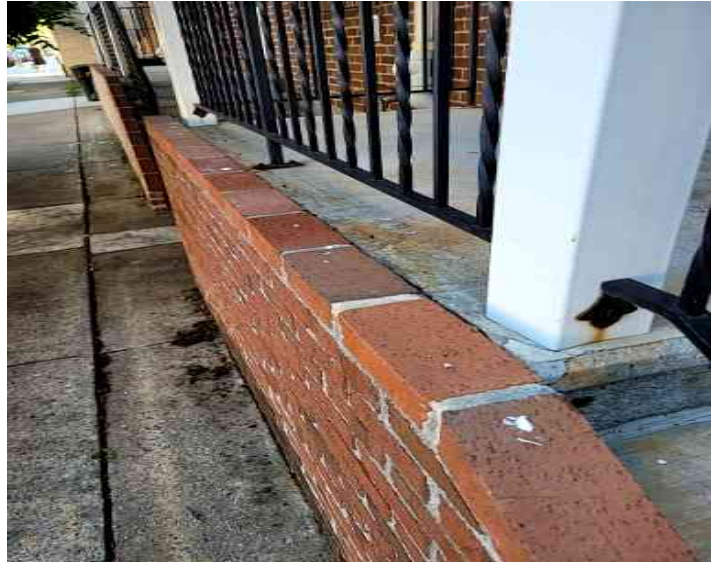
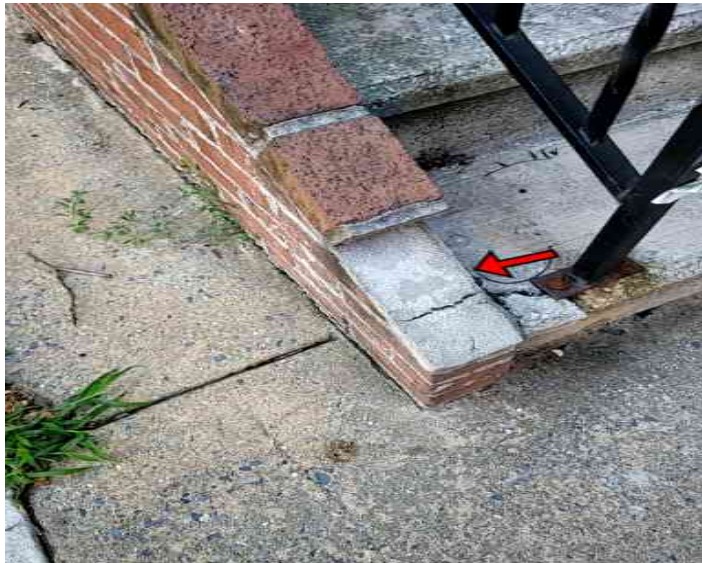
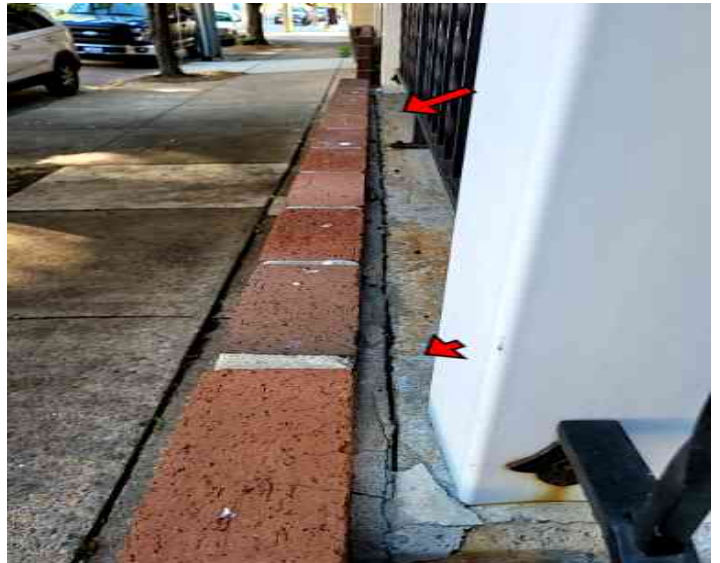
0309: Masonry Walls

Cracks between brick veneer and stairs were noted and should be repaired.
Damaged/missing brick was noted and should be replaced.

Cracks between brick veneer and stairs were noted and should be repaired. Damaged/missing brick was noted and should be replaced.

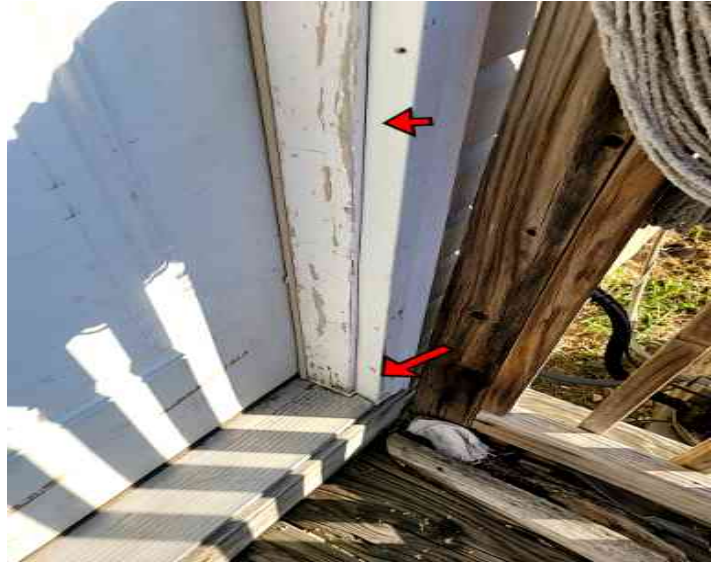
0310: Trim Work

Some loose paint and wood rot noted.

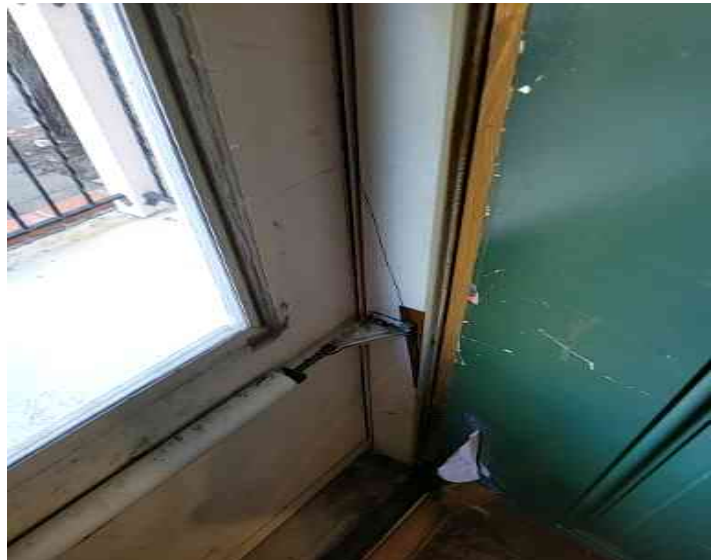
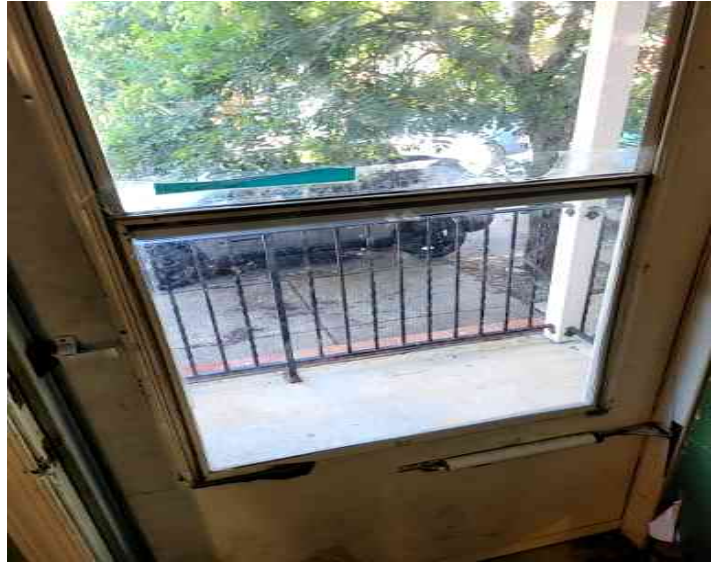
0312: Storm Doors

Damaged storm door and frame were noted and should be repaired/replaced.

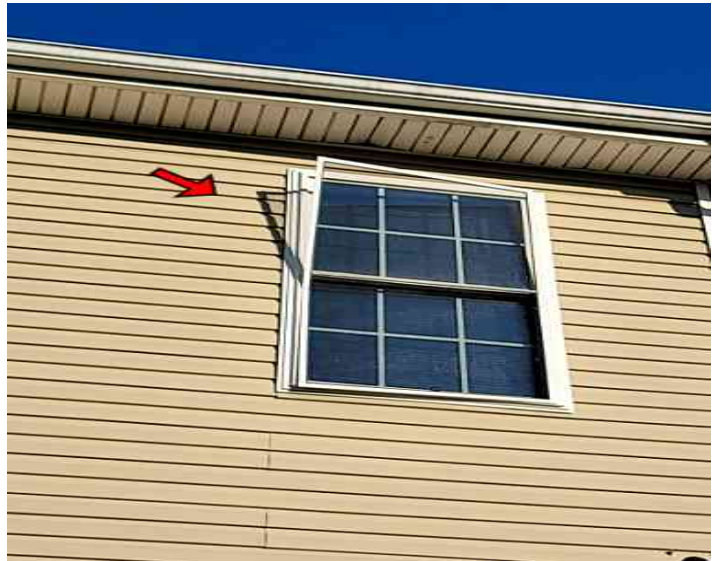
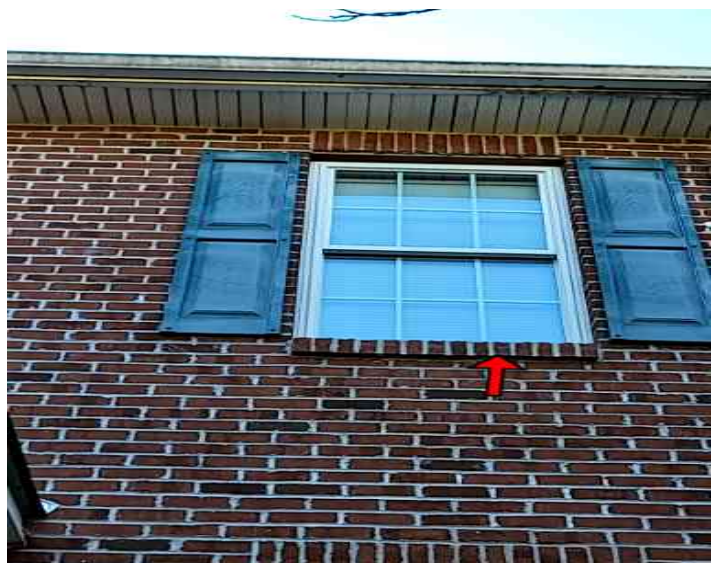
0318: Windows Storm\Screen

Some damaged and missing screens were noted.

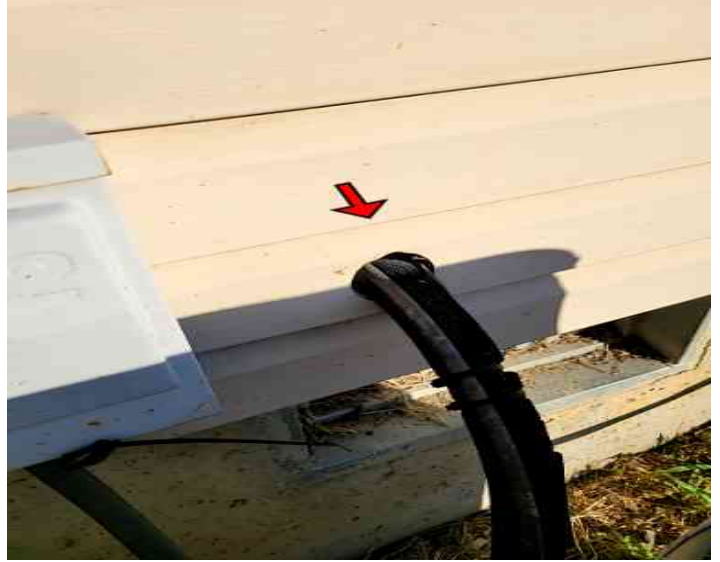
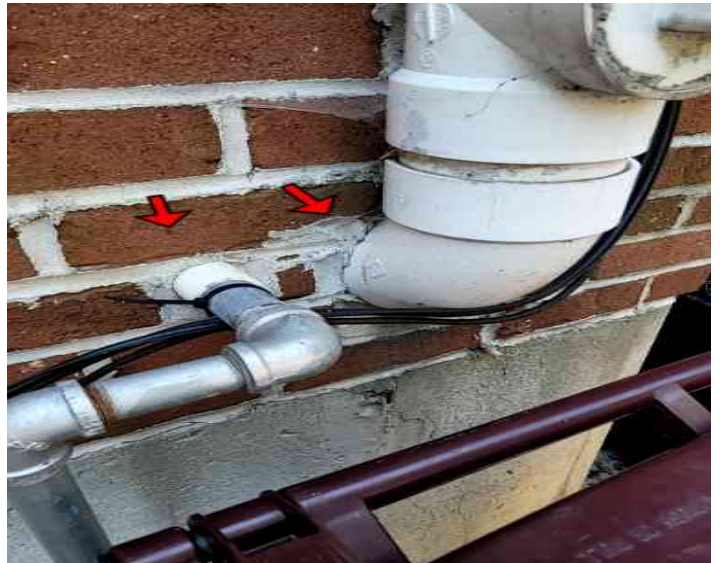
0320: Caulking

Caulking should be improved.

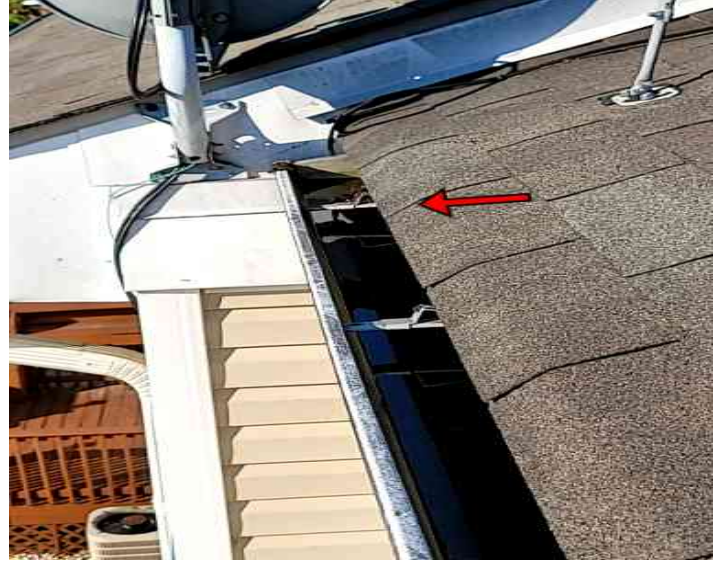
0404: Gutter Type

Gutters should be cleaned regularly to prevent rot and roof damage.
Some debris and standing water was noted and should be cleared for proper drainage.

Gutters should be cleaned regularly to prevent rot and roof damage. Some debris and standing water was noted and should be cleared for proper drainage.

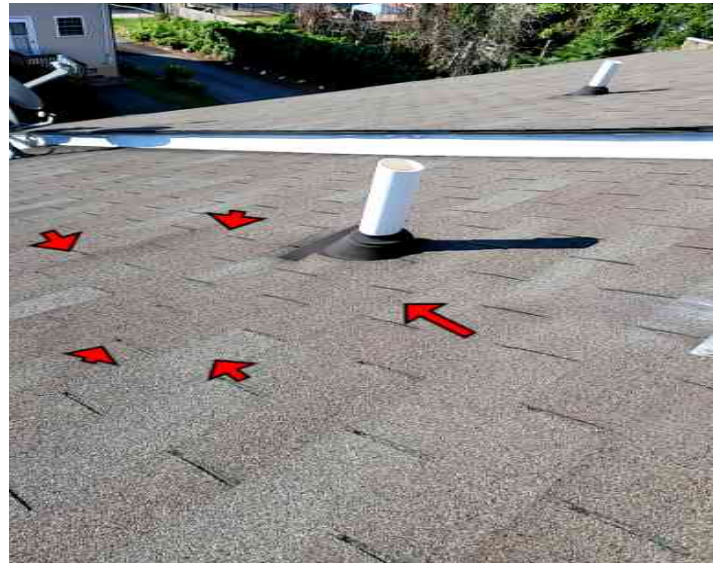
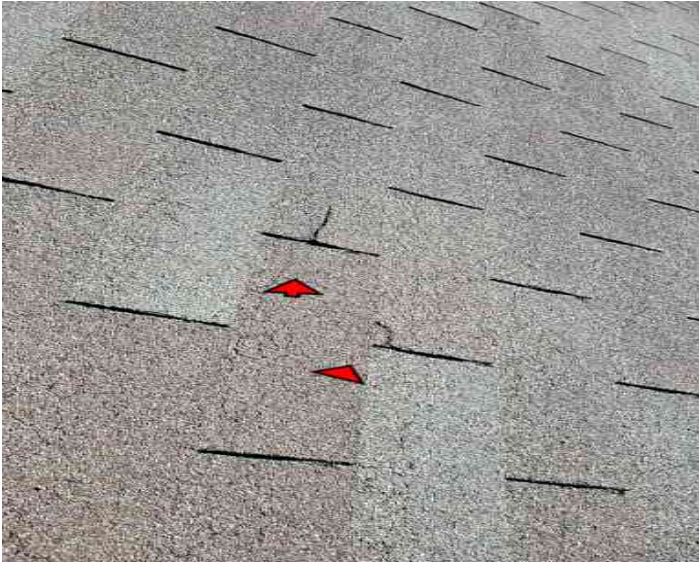
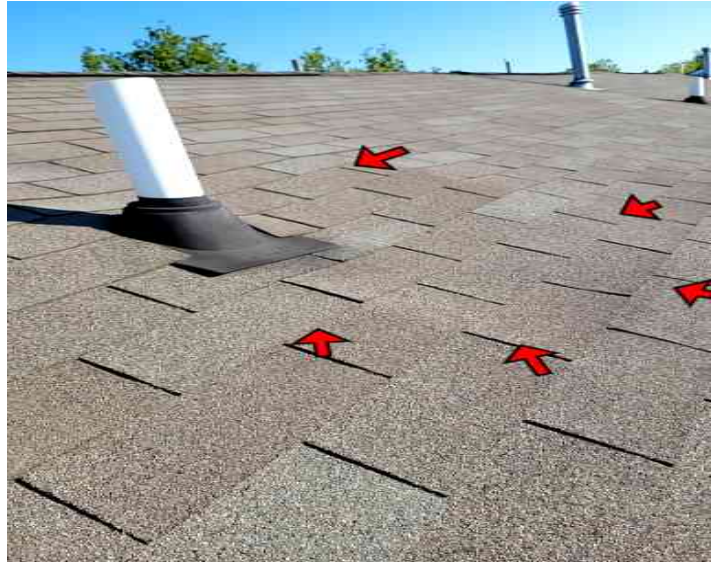
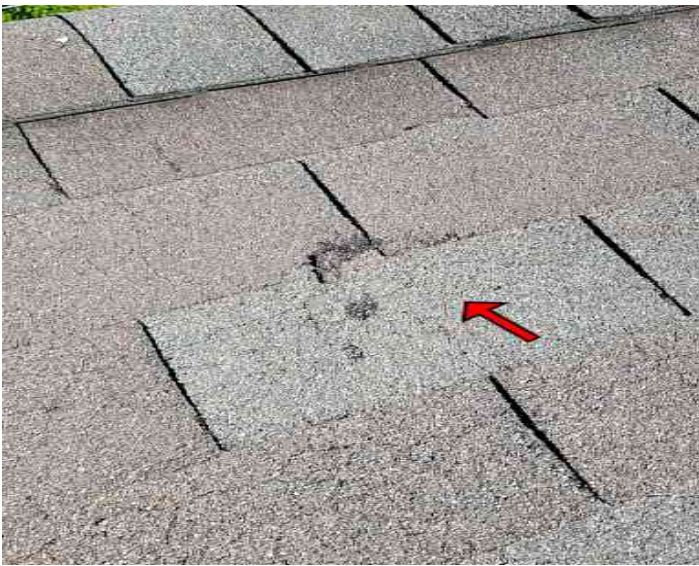
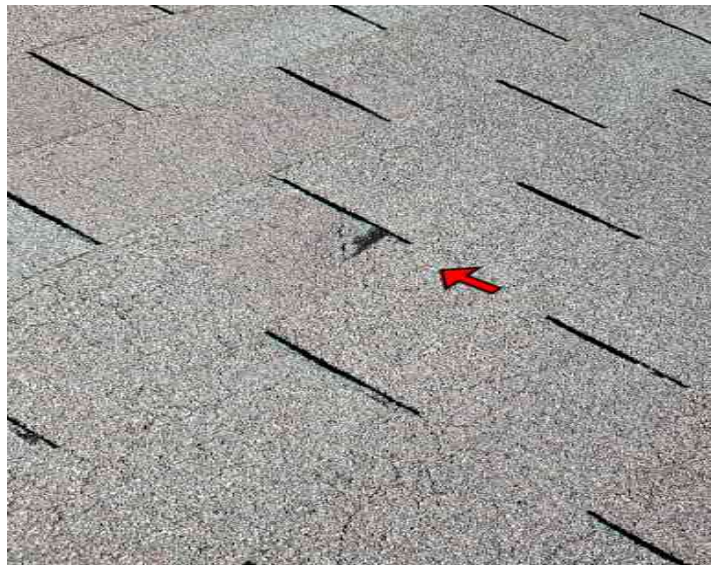
0505: Roof Covering Primary Type

Roof is showing wear.
Some scuffing and aggregate loss noted and should be monitored.
Soft and sagging area was noted around pipe boot and should be evaluated and repaired.
A few cracked shingles were noted and should be repaired.

Roof is showing wear. Some scuffing and aggregate loss noted and should be monitored. Soft and sagging area was noted around pipe boot and should be evaluated and repaired. A few cracked shingles were noted and should be repaired.

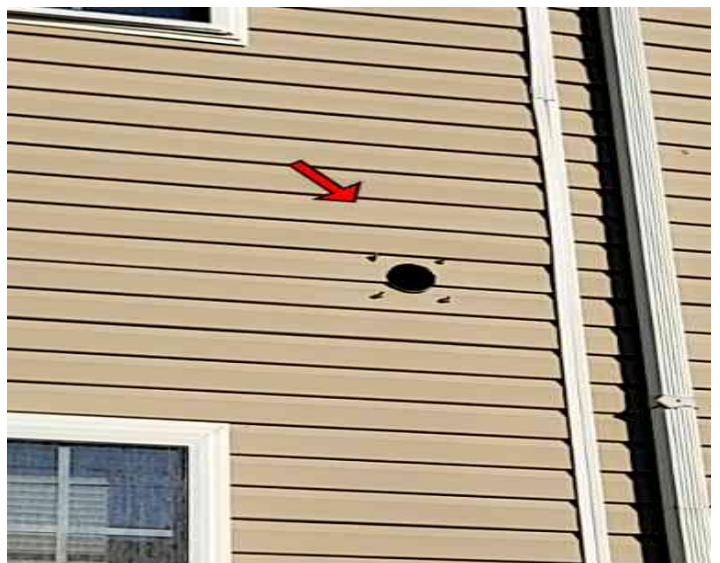
1208: Dryer Vented

Missing exterior vent cover was noted and should be replaced.

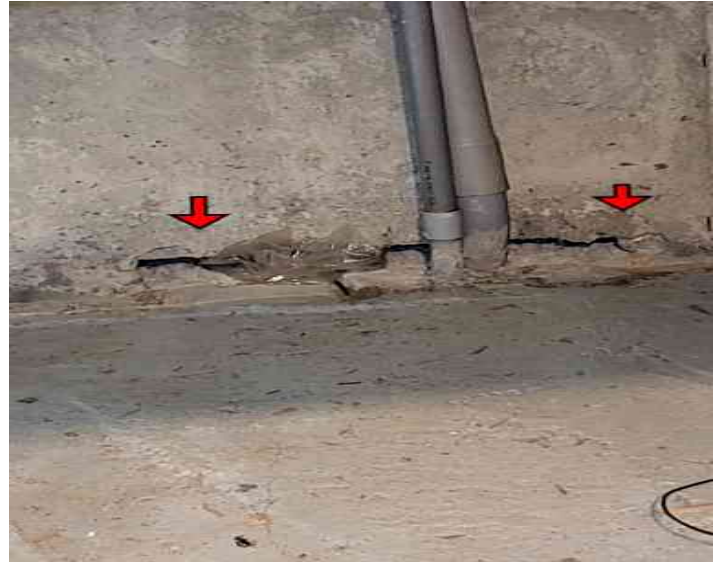
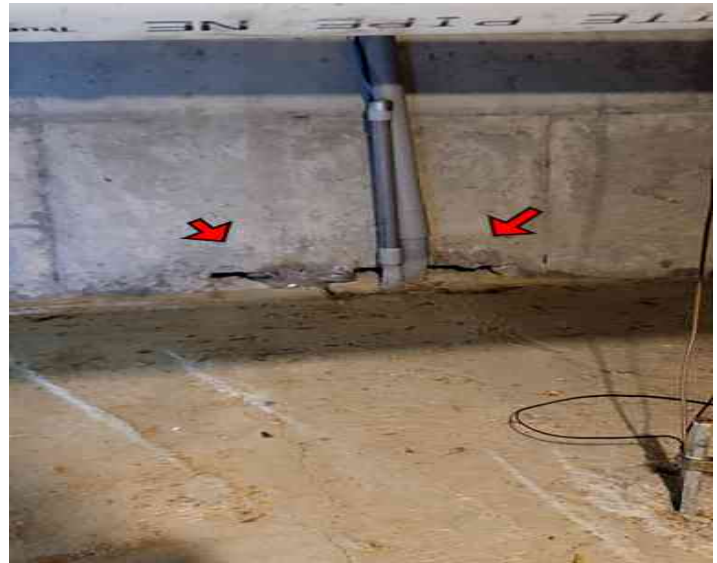
1604: Crawl Space Foundation Walls

Some cracks and water penetration noted.
Hole at bottom of shared wall was noted and should be repaired.

Some cracks and water penetration noted. Hole at bottom of shared wall was noted and should be repaired.

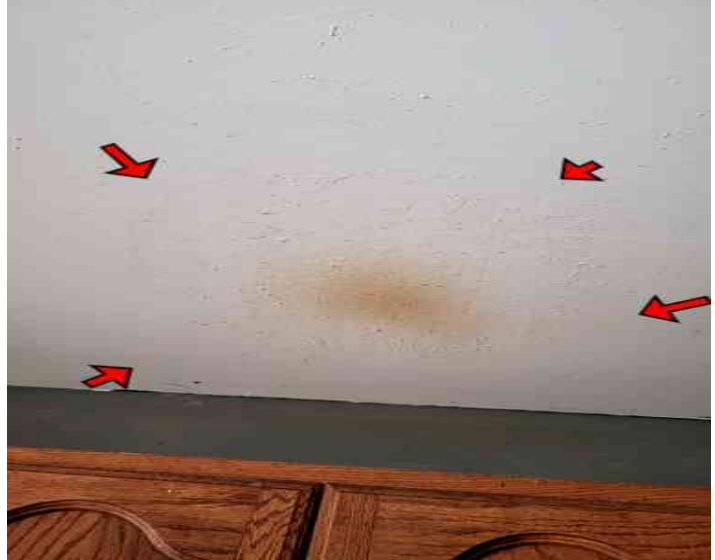
1703: Kitchen Ceiling

Some damage above range was noted and should be repaired.

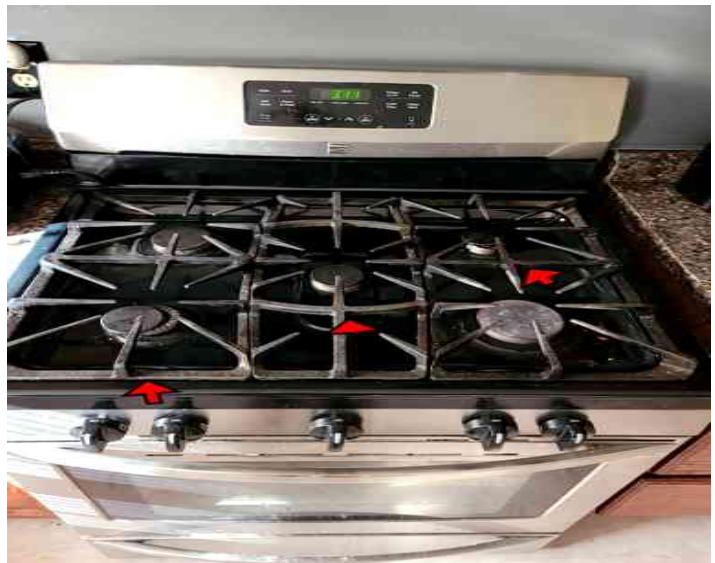
1719: Surface Cooktop

Front left, middle and rear right burners did not work at time of the inspection and should be repaired.

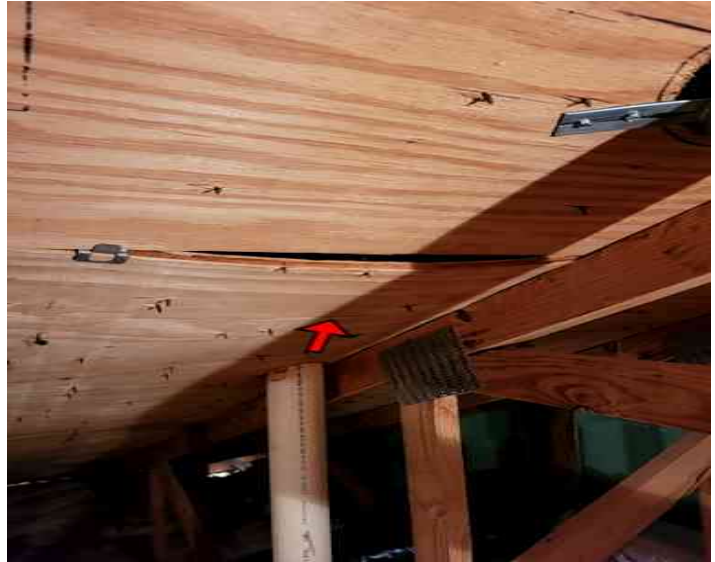
2007: Attic Sheathing

Sagging piece of sheathing was noted and should be repaired.

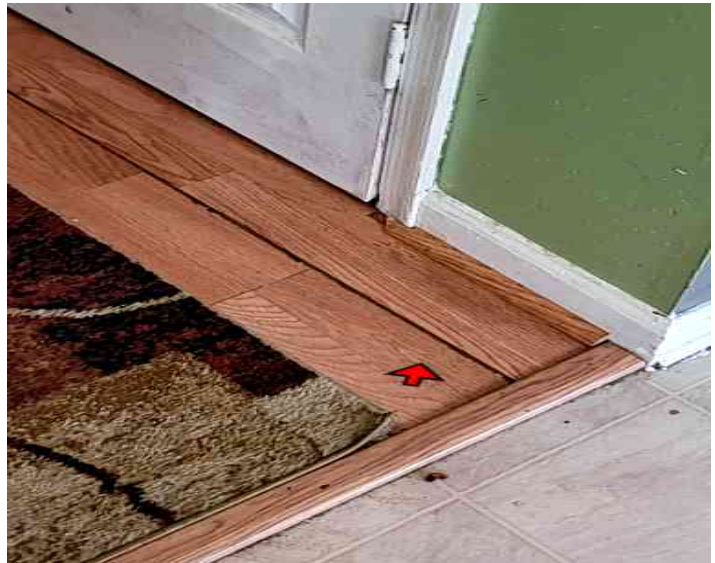
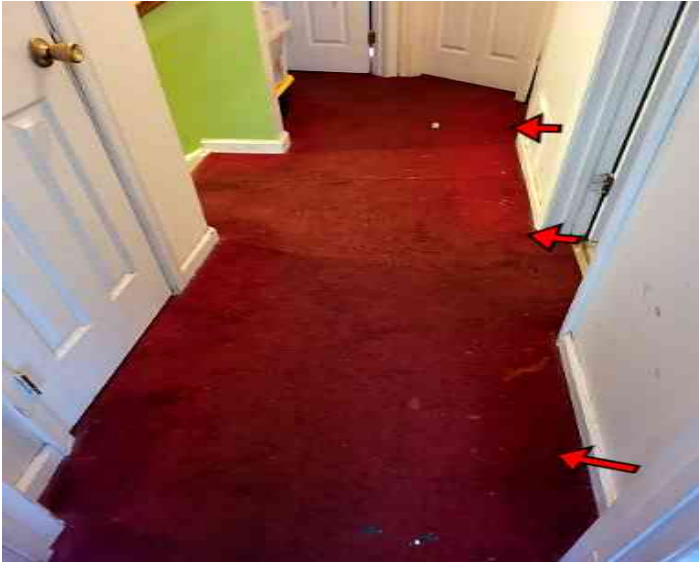
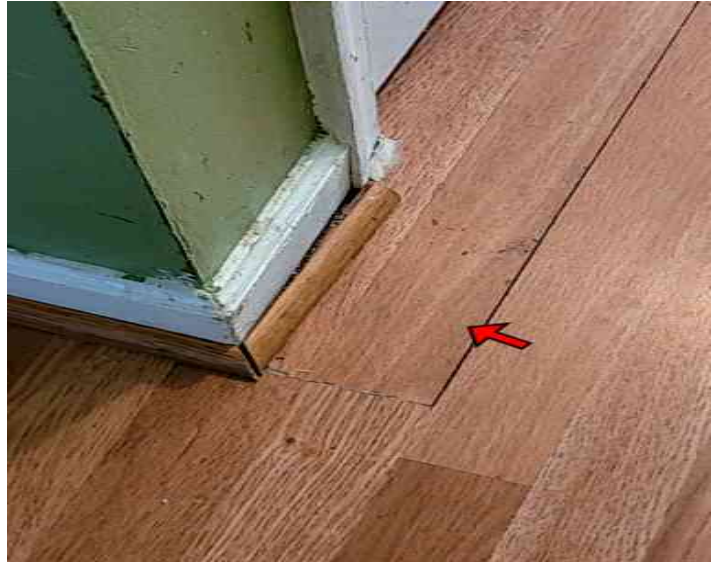
2106: Interior Floors

Some lifted and damaged flooring was noted. Some squeaky floors were noted. When the carpet is replaced, secure floor sheathing to joist/trusses with wood screws. This is not typically a structural concern.

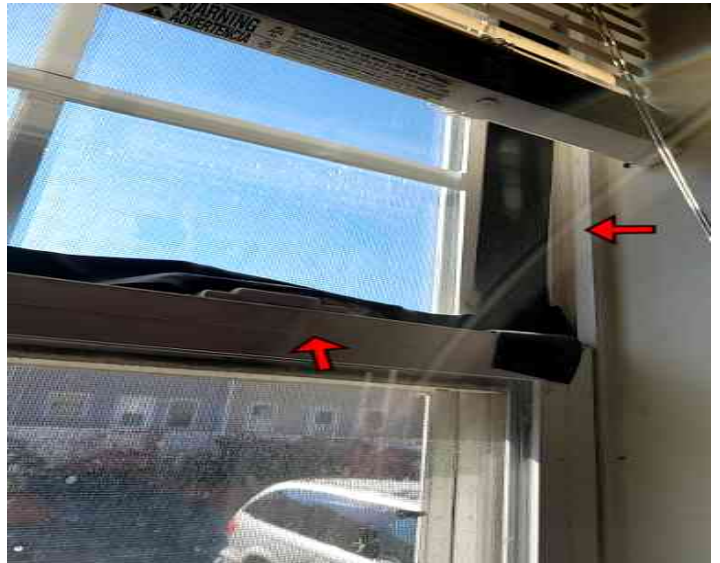
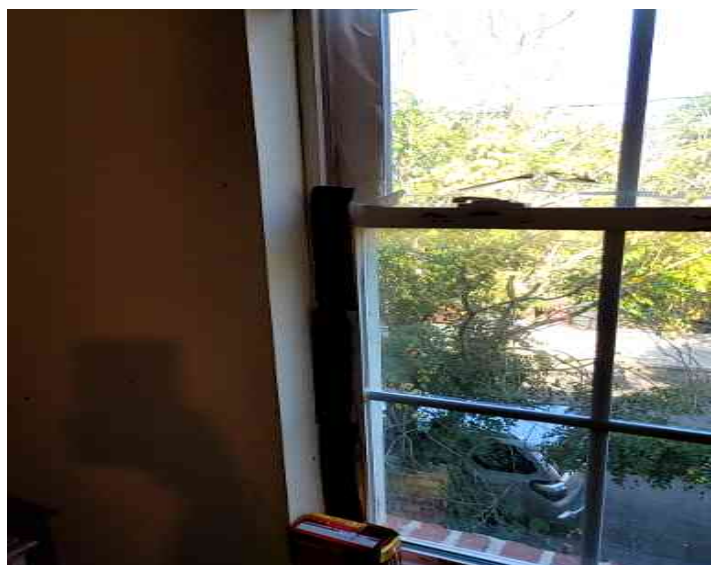
2122: Windows

Some damaged windows were noted and should be evaluated and repaired.
