Reliable Home Inspection Service
100 Old Kennett Road
Wilmington, DE 19807
302/993-9100
reliablehomeinspections1@gmail.com
www.reliablehomeinspectionsservice.com

Inspection Summary

Inspection Report Details

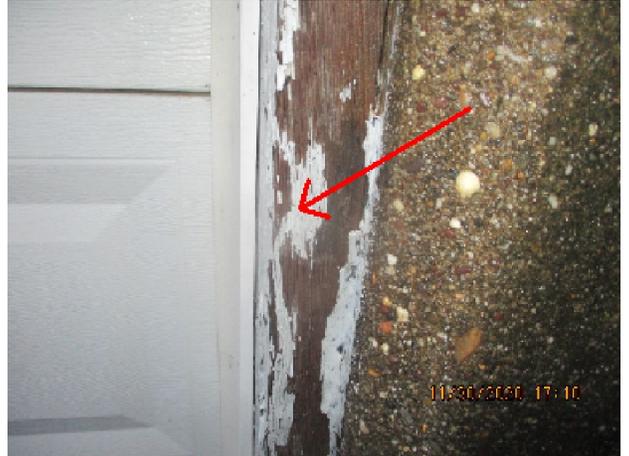
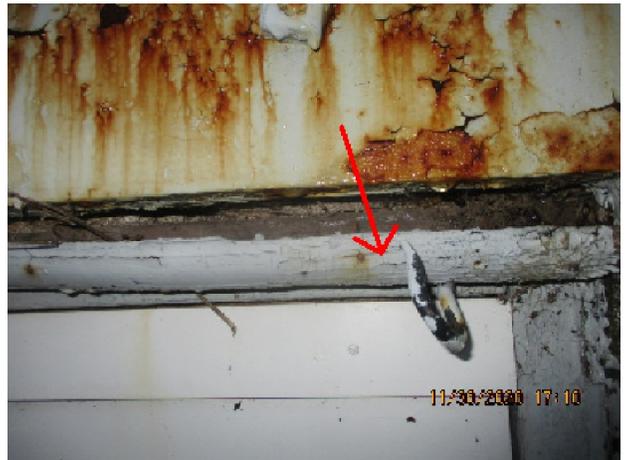
EXTERIOR

All exterior wood should be evaluated, and repaired, due to wood rot

All exterior wood should be evaluated, and repaired, due to wood rot

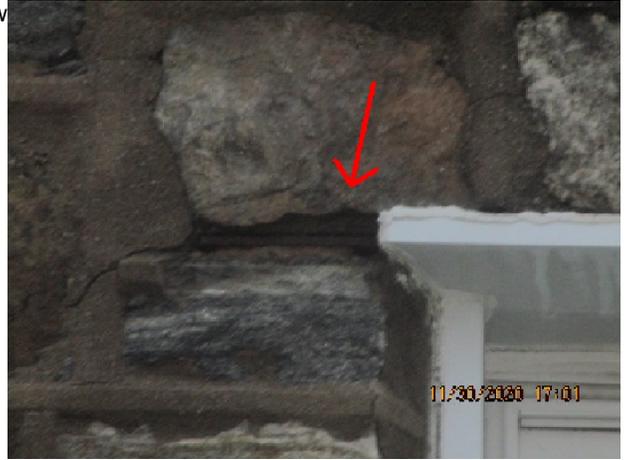
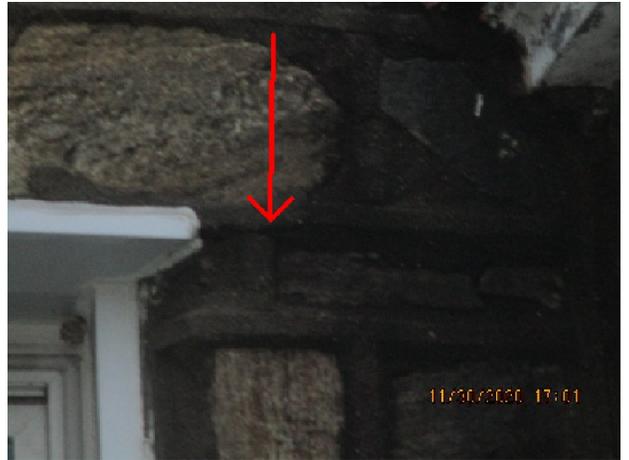
Masonry Walls

Corroded window lintel noted with cracking of brick.have wall /window evaluated, and repaired.
Some loose and missing mortar joints noted and should be repaired.

Corroded window lintel noted with cracking of brick.have wall /window evaluated, and repaired.
Some loose and missing mortar joints noted and should be repaired.

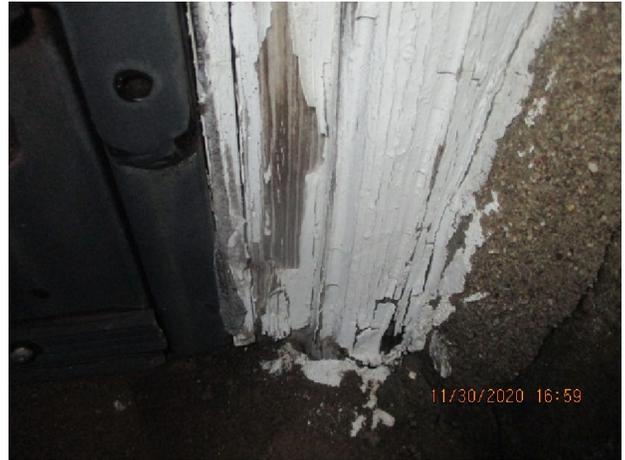
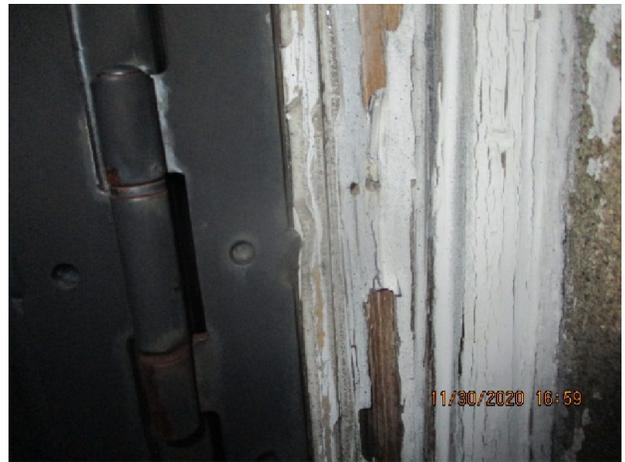
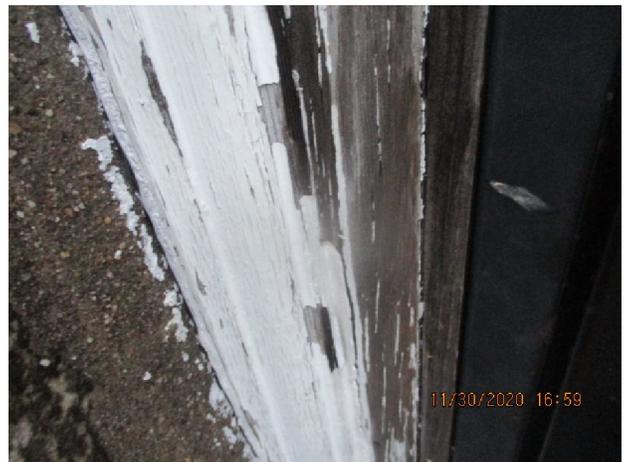
Trim Work

Some loose paint and wood rot noted.
All exterior wood products should be evaluated by a qualified contractor and all needed repairs should be made.

Some loose paint and wood rot noted.
All exterior wood products should be evaluated by a qualified contractor and all needed repairs should be made.

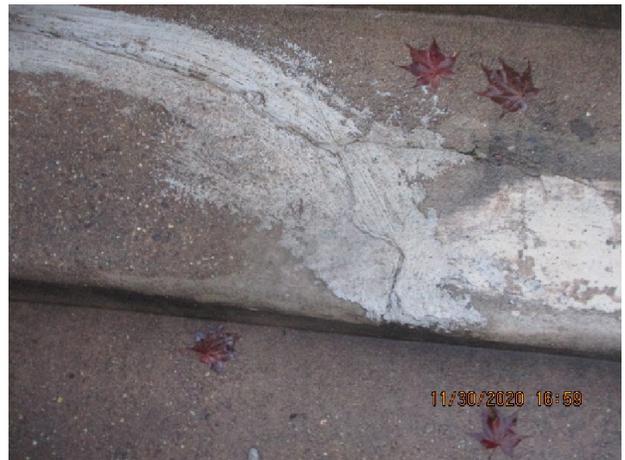
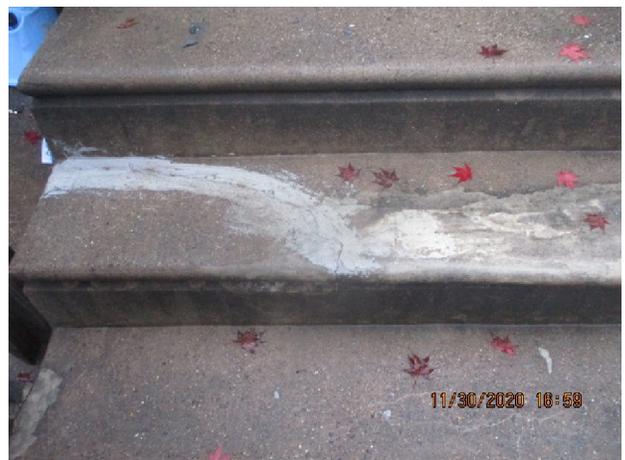
Steps

Cracks and some settlement noted. Evidence of motion was noted in the front steps and erosion was noted under the same. The structural condition of the entire porch should be evaluated by a qualified structural contractor or engineer and all needed repairs should be made.

Evidence of motion was noted in the front steps and erosion was noted under the same. The structural condition of the entire porch should be evaluated by a qualified structural contractor or engineer and all needed repairs should be made.

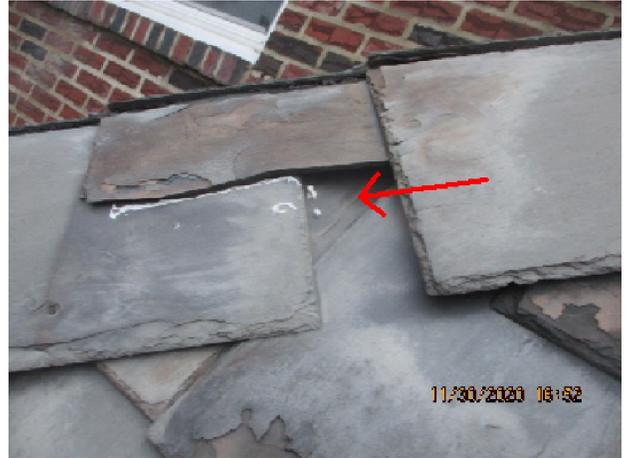
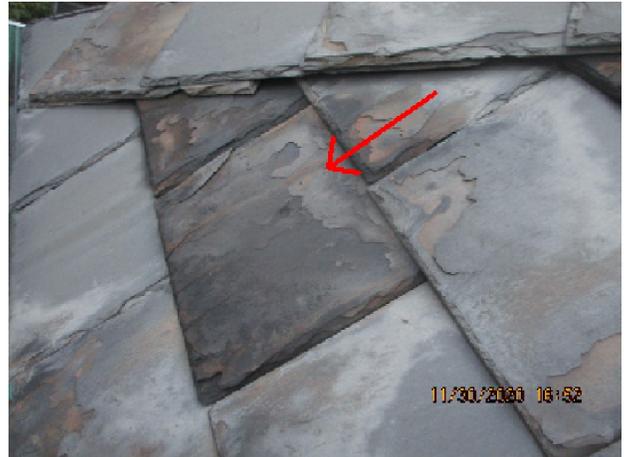
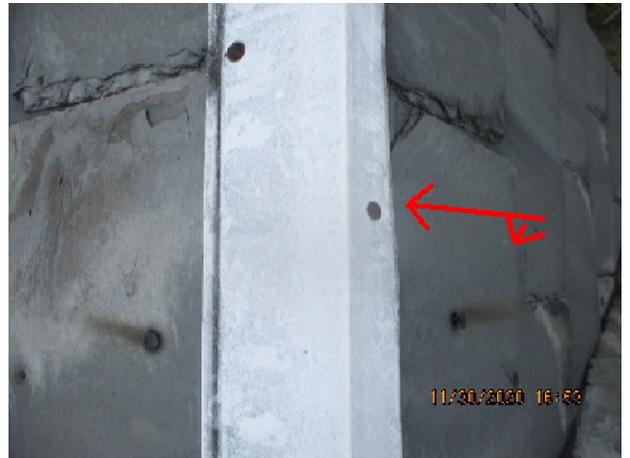
ROOF

All nail heads should be sealed where exposed.
Some cracked shingles, staining, ponding noted.
Missing shingle tab noted.

All nail heads should be sealed where exposed.
Some cracked shingles, staining, ponding noted.
Missing shingle tab noted.

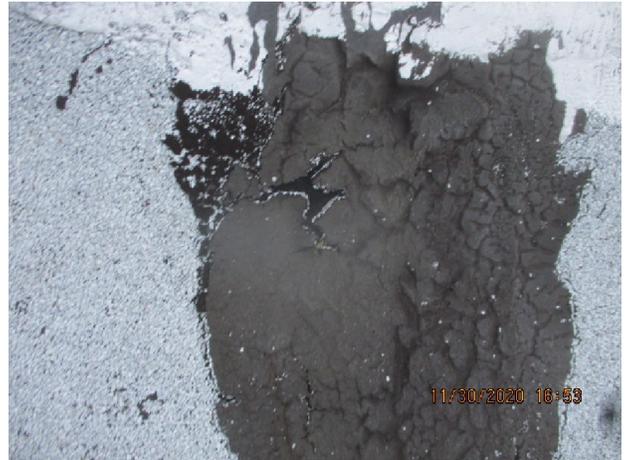
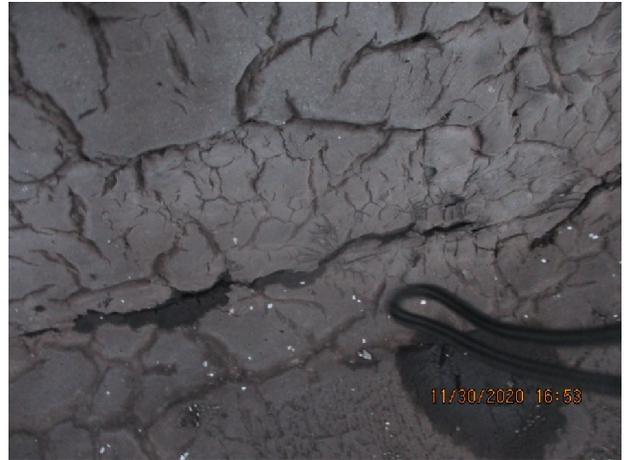
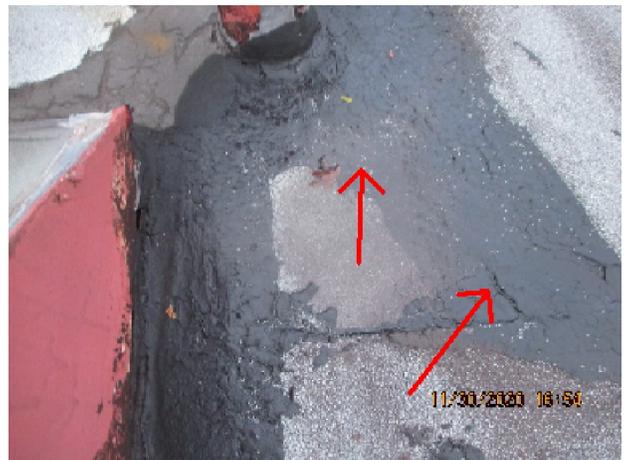
Flashing

Asphalt patch used as flashings will require maintenance. Some loose, separated areas of flashings were noted and should be repaired. Leaking flashings should be evaluated by a qualified contractor and all needed repairs should be made.

Asphalt patch used as flashings will require maintenance.
 Some loose, separated areas of flashings were noted and should be repaired.
 Leaking flashings should be evaluated by a qualified contractor and all needed repairs should be made.

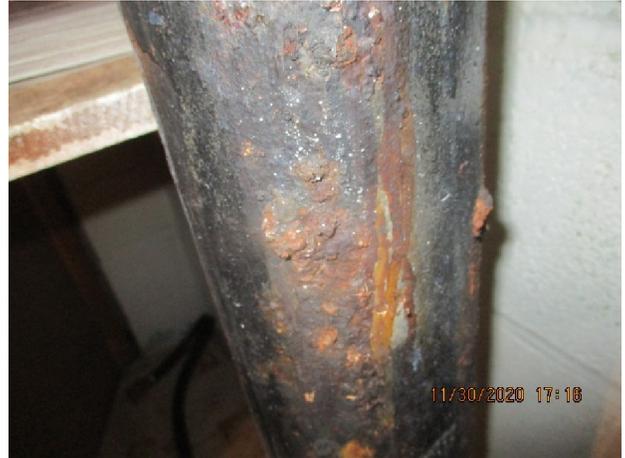
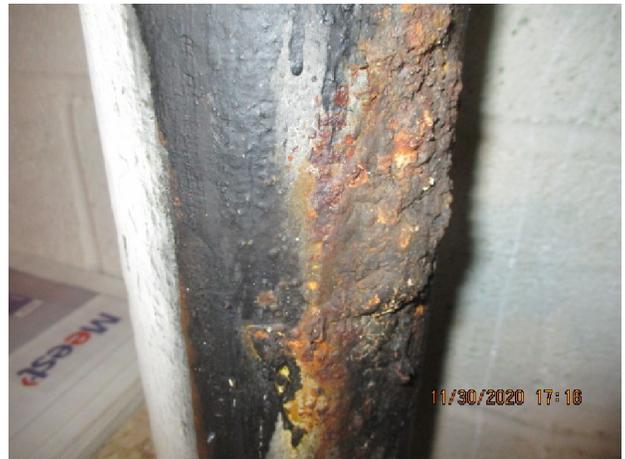
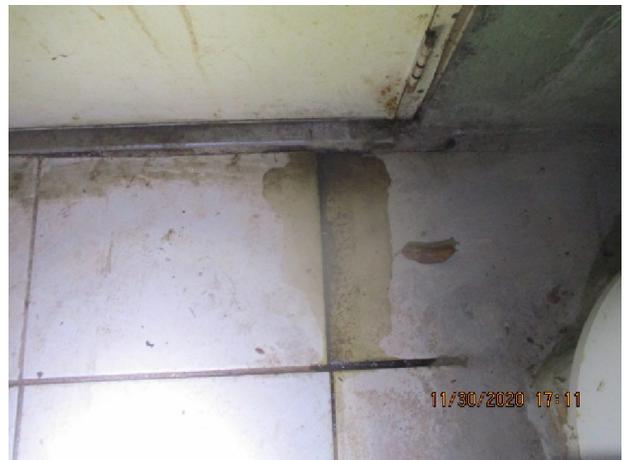
Interior Waste/Vent Pipes Primary Visible Type

Most piping concealed supply and drain.
Damaged cast piping with evidence of leakage and the entire plumbing system should be evaluated and all needed repairs made
Apparent leak in underground piping,, when utility sink runs, water collects, near rear door
Damaged piping with evidence of leakage and the entire plumbing system should be evaluated and all needed repairs made

Most piping concealed supply and drain.
Damaged cast piping with evidence of leakage and the entire plumbing system should be evaluated and all needed repairs made
Apparent leak in underground piping,, when utility sink runs, water collects, near rear door
Damaged piping with evidence of leakage and the entire plumbing system should be evaluated and all needed repairs made

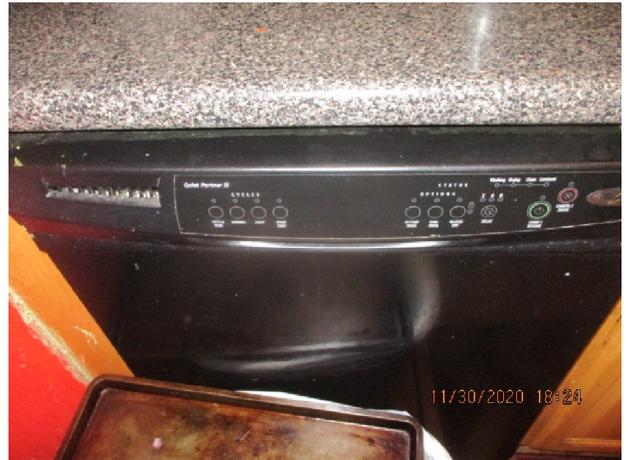
Dishwasher Approx. Age

Unit very old and extended life should not be expected.
The dishwasher was not operable on day of inspection, have
evaluated, and repaired.

The dishwasher was not operable on day of inspection, have evaluated, and repaired.

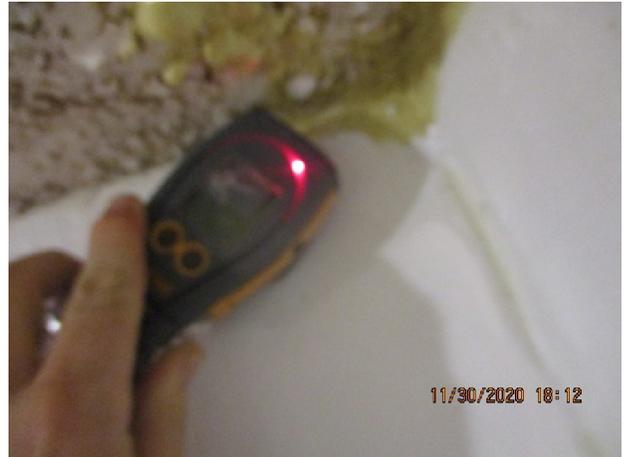
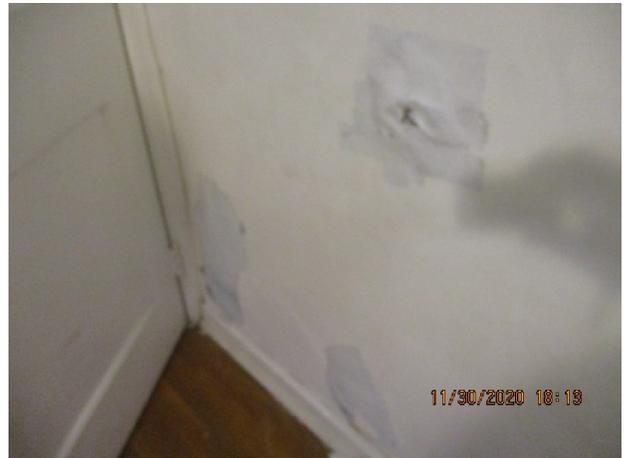
Interior Walls

Typical drywall flaws were noted.
Currently wet areas were noted , and the source of the water should be identified and repaired, rear bedroom at downspout.
Some poorly finished areas were noted.

Typical drywall flaws were noted.
Currently wet areas were noted , and the source of the water should be identified and repaired, rear bedroom at downspout.
Some poorly finished areas were noted.

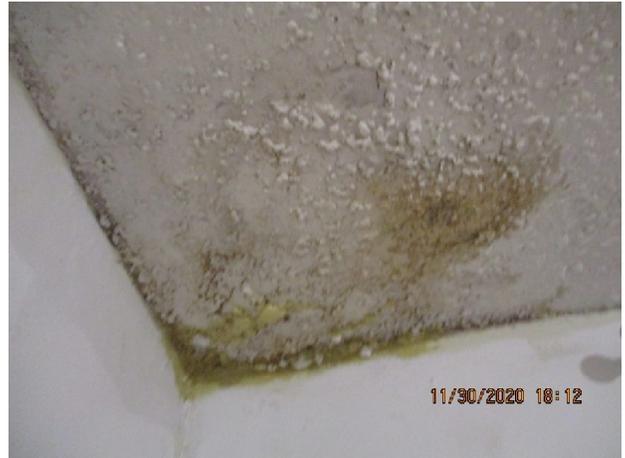
Interior Ceilings

Typical drywall flaws were noted.
Poorly finished areas of drywall were and should be repaired.
Currently wet stains were noted and the source should be identified and repaired.

Typical drywall flaws were noted.
Poorly finished areas of drywall were and should be repaired.
Currently wet stains were noted and the source should be identified and repaired.

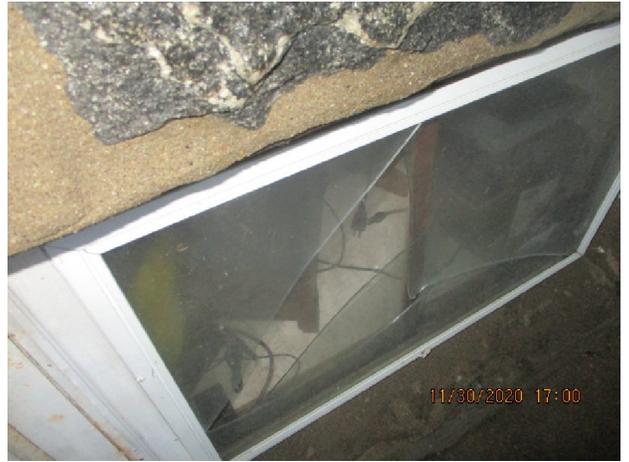
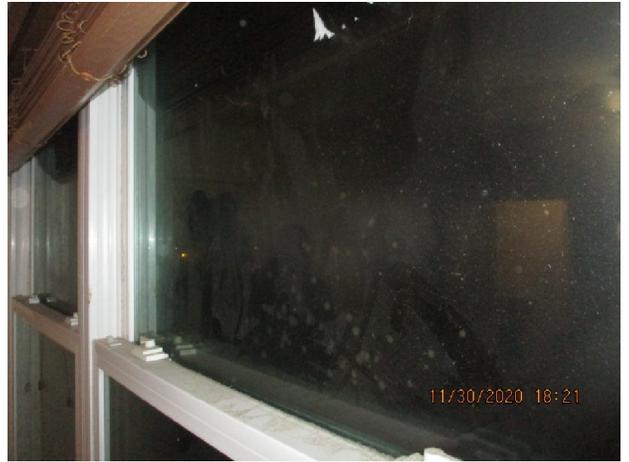
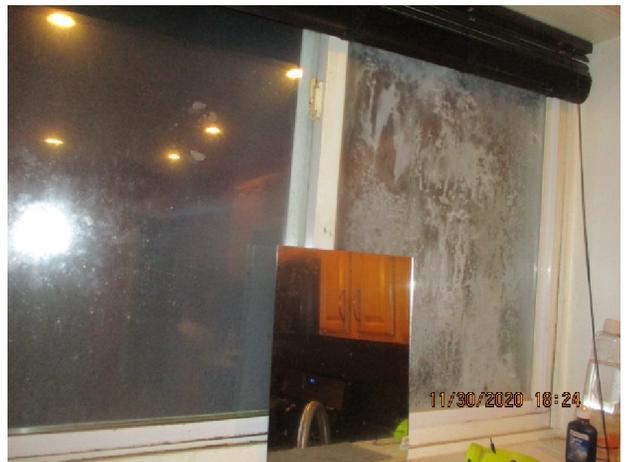
Windows

Some missing screens were noted.
Some cracked windows were noted.
Condensation was noted between multiple insulated window panes
all windows should be evaluated and all damaged glass replaced.

Some missing screens were noted.
Some cracked windows were noted.
Condensation was noted between multiple insulated window panes all windows should be evaluated and all damaged glass replaced.

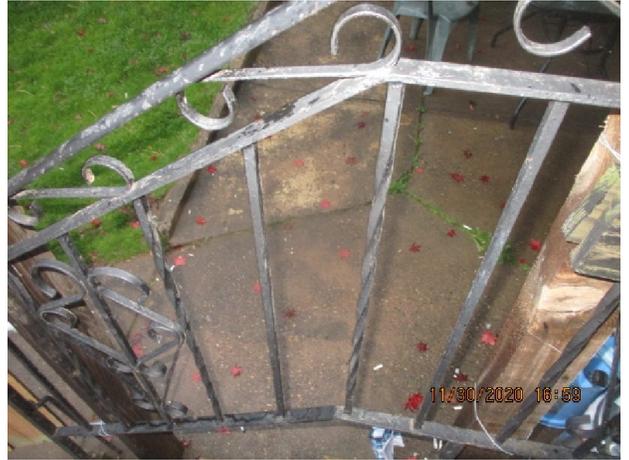
Hand Rail

Loose railing on front and should be repaired.

Loose railing on front and should be repaired.

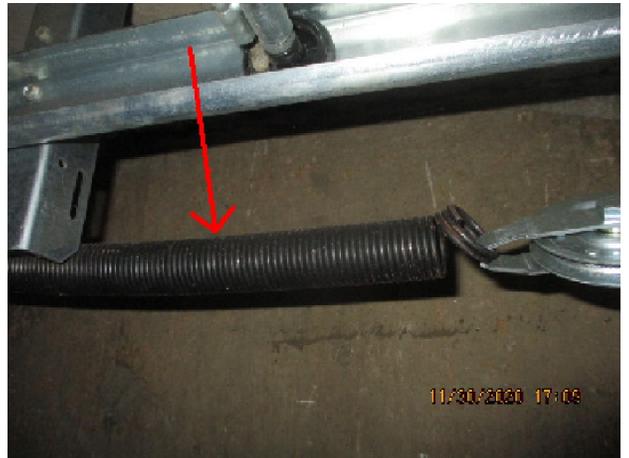
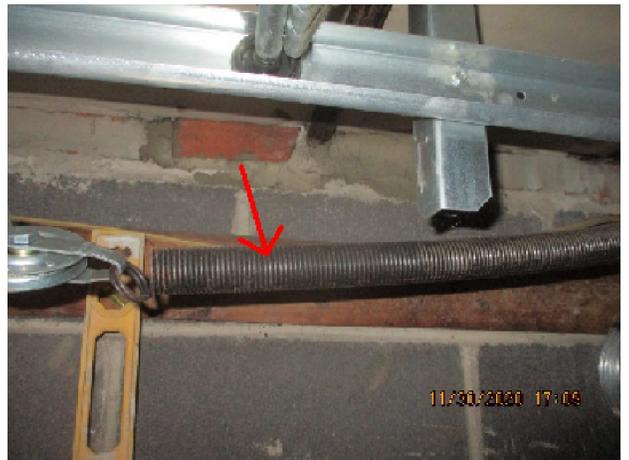
Garage Doors

Some dents in doors.
Missing safety guide wire on springs noted

Some dents in doors.
Missing safety guide wire on springs noted

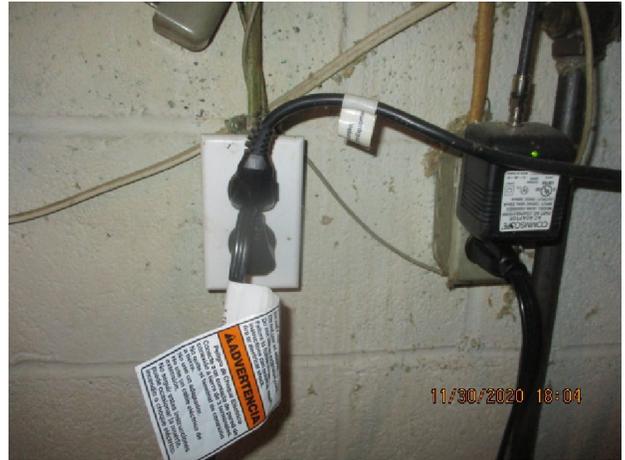
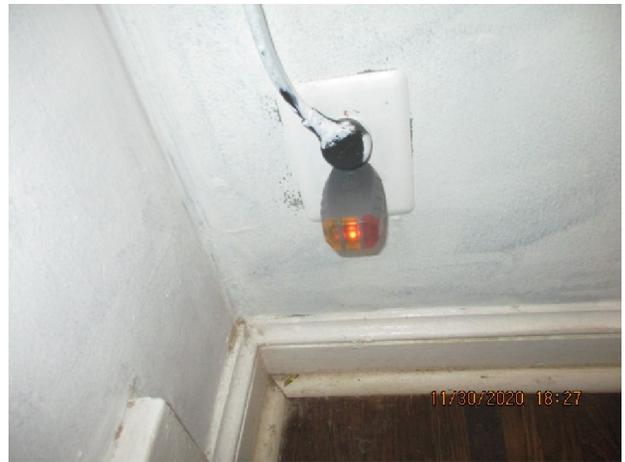
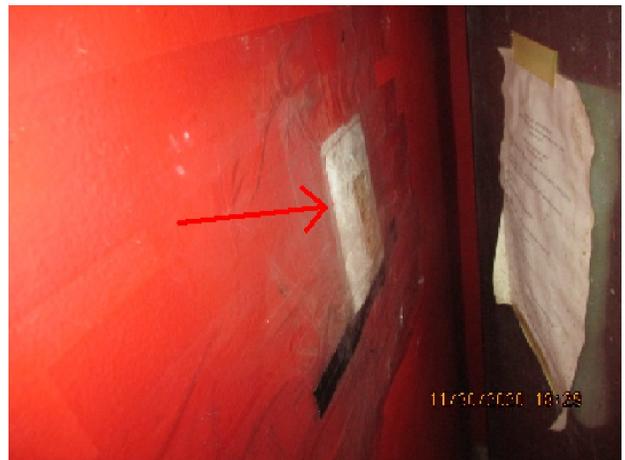
Electrical Duplex Receptacles Primary Type

Limited number of outlets noted.
Three prong ungrounded outlet noted
Unpowered outlets noted,

Limited number of outlets noted.
Three prong ungrounded outlet noted
Unpowered outlets noted,

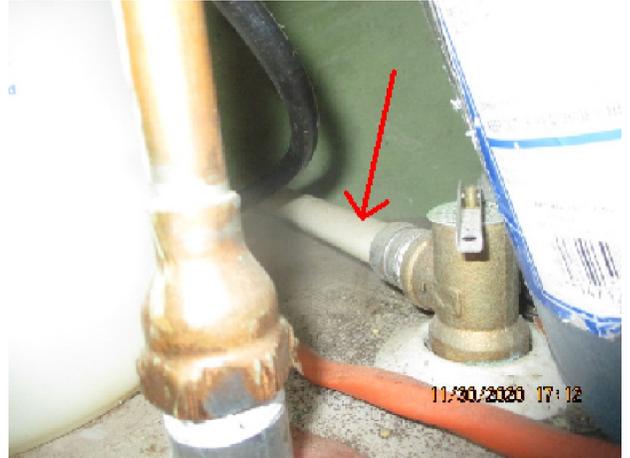
Temp. Pressure Relief Valve and Pipe

Temperature and pressure valve extension should be extended to within 6" of floor.

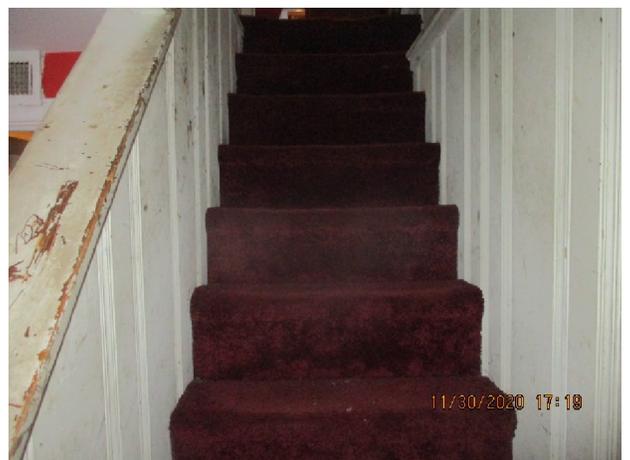
Basement Access

There was no hand rail noted in basement and one should be installed.

There was no hand rail noted in basement and one should be installed.

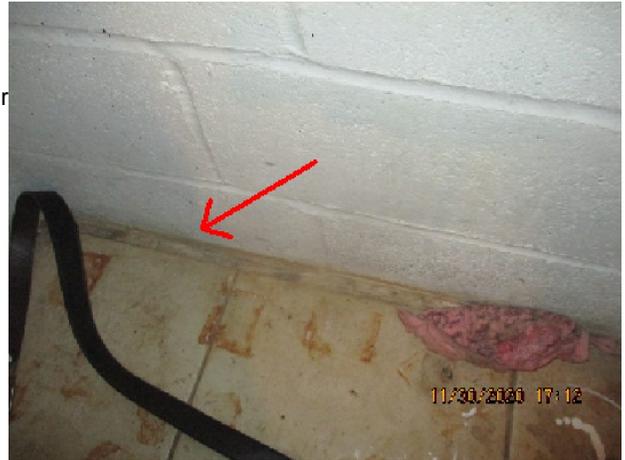
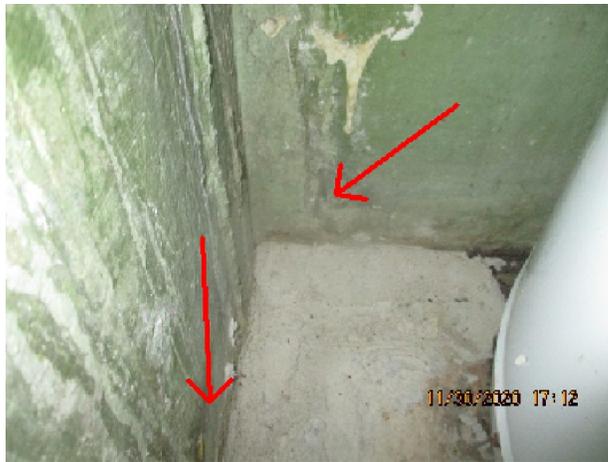
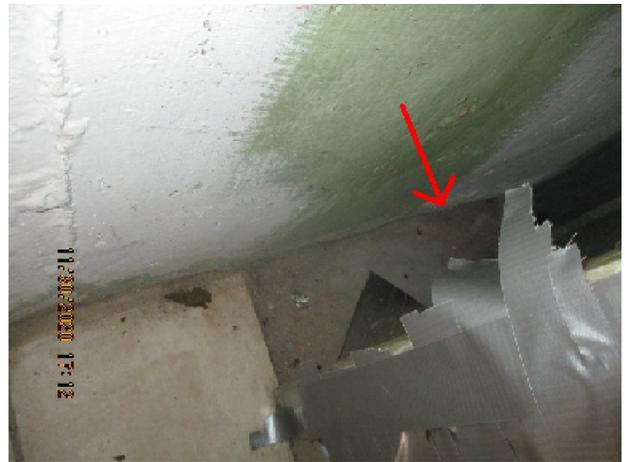
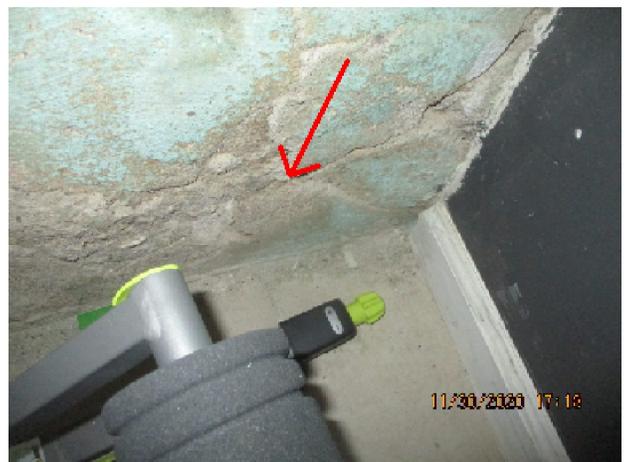
Basement Foundation Walls Primary Visable type

Some cracks and water penetration.
Some mold/mildew was noted in the lowest level and should be evaluated and cleaned by qualified personnel. As mold and mildew are not part of the home inspection the client may decide to do further evaluation to determine the extent of the problem and cost to cleanup/repair.

Some cracks and water penetration.

Some mold/mildew was noted in the lowest level and should be evaluated and cleaned by qualified personnel. As mold and mildew are not part of the home inspection the client may decide to do further evaluation to determine the extent of the problem and cost to cleanup/repair.

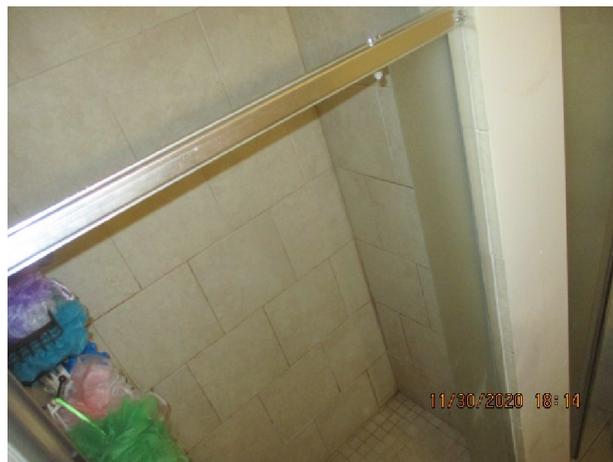
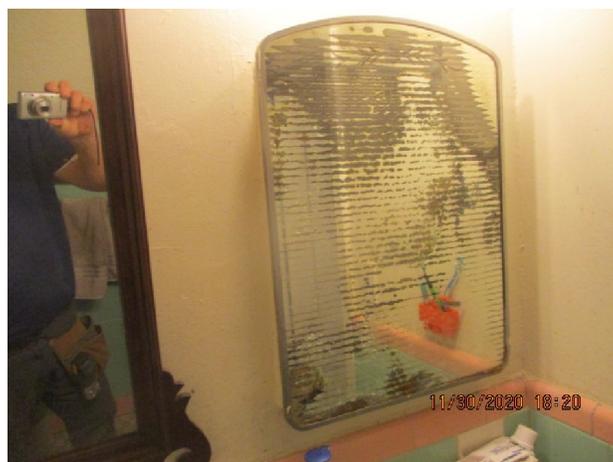
BATHROOM

shower door is removed.
Damaged mirror noted.

shower door is removed.
Damaged mirror noted.

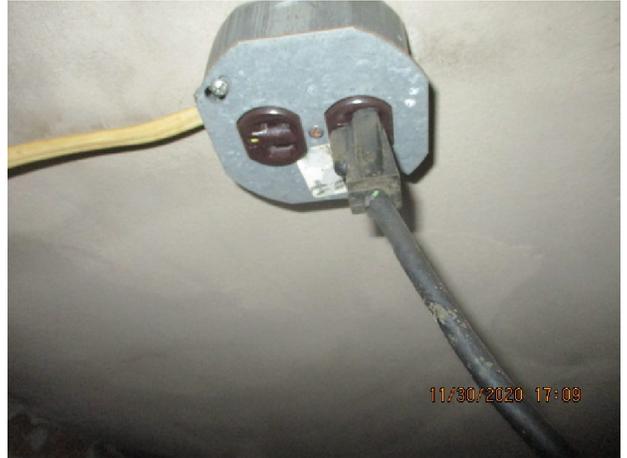
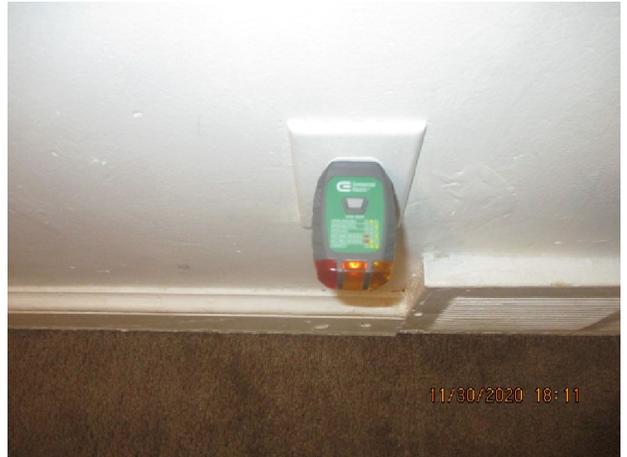
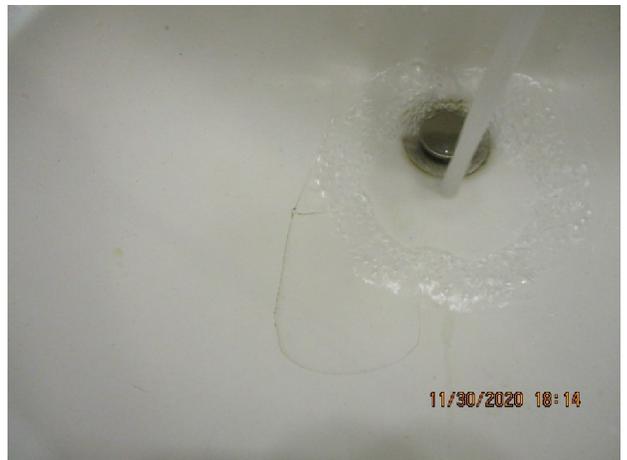
Interior Outlets

Three prong ungrounded outlets noted and should be repaired.
Unpowered outlets noted

Three prong ungrounded outlets noted and should be repaired.
Unpowered outlets noted

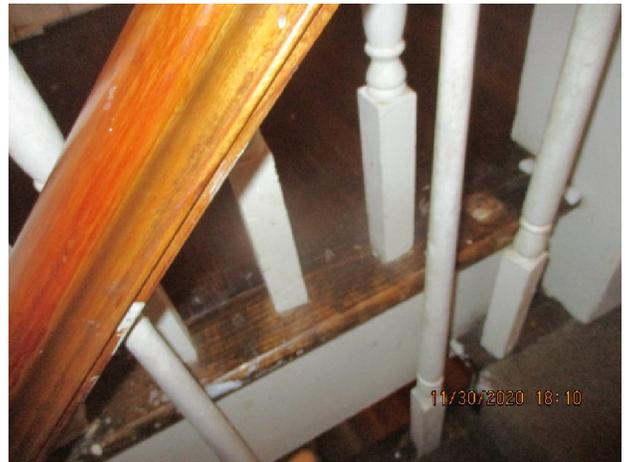
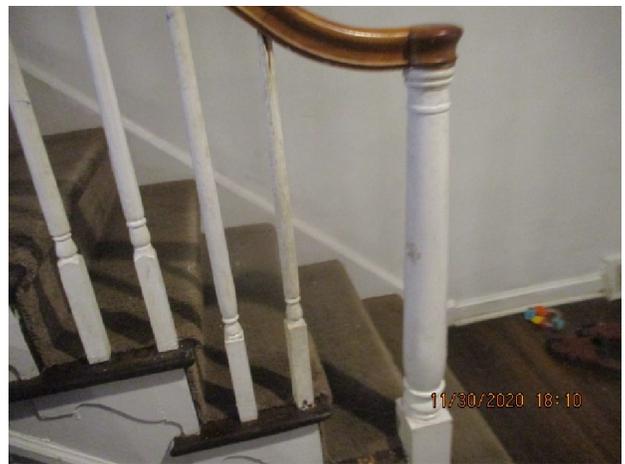
Stairways

Missing baluster noted
Loose railing noted on the main stairs.

Missing baluster noted
Loose railing noted on the main stairs.

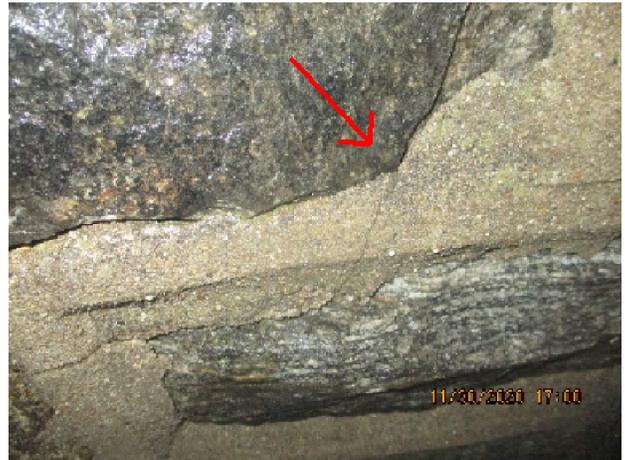
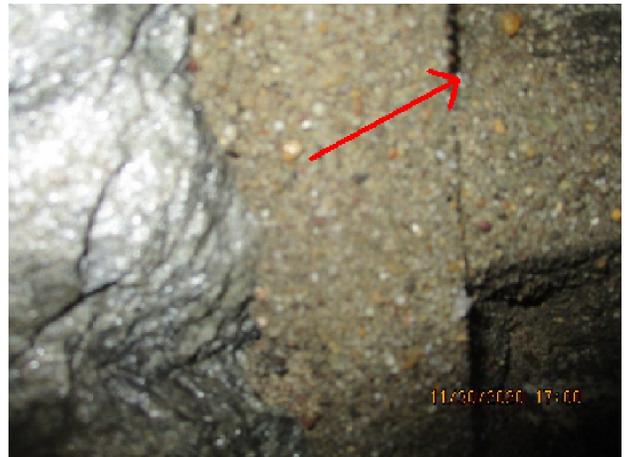
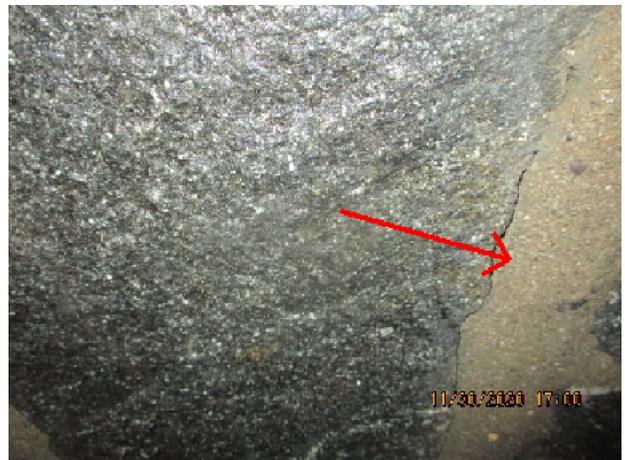
Exposed Foundation Primary Visible Type

Some cracks noted.

Some cracks noted.

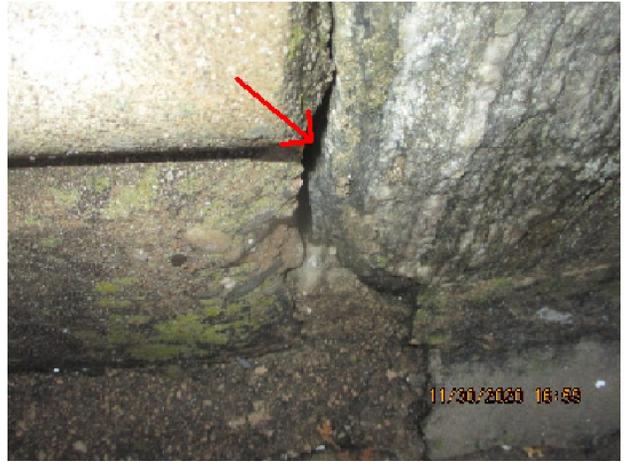
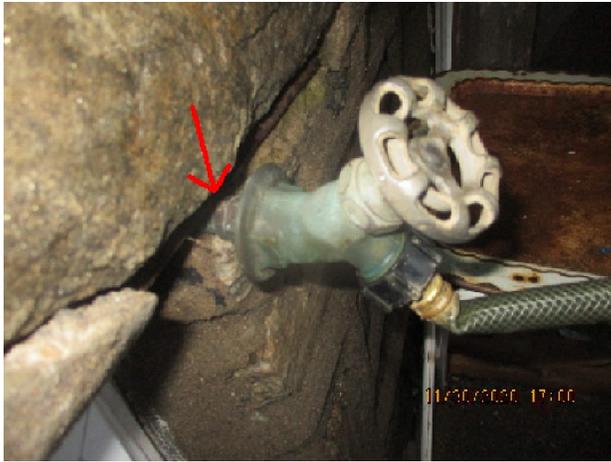
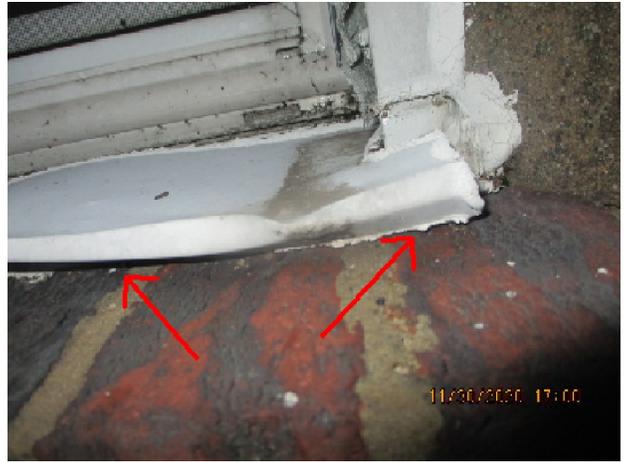
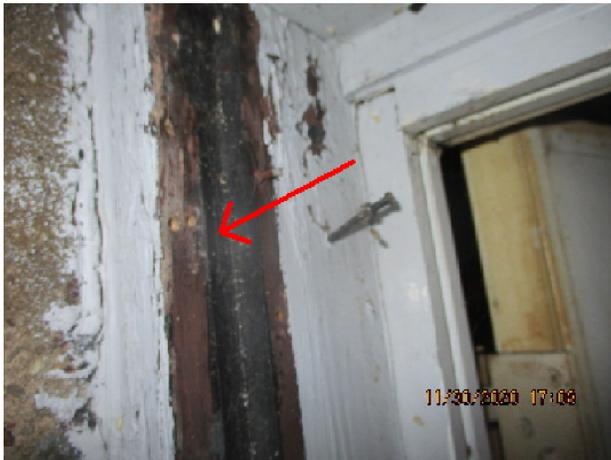
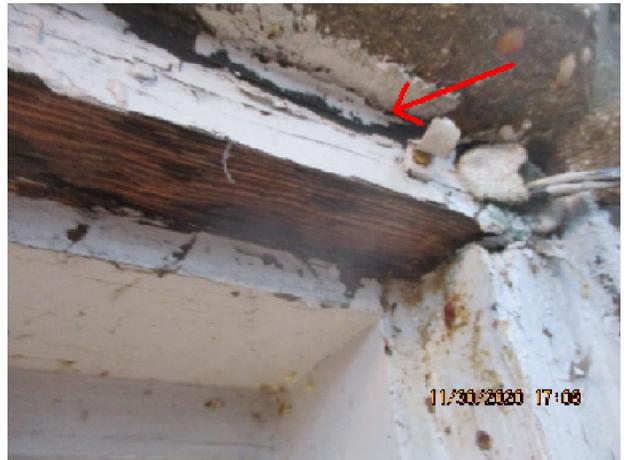
Caulking should be improved.

Caulking should be improved.

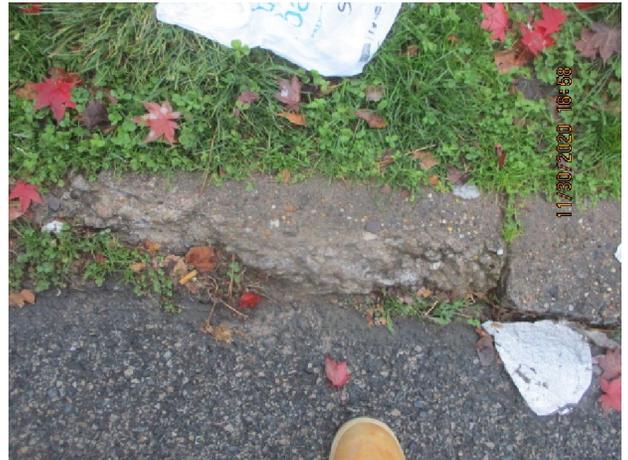
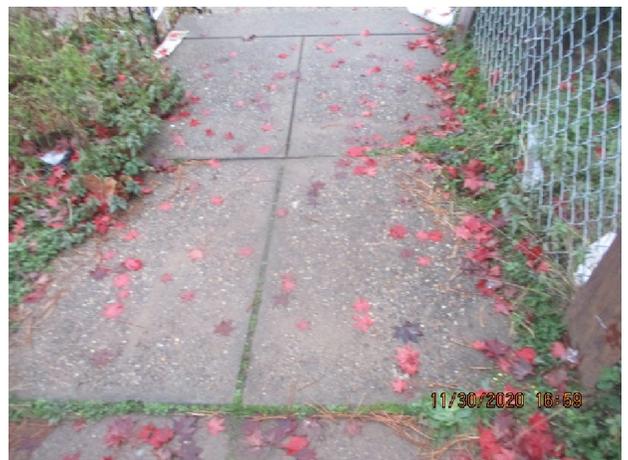
Walks

Cracks and some settlement noted.

Cracks and some settlement noted.

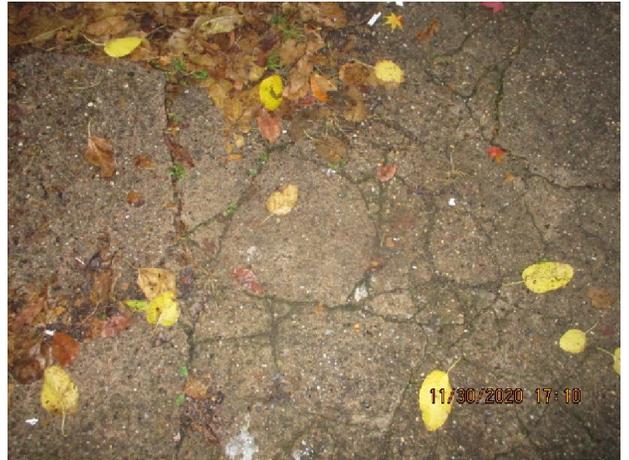
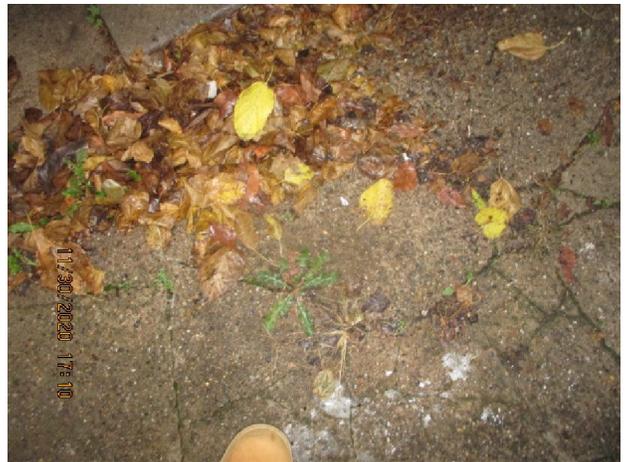
Patio

Cracks and some damage noted and should be repaired.

Cracks and some damage noted and should be repaired.

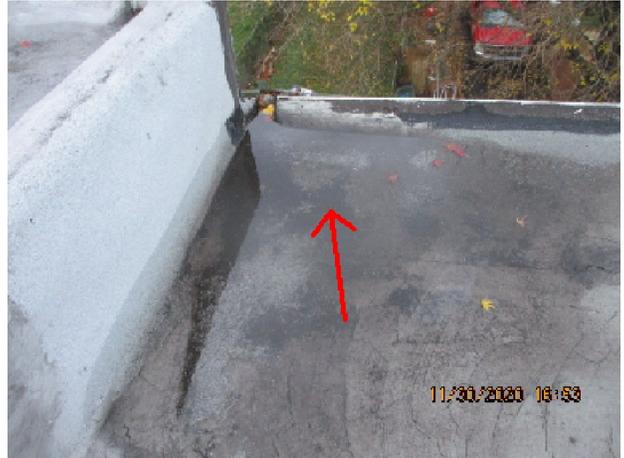
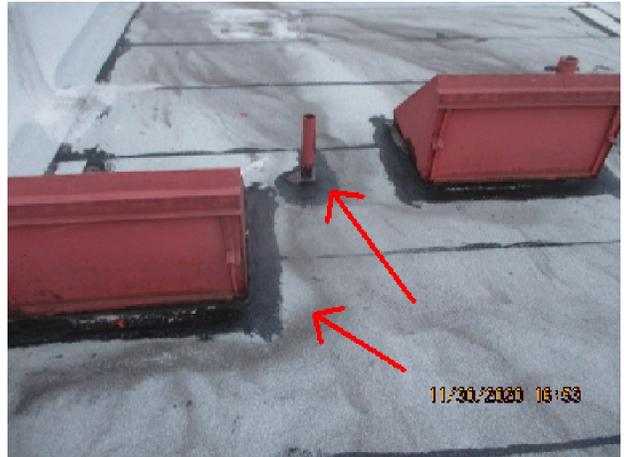
Roof Covering Primary Type

Nail heads should be sealed where exposed.
A few cracked shingles were noted and should be repaired.
A missing shingle tab was noted and should be repaired.
On flat or low pitch roofs, ponding water created by sags or clogged drains, develop roof leaks.

Nail heads should be sealed where exposed.
 A few cracked shingles were noted and should be repaired.
 A missing shingle tab was noted and should be repaired.
 On flat or low pitch roofs, ponding water created by sags or clogged drains, develop roof leaks.

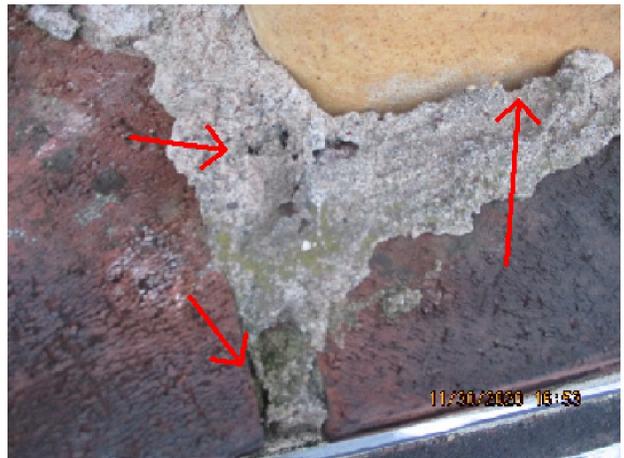
Chimney Top

Some cracks noted in chimney top.

Some cracks noted in chimney top.

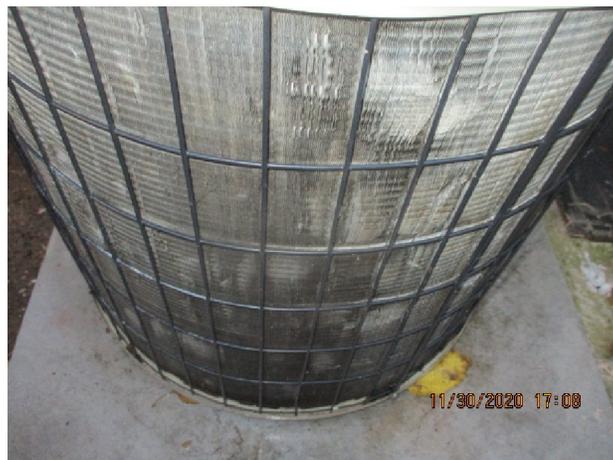
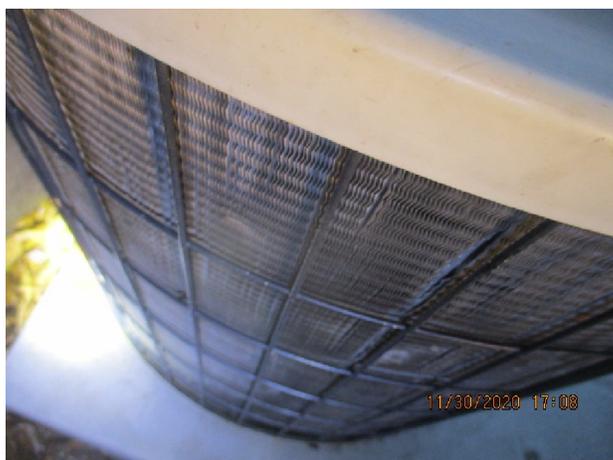
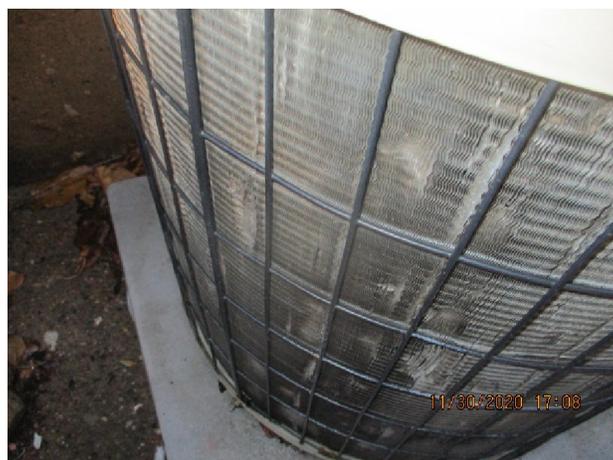
Cooling System Coils and Fins

Damaged fins noted.
Some rust was noted on casings.
The fins are damaged and should be repaired, damaged fins reduce air flow.

Damaged fins noted.

Some rust was noted on casings.

The fins are damaged and should be repaired, damaged fins reduce air flow.

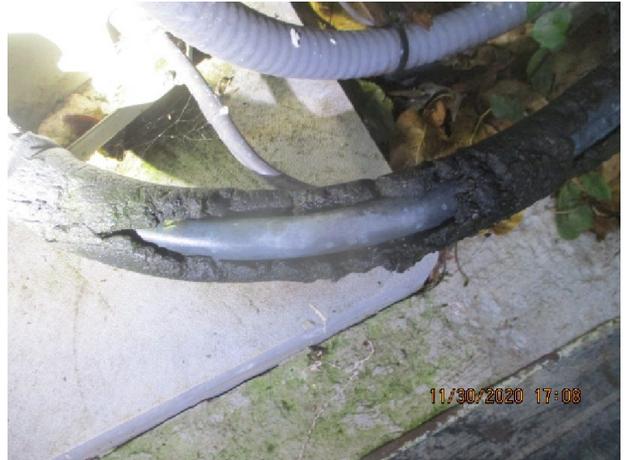
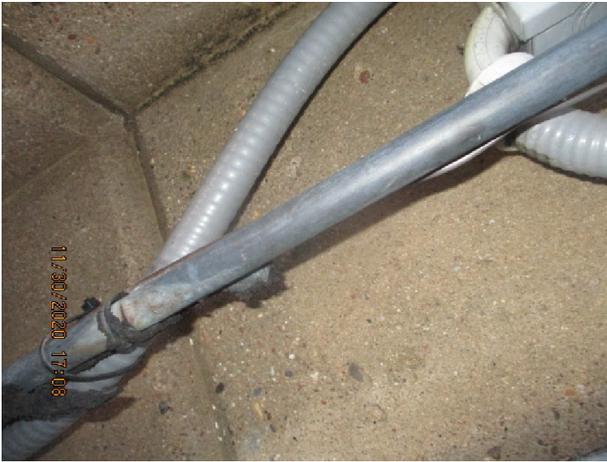
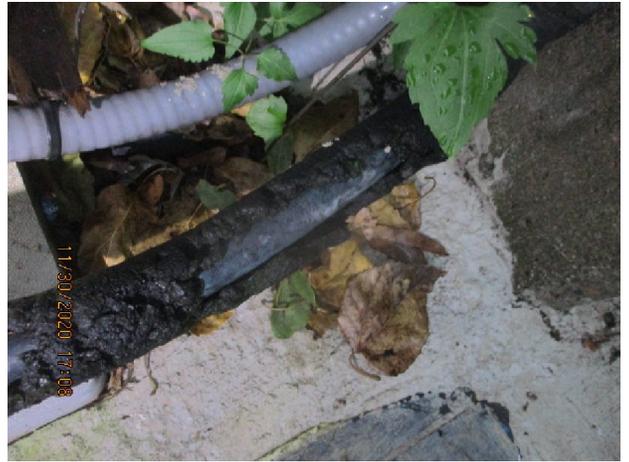
Cooling Lines

The insulation should be improved.

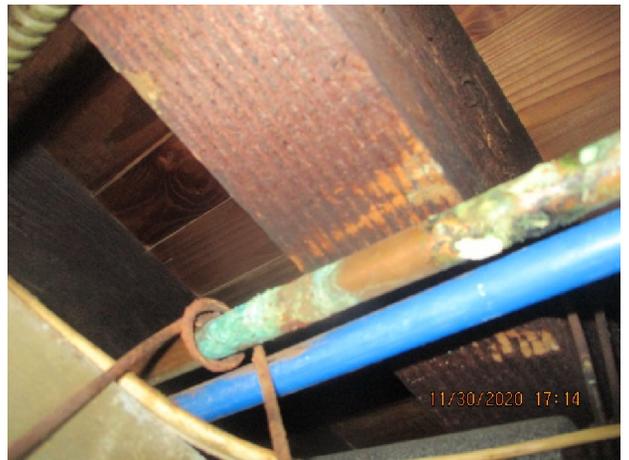
Interior Water Pipes Primarey Visible Type

Some minor leaks were noted at valves and should be repaired.
Some corrosion leaks were noted at valves,,pipes, and should be repaired.

Some minor leaks were noted at valves and should be repaired.
Some corrosion leaks were noted at valves,,pipes, and should be repaired.

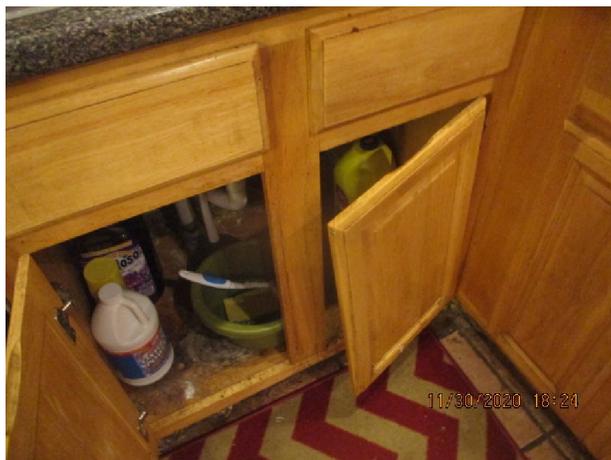
Kitchen Cabinets

Some loose hardware was noted.

Some loose hardware was noted.

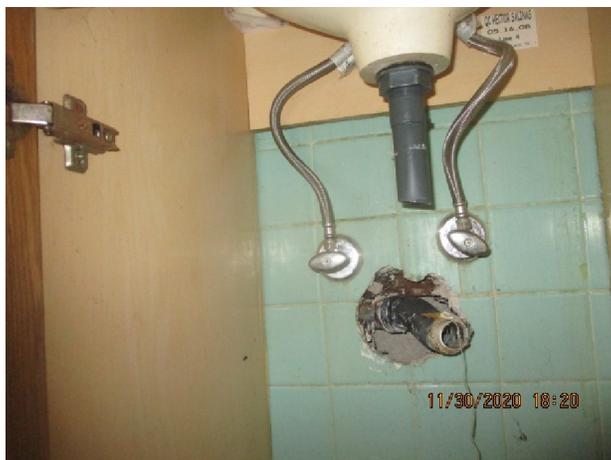
Bathroom Sink Basin

Some complete cracking around drain, and basin.

Some complete cracking around drain, and basin.

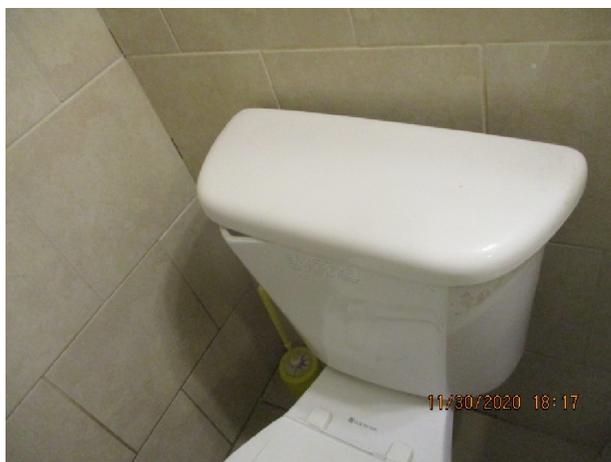
Toilet Operation

mismatched, lid on toilet noted

mismatched, lid on toilet noted

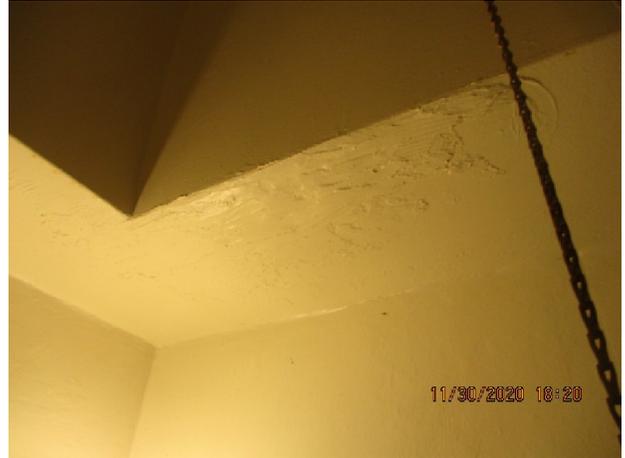
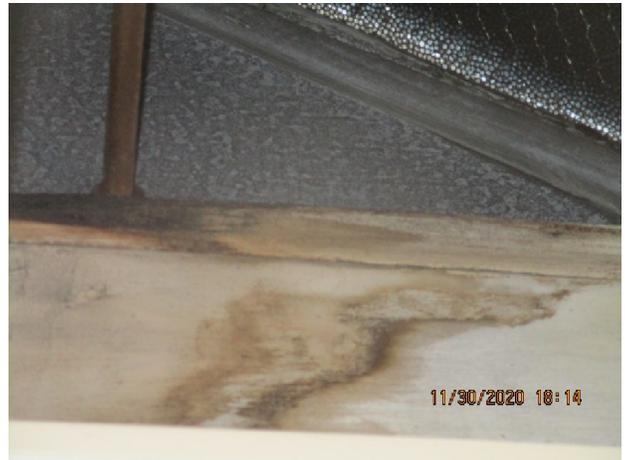
Skylight

Evidence of past leakage was noted.
Operation should be demonstrated before settlement.

Evidence of past leakage was noted.
Operation should be demonstrated before settlement.

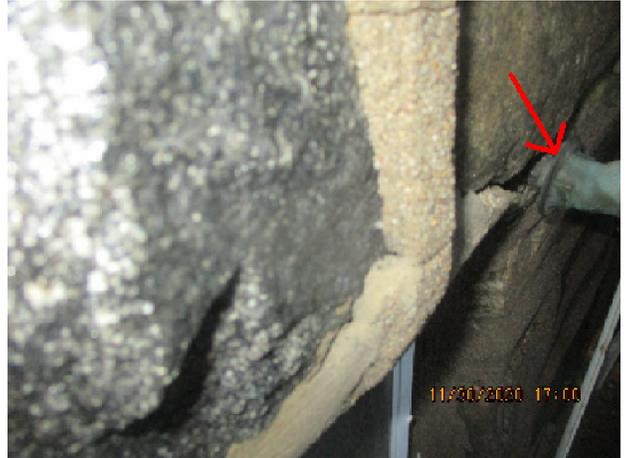
Type of Outside Spigots

Unprotected hose connections should be shut off and drained before first freeze each year.
