Reliable Home Inspection Service
100 Old Kennett Road
Wilmington, DE 19807
302/993-9100
reliablehomeinspections1@gmail.com
www.reliablehomeinspectionsservice.com

Inspection Summary

Inspection Report Details

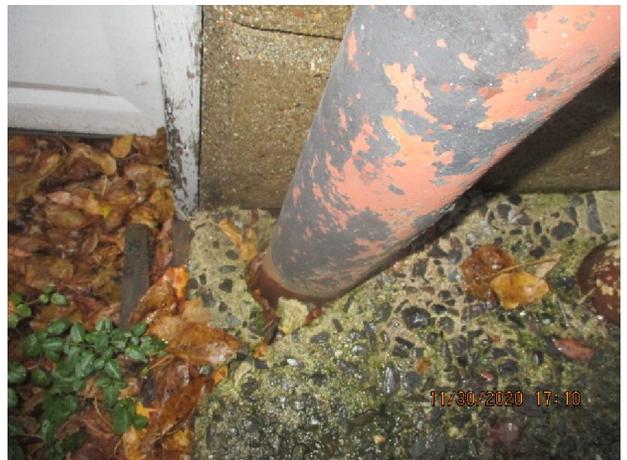
Runoff Drains

Location and condition of underground drains unknown.

Location and condition of underground drains unknown.

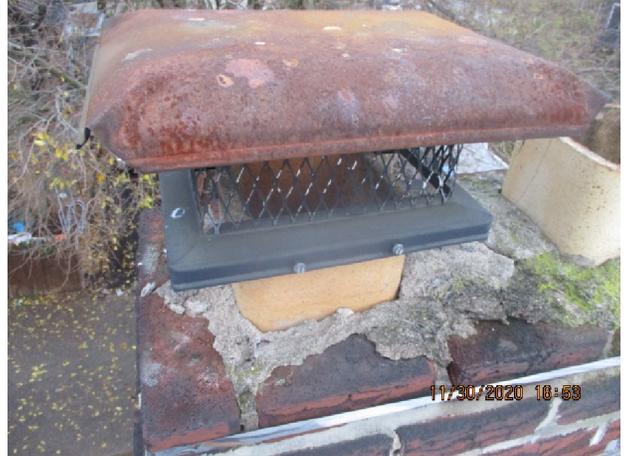
Could not view interior of chimney due to cap, caps are not removed as part of the home inspection.

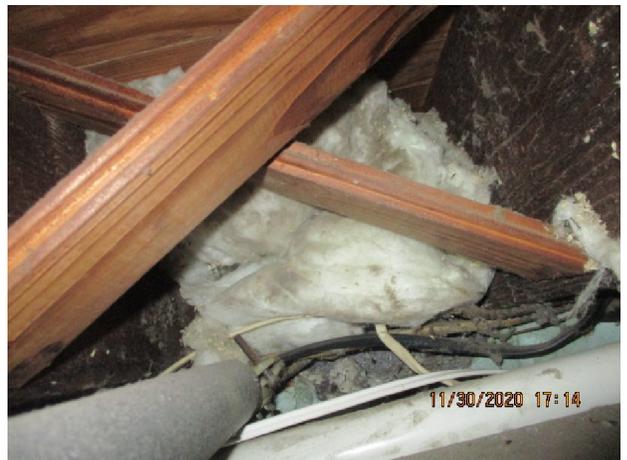
Basement Insulation Visible Primary Type

Insulation limits inspection.

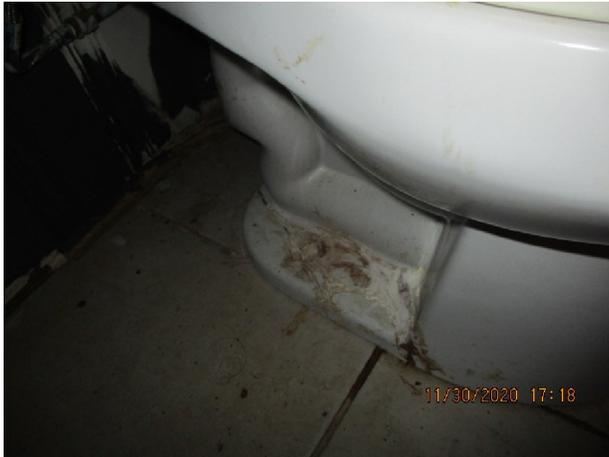
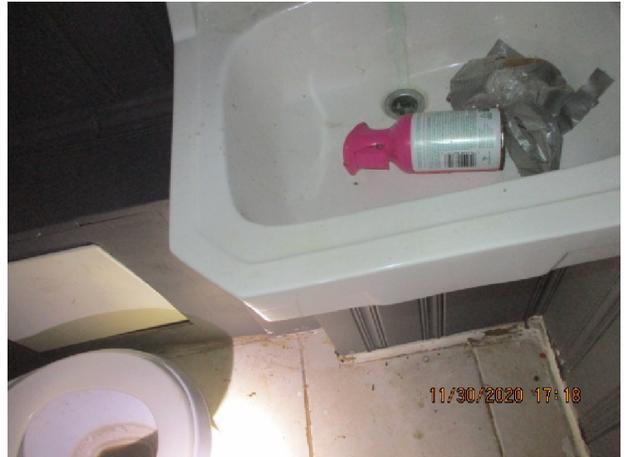
HALF BATH

basement toilet, sink not working at the time of inspection
