Reliable Home Inspection Service
100 Old Kennet Rd
Wilmington, DE 19807
302-993-9100
<https://www.reliablehomeinspectionsservice.com/>

Inspection Summary

Pre drywall inspection limited and is part one of two inspections and will not be a complete inspection until finish out is completed. the primary reason for inspection is areas to be covered in drywall in this case insulation was in and limited inspection.

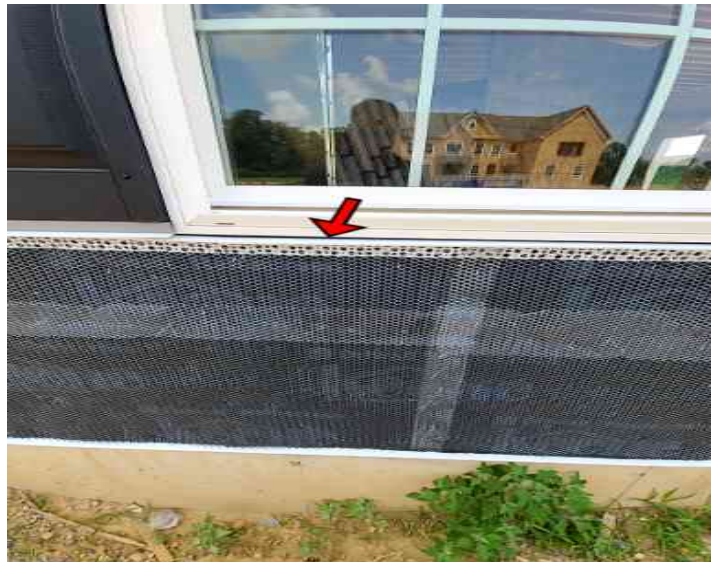
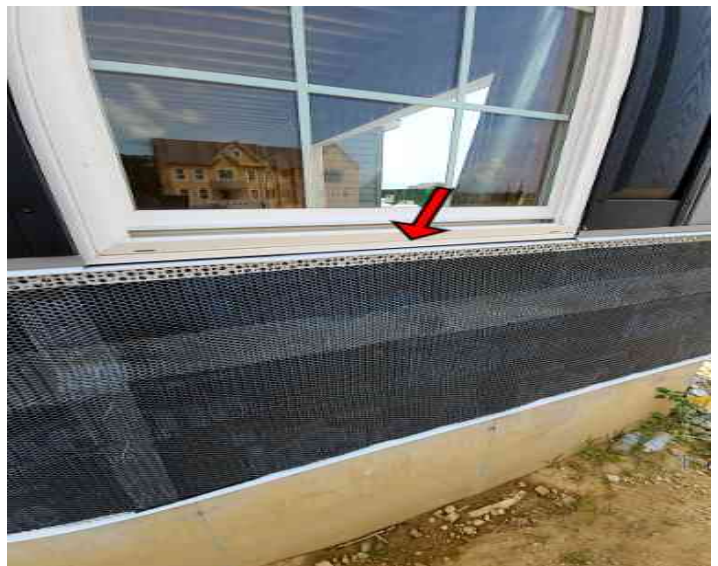
0309: Masonry Walls

Other= Missing areas of flashing noted at the garage windows and should be repaired.

Other= Missing areas of flashing noted at the garage windows and should be repaired.

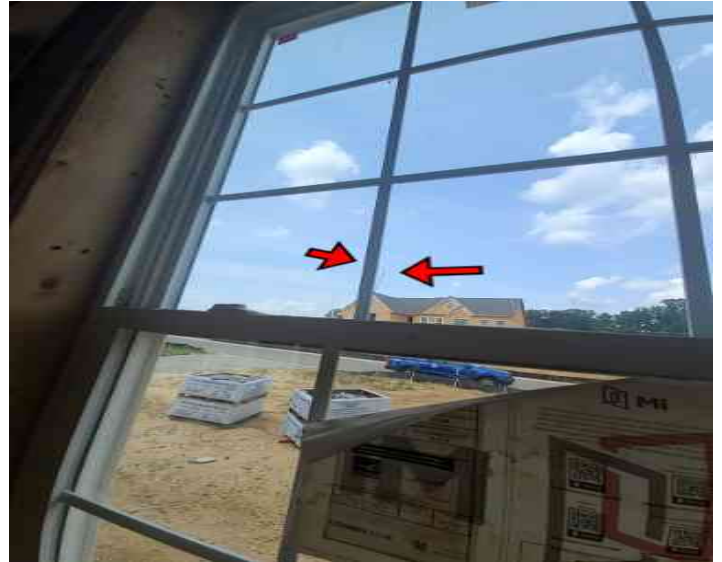
0806: Garage Windows

Cracked glass was noted and should be repaired.

Cracked glass was noted and should be repaired.

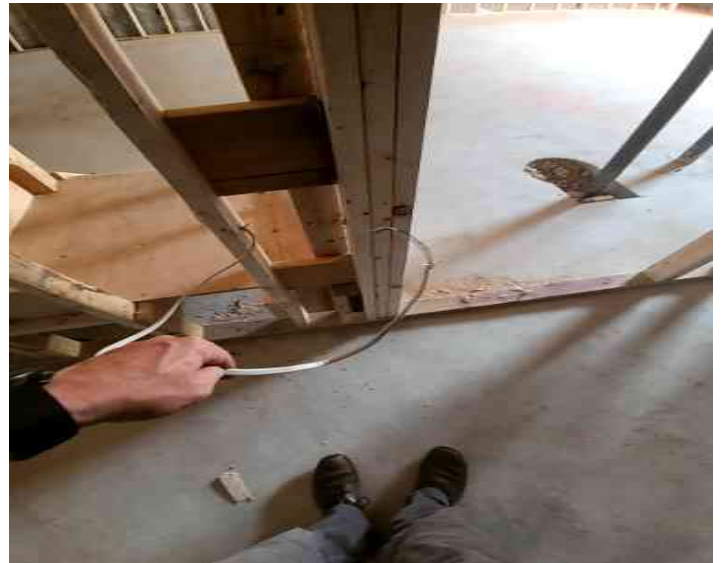
0919: Electrical Defaults

Disconnected wiring noted in the basement and should be connected or removed.

Disconnected wiring noted in the basement and should be connected or removed.

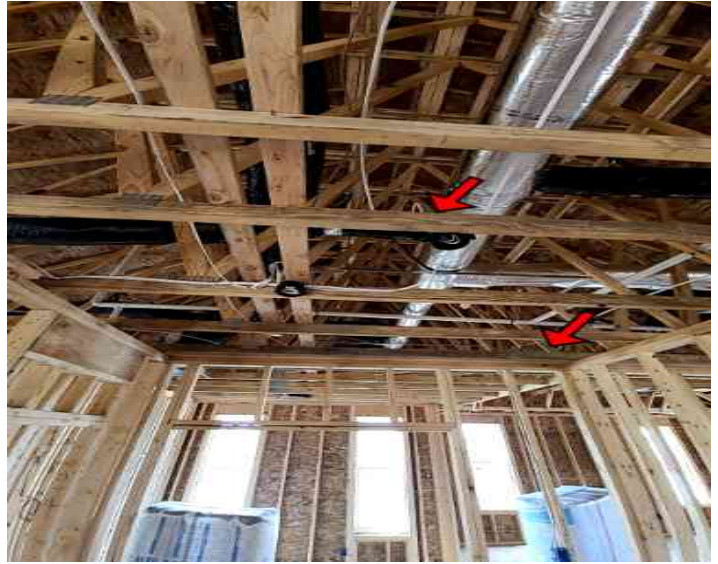
2005: Attic Structural Framing Type

As is common in most home in America some possible mold/mildew was noted on some structural surfaces and sheathing and should be cleaned by qualified personnel. As mold and mildew are not part of the home inspection the client may decide to do further evaluation to determine the extent of the problem and cost of cleanup/repair.

As is common in most home in America some possible mold/mildew was noted on some structural surfaces and sheathing and should be cleaned by qualified personnel. As mold and mildew are not part of the home inspection the client may decide to do further evaluation to determine the extent of the problem and cost of cleanup/repair.

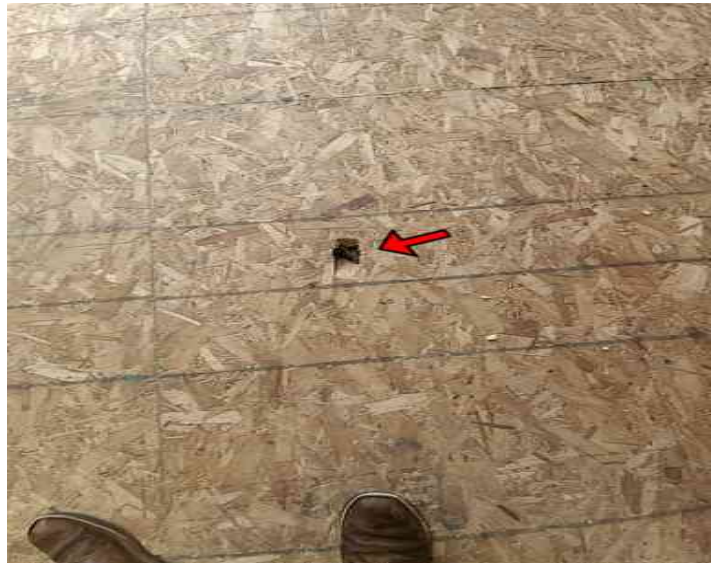
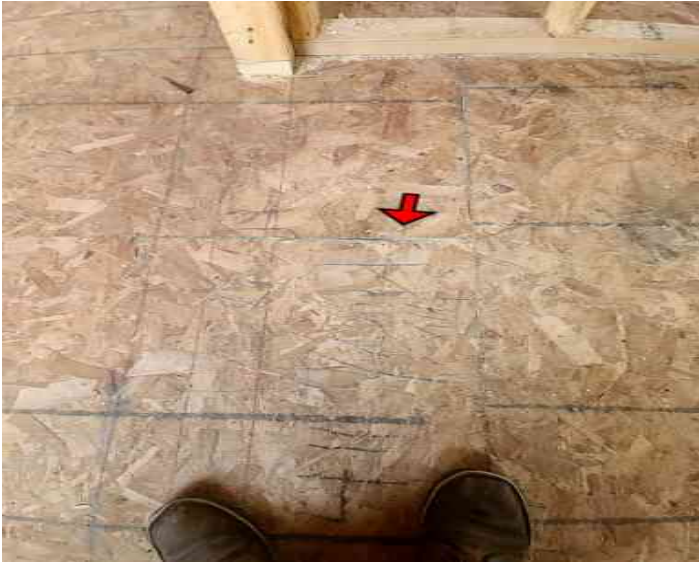
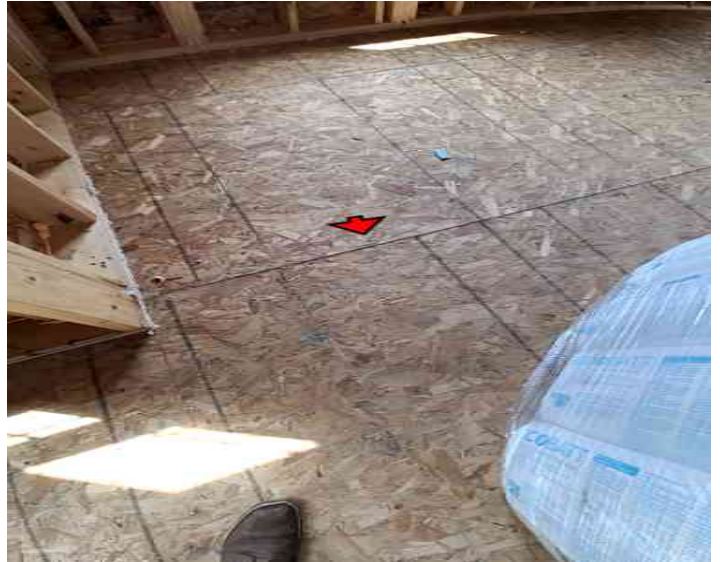
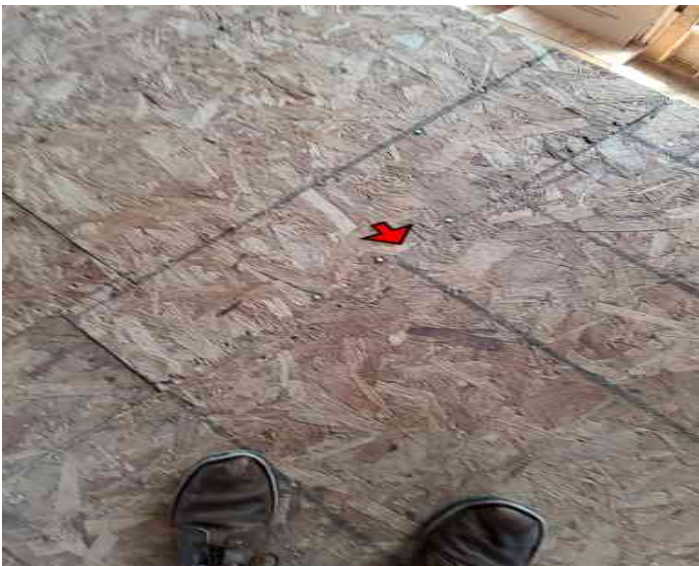
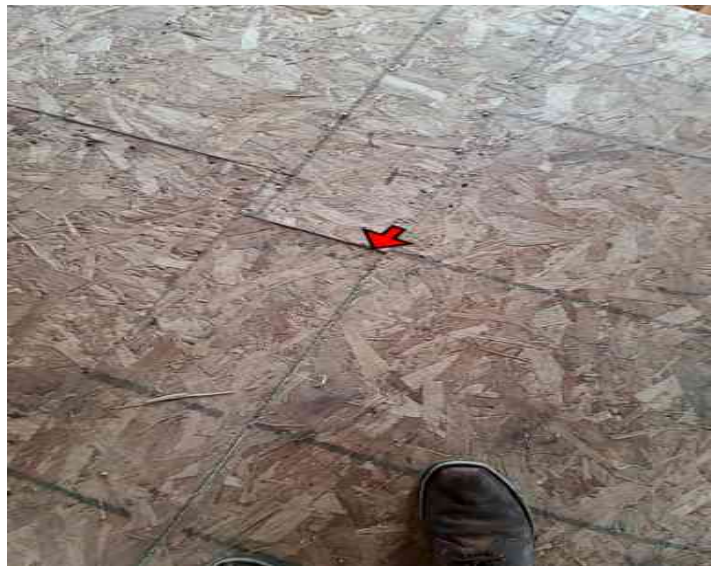
2106: Interior Floors

Hole in the floor should be repaired. Main living area.
Uneven areas of the sub floor noted in the master bedroom and should be repaired.
Uneven subfloor noted at the master closet and should be repaired.
Uneven areas were noted at the sub floor at the 2nd floor hallway and should be repaired.
Raised nails were noted at the 2nd floor hallway floor and should be repaired.

Hole in the floor should be repaired. Main living area. Uneven areas of the sub floor noted in the master bedroom and should be repaired. Uneven subfloor noted at the master closet and should be repaired. Uneven areas were noted at the sub floor at the 2nd floor hallway and should be repaired. Raised nails were noted at the 2nd floor hallway floor and should be repaired.

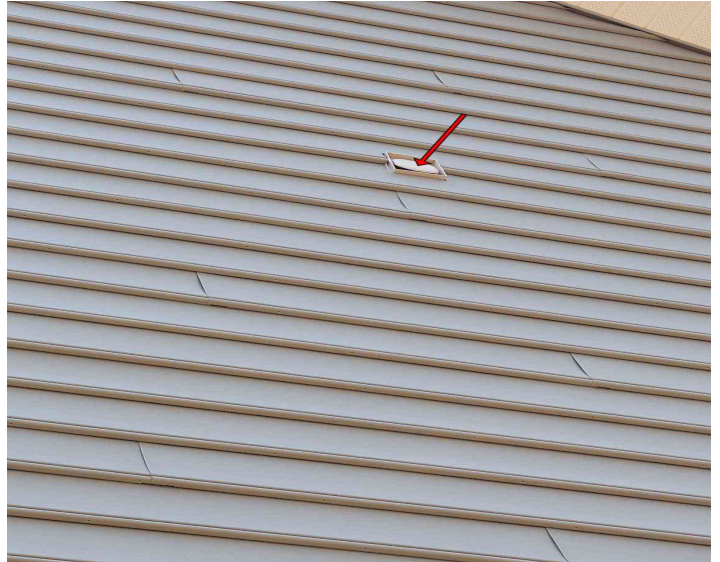
0301: EXTERIOR

Missing vent cover was noted and should be repaired.

Missing vent cover was noted and should be repaired.

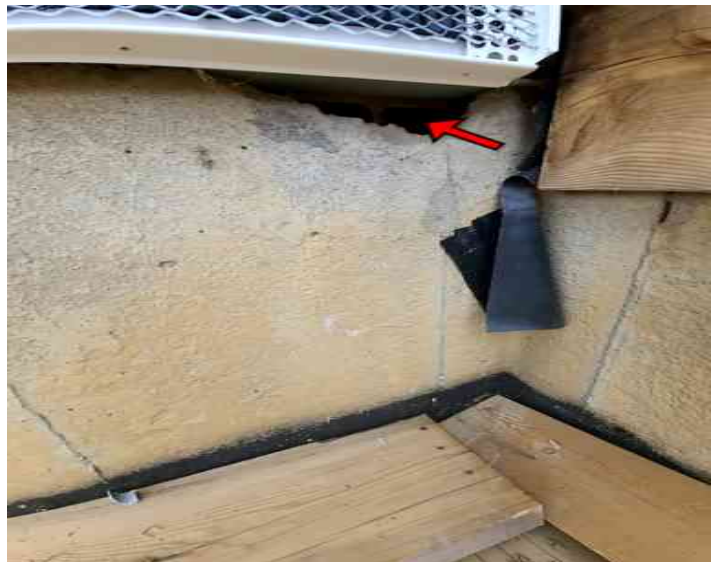
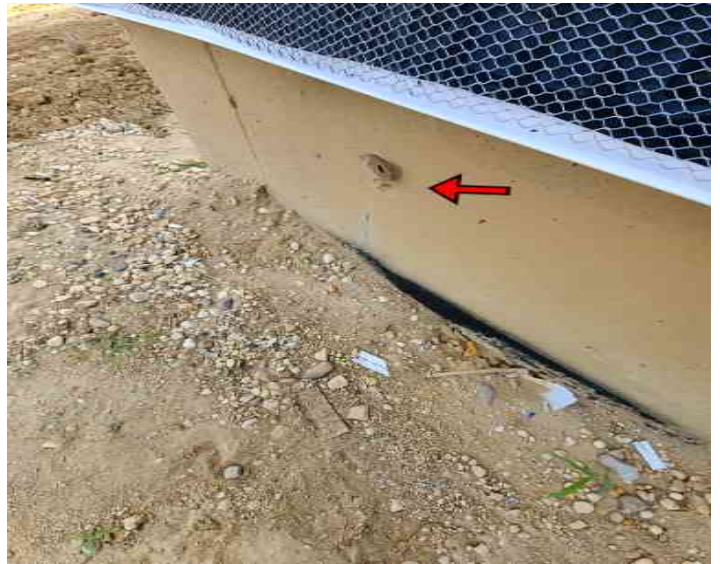
0304: Exposed Foundation Primary Visible Type

Some cracks noted. Open areas were noted at the front side door and should be repaired.
Set in should be removed.

Some cracks noted. Open areas were noted at the front side door and should be repaired. Set in should be removed.

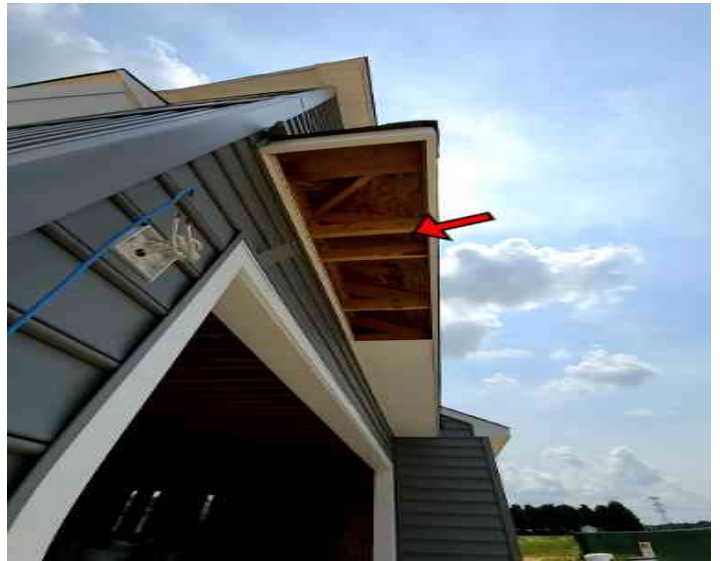
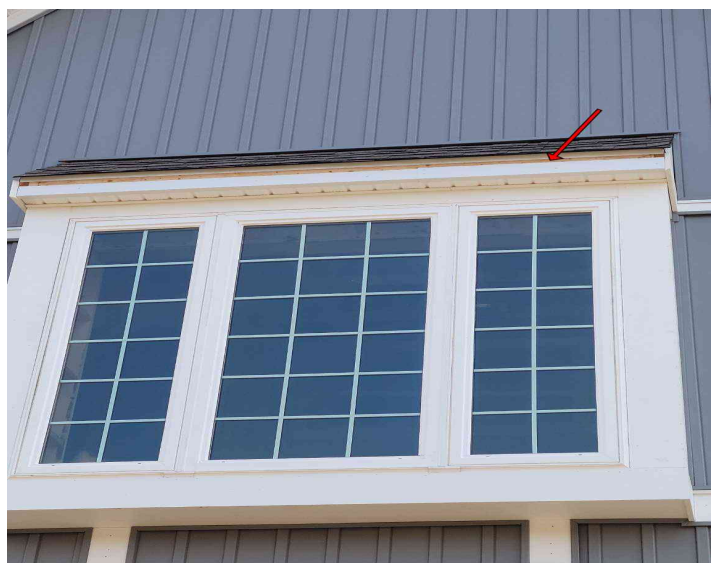
0306: Soffit\Fascia

Missing section was noted and should be repaired.
Exposed wood above the master bathroom window and should be repaired.

Missing section was noted and should be repaired. Exposed wood above the master bathroom window and should be repaired.

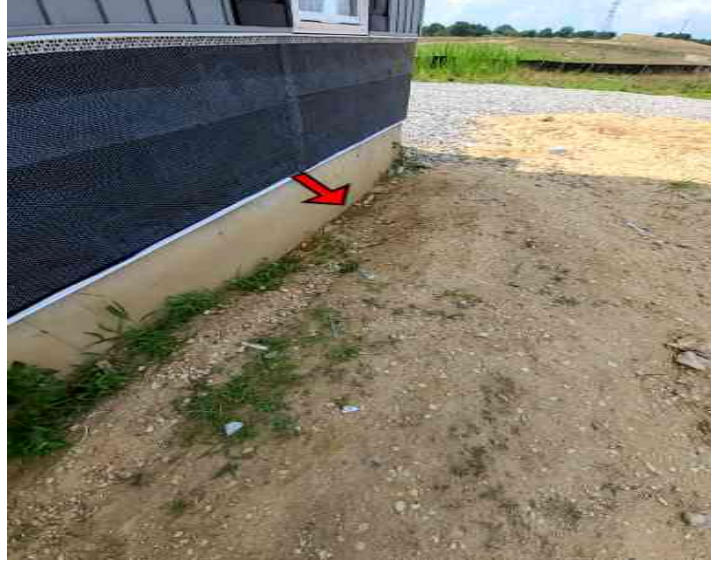
0307: Grading

Soil should be sloped away from house to improve drainage.

Soil should be sloped away from house to improve drainage.

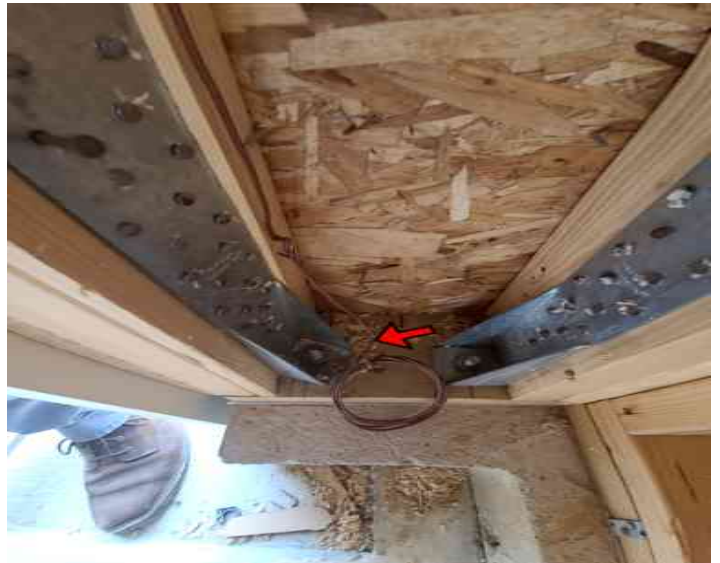
0811: Garage Interior Walls

Some bolts should be tightened.

Some bolts should be tightened.

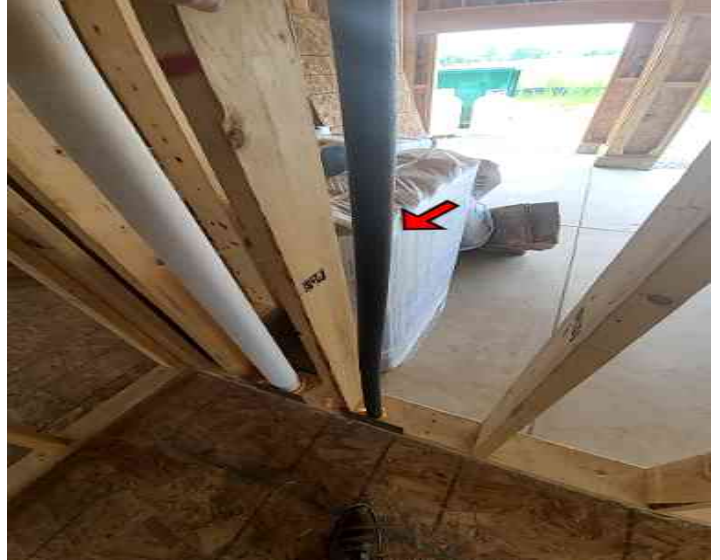
1007: Interior Water Pipes Primary Visible Type

Some areas of plumbing should be better supported.
Garage shared wall.

Some areas of plumbing should be better supported. Garage shared wall.

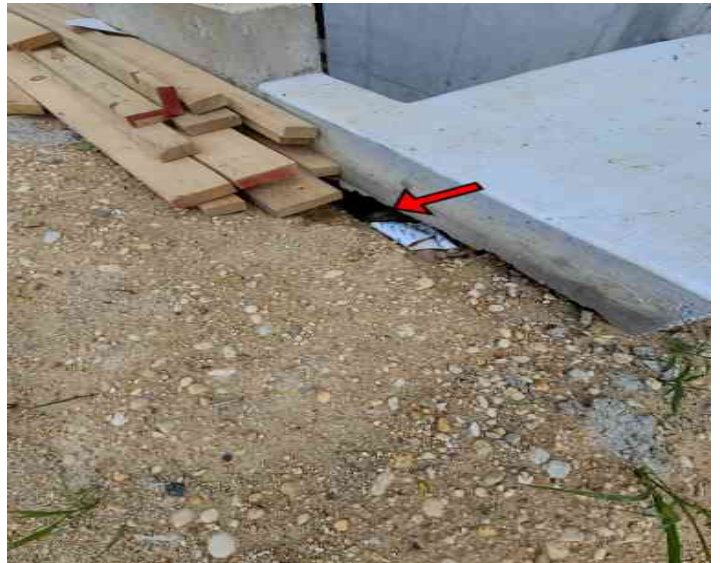
1503: Basement Access

Undermining was noted at the exterior stairs and
should be repaired.

Undermining was noted at the exterior stairs and should be repaired.

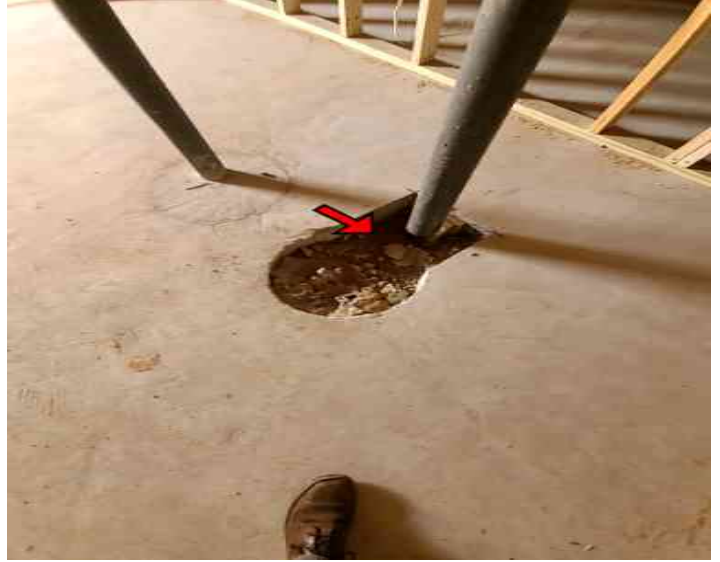
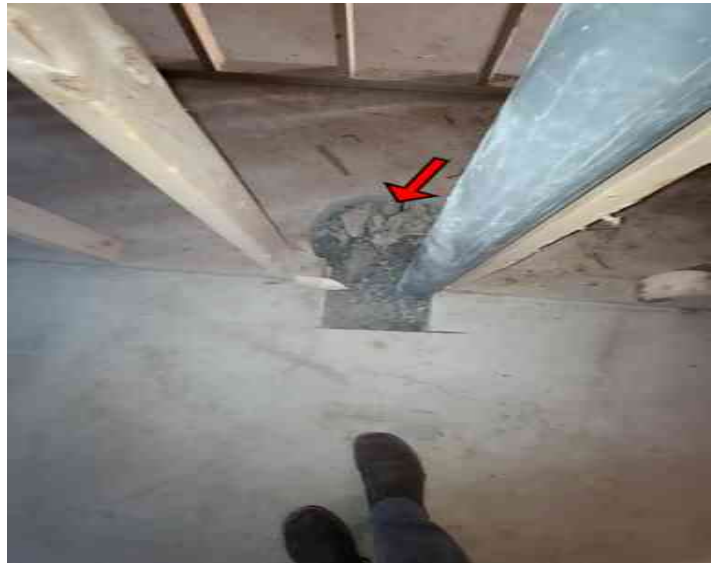
1508: Basement Structural Columns Visible Primary Type

Footer holes should be filled in.

Footer holes should be filled in.

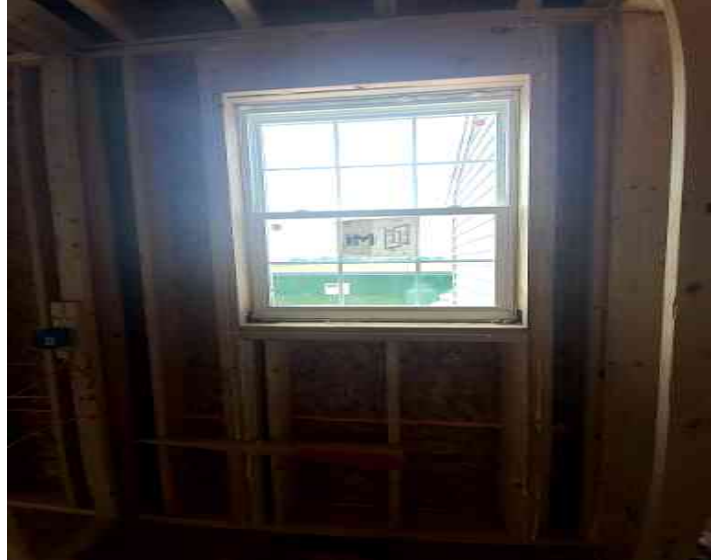
1707: Kitchen Doors Windows

Pantry window is tight to open and does not lock properly and should be repaired.

Pantry window is tight to open and does not lock properly and should be repaired.

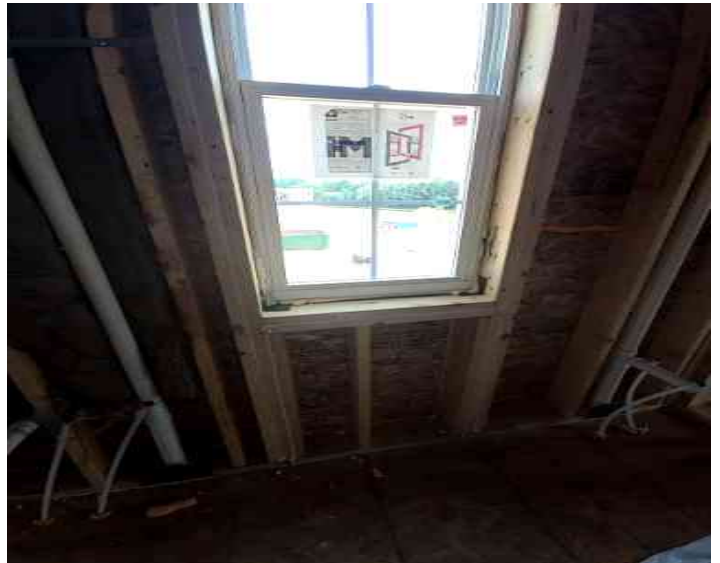
1902: Bathroom Doors, Windows

Jack and Jill bathroom window is tight to open.

Jack and Jill bathroom window is tight to open.

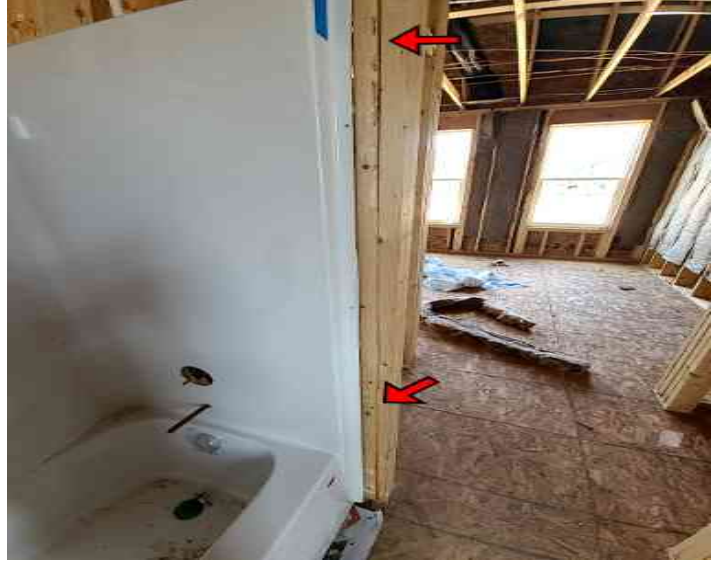
1917: Seal Around Tub

Jack and Jill tub surround should be better attached to the wall.

Jack and Jill tub surround should be better attached to the wall.

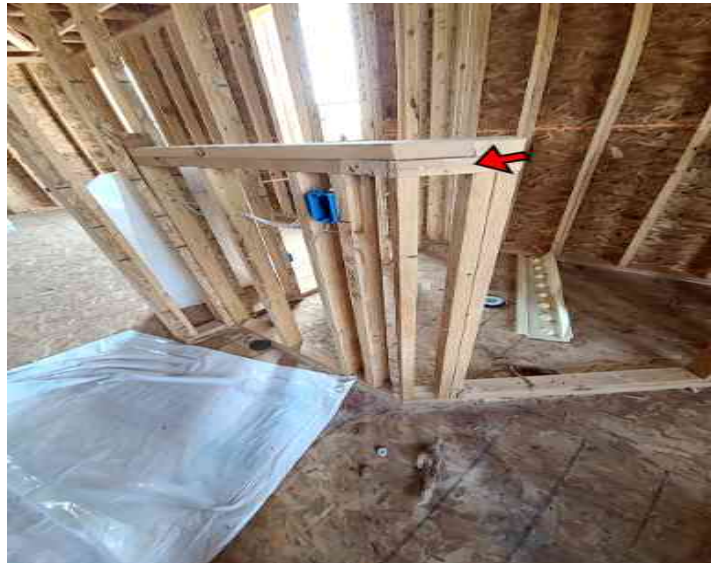
1921: Shower Stall Walls

Other = Rough framing.
Shower stall half wall is loose and should be repaired.

Other = Rough framing. Shower stall half wall is loose and should be repaired.

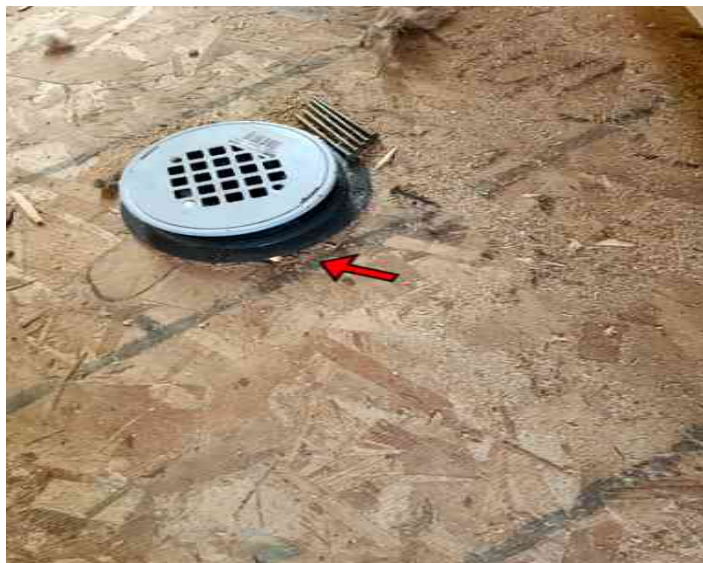
1922: Shower Drain

Daylight showing at the master shower drain hole and should be properly sealed.

Daylight showing at the master shower drain hole and should be properly sealed.

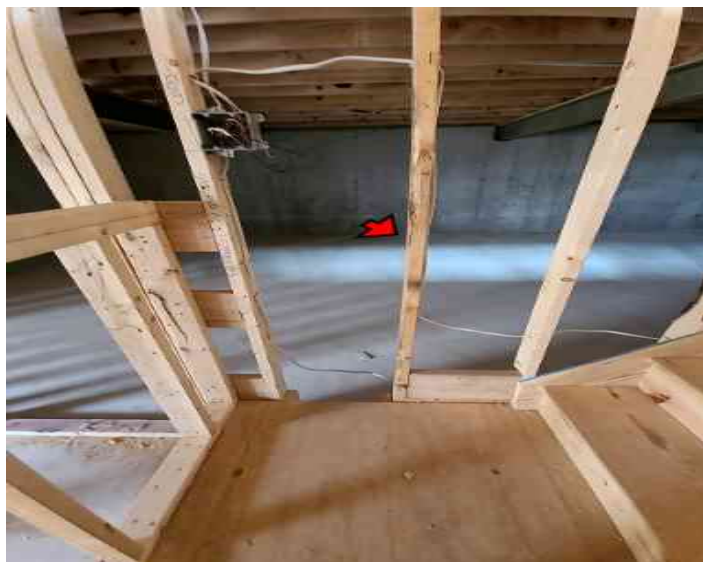
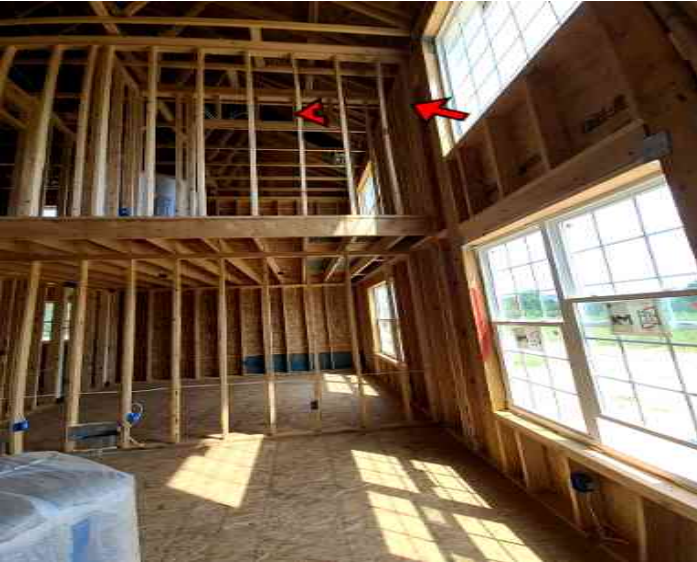
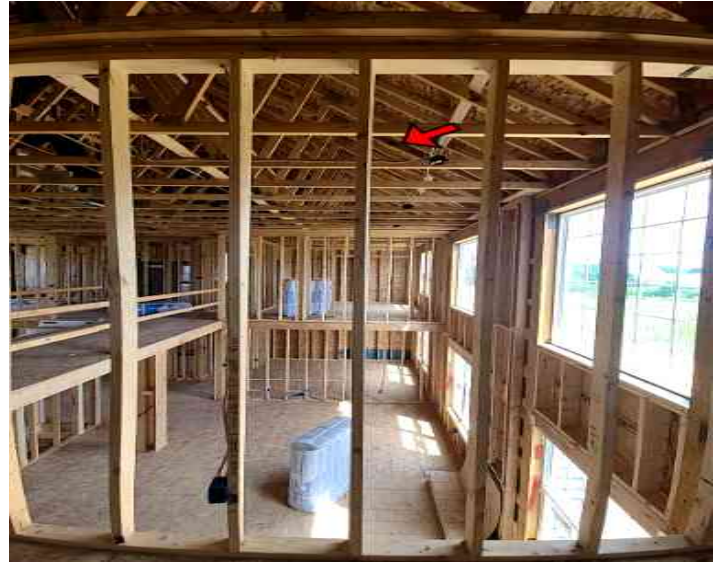
2104: Interior Walls

Other = Rough framing.

Bowed stud at the bottom of the basement steps and should be repaired.

Bowed and loose stud at the rear right bedroom wall and should be repaired.

Bowed studs at the left rear bedroom and should be repaired.

Other = Rough framing. Bowed stud at the bottom of the basement steps and should be repaired. Bowed and loose stud at the rear right bedroom wall and should be repaired. Bowed studs at the left rear bedroom and should be repaired.

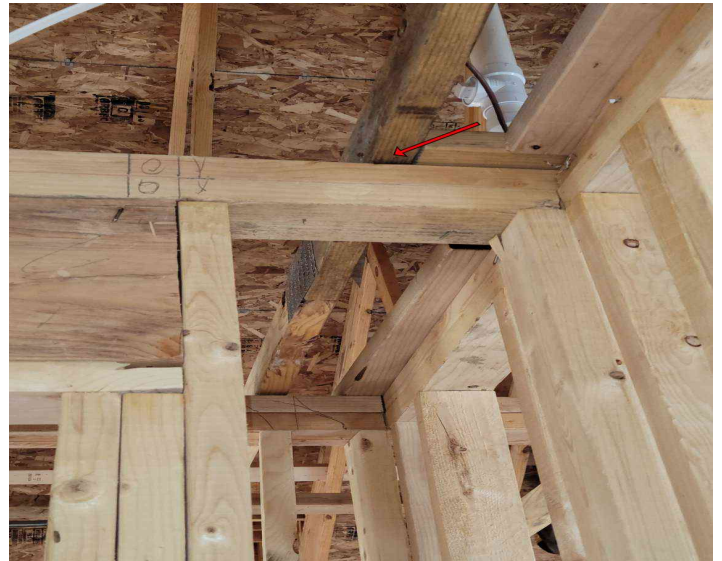
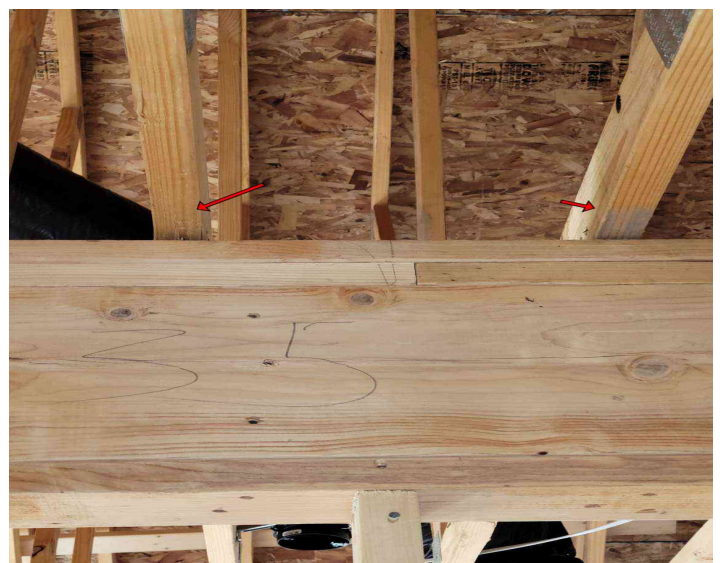
2105: Interior Ceilings

Other = Rough framing.
Roof trusses are raised off the top of the wall sill and should be repaired.

Other = Rough framing. Roof trusses are raised off the top of the wall sill and should be repaired.

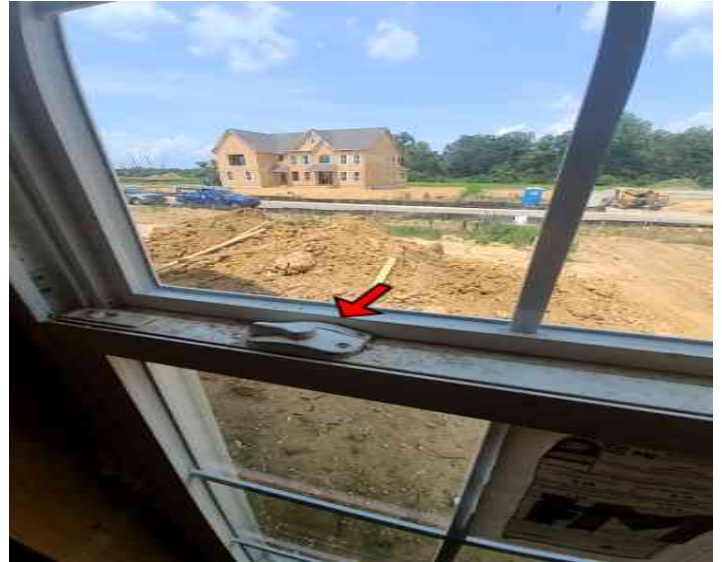
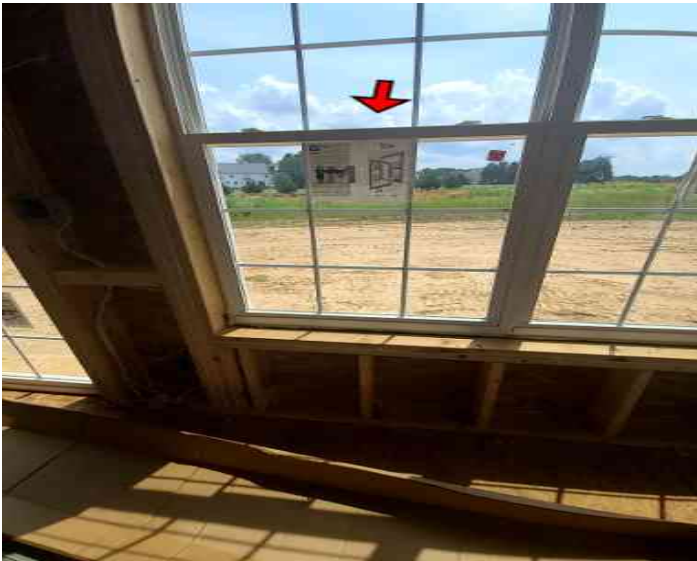
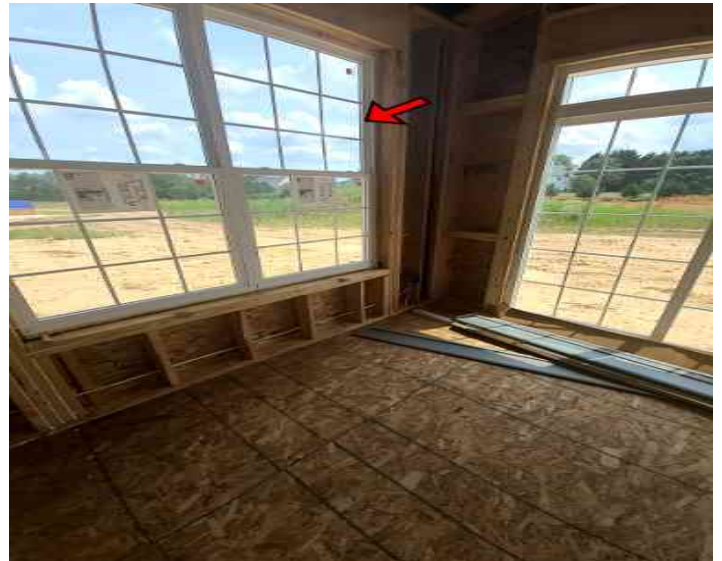
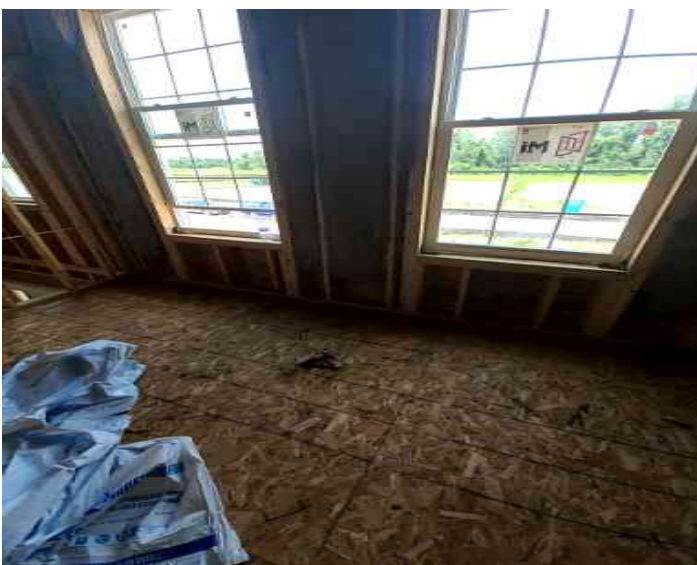
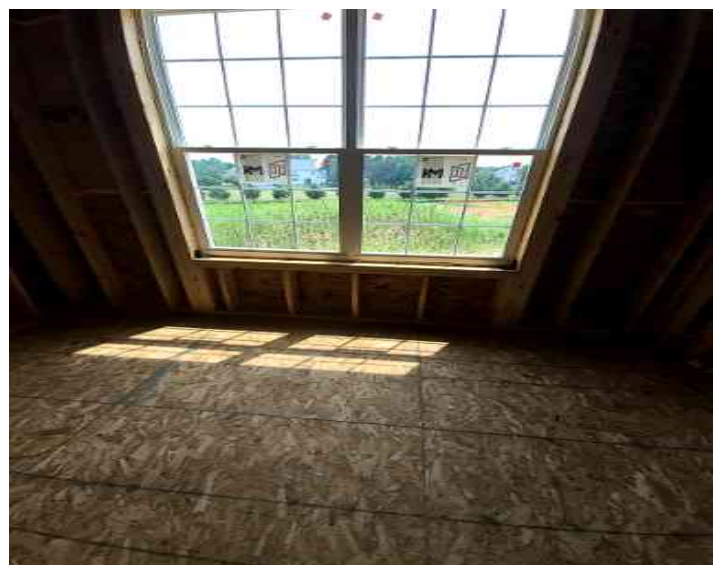
2122: Windows

Front family room right window will not lock properly and should be repaired.

Sunroom left rear window does not lock and should be repaired.

Rear window at sunroom right of the sliding door does not lock and should be repaired.

Back left bedroom windows so not lock and should be repaired.

Front right bedroom windows get stuck opening and should be repaired.

Front family room right window will not lock properly and should be repaired. Sunroom left rear window does not lock and should be repaired. Rear window at sunroom right of the sliding door does not lock and should be repaired. Back left bedroom windows so not lock and should be repaired. Front right bedroom windows get stuck opening and should be repaired.

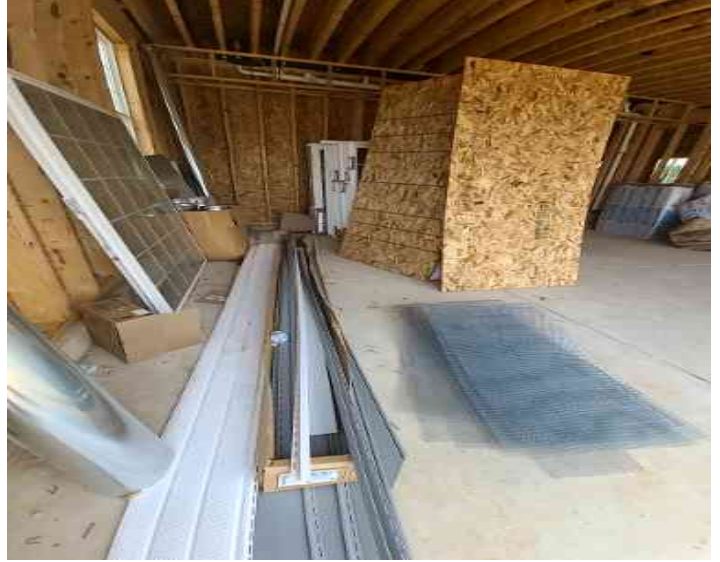
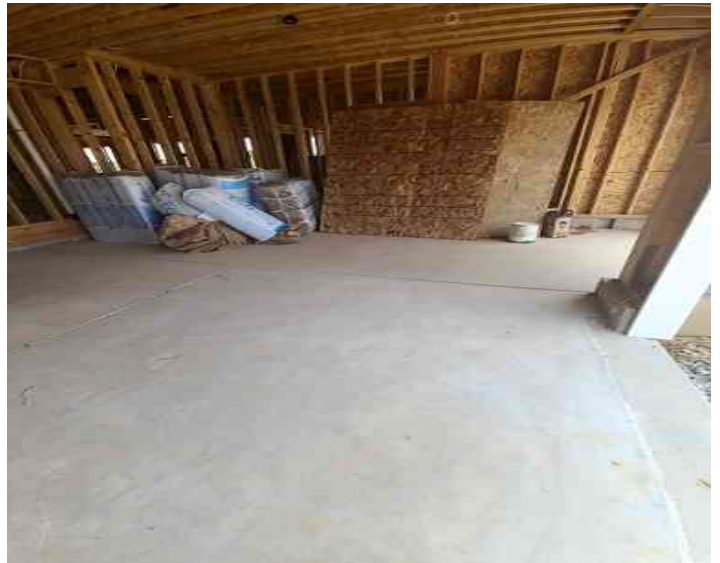
0801: GARAGE

Garage inspection limited by heavy storage.

Garage inspection limited by heavy storage.
