Reliable Home Inspection Service
100 Old Kennett Rd
Wilmington, DE 19807
302-993-9100
<https://www.reliablehomeinspectionsservice.com/>

FRONT VIEW

Inspection Summary

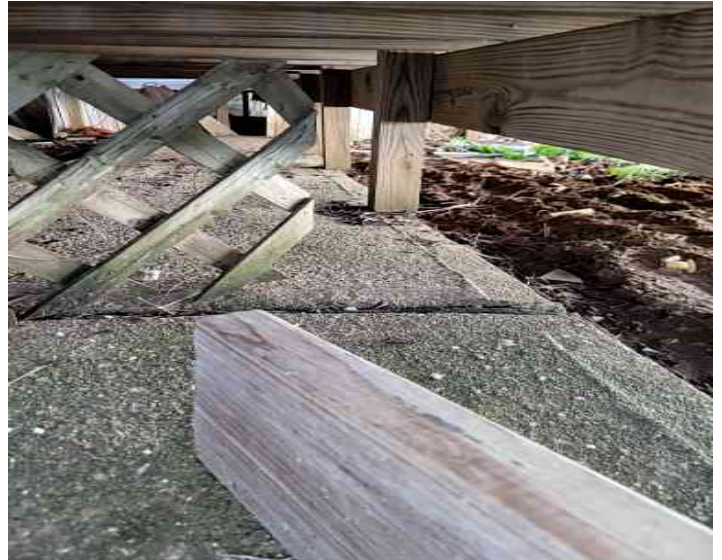
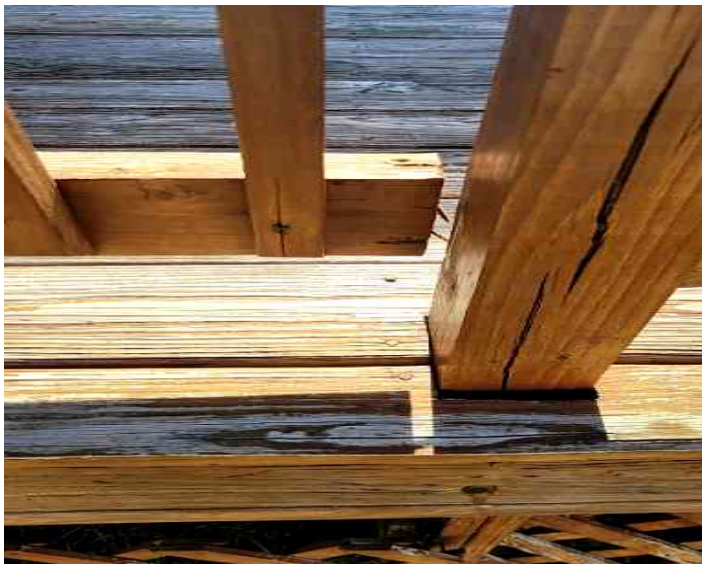
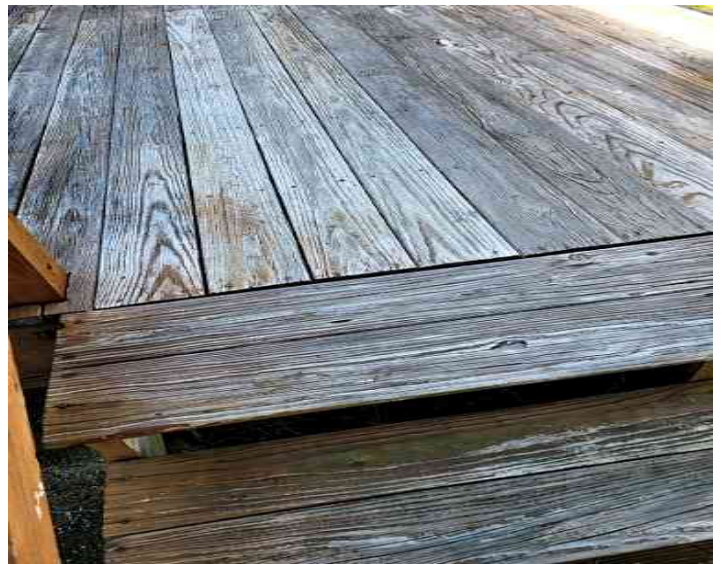
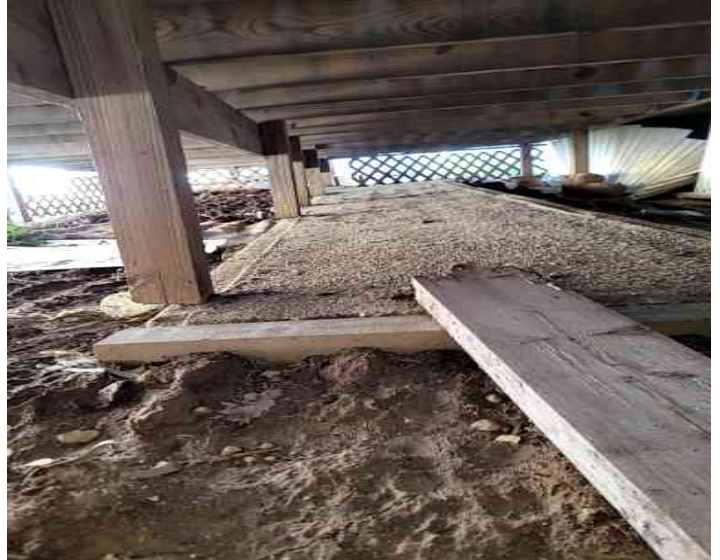
0207: Decks

Poorly supported deck system was noted. Deck is installed on top of the sidewalk. Loose railing was noted and should be repaired.

Poorly supported deck system was noted. Deck is installed on top of the sidewalk. Loose railing was noted and should be repaired. The entire deck system should be evaluated by a qualified contractor and all needed repairs should be made. The deck should be power washed and treated with water repellent.

The entire deck system should be evaluated by a qualified contractor and all needed repairs should be made.

The deck should be power washed and treated with water repellent.

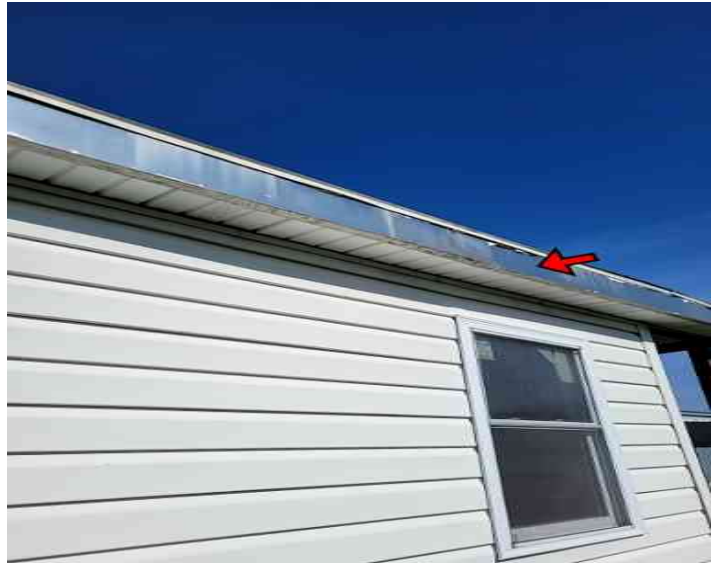
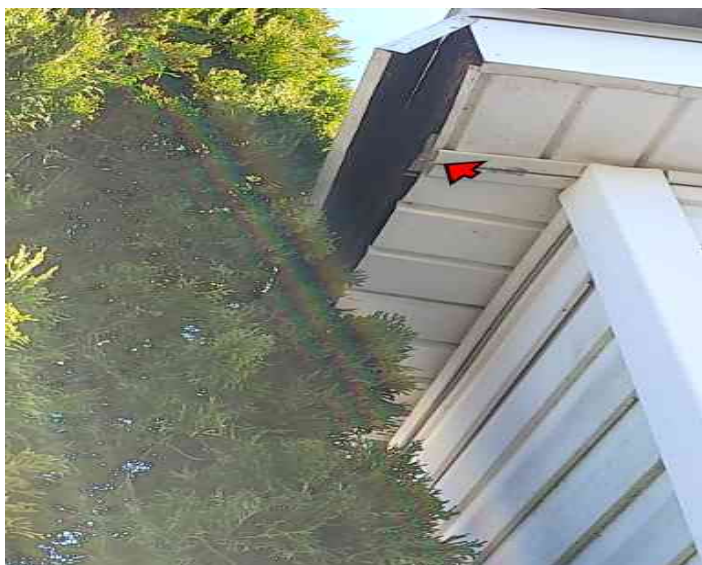
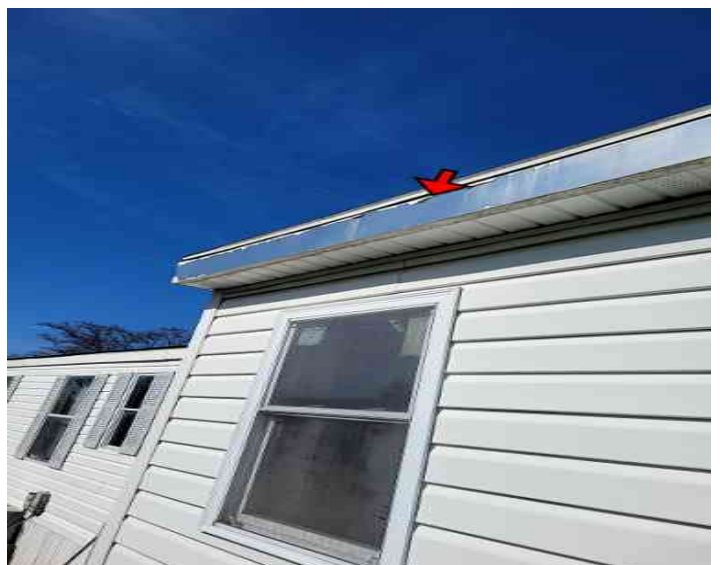
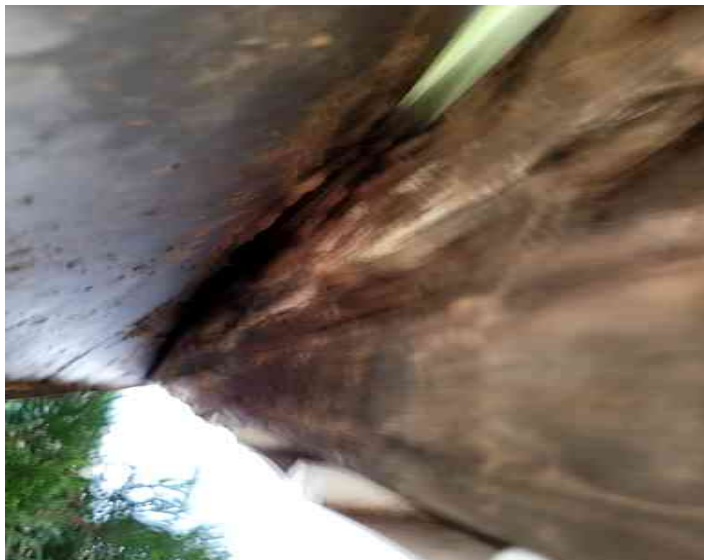
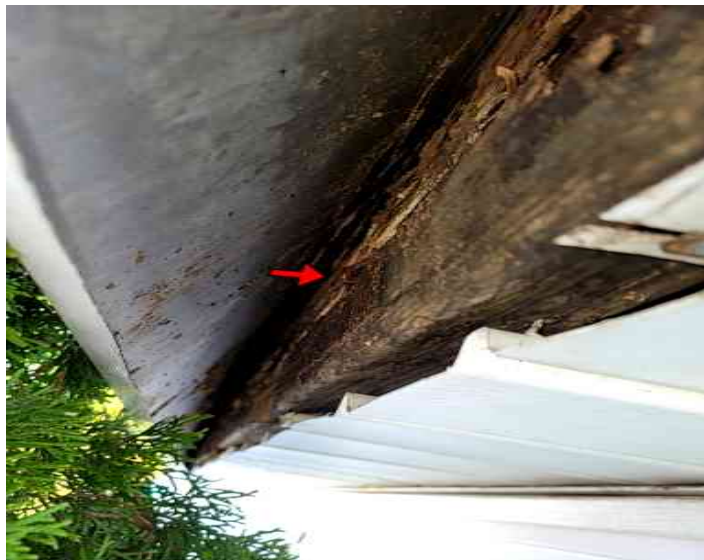
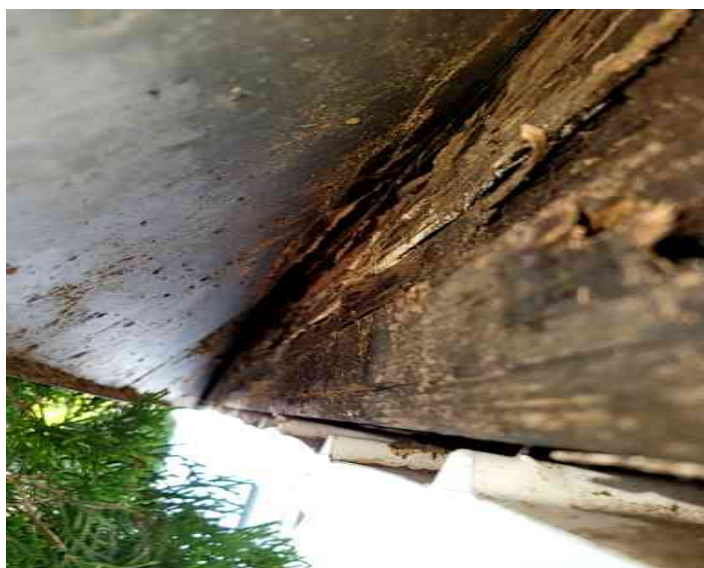
0306: Soffit\Fascia

Paint has come off at some areas and should be repaired.
Loose fitting section was noted and should be repaired.
Termite tubes and damage was noted at the wood behind the metal.
The entire structural condition should be evaluated by a qualified structural contractor or engineer and all needed repairs should be made.

Paint has come off at some areas and should be repaired. Loose fitting section was noted and should be repaired. Termite tubes and damage was noted at the wood behind the metal. The entire structural condition should be evaluated by a qualified structural contractor or engineer and all needed repairs should be made.

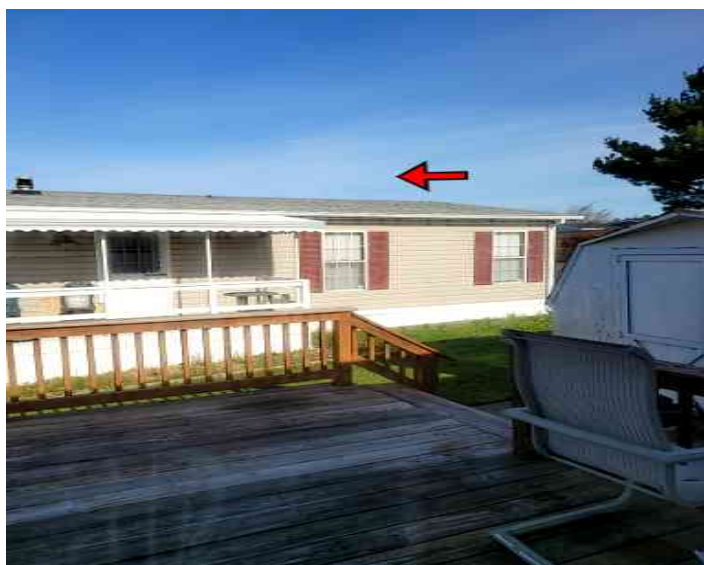
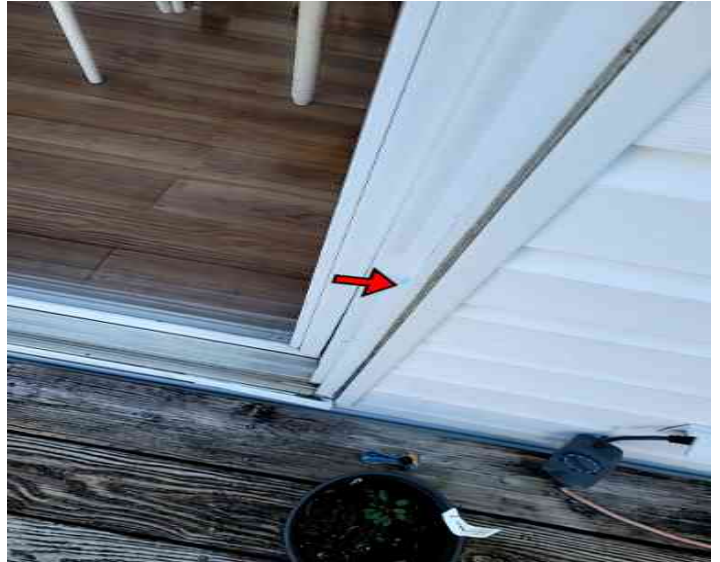
0313: Patio Doors

Condensation was noted between the panes of insulated glass on the sliding door and damaged glass should be replaced.

Damage to the exterior trim was noted

Condensation was noted between the panes of insulated glass on the sliding door and damaged glass should be replaced Damage to the exterior trim was noted

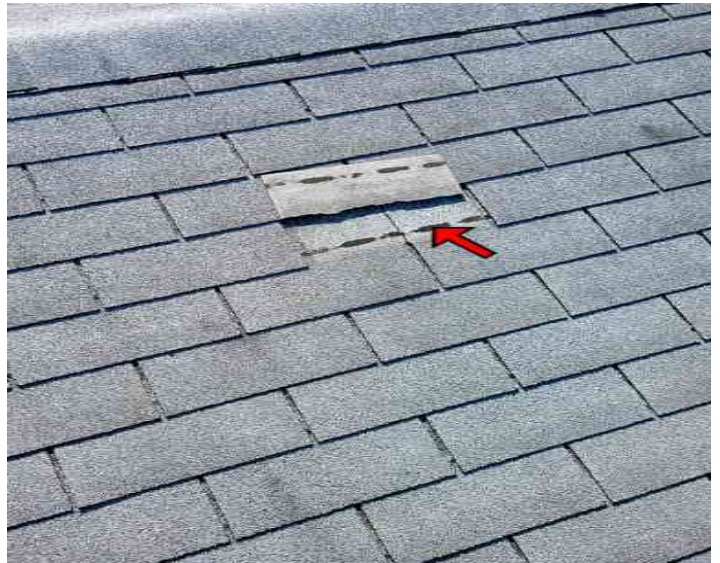
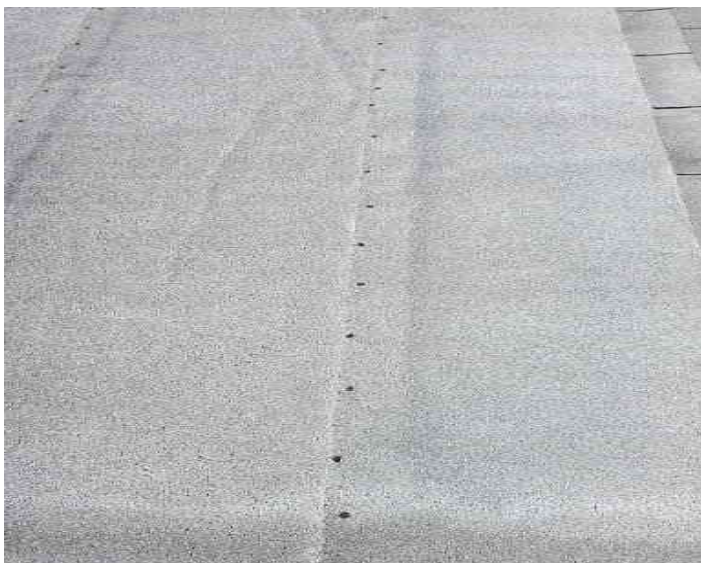
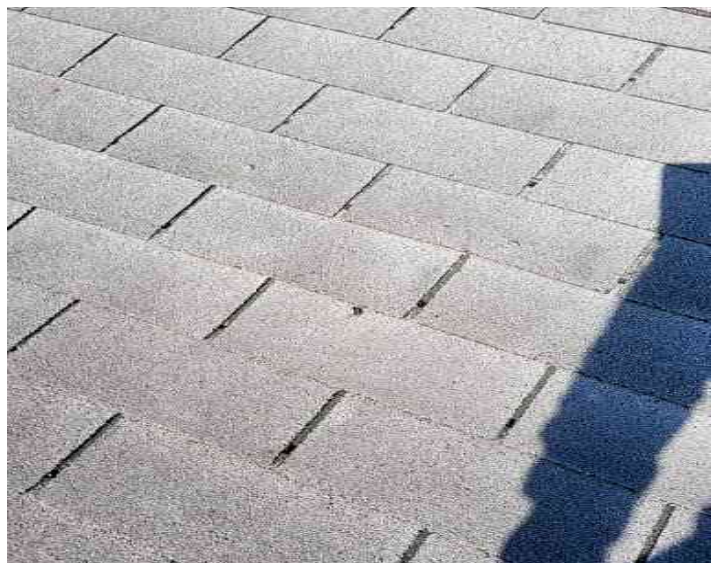
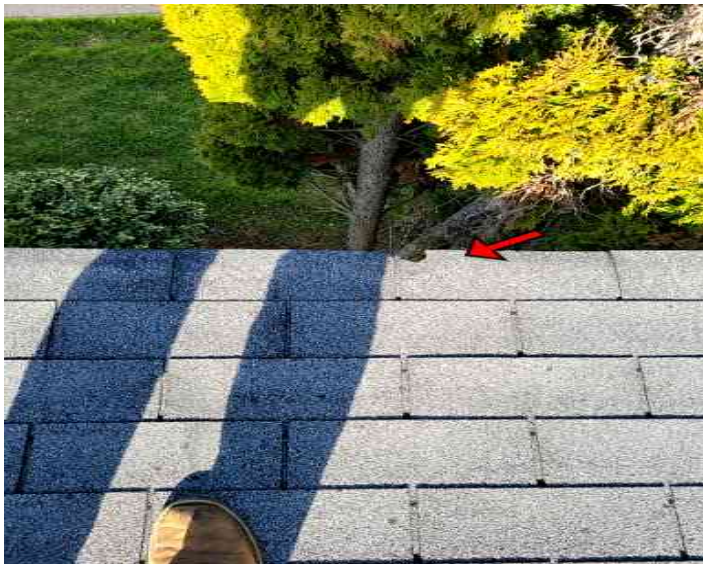
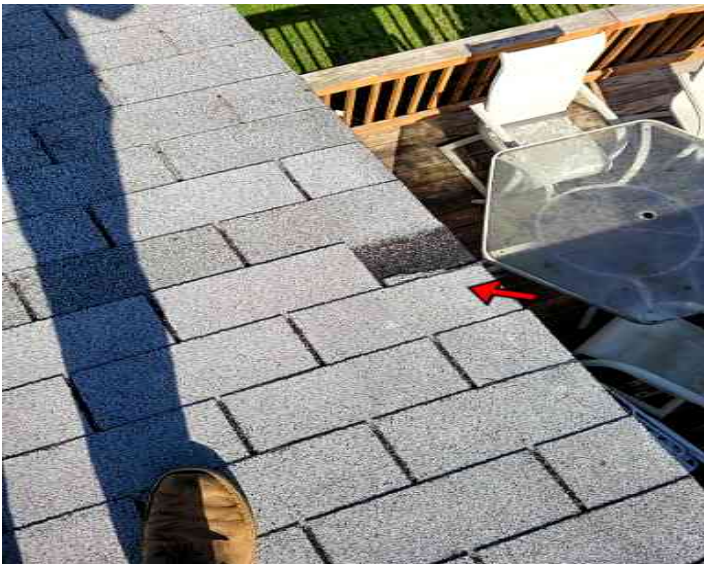
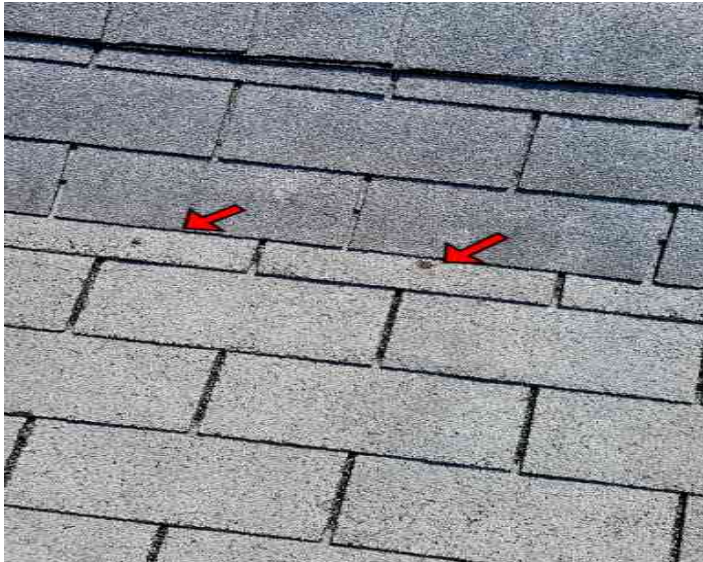
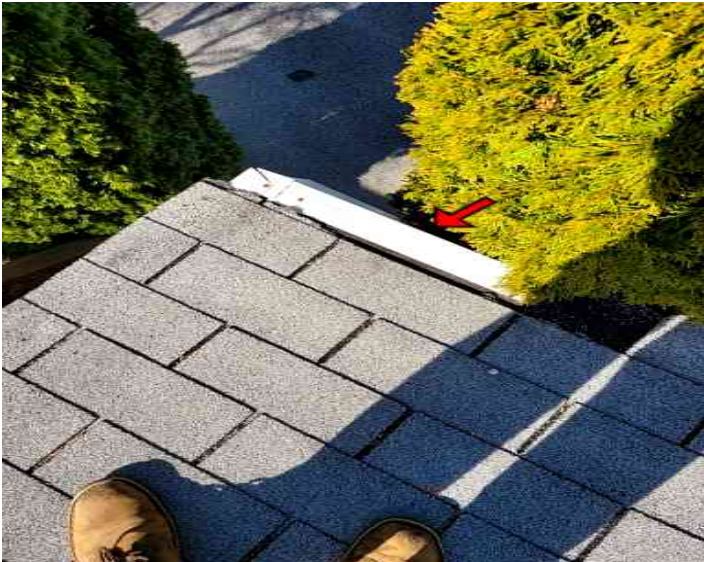
0505 Roof Covering Primary Type

Missing shingle tabs were noted and should be repaired.
Nail heads should be sealed where exposed
Poorly installed areas were noted. Loose fitting areas were noted
Soft area was noted at the roof edge.
The entire roof system should be evaluated by a qualified roofing contractor and all needed repairs should be made

Missing shingle tabs were noted and should be repaired. Nail heads should be sealed where exposed. Poorly installed areas were noted. Loose fitting areas were noted. Soft area was noted at the roof edge. The entire roof system should be evaluated by a qualified roofing contractor and all needed repairs should be made.

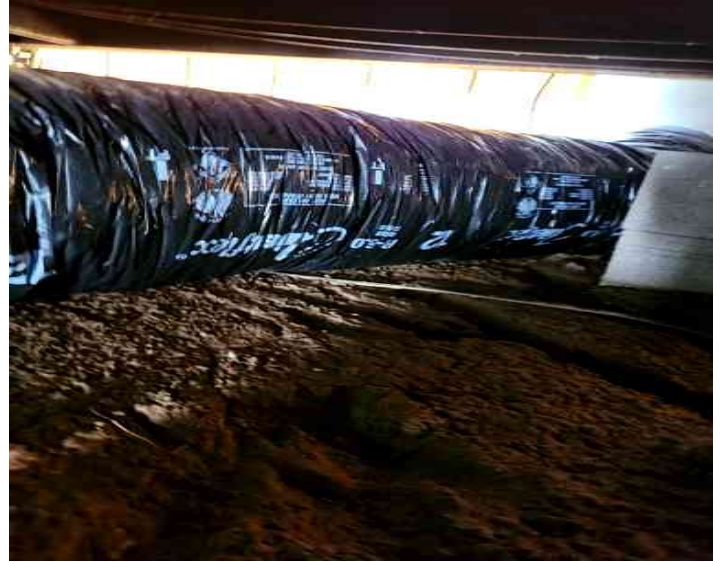
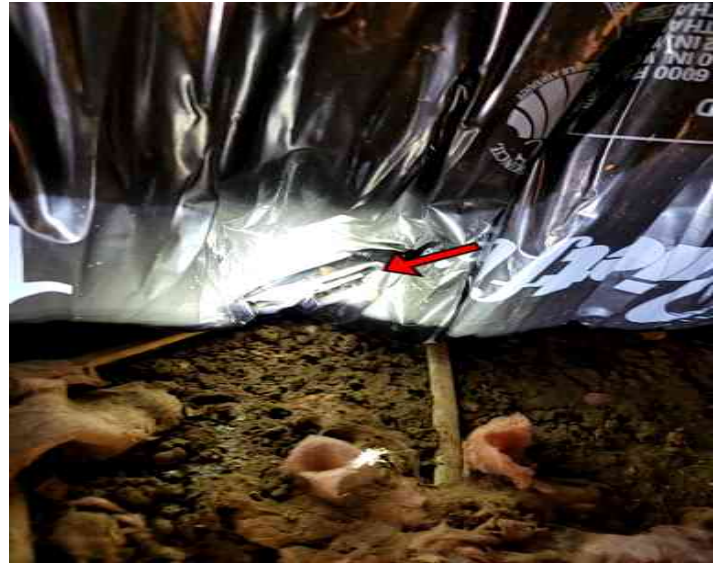
1311: Distribution System Material

Some duct work lying on the crawl space floor was water soaked and should be replaced.

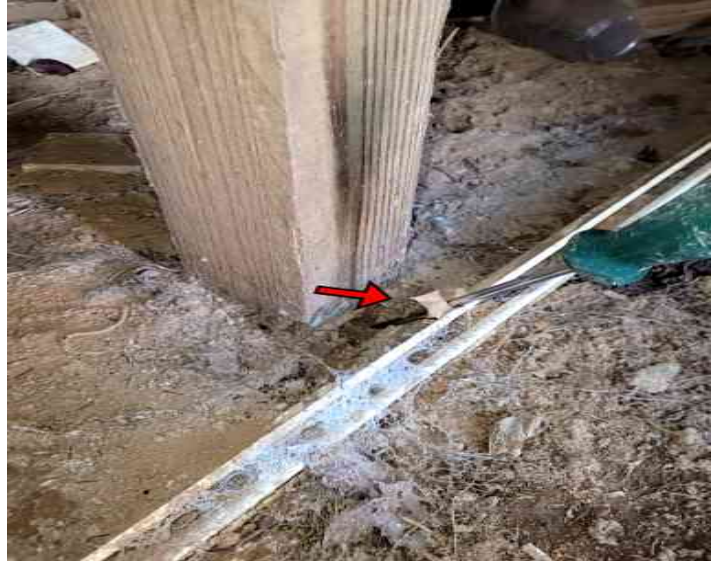
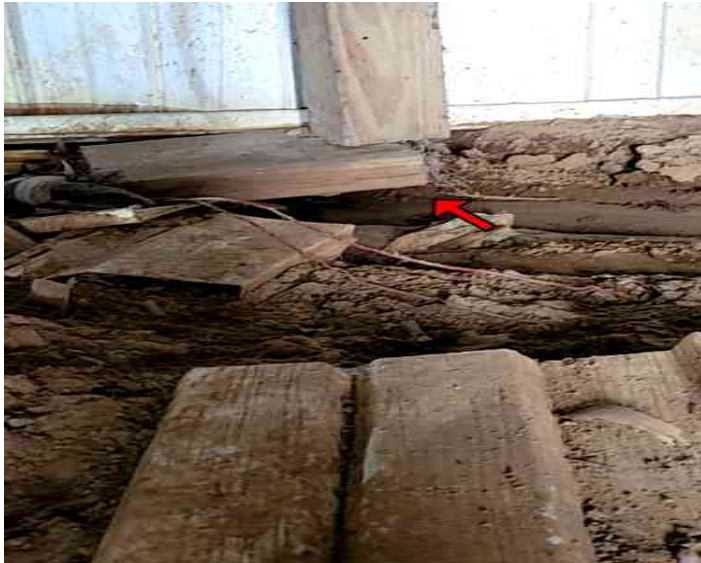
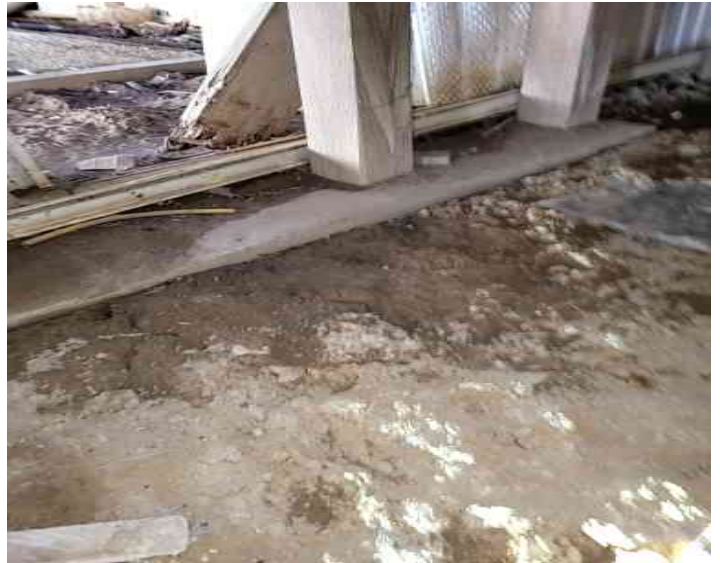
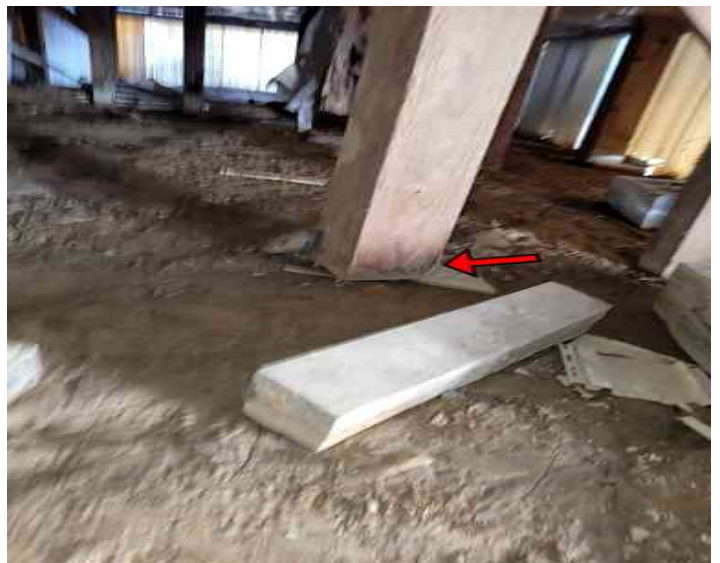
1606: Crawl Space Structural Columns

The wood piers were not supported properly . The entire structural condition should be evaluated by structural contractor or engineer and all needed repairs should be made.

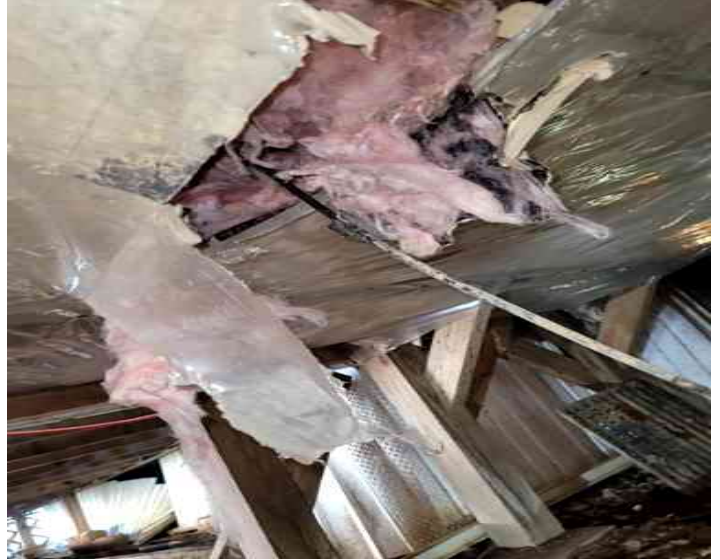
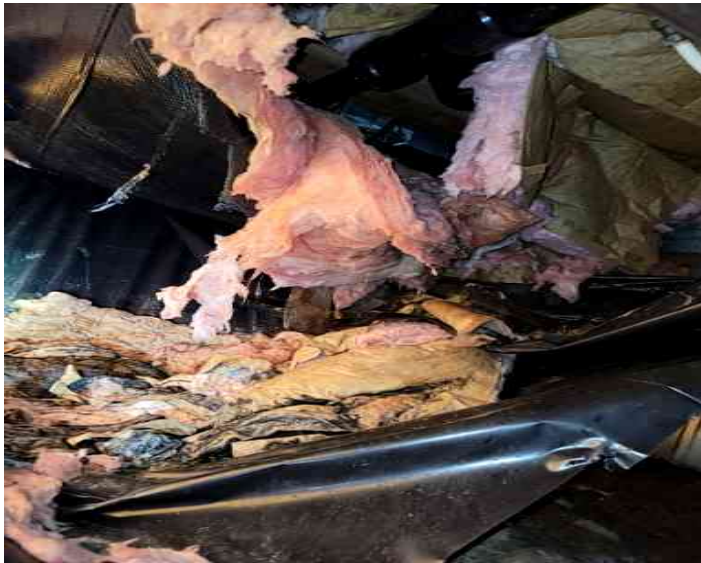
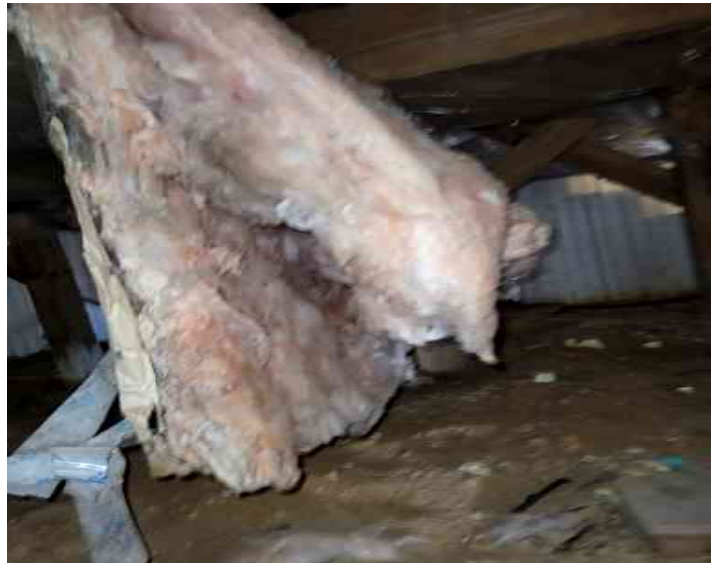
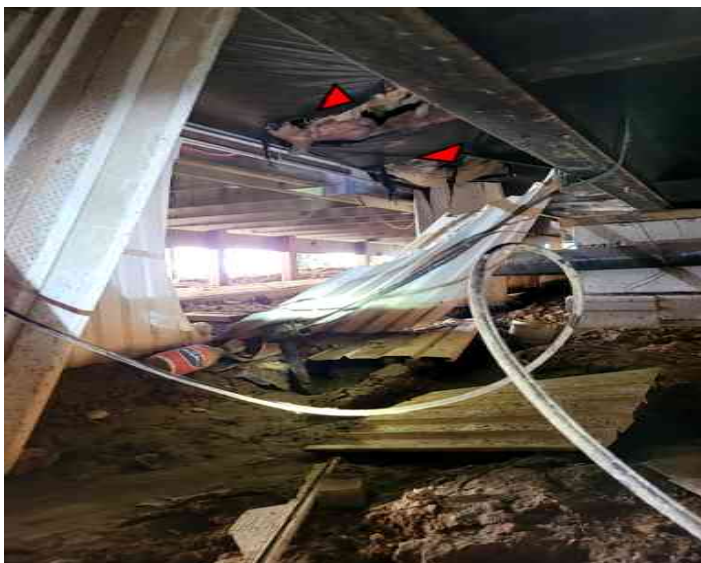
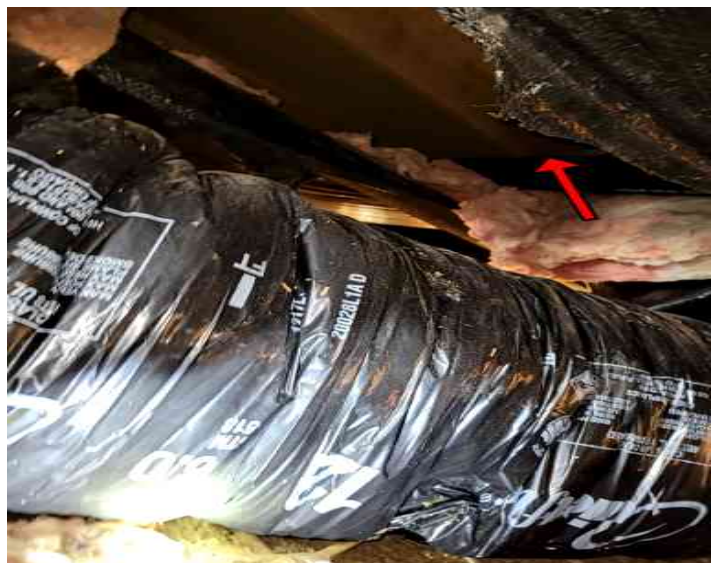
1610: Crawl Space Insulation

Other = Bladder insulation.
Insulation limits inspection of crawl space
Tears in bottom covering of home expose insulation
and should be repaired
All should be evaluated and all needed repairs should
be made
Some mildew was noted on the insulation .

Other Bladder insulation Insulation limits inspection of crawl space Tears in bottom covering of home expose insulation and should be repaired. All should be evaluated and all needed repairs should be made. Some mildew was noted on the insulation

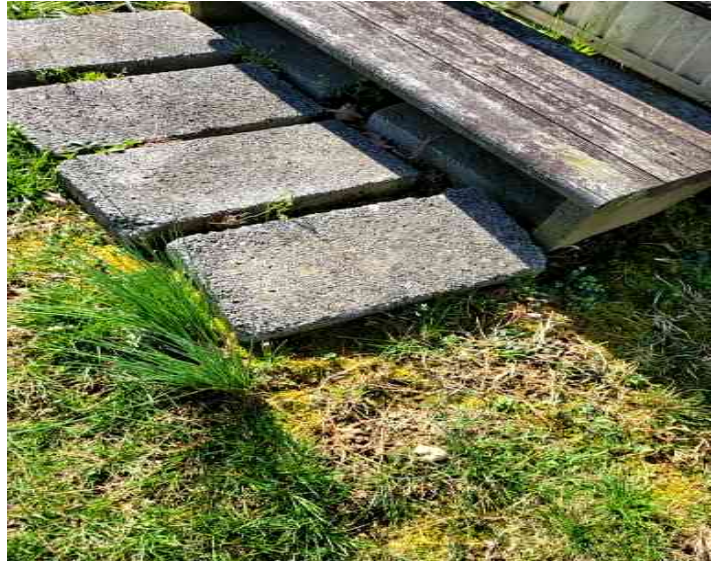
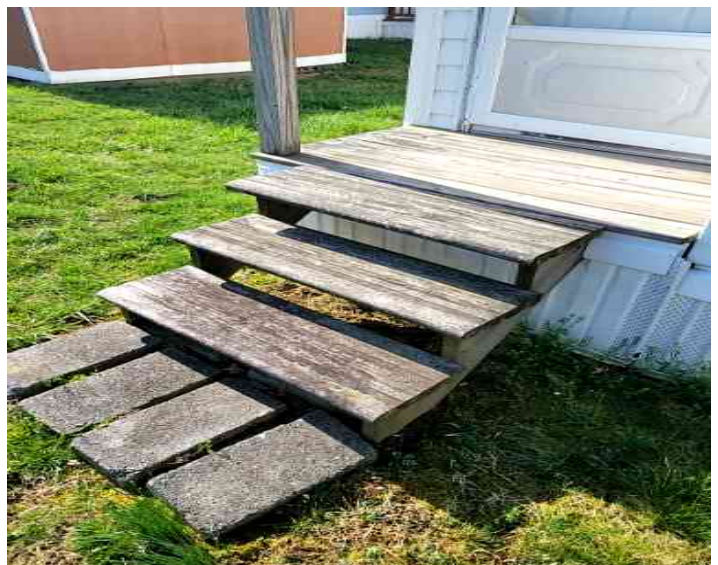
0204: Steps

Poorly supported rear steps and should be repaired.
Missing railing was noted and should be repaired.

Poorly supported rear steps and should be repaired. Missing railing was noted and should be repaired.

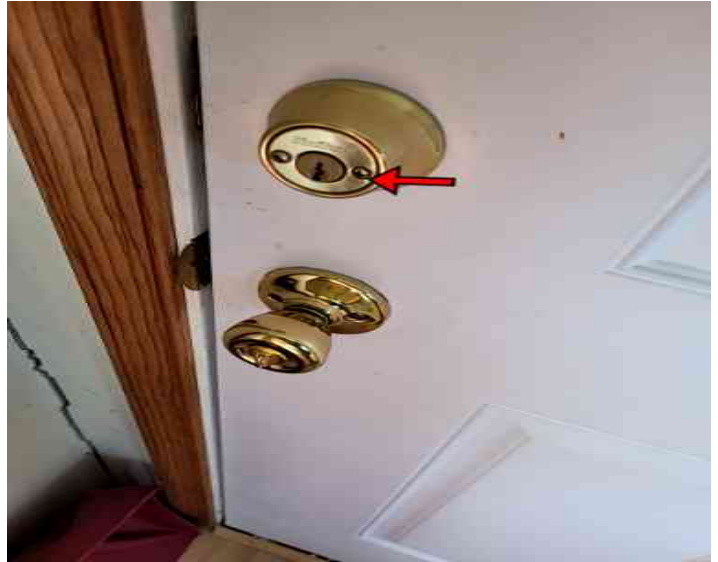
0311: Entry Doors

The key type dead bolt should be replaced with a knob type for ease of escape in the event of fire.
Back door sticks.

The key type dead bolt should be replaced with a knob type for ease of escape in the event of fire. Back door sticks

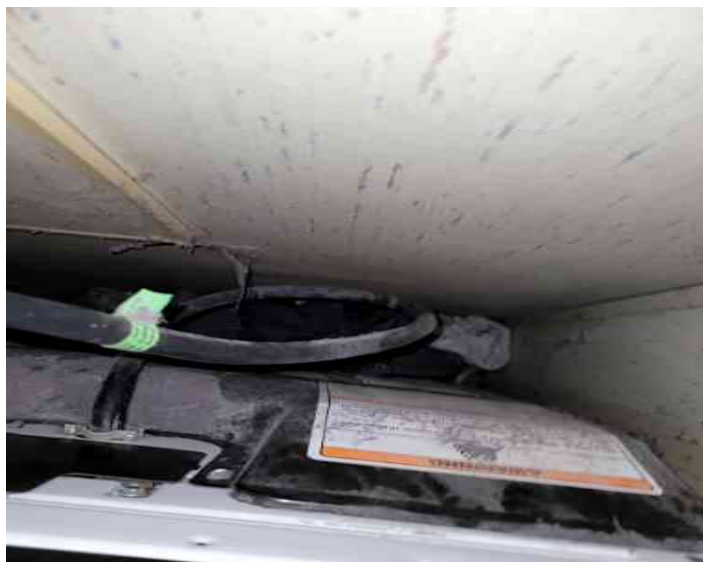
1208 Dryer Vented

Lint leakage was noted and vent should be better sealed.

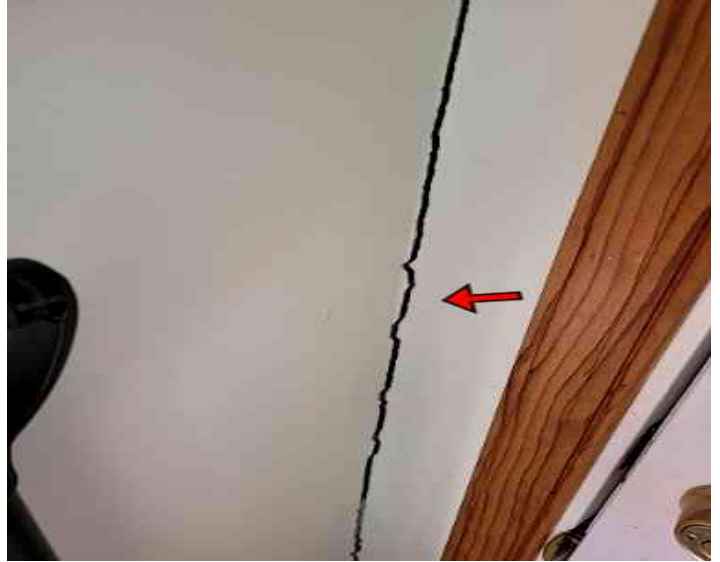
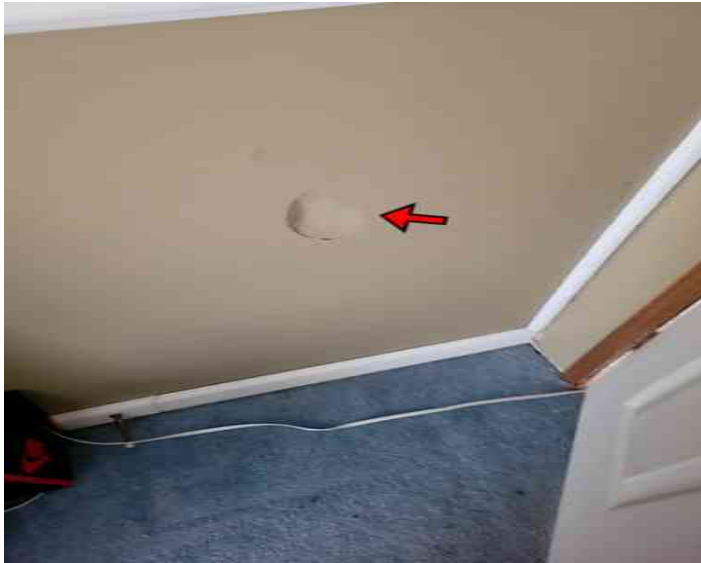
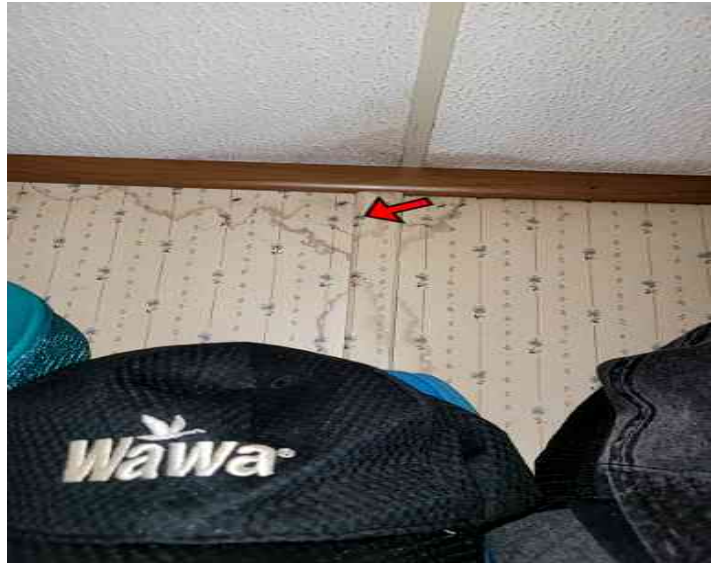
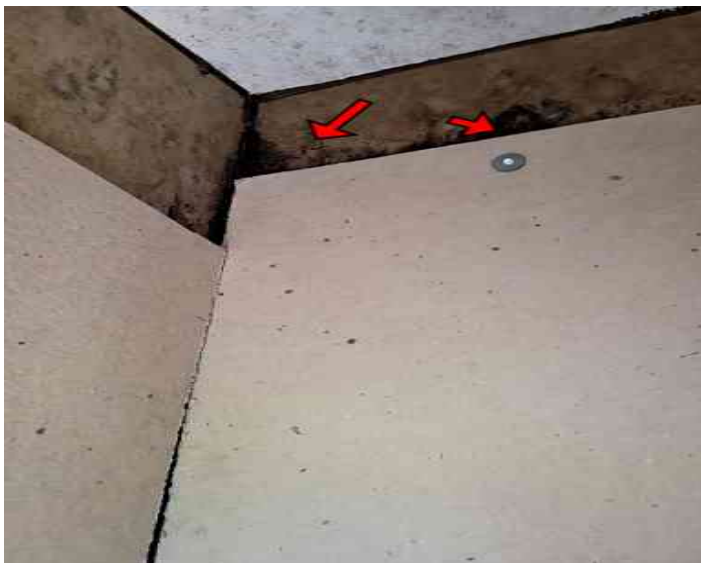
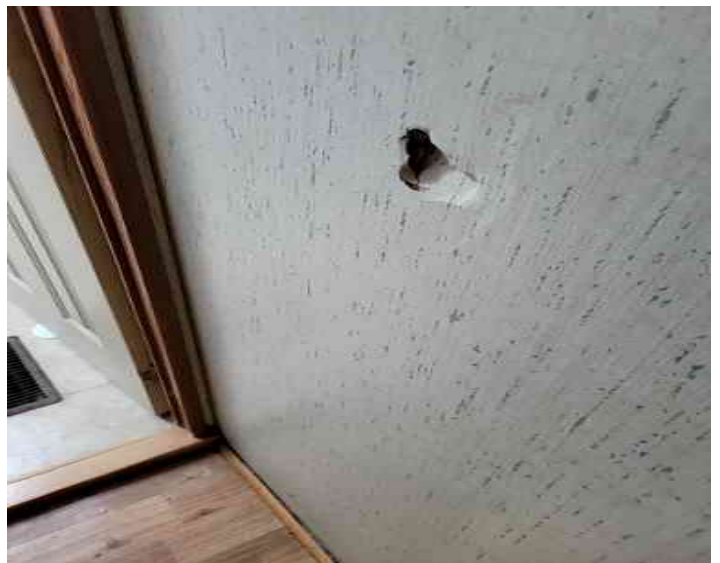
2104: Interior Walls

Typical drywall flaws were noted.
Some cracks were noted.
Damage was noted and should be repaired.
Stains were noted and were dry at inspection.
Some mold/mildew was noted on lower level of wall and should be cleaned by qualified personnel. As mold and mildew are not part of the home inspection the client may decide to do further evaluation to determine the extent of the problem and cost of cleanup/repair.

Typical drywall flaws were noted. Some cracks were noted. Damage was noted and should be repaired. Stains were noted and were dry at inspection. Some mold/mildew was noted on lower level of wall and should be cleaned by qualified personnel. As mold and mildew are not part of the home inspection the client may decide to do further evaluation to determine the extent of the problem and cost of cleanup/repair.

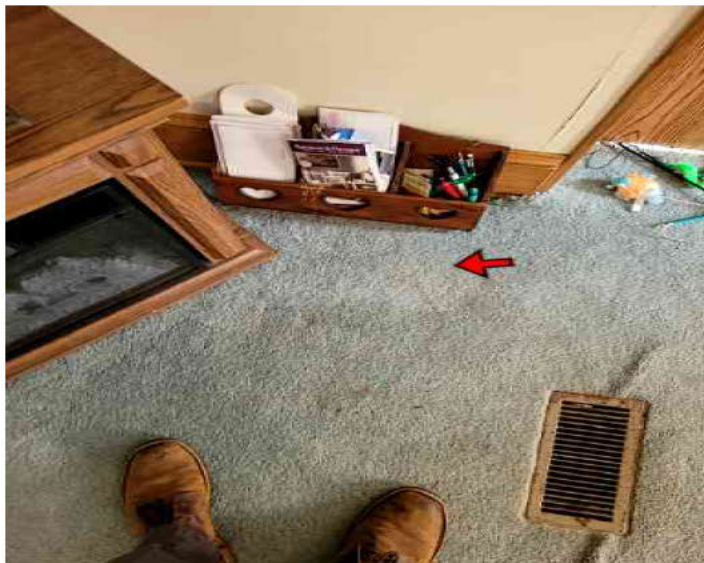
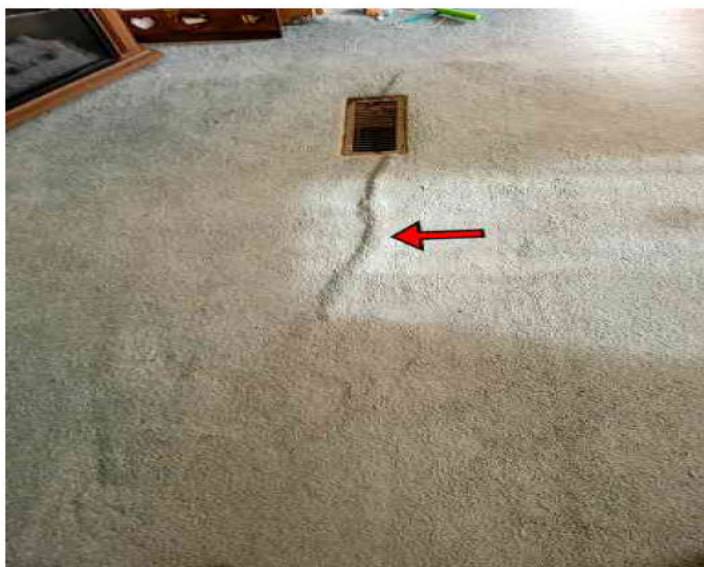
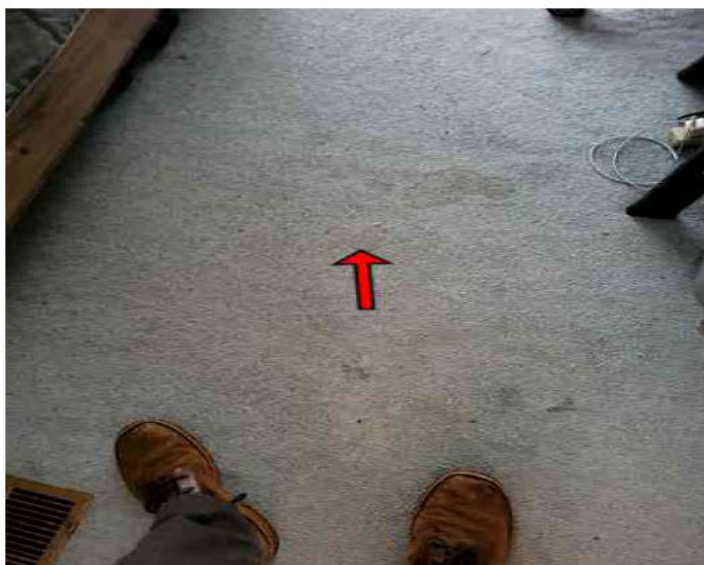
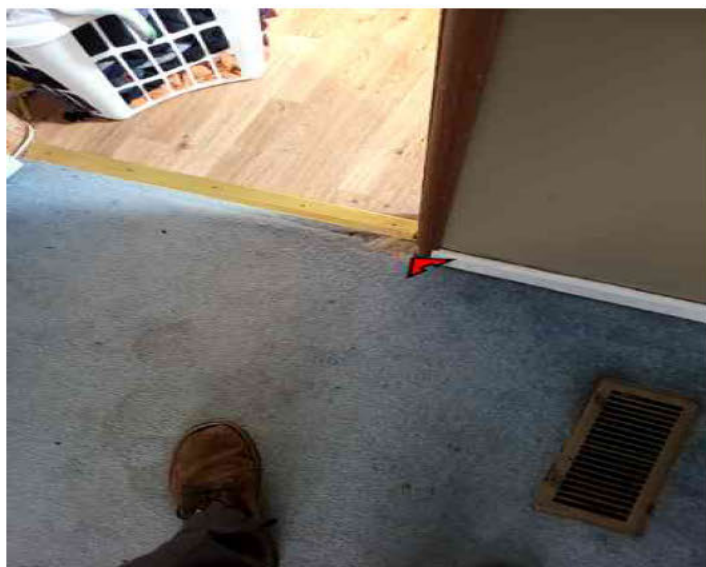
2106: Interior Floors

Damage carpet was noted and should be repaired. Uneven areas were noted and should be repaired. Living room and front bedroom. Some loose carpet noted and could cause a tripping hazard and should be repaired.

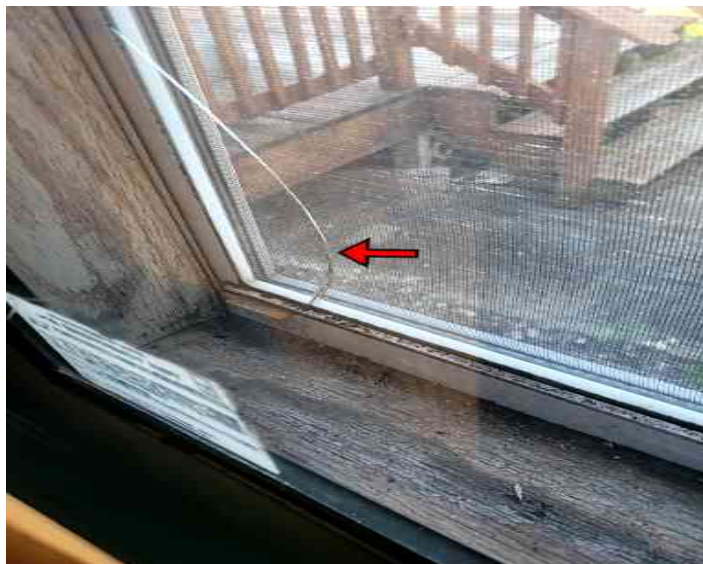
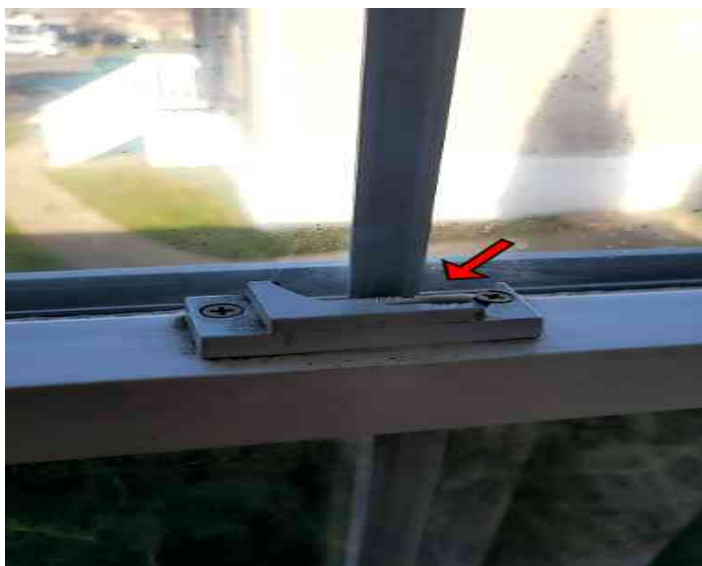
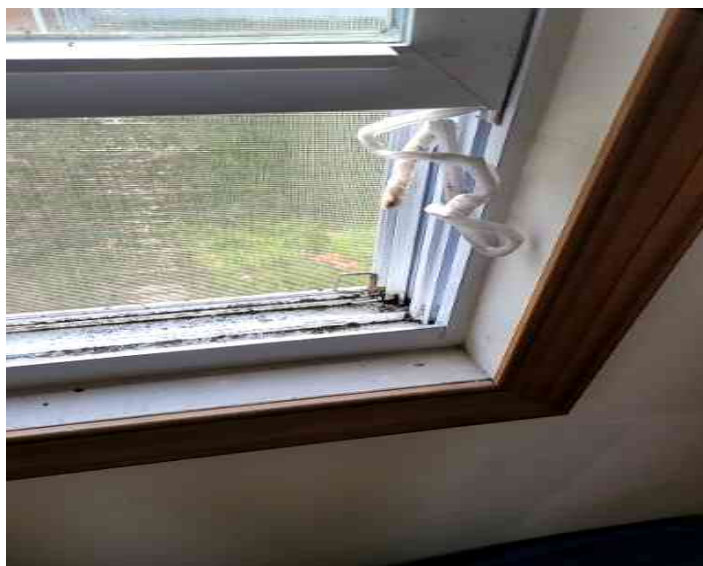
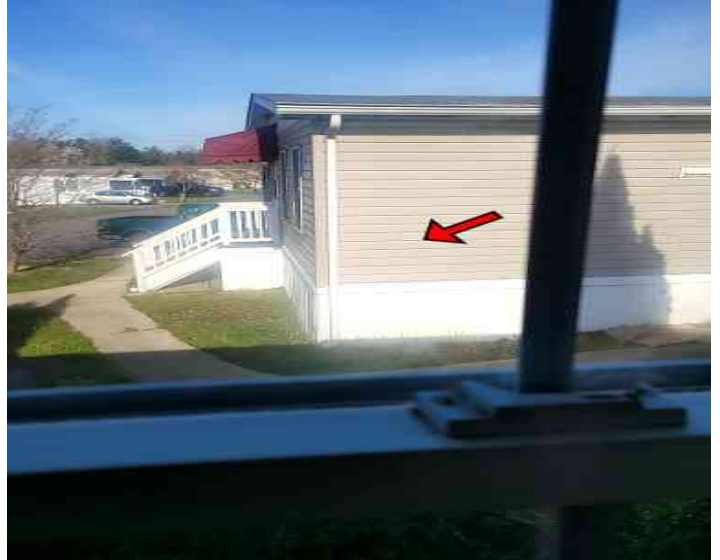
2122: Windows

Cracked glass was noted at the master bedroom and should be repaired.

Damage weather stripping was noted and should be repaired.

Missing lock was noted and should be repaired.

(addition window.)

Condensation was noted between insulated window panes and should be repaired. (Addition window)

Cracked glass was noted at the master bedroom and should be repaired. Damage weather stripping was noted and should be repaired. Missing lock was noted and should be repaired. (addition window.) Condensation was noted between insulated window panes and should be repaired. (Addition window)

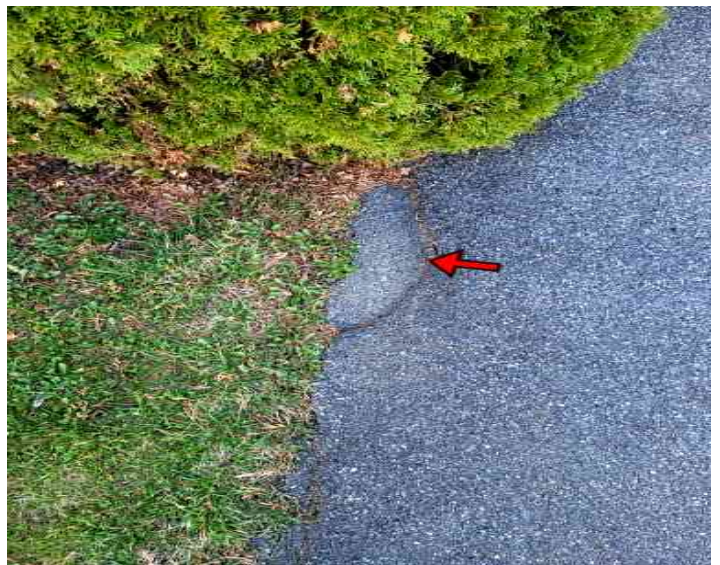
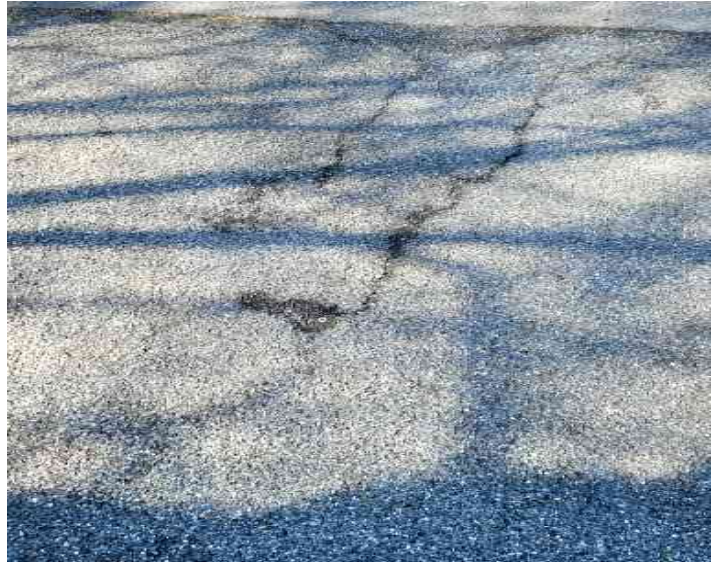
0208: Driveway/Parking Lot

Some cracks noted.

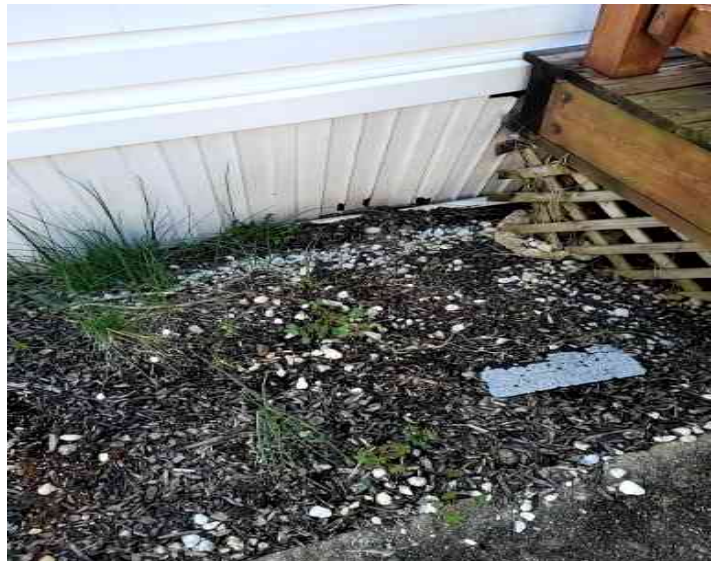
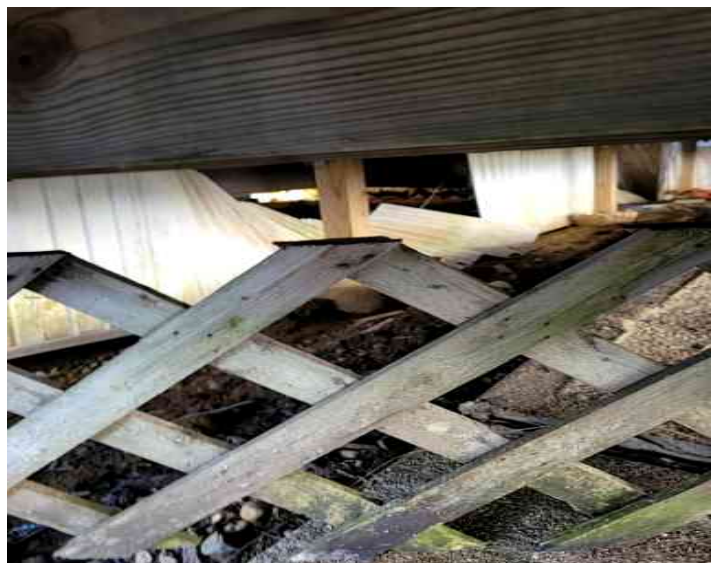
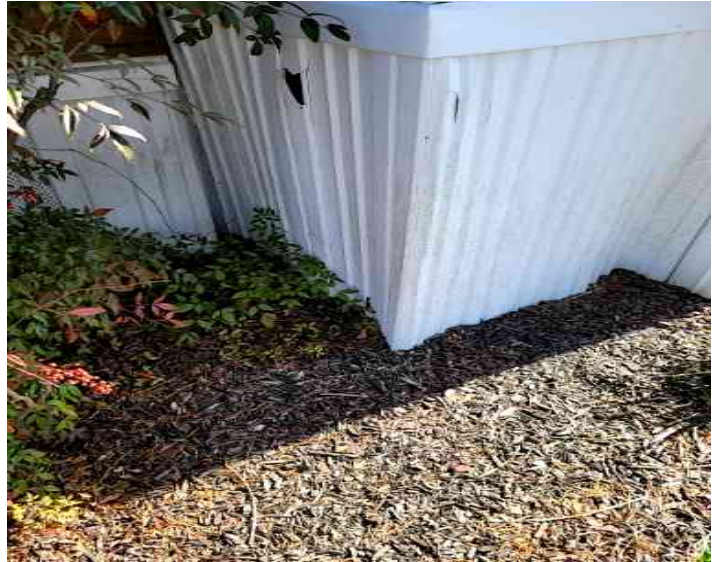
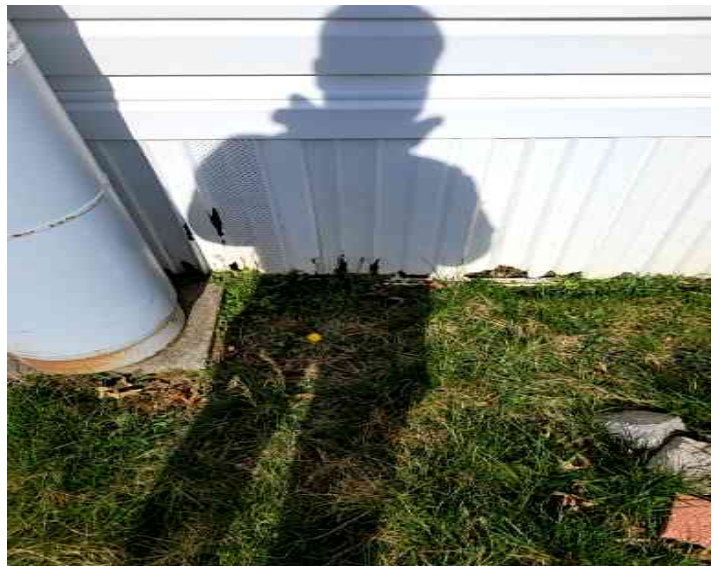
0304: Exposed Foundation Primary Visible Type

Other = Skirting.

Missing sections were noted and should be replaced
Damaged skirting was noted and should be repaired to
prevent vermin/rodents from entering the crawl space

Other = Skirting. Missing sections were noted and should be replaced. Damaged skirting was noted and should be repaired to prevent vermin/rodents from entering the crawl space
