Reliable Home Inspection Service
100 Old Kennett Rd
Wilmington, DE 19807
302-993-9100
<https://www.reliablehomeinspectionsservice.com/>

FRONT VIEW

Inspection Summary

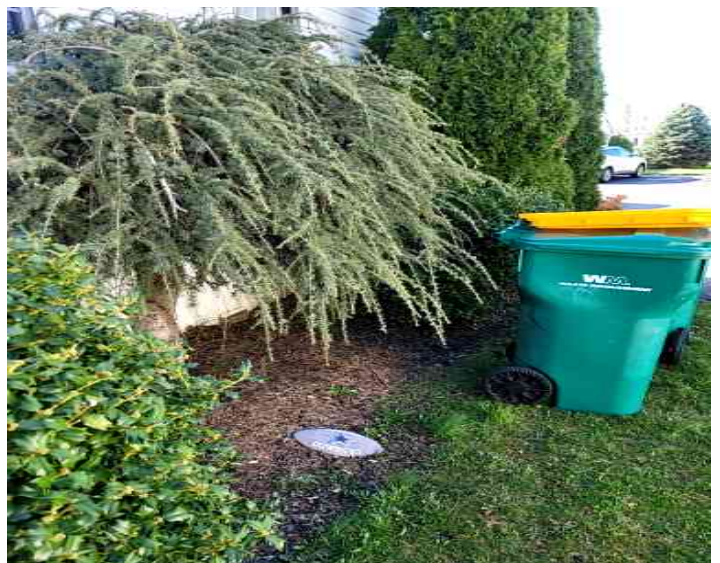
0307: Grading

Soil should be sloped away from house to improve drainage.
Plantings were noted too close to house and should be removed.

Soil should be sloped away from house to improve drainage. Plantings were noted too close to house and should be removed.

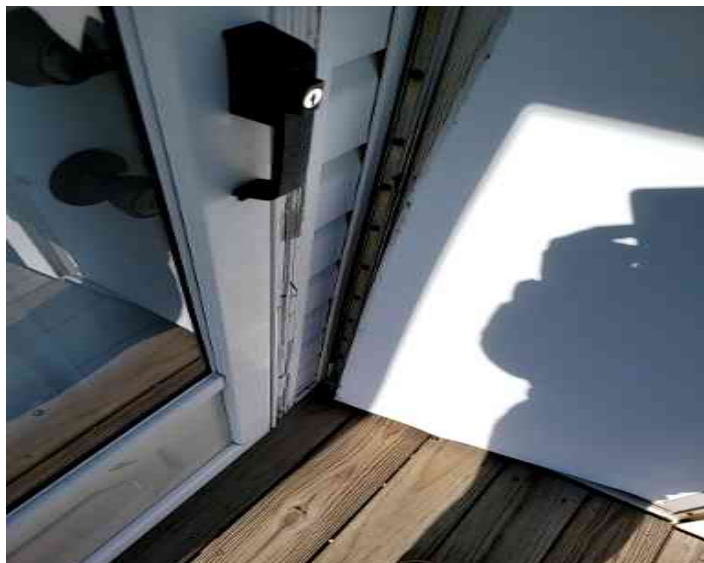
0308: Siding

Some dents noted.

Some dents noted

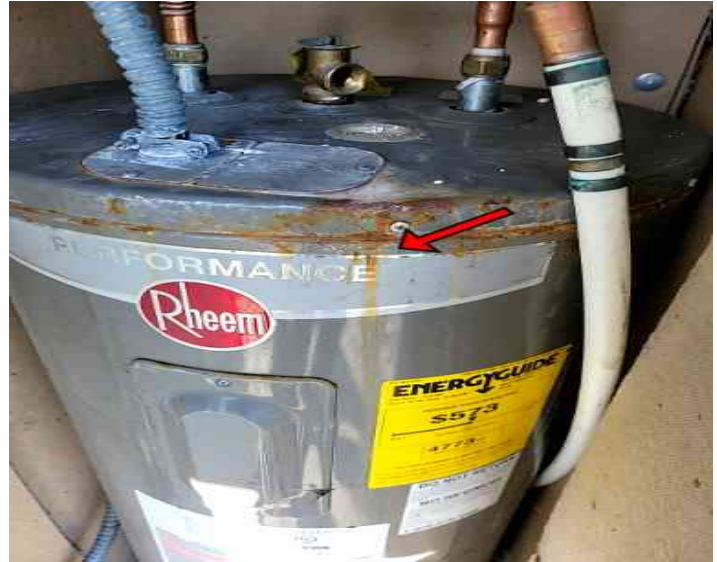
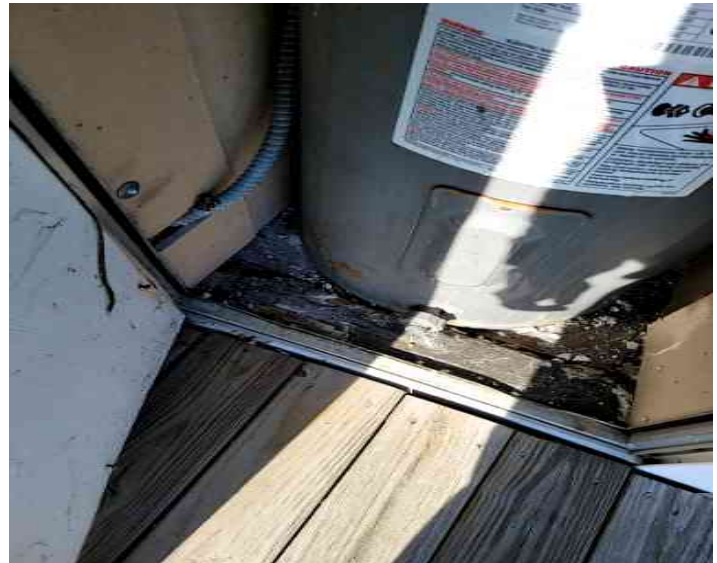
1113: Water Heater Exterior Jacket

Rust noted on the exterior of the Water Heater

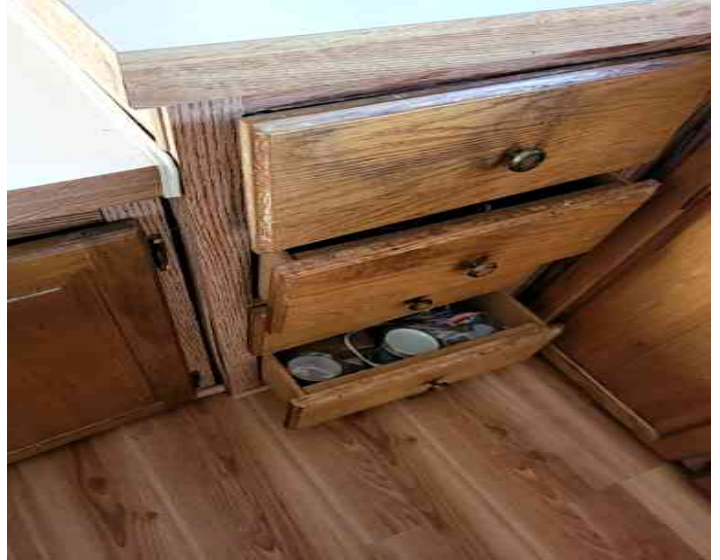
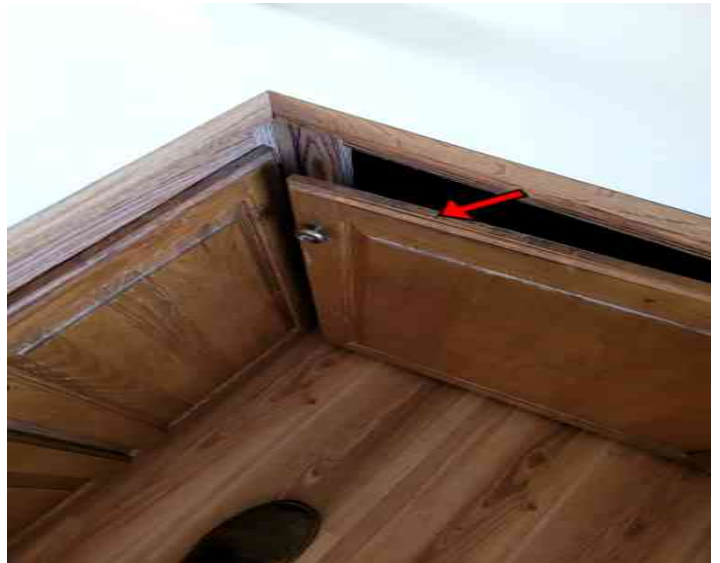
1708: Kitchen Cabinets

Damaged drawers and guides were noted and should be repaired.

Some doors would not stay closed.

Damaged drawers and guides were noted and should be repaired. Some doors would not stay closed.

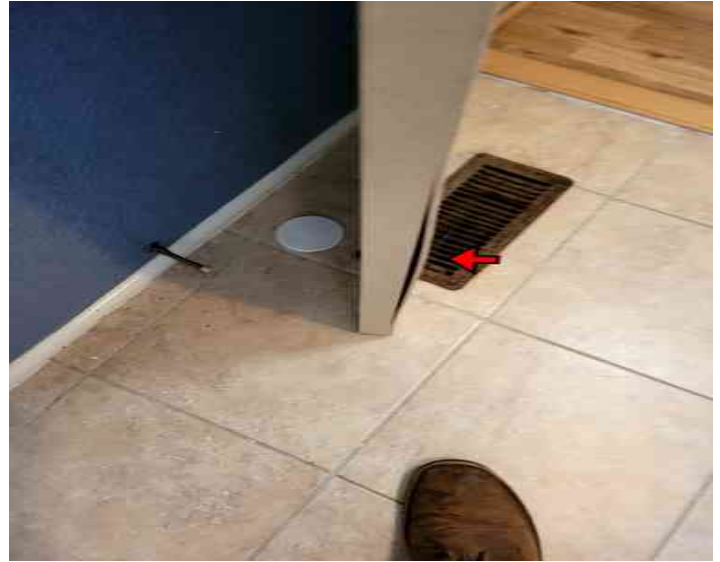
1902: Bathroom Doors, Windows

Master bathroom door does not close properly and should be repaired
Loose panel noted at the hallway bathroom door.

Master bathroom door does not close properly and should be repaired. Loose panel noted at the hallway bathroom door.

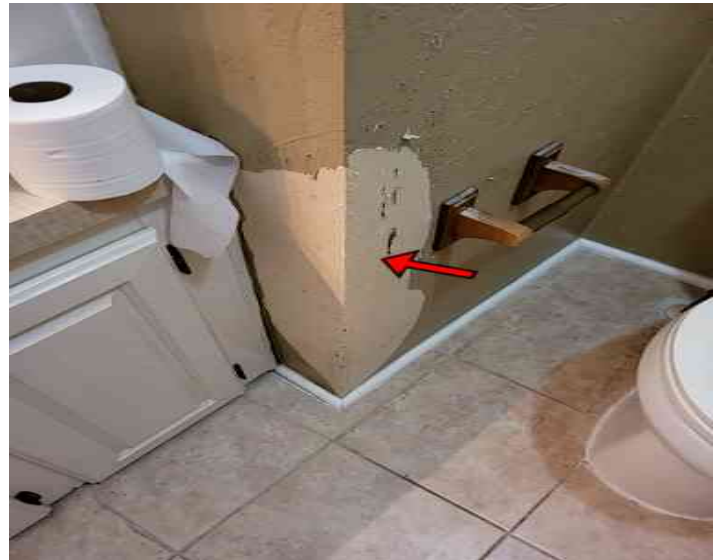
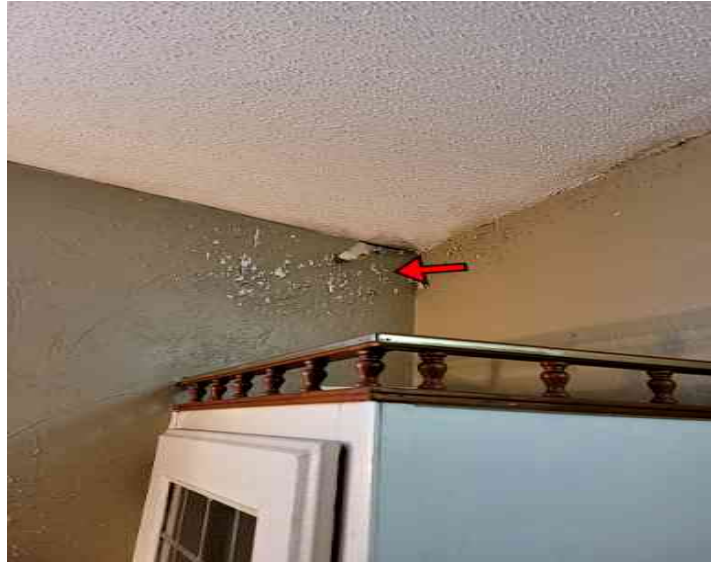
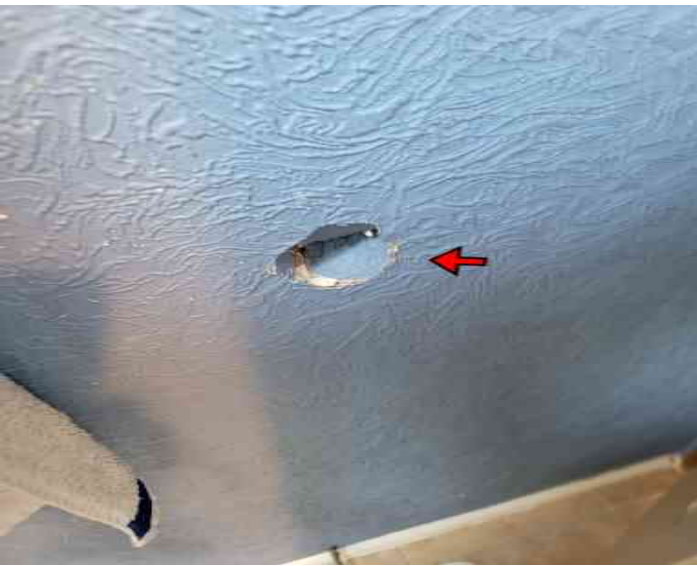
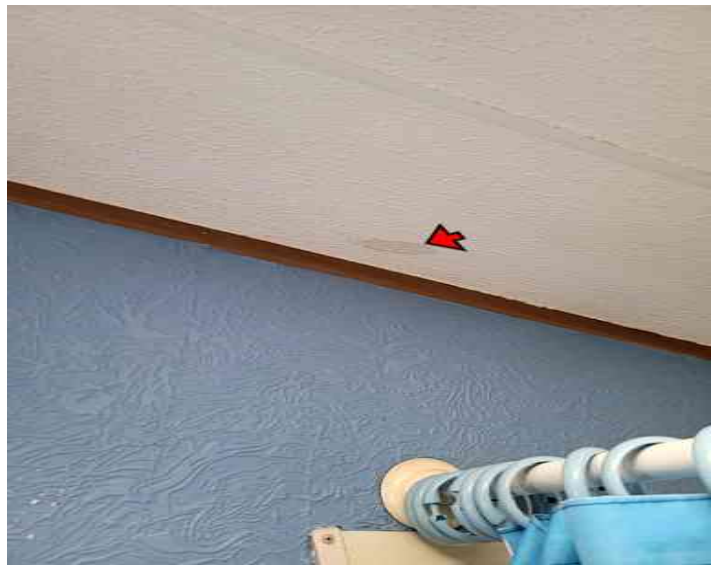
1905 Bathroom Walls and Ceilings

Some damage was noted and should be repaired
Stains were noted but were not wet at time of the inspection

Some damage was noted and should be repaired. Stains were noted but were not wet at time of the inspection.

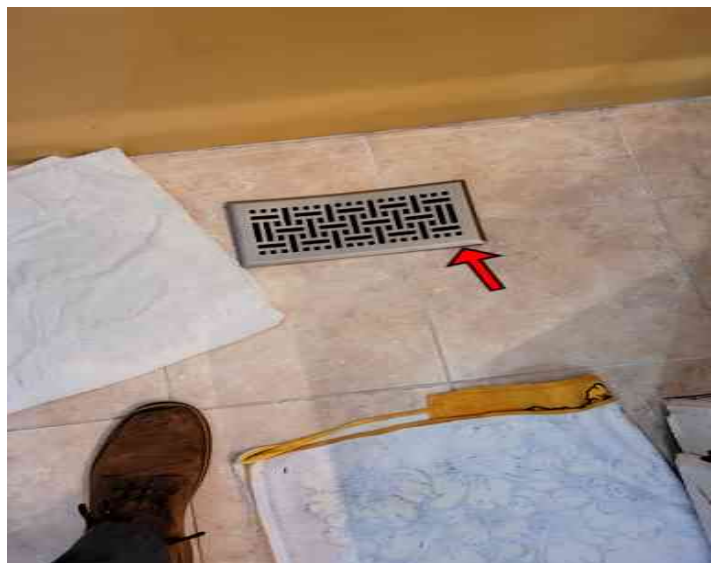
1907: Bathroom Heating Cooling

Loose fitting vent cover wad noted and should be repaired

Loose fitting vent cover was noted and should be repaired.

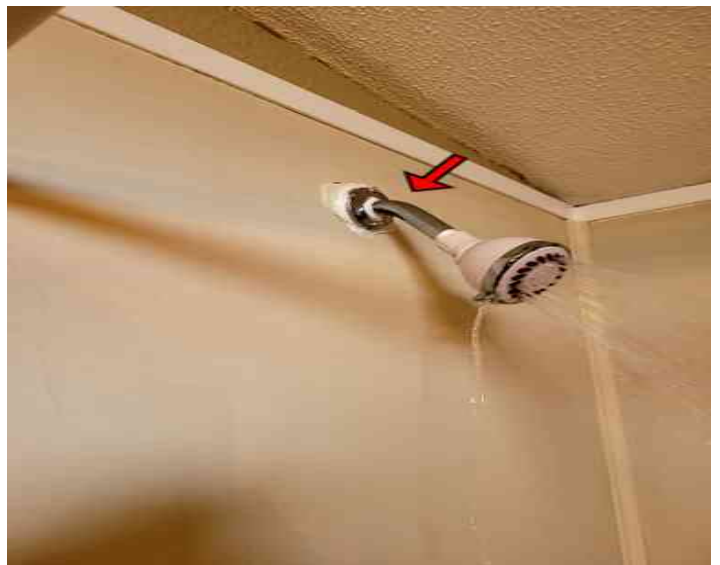
1916: Bath Showerhead

Shower head is loose where it meets the wall and should be repaired.

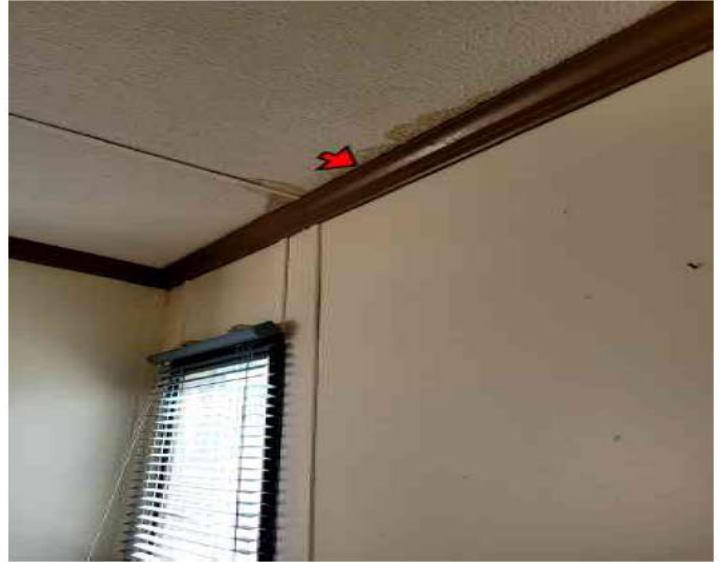
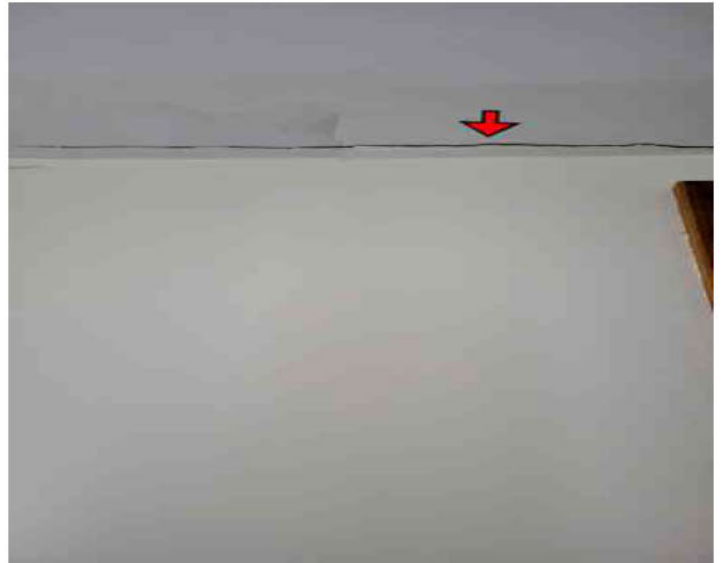
2105: Interior Ceilings

Typical drywall flaws were noted.
Water stains were noted but were not currently wet at the time of inspection.
Some cracks were noted.

Typical drywall flaws were noted. Water stains were noted but were not currently wet at the time of inspection. Some cracks were noted.

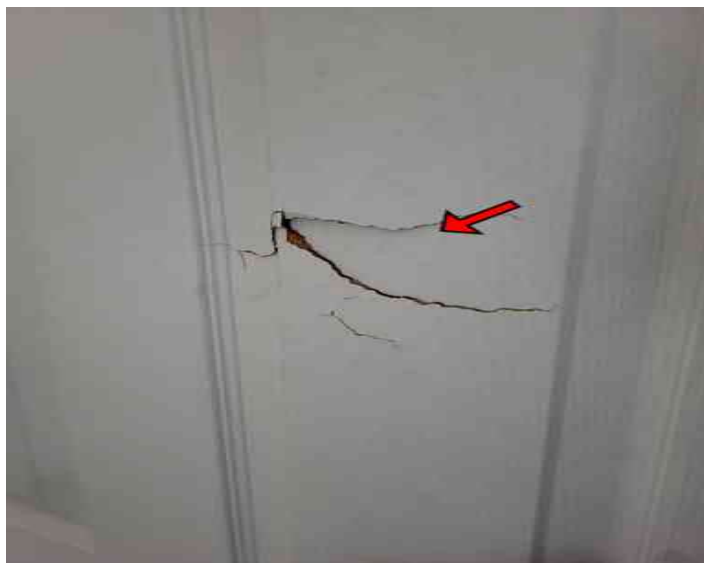
2116: Closets/ Interior Doors

Some doors are missing.
Damage to the front bedroom door
Front door does not close properly and should be repaired
Rear bedroom door does not stay open.

Some doors are missing. Damage to the front bedroom door. Front door does not close properly and should be repaired. Rear bedroom door does not stay open.

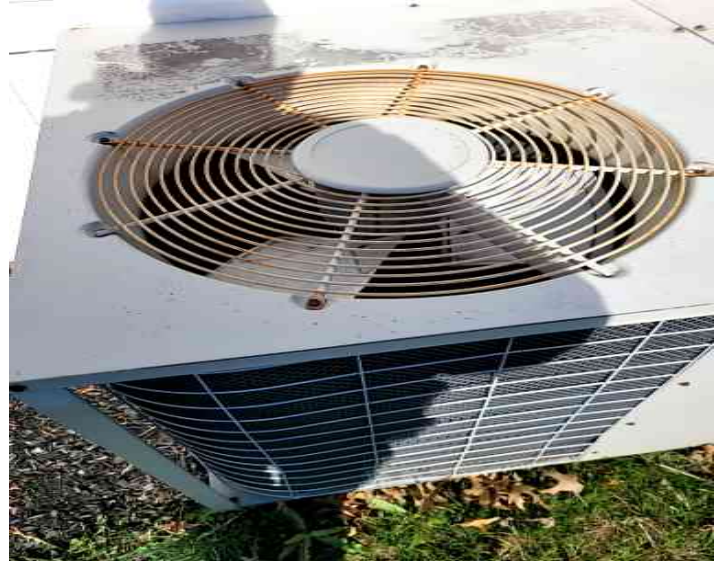
0706: Cooling System Coils and Fins

Some rust was noted on casings.
