Reliable Home Inspection Service
100 Old Kennett Rd
Wilmington, DE 19807
302-993-9100
[https //www reliablehomeinspectionsservice com/](https://www.reliablehomeinspectionsservice.com/)

FRONT VIEW

Inspection Summary

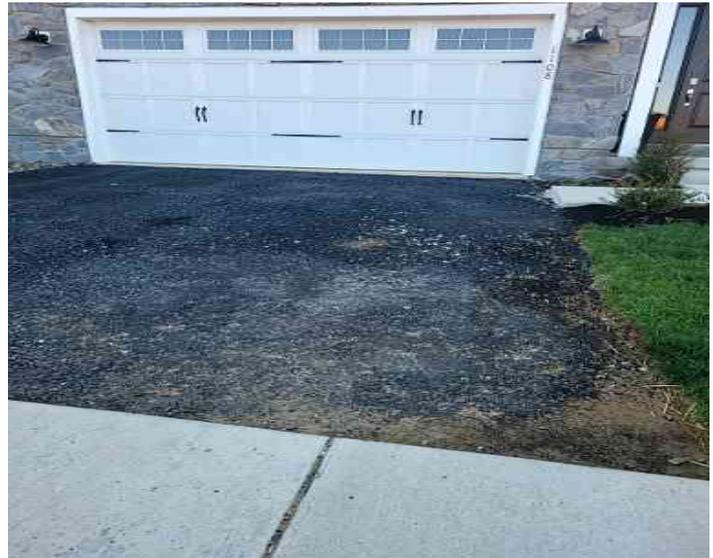
0208: Driveway/Parking Lot

Final coat was not installed at time of inspection.
Recommend to client to request documentation on completion date.

Final coat was not installed at time of inspection. Recommend to client to request documentation on completion date.

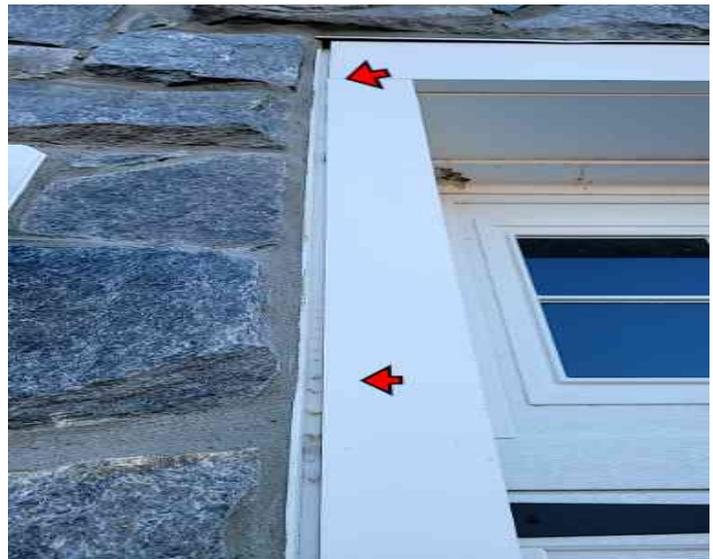
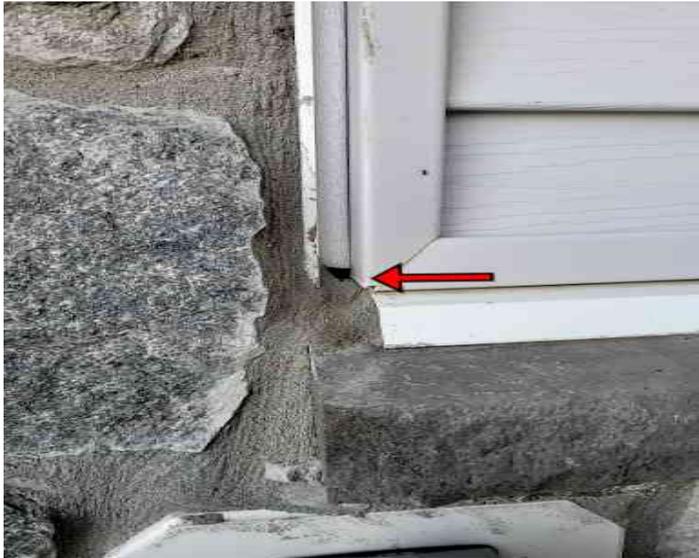
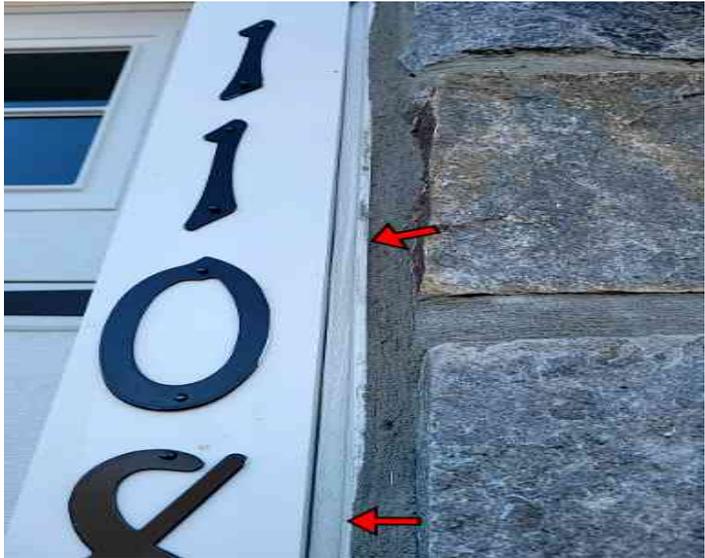
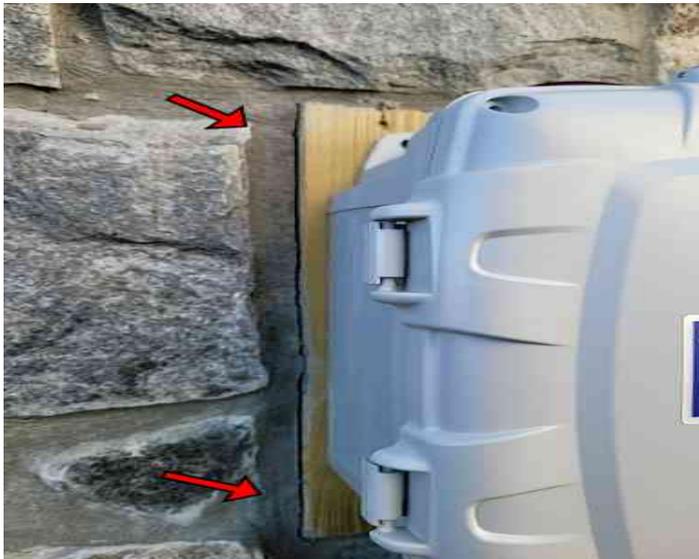
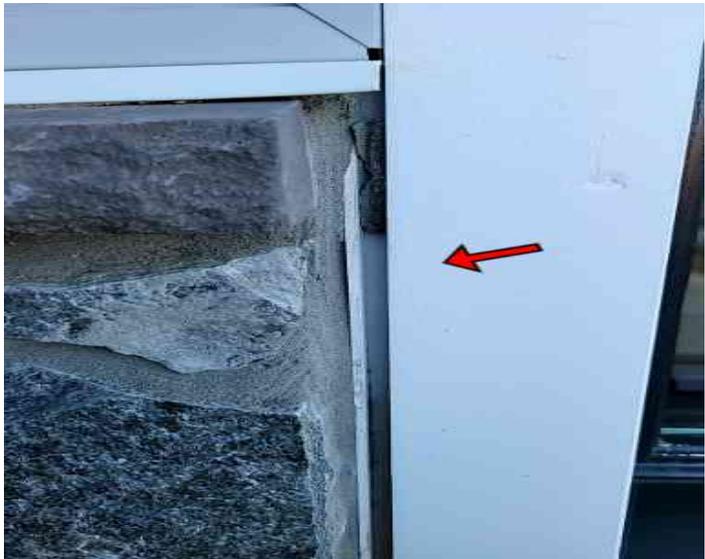
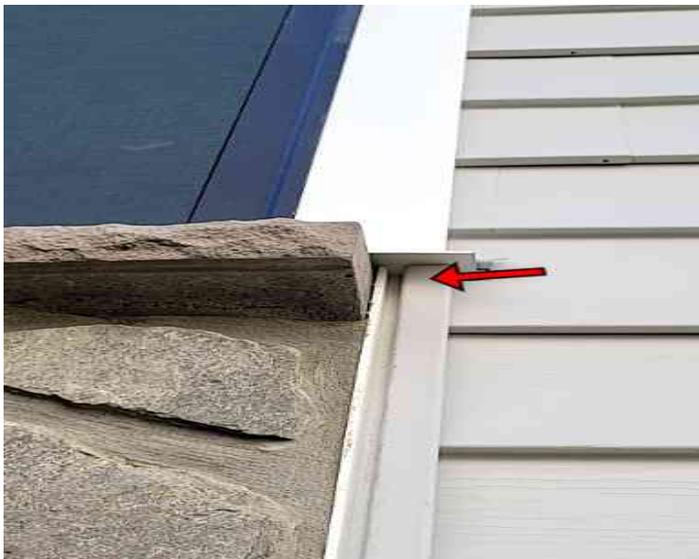
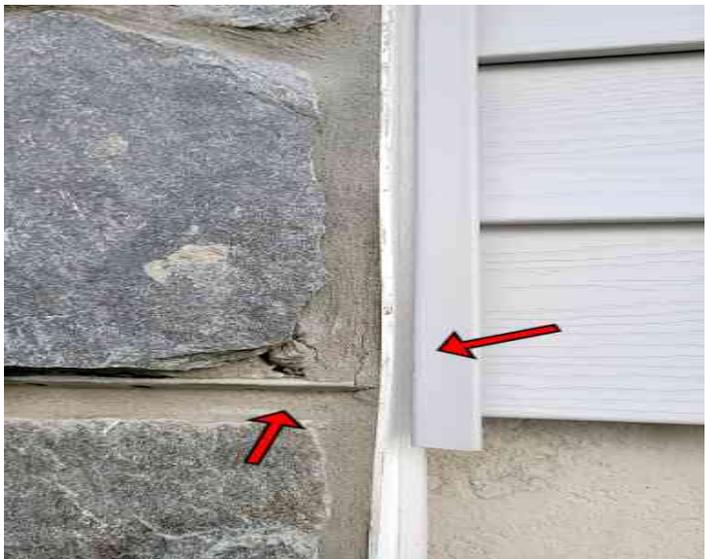
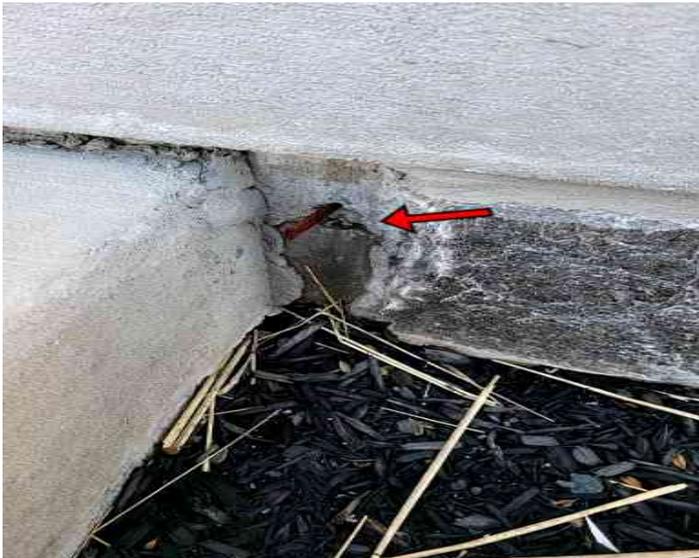
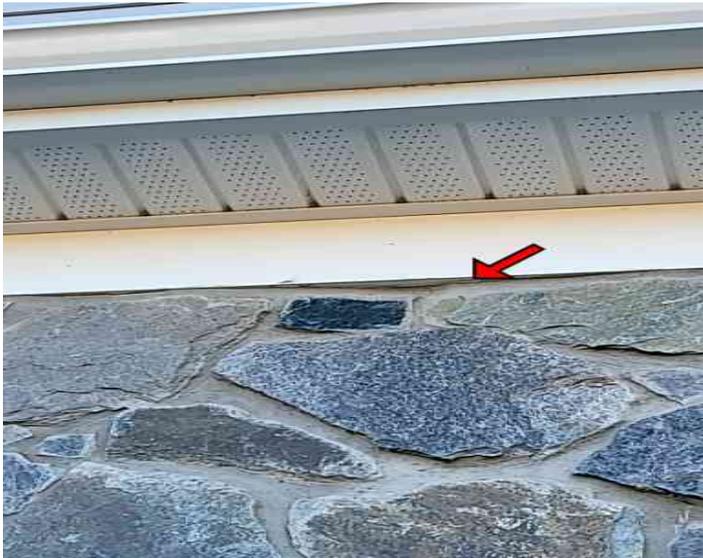
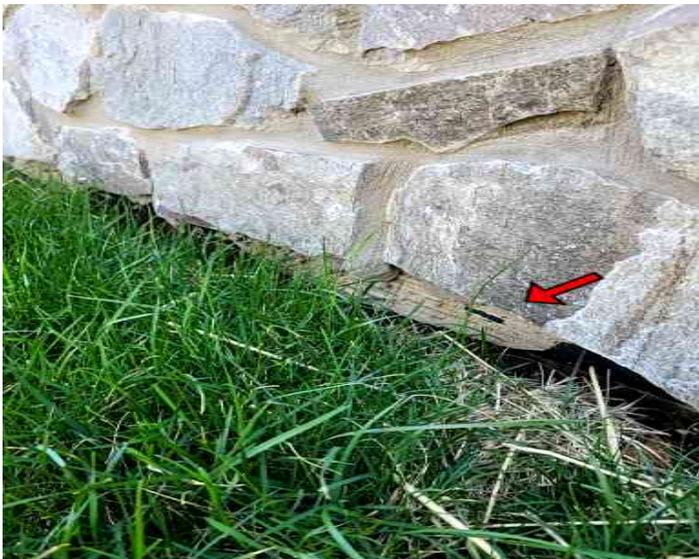
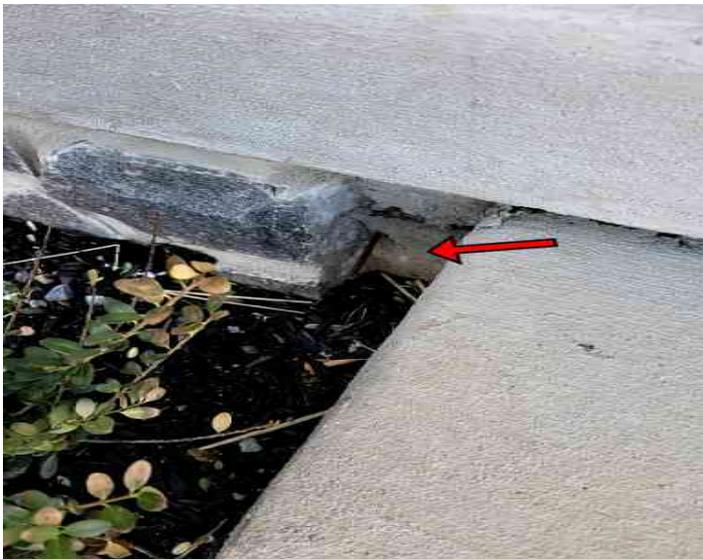
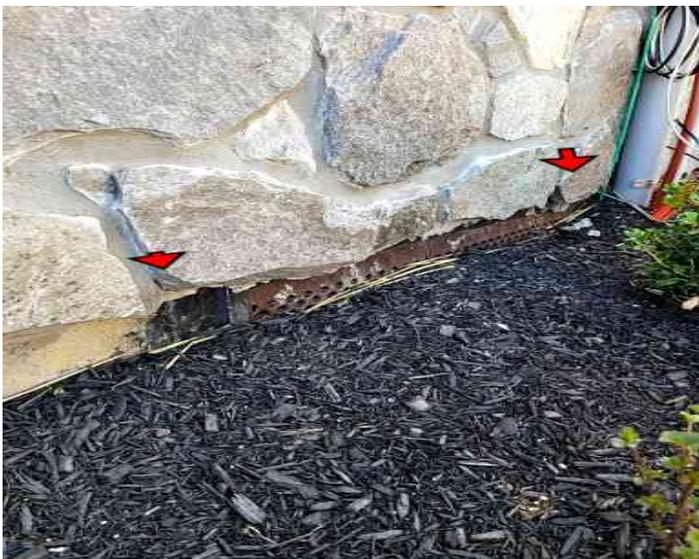
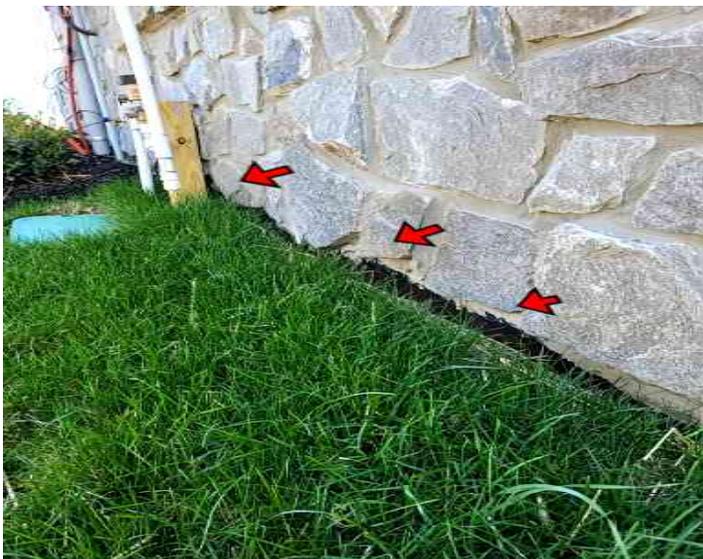
0309: Masonry Walls

Other= Faux stone.
Uncaulked casing bead noted. Some missing caulk joints noted. Some missing mortar was noted. All exterior walls should be evaluated by qualified contractor and all needed repairs made.

Other Faux stone Uncaulked casing bead noted Some missing caulk joints noted Some missing mortar was noted. All exterior walls should be evaluated by qualified contractor and all needed repairs made.

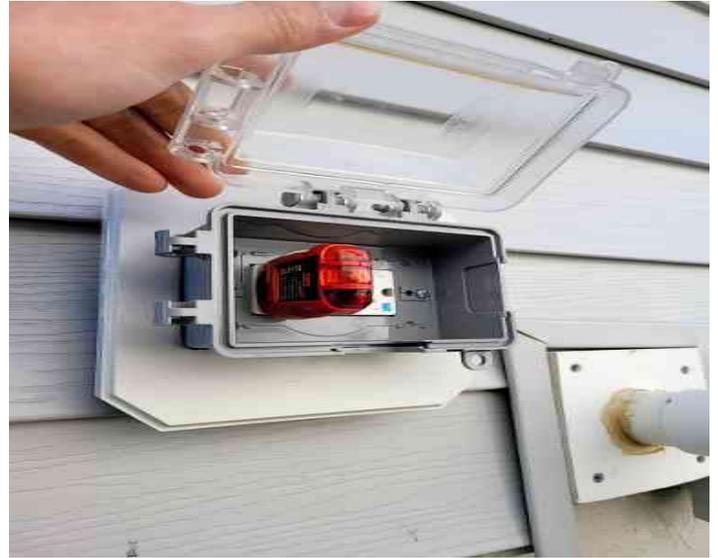
0302: Outside Outlets

The right elevation GFCI would not trip when tested and should be repaired

The right elevation GFCI would not trip when tested and should be repaired.

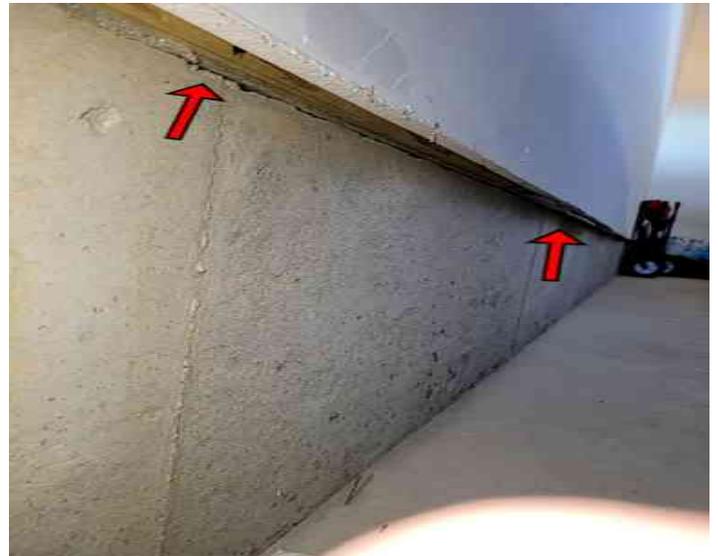
0811 Garage Interior Walls

All gaps and seams in fire rated walls should be sealed with fire rated materials.

All gaps and seams in fire rated walls should be sealed with fire rated materials

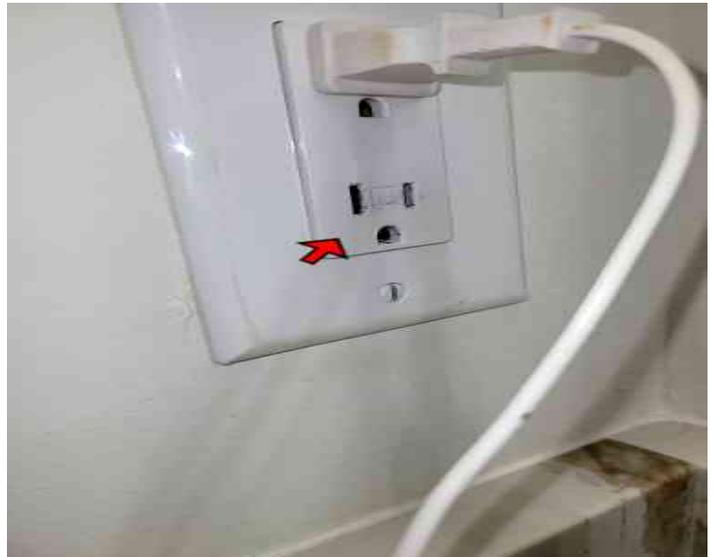
1904: Bathroom Receptacles

Burn marks noted on outlet and should be evaluated and repaired.

Burn marks noted on outlet and should be evaluated and repaired.

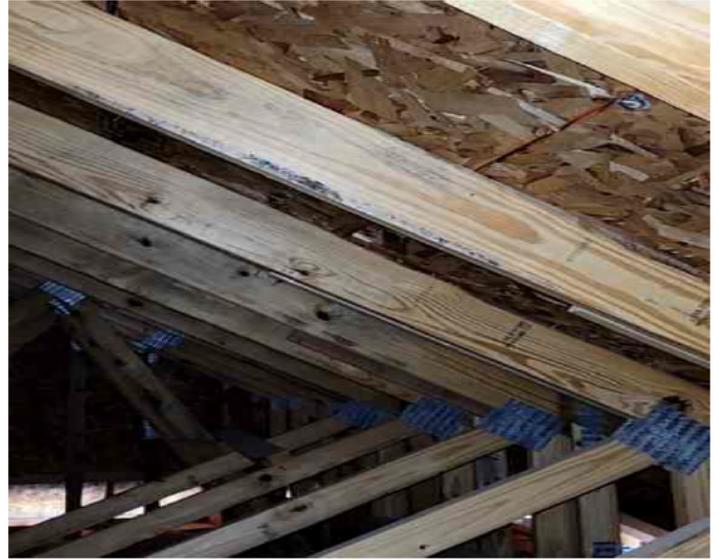
2005: Attic Structural Framing Type

Some mold/mildew was noted in the attic and should be evaluated and cleaned by qualified personnel. As mold and mildew are not part of the home inspection, the client may decide to do further evaluation to determine the extent of the problem and cost to cleanup/repair.

Some mold/mildew was noted in the attic and should be evaluated and cleaned by qualified personnel. As mold and mildew are not part of the home inspection the client may decide to do further evaluation to determine the extent of the problem and cost to cleanup/repair.

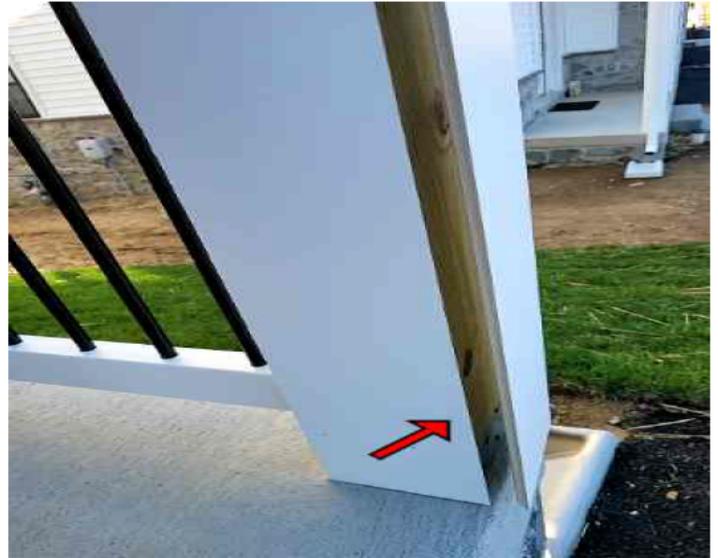
0206: Porches

Loose casing on post was noted and should be repaired.

Loose casing on post was noted and should be repaired.

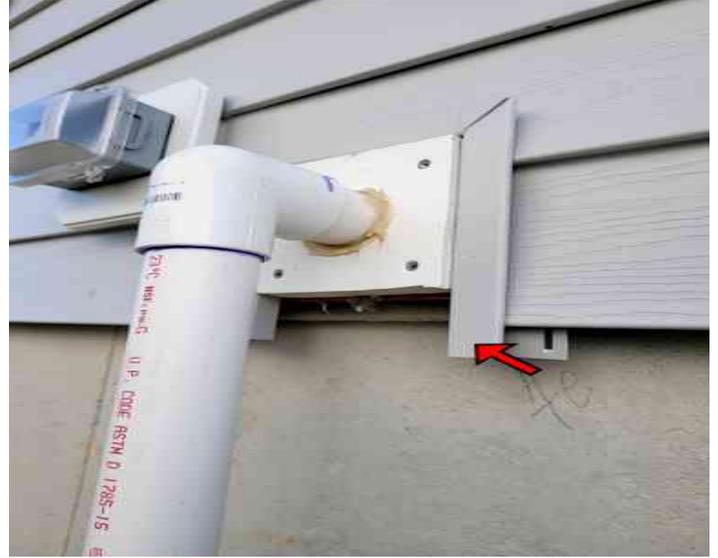
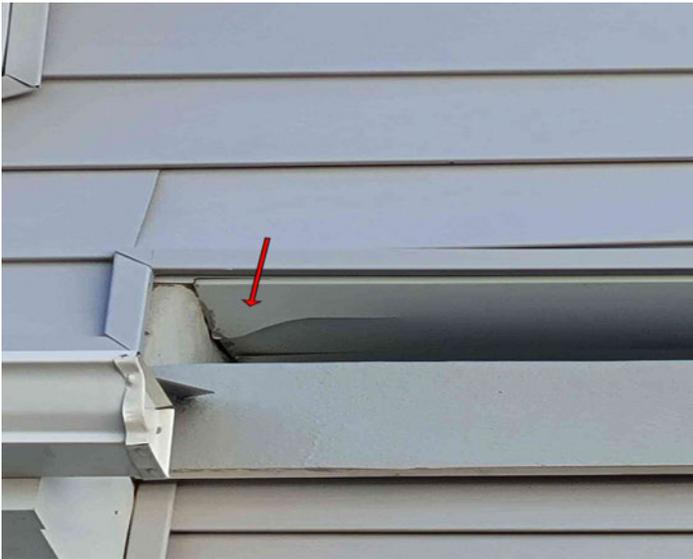
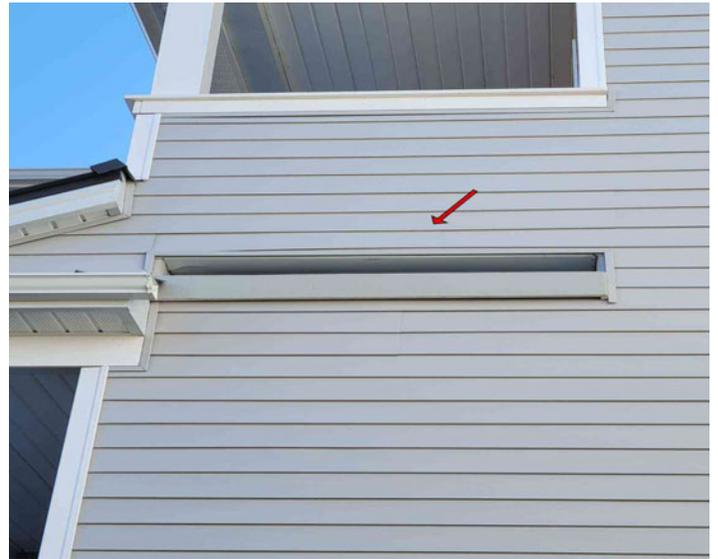
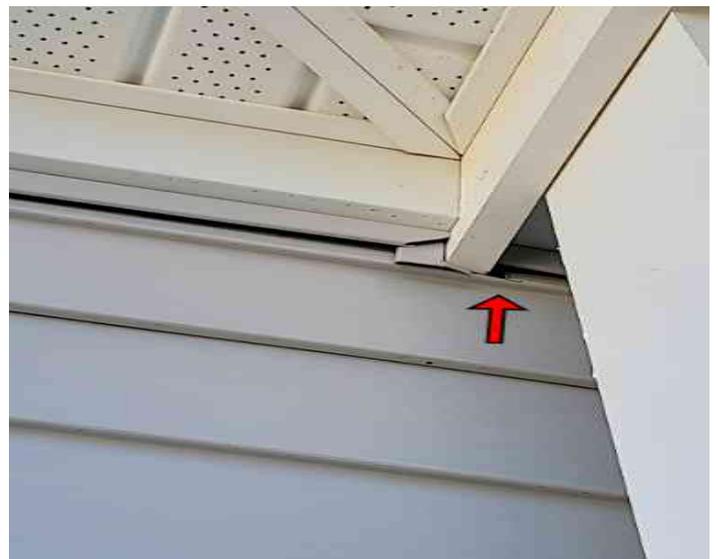
0308: Siding

Missing siding trim noted and should be installed.
Some loose siding was noted and should be replaced.
Some damaged siding was noted. All should be included in the exterior wall evaluation and repairs. All fasteners should be sealed.

Missing siding trim noted and should be installed Some loose siding was noted and should be replaced Some damaged siding was noted All should be included in the exterior wall evaluation and repairs. All fasteners should be sealed

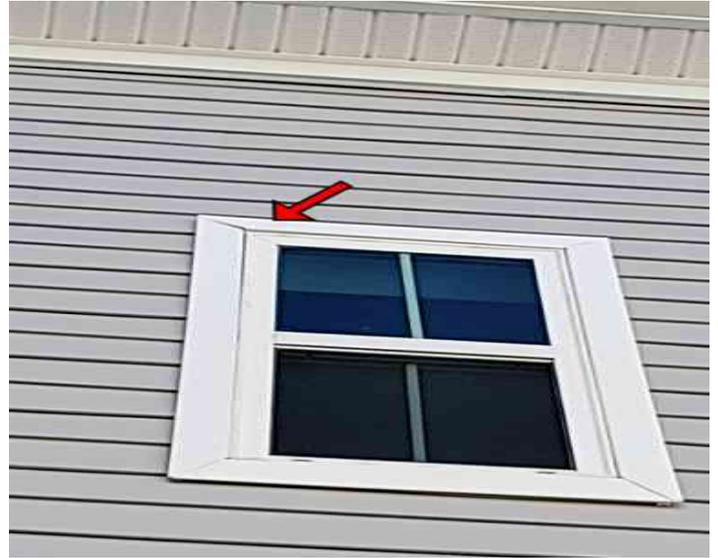
0310: Trim Work

Some loose trim was noted and should be repaired.

Some loose trim was noted and should be repaired

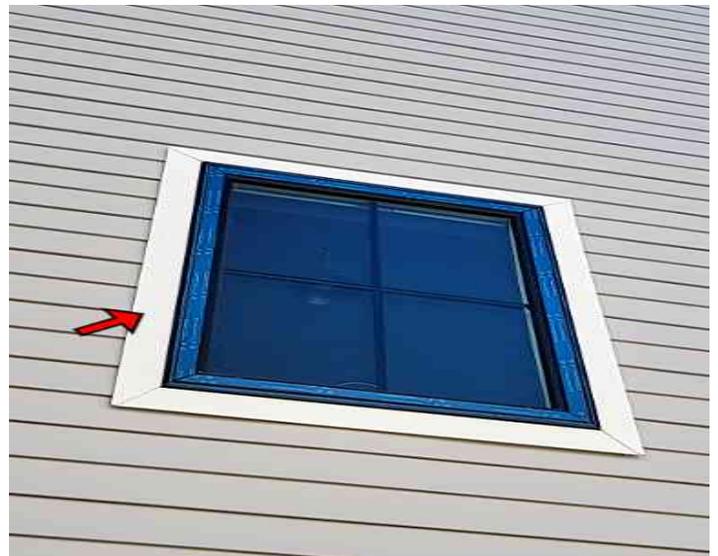
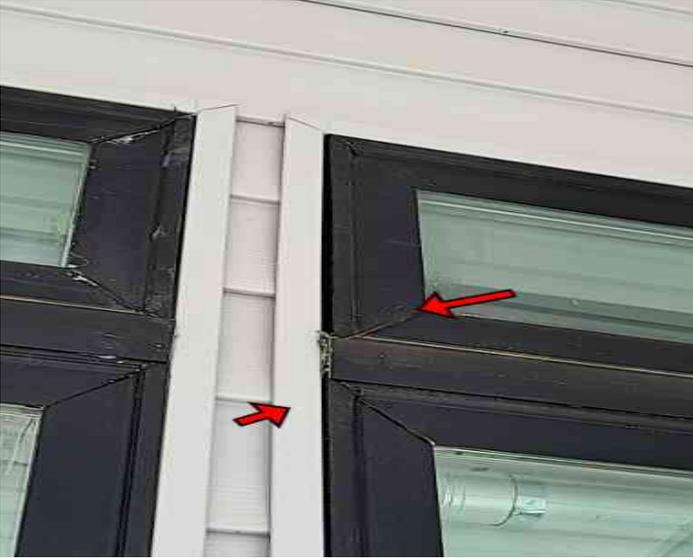
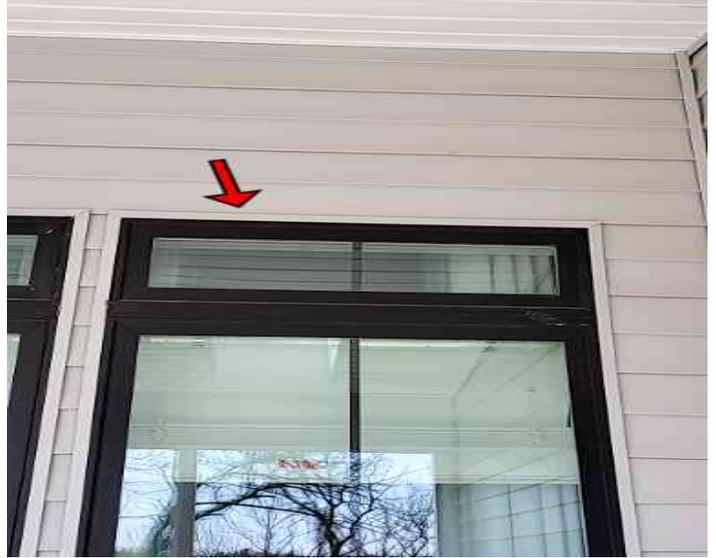
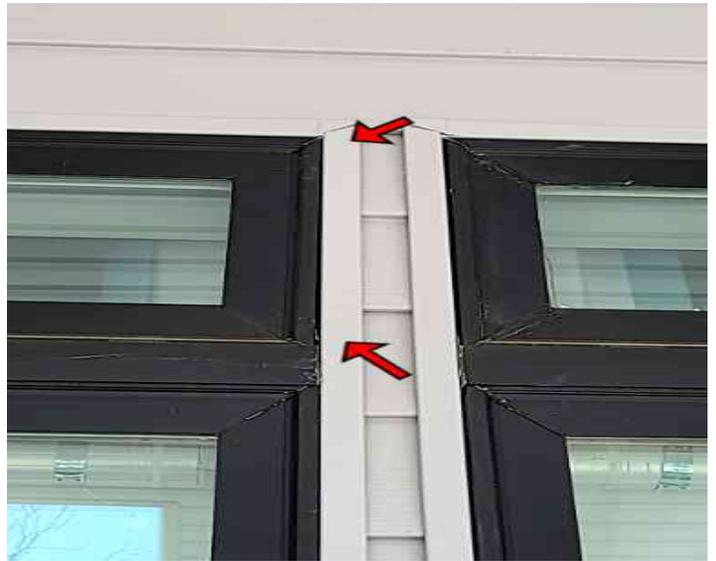
0316 Additional Windows

Missing casing was noted and should be repaired
Poorly fitting windows were noted and should be repaired
All windows should be included in the exterior wall evaluation and repairs.

Missing casing was noted and should be repaired. Poorly fitting windows were noted and should be repaired. All windows should be included in the exterior wall evaluation and repairs

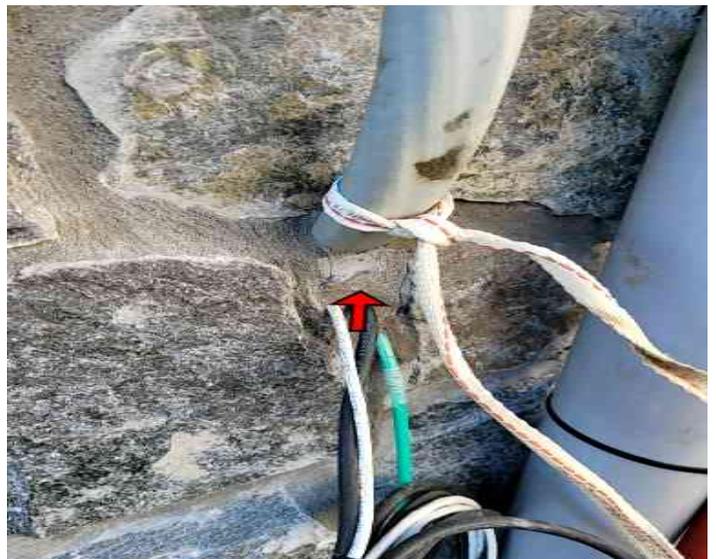
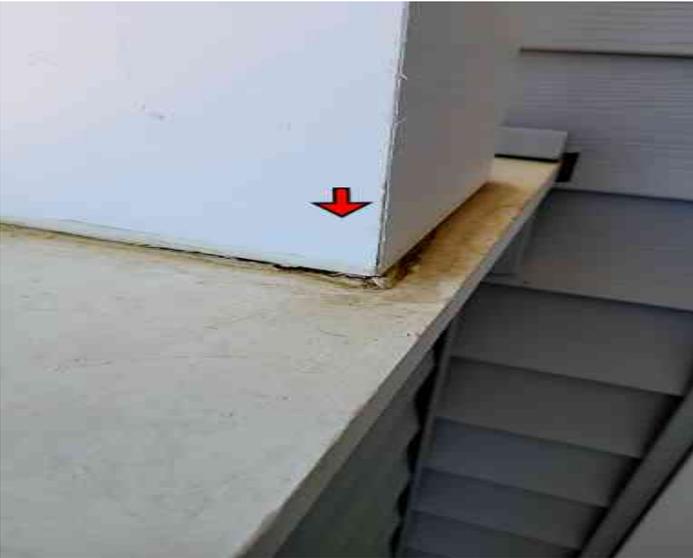
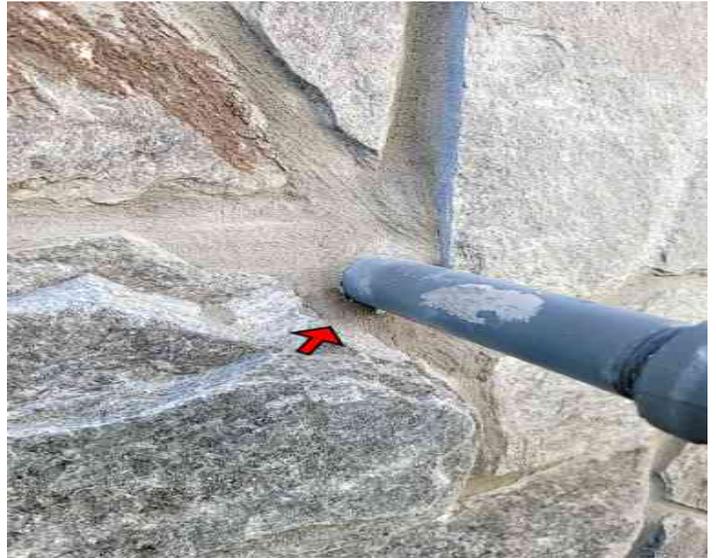
0320: Caulking

Caulking should be improved.

Caulking should be improved.

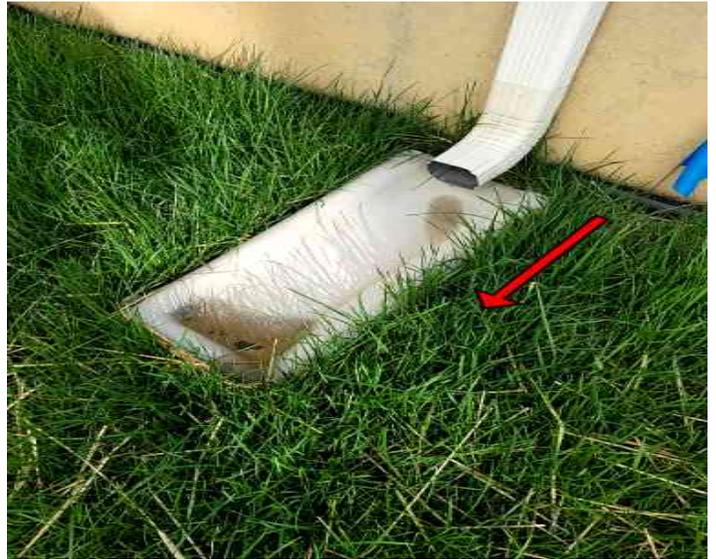
0408: Splash Blocks

Splash blocks should be reversed.

Better Splash blocks or run off drains should be added.

Splash blocks should be reversed. Better Splash blocks or run off drains should be added.

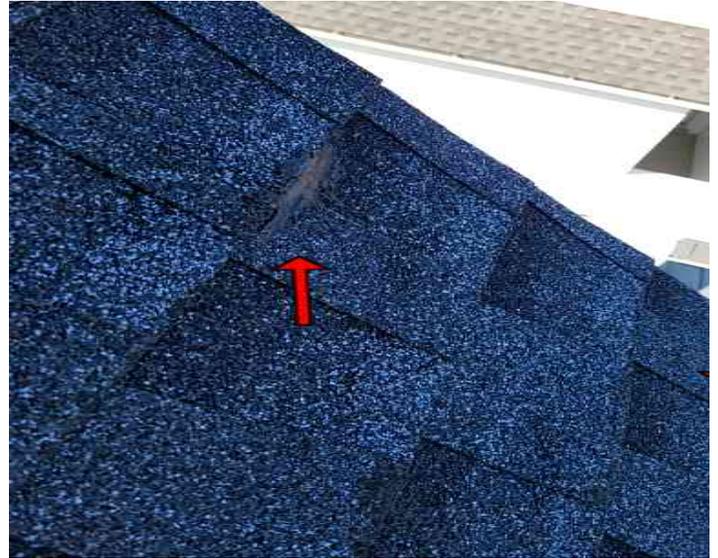
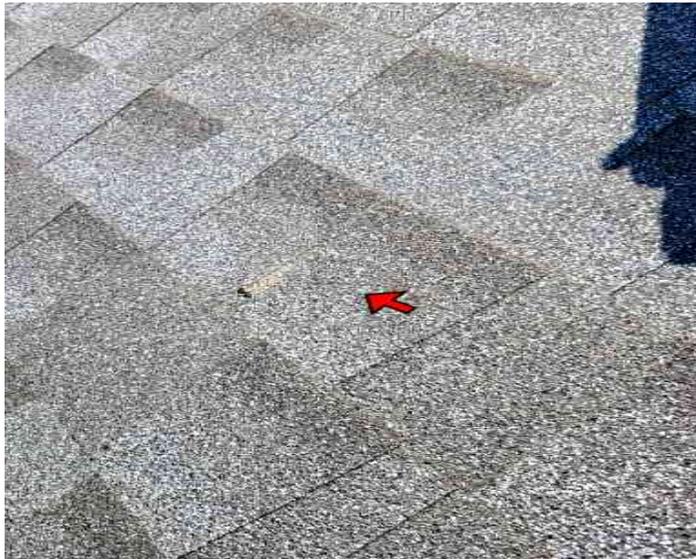
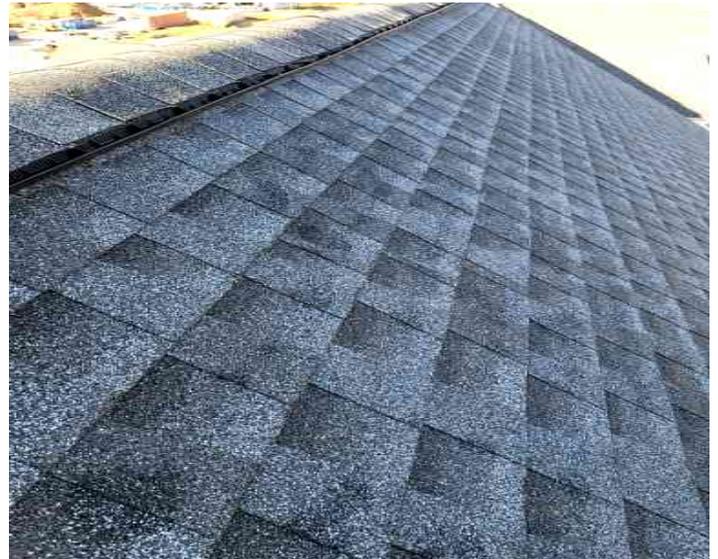
0505: Roof Covering Primary Type

Metal roofs are not walked as part of home inspection due to possible damage to roofing
Some scuffing and aggregate loss noted and should be monitored

Some sealant was noted on the roof surface and will require maintenance

A few cracked/damaged shingles were noted.

Metal roofs are not walked as part of home inspection due to possible damage to roofing. Some scuffing and aggregate loss noted and should be monitored. Some sealant was noted on the roof surface and will require maintenance. A few cracked/damaged shingles were noted.

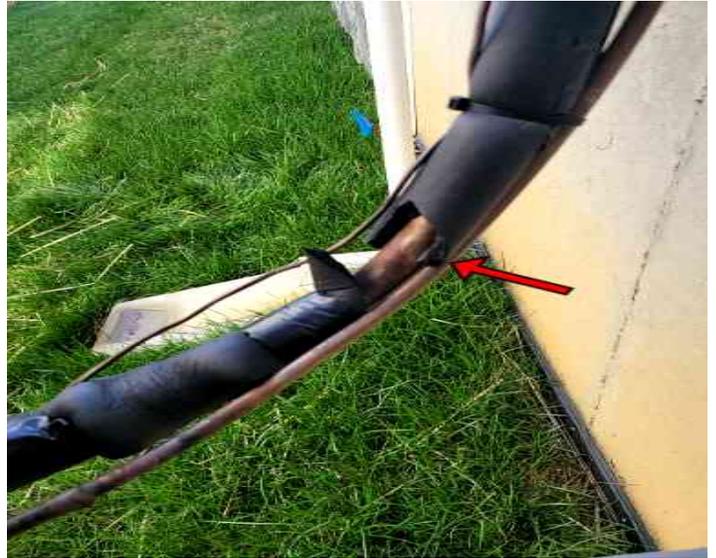
0708: Cooling Lines

The insulation should be improved.

The insulation should be improved.

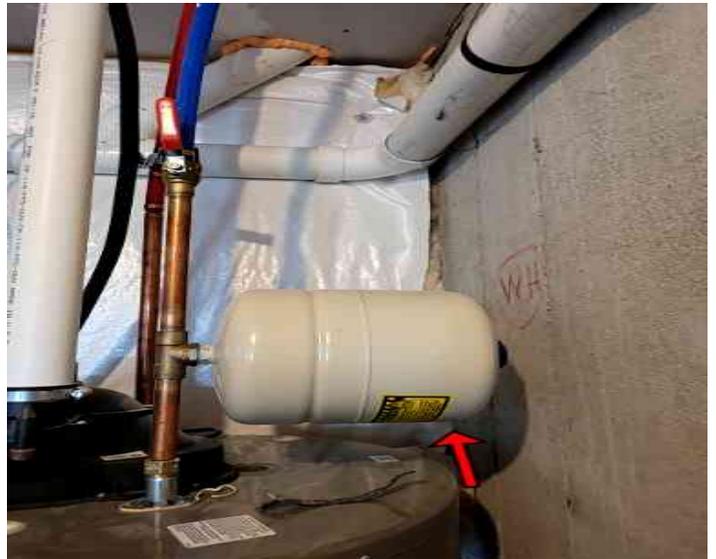
1111 Temp Pressure Relief Valve and Pipe

Expansion tank should be better supported

Expansion tank should be better supported

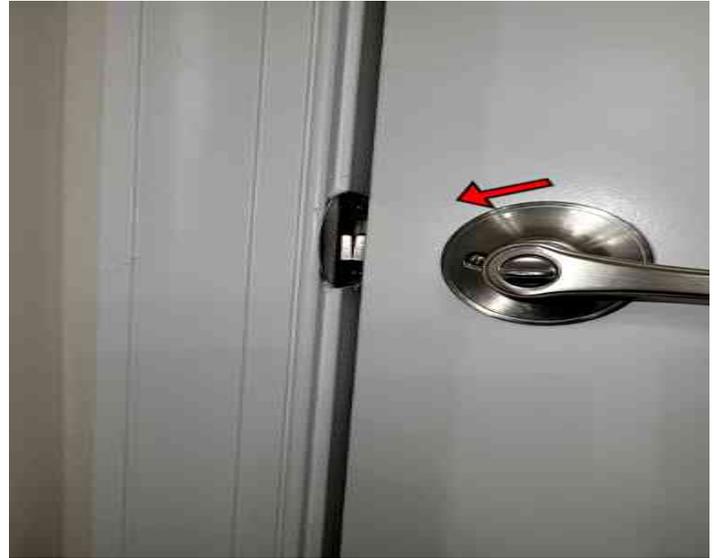
1902: Bathroom Doors, Windows

Door would not close properly and should be repaired.

Master bathroom door

Door would not close properly and should be repaired.

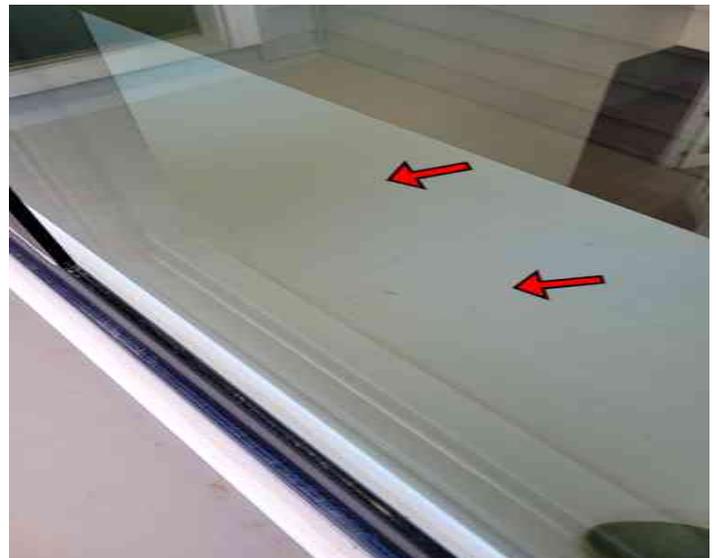
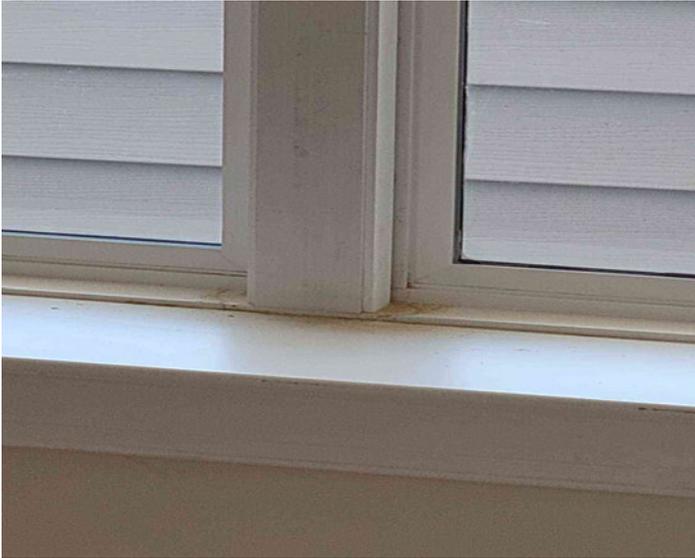
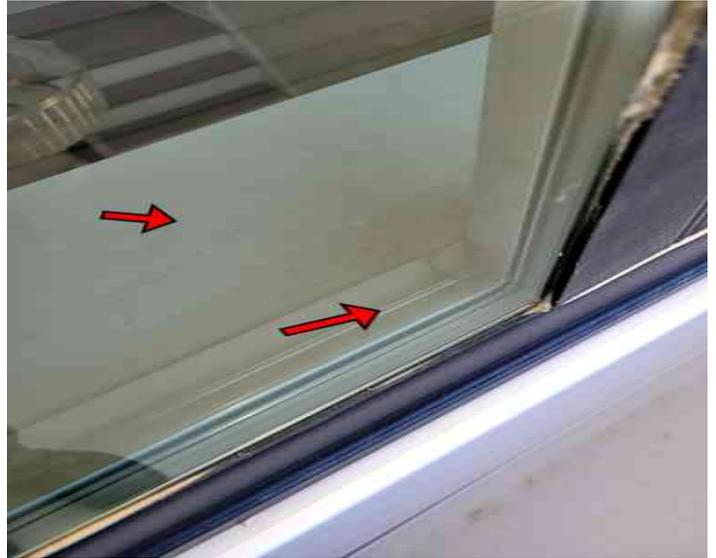
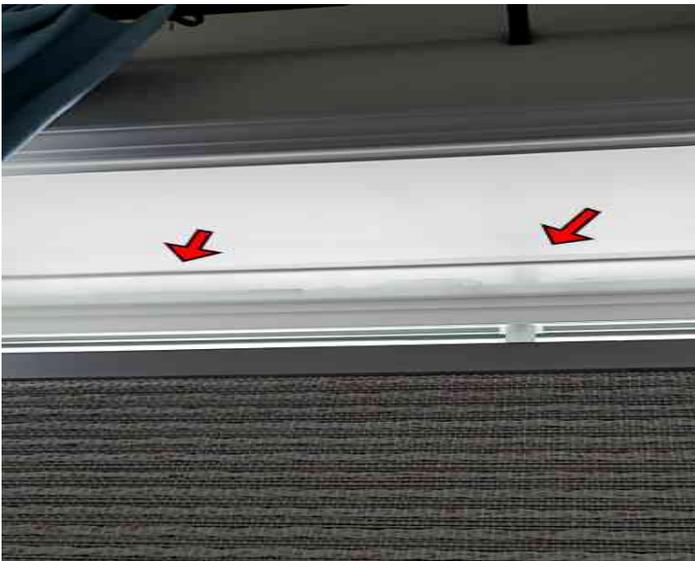
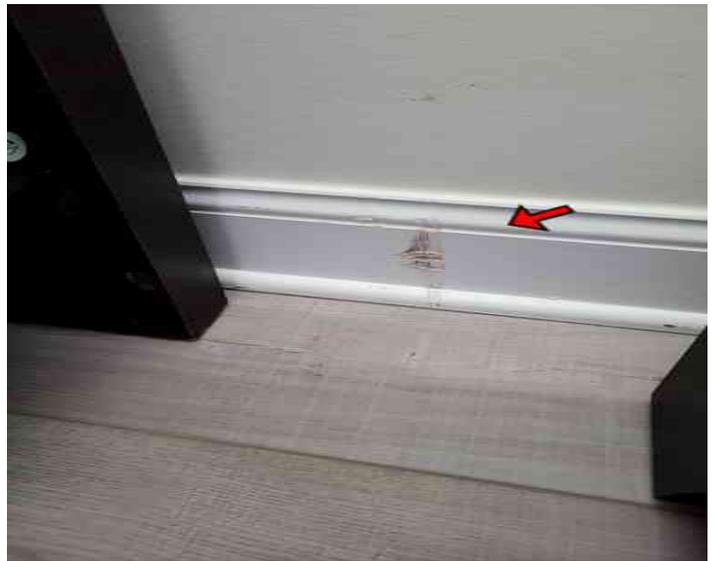
2104: Interior Walls

Typical drywall flaws were noted. Water stains/damage were noted but were dry at the time of the inspection. Some damaged trim was noted. Some poorly finished areas were noted. All should be repaired.

Master bedroom window

Typical drywall flaws were noted. Water stains/damage were noted but were dry at the time of the inspection. Some damaged trim was noted. Some poorly finished areas were noted. All should be repaired.

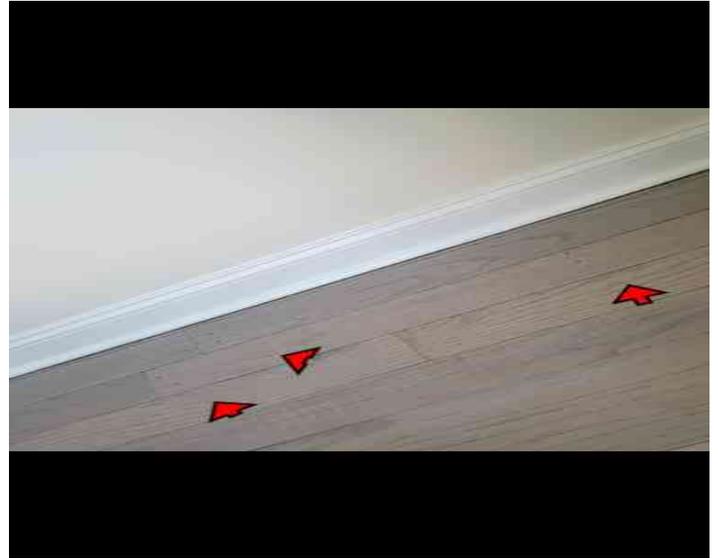
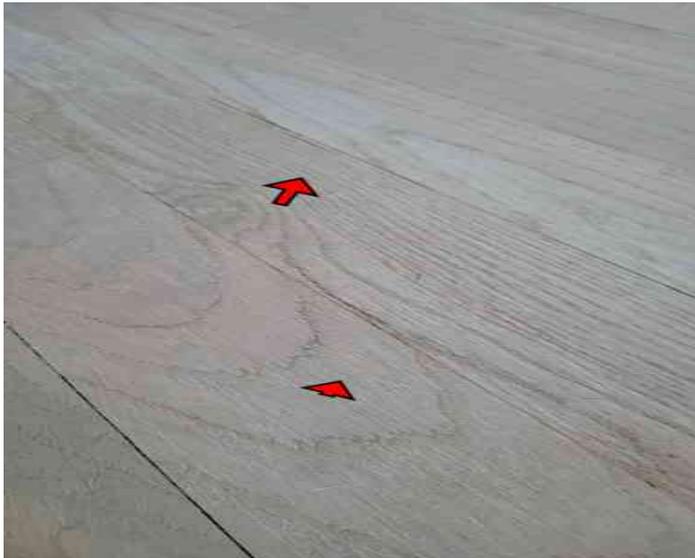
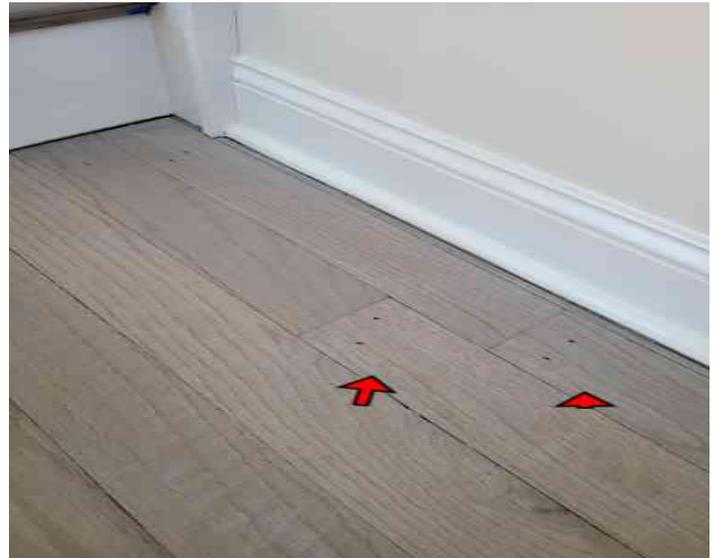
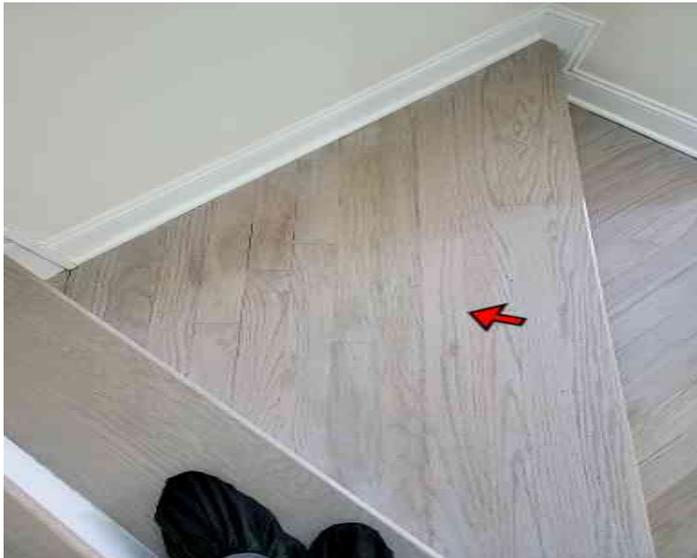
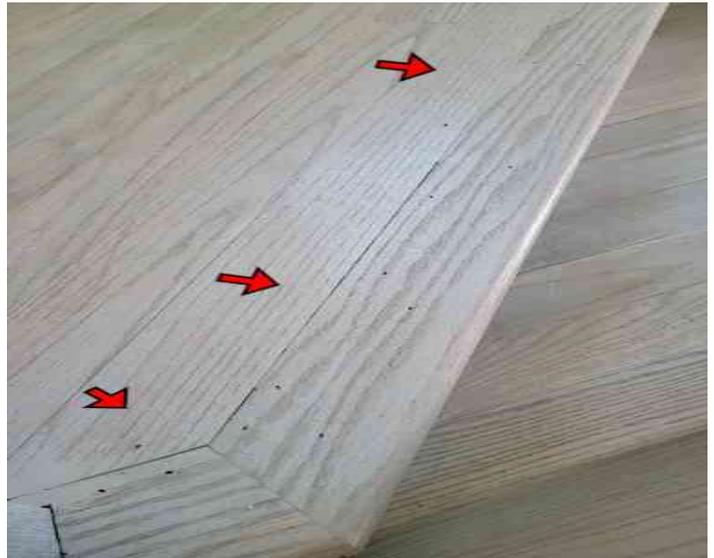
2106: Interior Floors

Poorly installed flooring was noted and should be repaired. Mismatched stains were noted and should be corrected.

Stair mid landing

Poorly installed flooring was noted and should be repaired. Mismatched stains were noted and should be corrected.

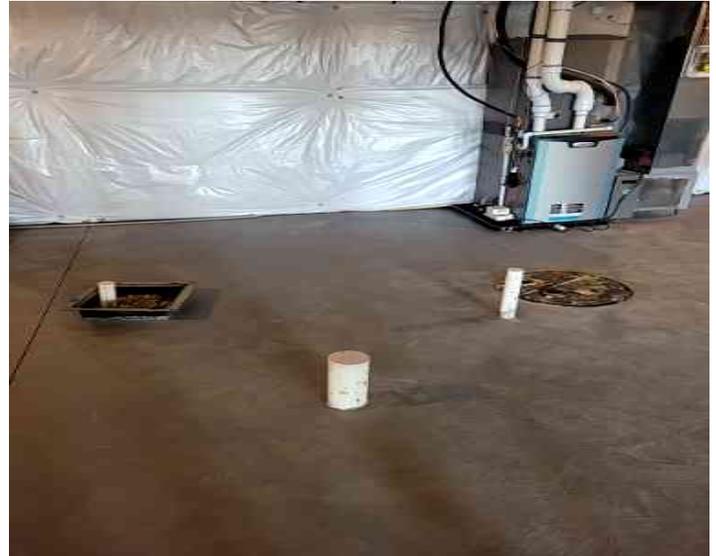
1017: Sewer Injector Pump

Basement is plumbed for an additional bathroom.
