**RELIABLE HOME INSPECTION SERVICE**

Inspected 10/8/20 12:00 PM

FRONT VIEW

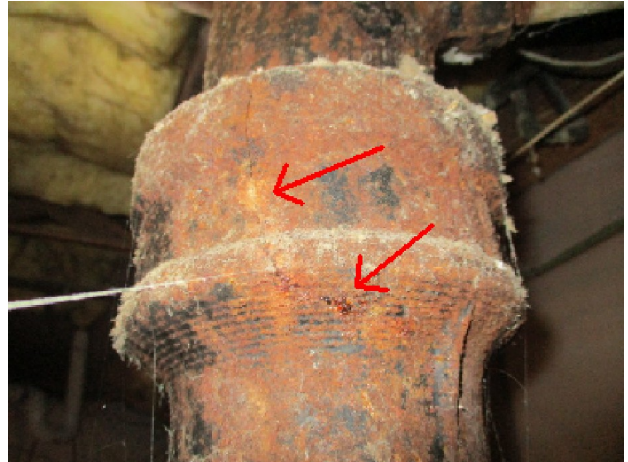
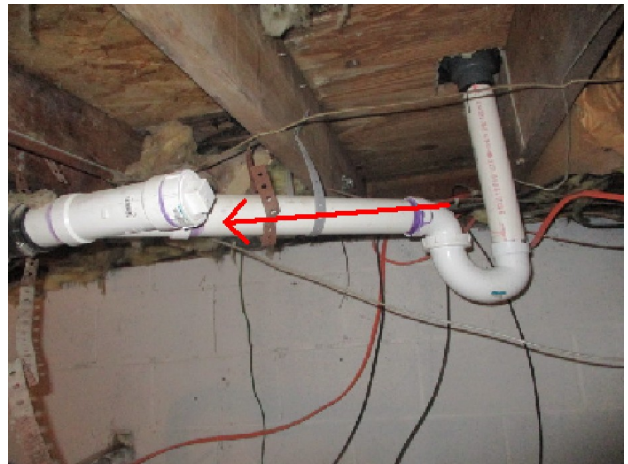
#### Interior Waste/Vent Pipes Visible Primary Type

Most piping concealed supply and drain.  
Blistering and evidence of leakage was noted. Cracked section was noted.  
Poorly pitched areas were noted and should be repaired.  
The entire plumbing system should be evaluated by a qualified plumbing contractor and all needed repairs should be made.

Most piping concealed supply and drain.  
 Blistering and evidence of leakage was noted. Cracked section was noted.  
 Poorly pitched areas were noted and should be repaired.  
 The entire plumbing system should be evaluated by a qualified plumbing contractor and all needed repairs should be made.

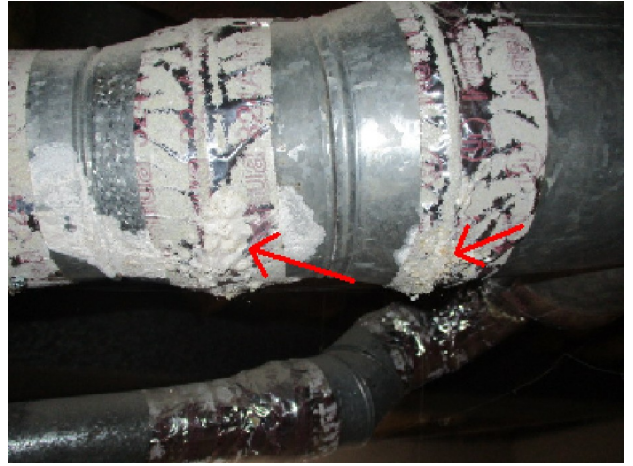
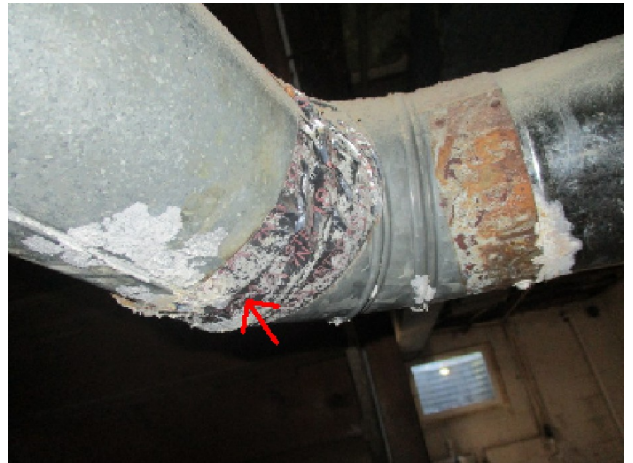
### Flue Piping

Rusted and damaged vent pipe was noted. Evidence of leakage was noted.

Rusted and damaged vent pipe was noted. Evidence of leakage was noted.  
The entire unit should be evaluated by a qualified heating contractor and all needed repairs should be made.

The entire unit should be evaluated by a qualified heating contractor and all needed repairs should be made.

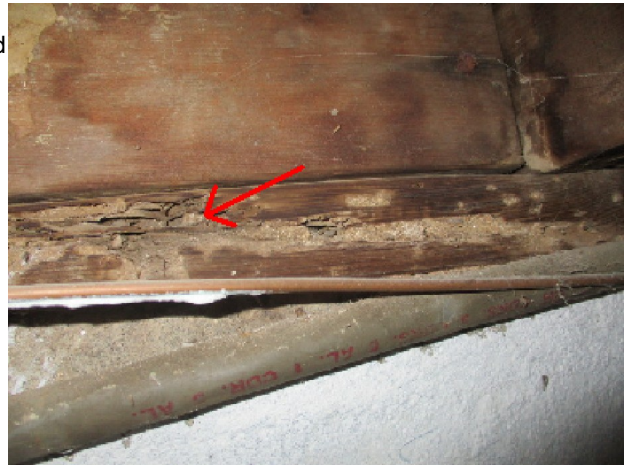
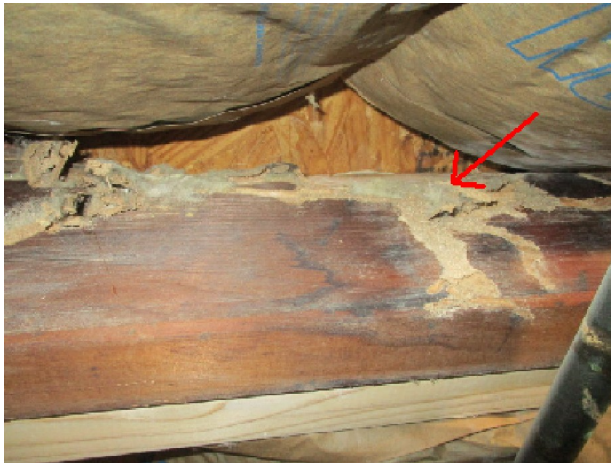
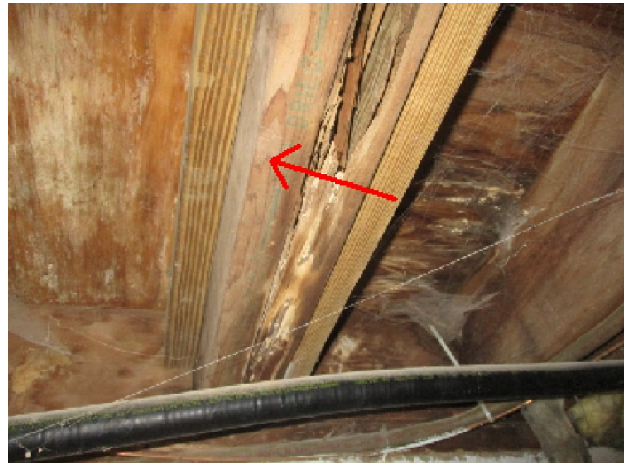
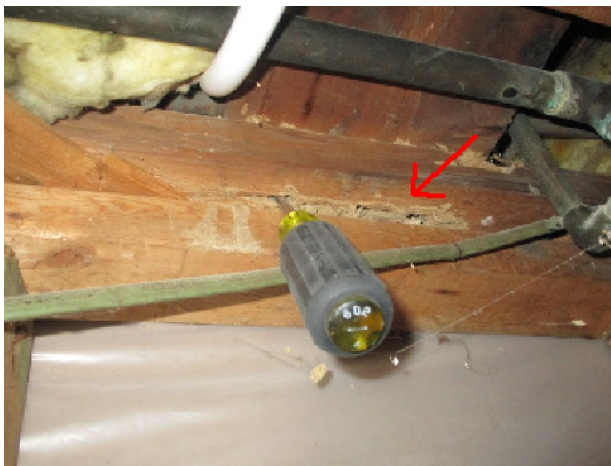
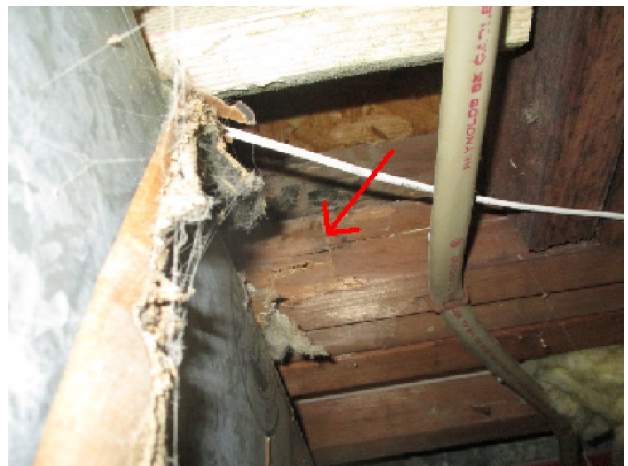
### Basement Ceiling Joist Visible Primary Type

There was termite damage noted to framing. Some poorly repaired areas were noted. The entire structural condition should be evaluated by a structural contractor or engineer and any needed repairs should be made.

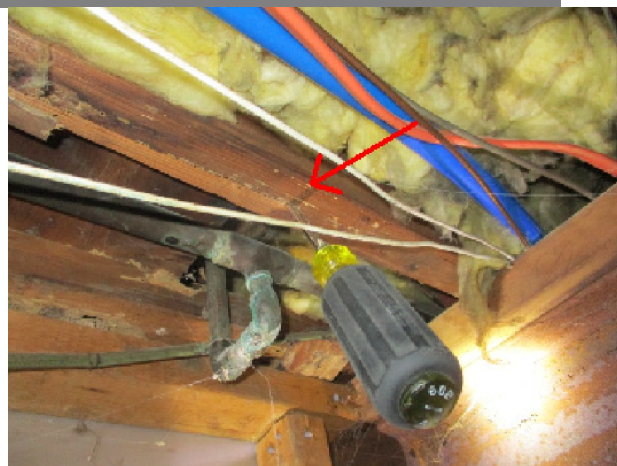
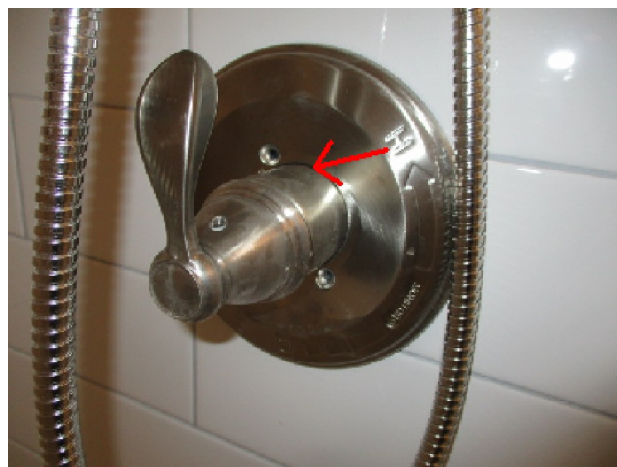
### Shower Faucets

Hot and cold are reversed and should be repaired.  
Missing screws were noted at the valve body.  
Water did not get cold and should be evaluated and all needed repairs should be made.

Hot and cold are reversed and should be repaired.

Missing screws were noted at the valve body.

Water did not get cold and should be evaluated and all needed repairs should be made.

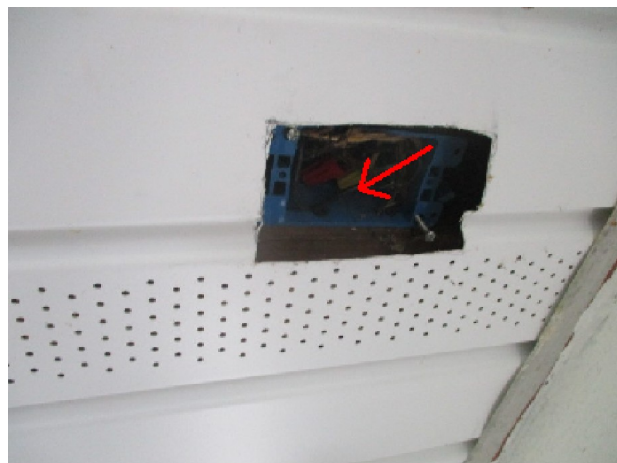
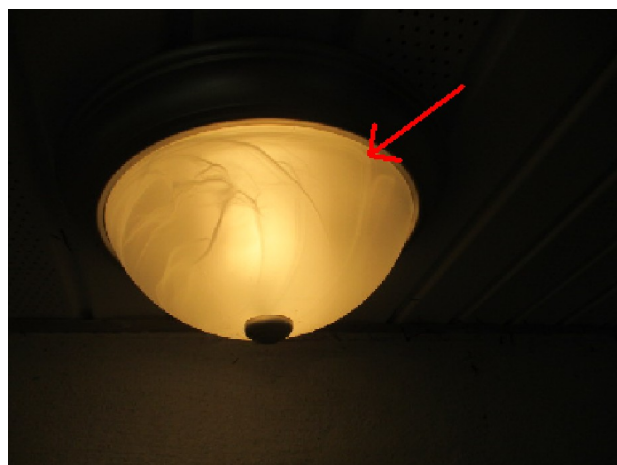
### Outside Outlets

Exposed wiring was noted at the rear bump out and should be repaired.  
Interior light was used on the exterior and should be repaired.

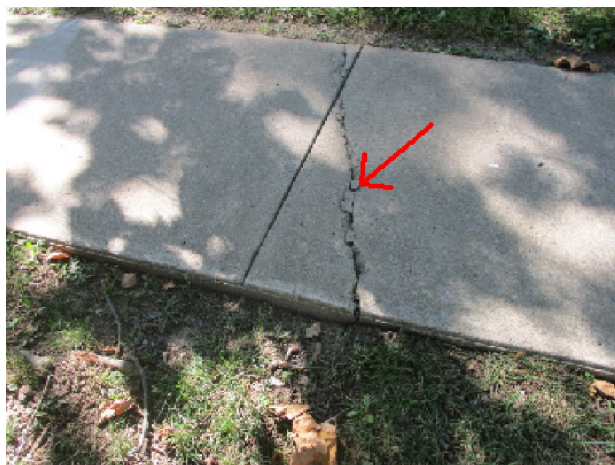
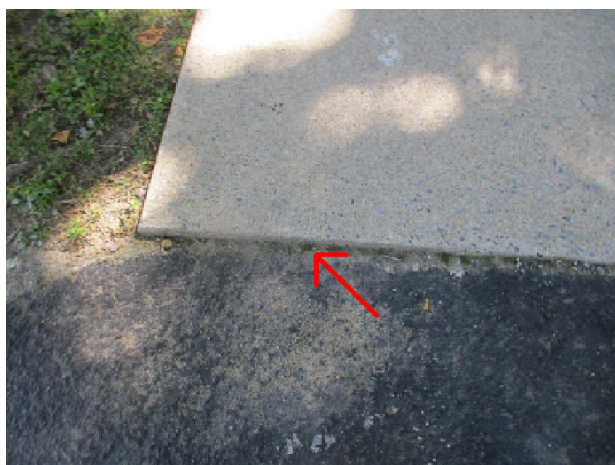
### Walks

Cracks and some settlement noted.  
Uneven areas present tripping hazard and should be repaired.

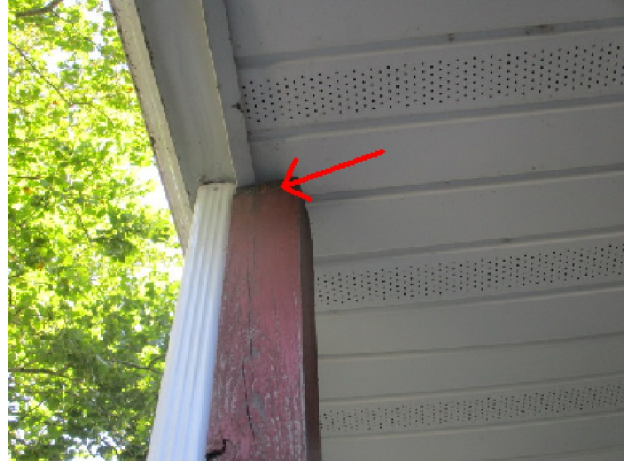
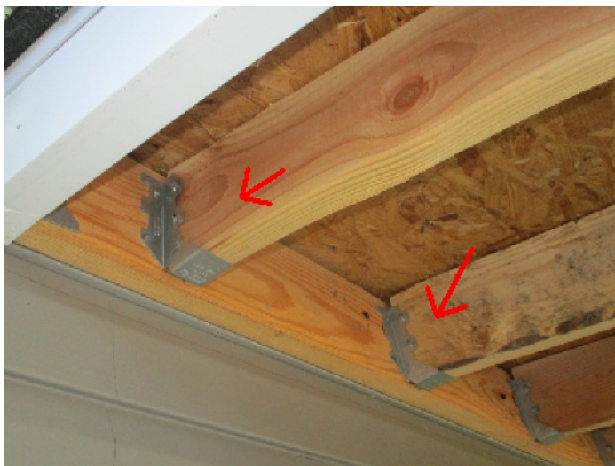
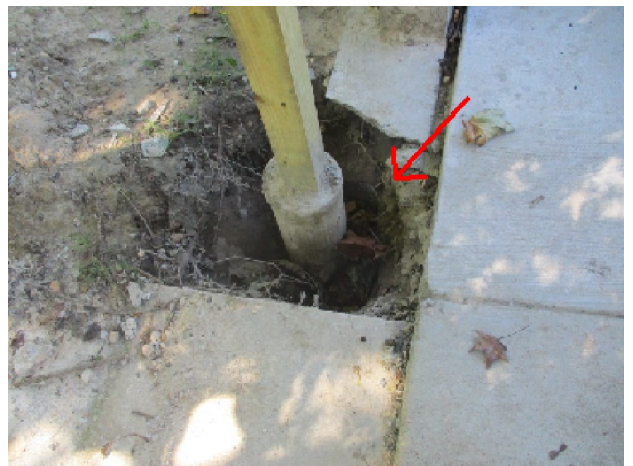
## Porches

Support post is not properly attached and should be repaired.  
Rear over hang is missing joist hanger fasteners and should be repaired.  
Footings are exposed and should be repaired.

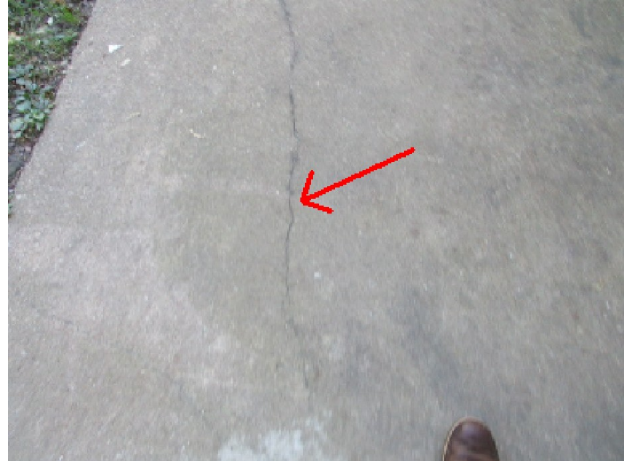
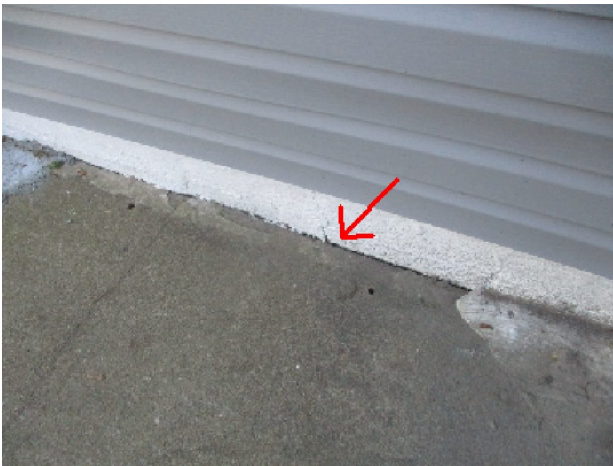
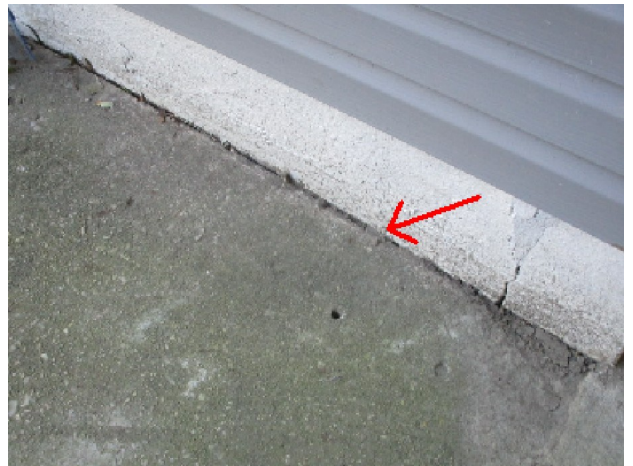
## Driveway

Some cracks noted.  
Uneven areas may present a tripping hazard and should be repaired to prevent injury.  
Seam from the driveway to the foundation should be sealed.

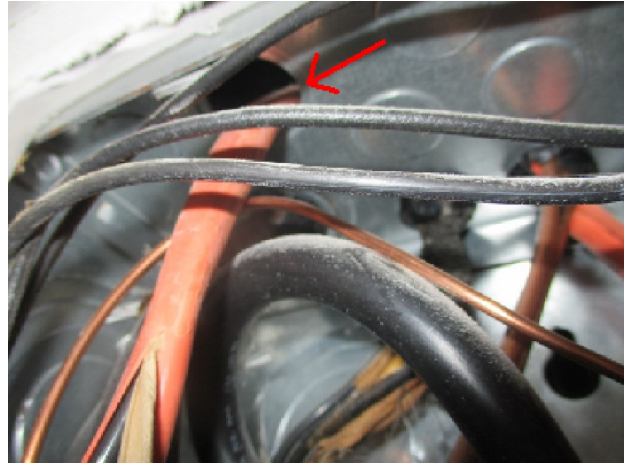
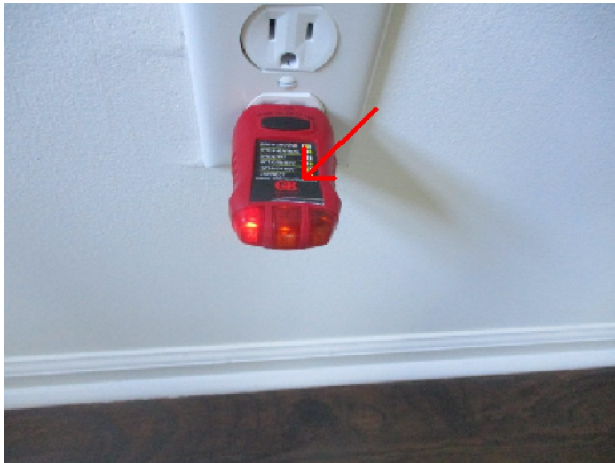
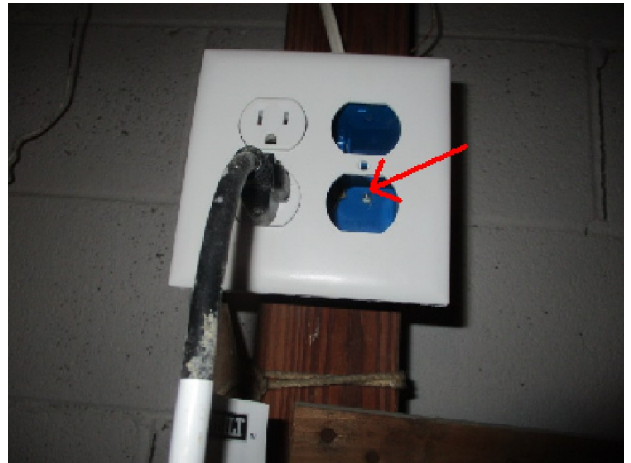
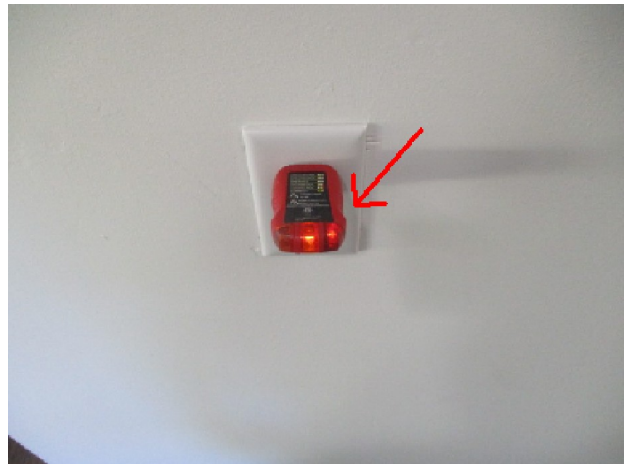
### Electrical Defaults

The missing panel cover knock out seals should be replaced.  
Wrong outlet cover was noted and should be repaired.  
Some outlets in the basement are loose and should be repaired.  
Reverse polarity was noted and should be repaired. Front right bedroom, wall at stairs.  
Gaps were noted at the recess lighting to the ceiling and should be repaired.

The missing panel cover knock out seals should be replaced.  
 Wrong outlet cover was noted and should be repaired.  
 Some outlets in the basement are loose and should be repaired.  
 Reverse polarity was noted and should be repaired. Front right bedroom, wall at stairs.  
 Gaps were noted at the recess lighting to the ceiling and should be repaired.

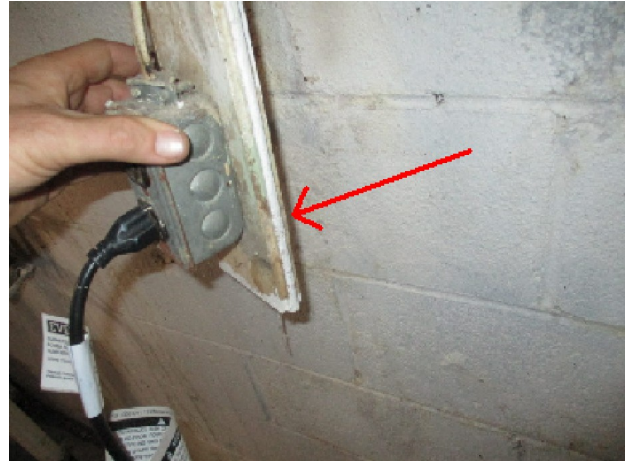
#### Laundry Water Faucets

Recommend GFCI outlets near water products.  
Outlet should be attached to the wall.

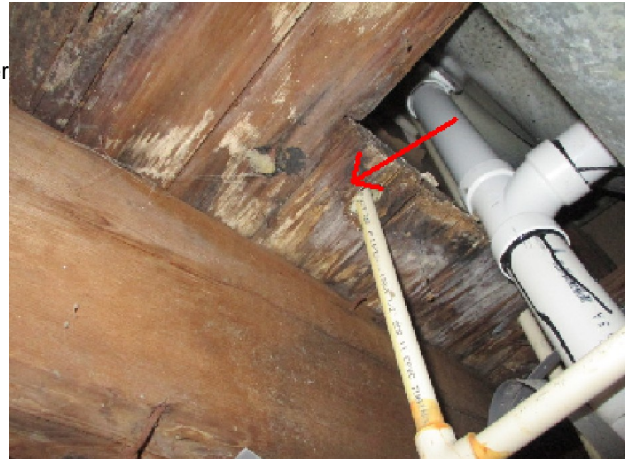
#### Basement Ceiling Sub Floor Visible Primary Type

Some mold/mildew was noted in the lowest level and should be evaluated and cleaned by qualified personnel. As mold and mildew are not part of the home inspection the client may decide to do further evaluation to determine the extent of the problem and cost to cleanup/repair.

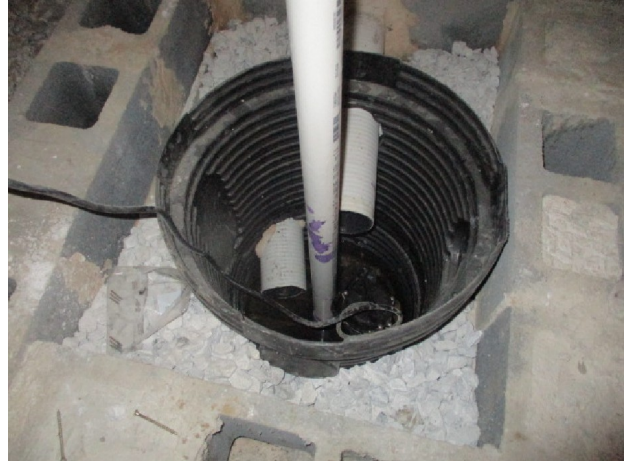
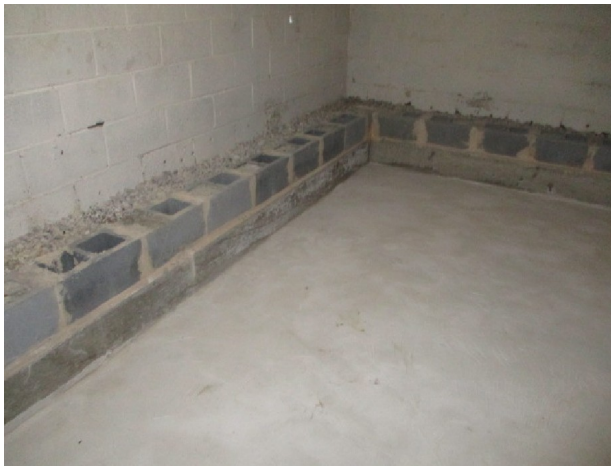
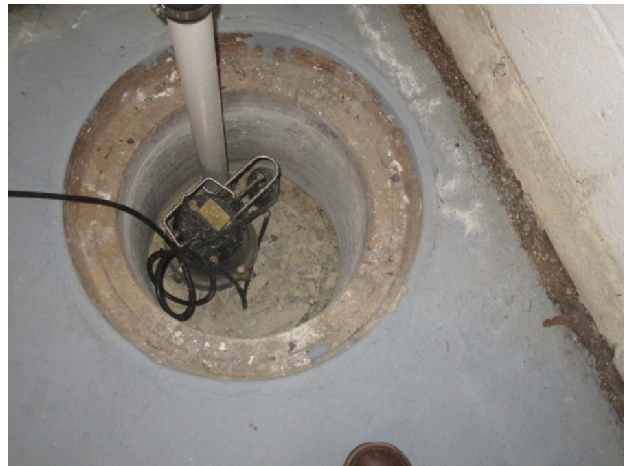
### Basement Drainage

Recommend back up system.  
Multiple sump pumps systems installed. This could indicate water management problem.  
The sump pit should be covered.  
Debris should be removed from the pit.

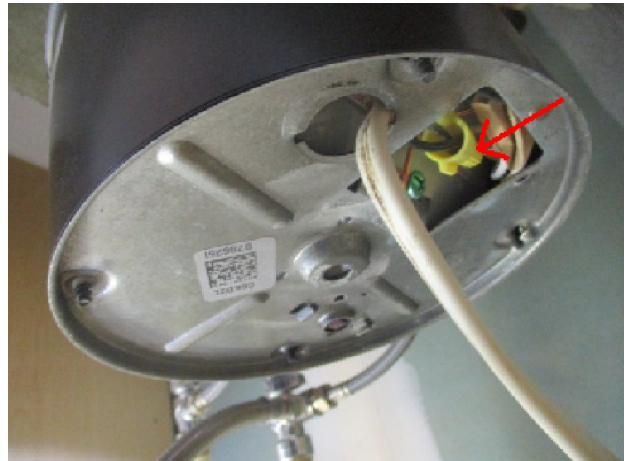
### Garbage Disposal

There is a missing connector at disposal.

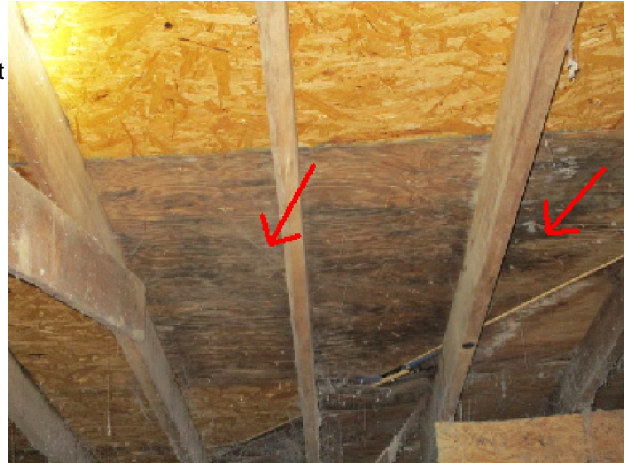
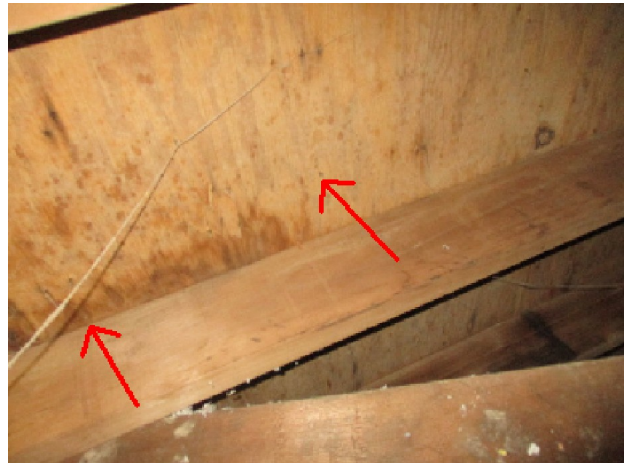
### Attic Sheathing

Some stains were noted but were not currently wet. Some mold/mildew was noted in the attic and should be evaluated and cleaned by qualified personnel. As mold and mildew are not part of the home inspection the client may decide to do further evaluation to determine the extent of the problem and cost to cleanup/repair.

Some stains were noted but were not currently wet.

Some mold/mildew was noted in the attic and should be evaluated and cleaned by qualified personnel. As mold and mildew are not part of the home inspection the client may decide to do further evaluation to determine the extent of the problem and cost to cleanup/repair.

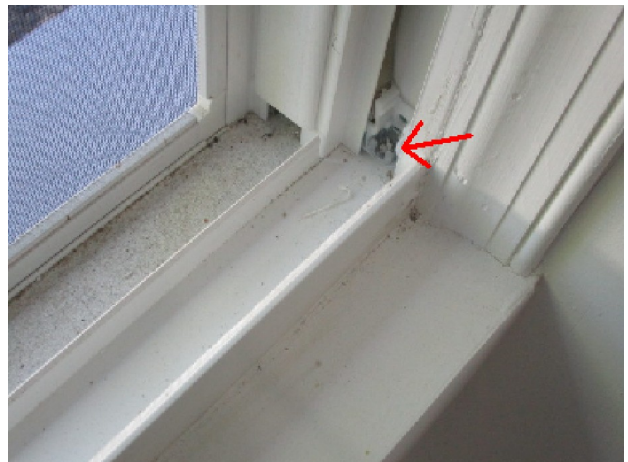
### Windows

Damage balance was noted and should be repaired.

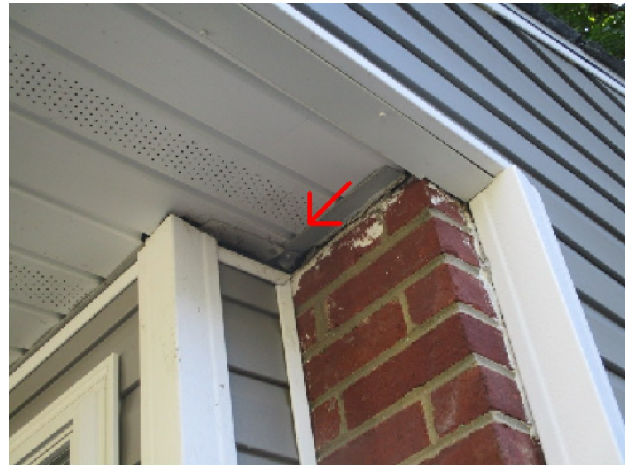
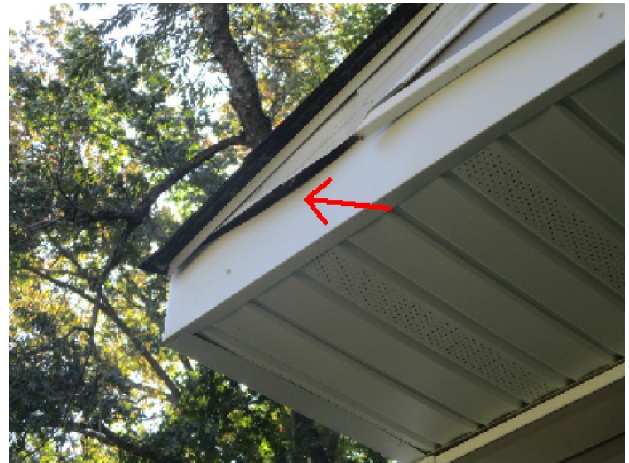
### Soffit/Fascia

Poorly fitting areas were noted and should be repaired.

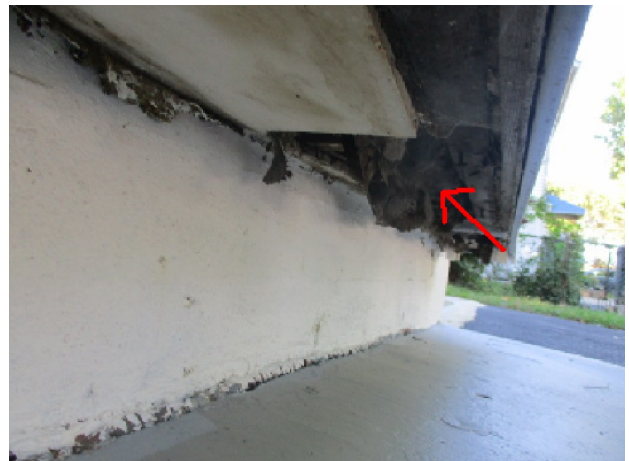
### Siding

Exposed areas were noted under the front kitchen bump out and should be repaired.

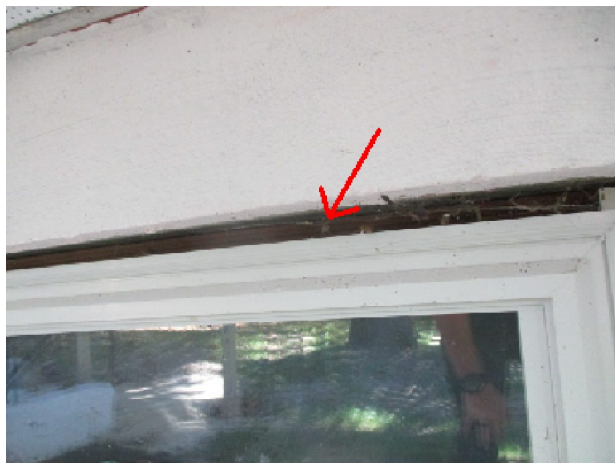
### Trim Work

Missing section was noted at the lower level window and should be repaired.

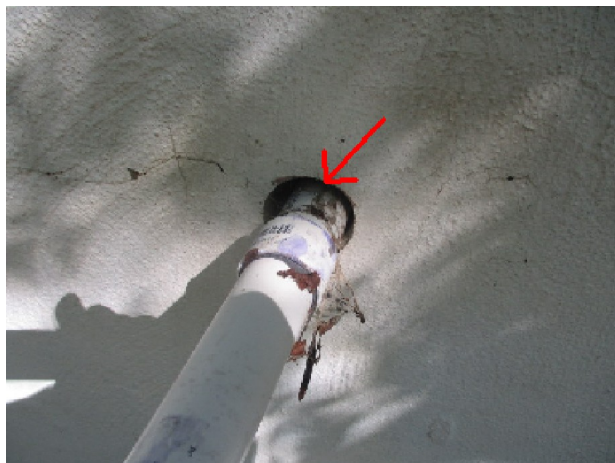
### Caulking

Caulking should be improved.

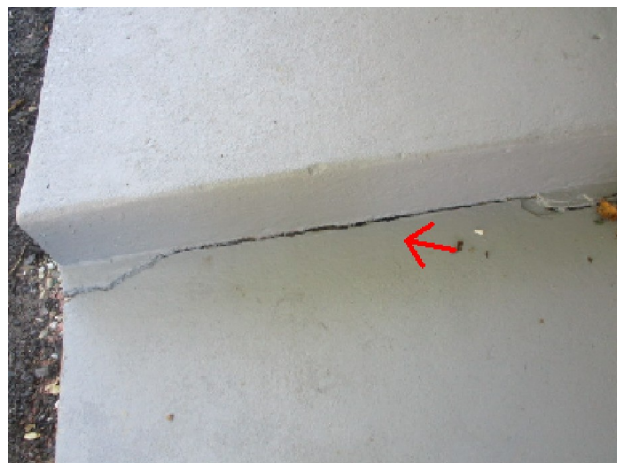
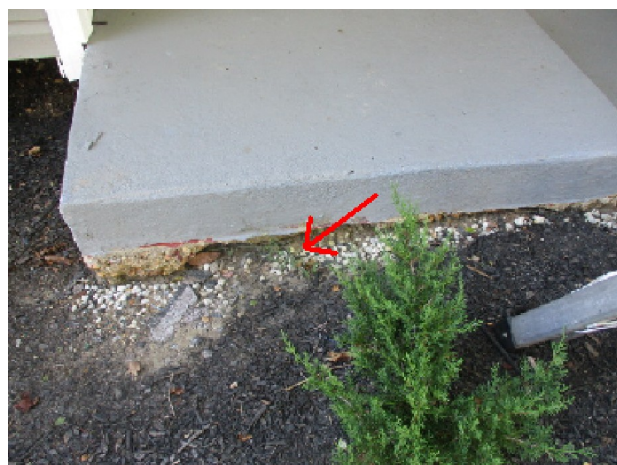
### Steps

Cracks and some settlement noted.  
Some undermining was noted and should be repaired.

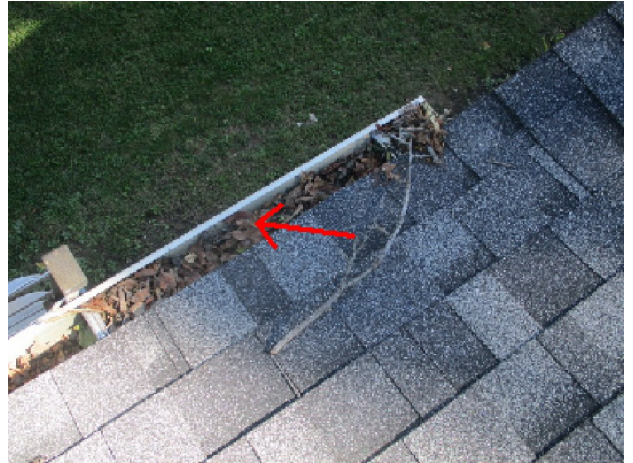
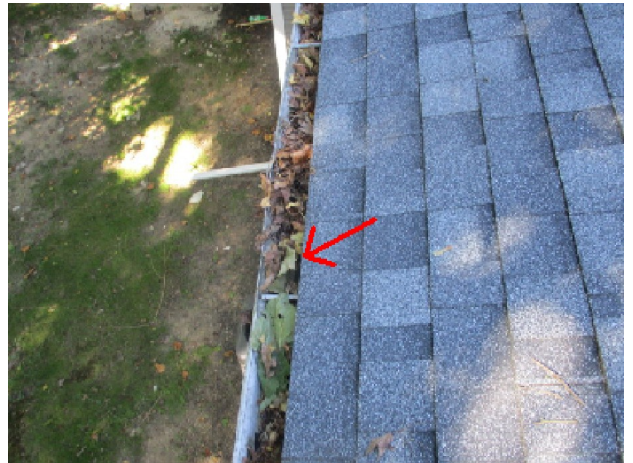
#### Gutter Type

Gutters should be cleaned regularly to prevent rot and roof damage. The gutters have debris in them and should be cleaned. Some dented areas were noted.

Gutters should be cleaned regularly to prevent rot and roof damage.  
The gutters have debris in them and should be cleaned.  
Some dented areas were noted.

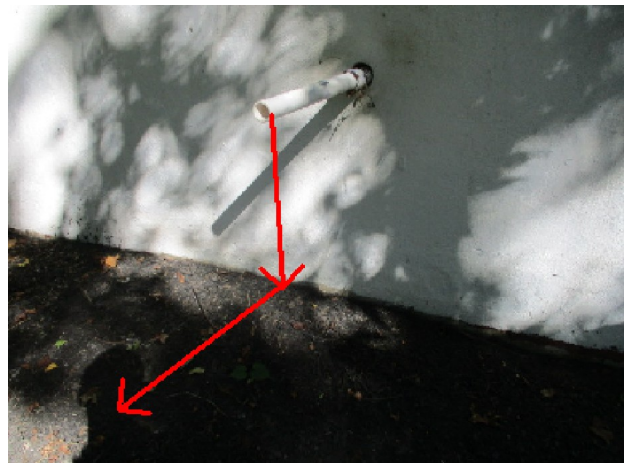
#### Splash Blocks

Run off drains should be added. Run-off drains would carry water further away from foundation than splash blocks, and are recommended. Sump pit outputs should be extended.

Run off drains should be added. Run-off drains would carry water further away from foundation than splash blocks, and are recommended.  
Sump pit outputs should be extended.

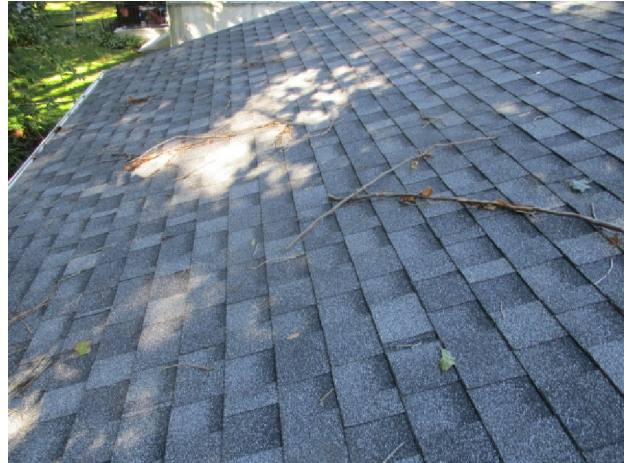
#### Roof Covering Primary Type

Tree debris should be removed.

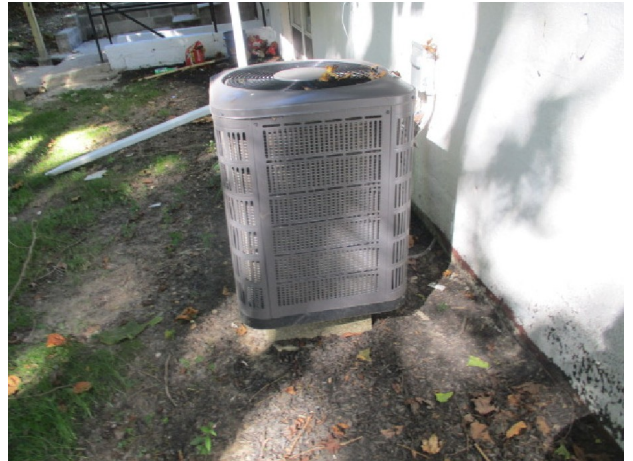
#### Cooling System Coils and Fins

The unit should be leveled.

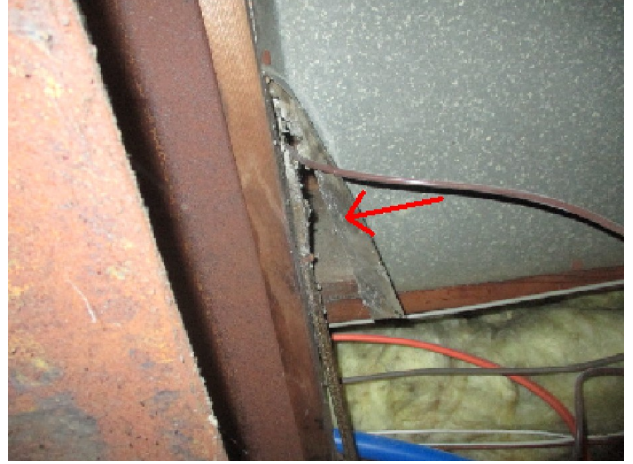
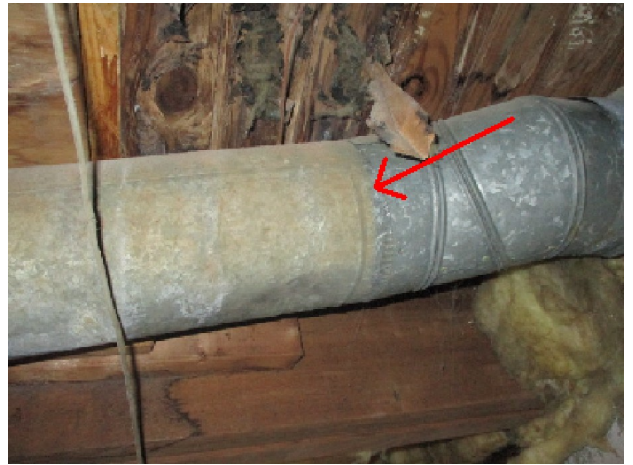
#### Distribution System Material

Poorly sealed duct work was noted and should be repaired.

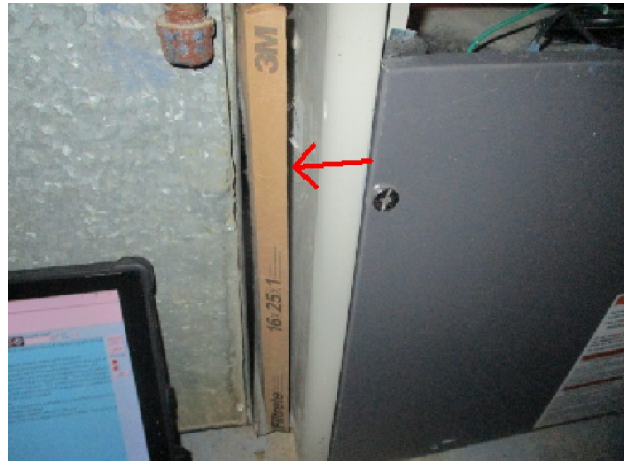
#### Filter System

Wrong size filter was noted.  
The filter is dirty and should be replaced.  
Filters should be replaced every three months.  
Missing cover was noted at the filter and should be repaired.

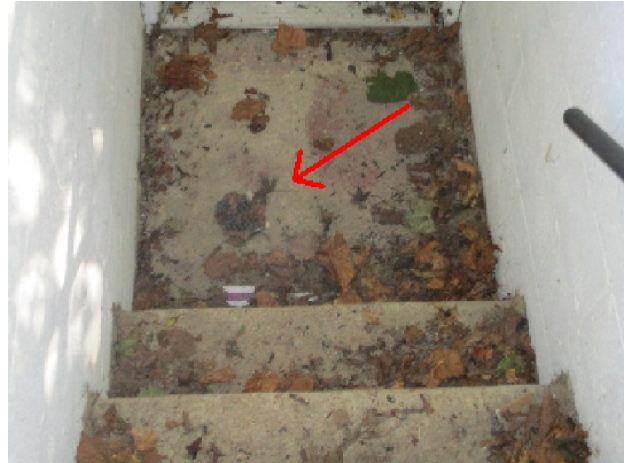
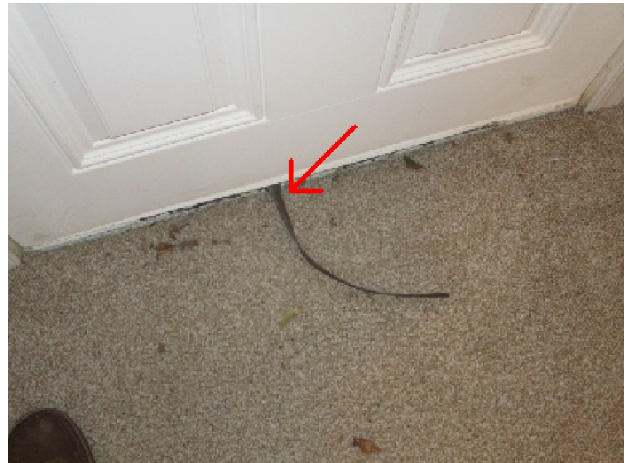
### Basement Access

Drain at the bottom of the exterior steps should be cleared of debris. Damage weather stripping was noted at the exterior door for the basement and should be repaired.

Drain at the bottom of the exterior steps should be cleared of debris.  
Damage weather stripping was noted at the exterior door for the basement and should be repaired.

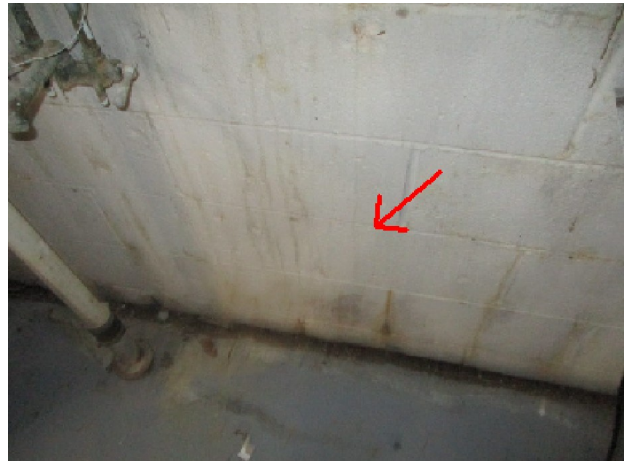
### Basement Foundation Walls

Some cracks and water penetration noted. There was efflorescence on the walls.

Some cracks and water penetration noted.  
There was efflorescence on the walls.

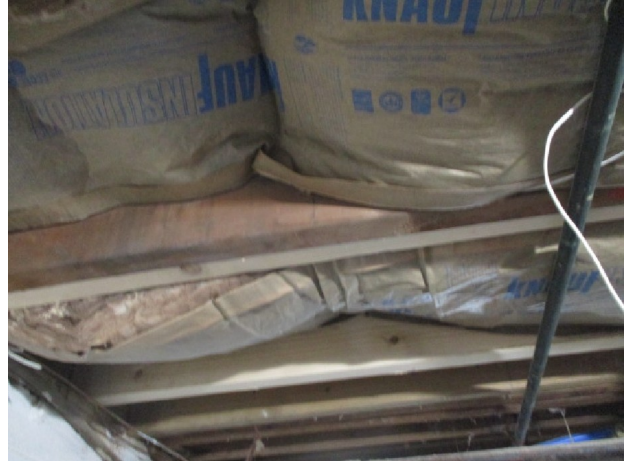
### Basement Insulation Visible Primary Type

Insulation limits inspection.  
Some areas were installed upside down and should be repaired.

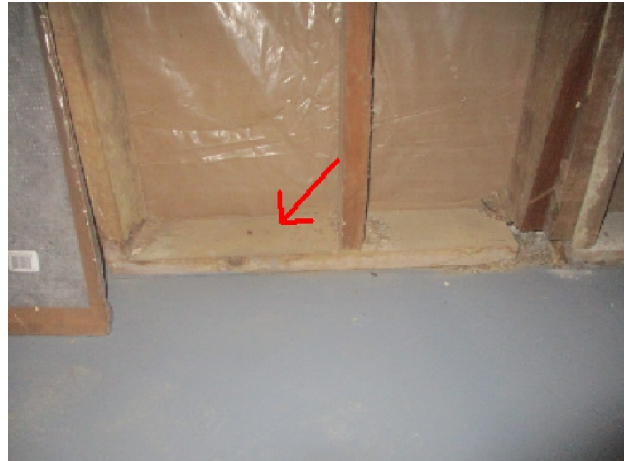
### Basement Wall Finish

Inspection limited by finished areas.  
Non-pressure treated wood makes contact with the slab and should be replaced/repared.

Non-pressure treated wood makes contact with the slab and should be replaced/repaired.

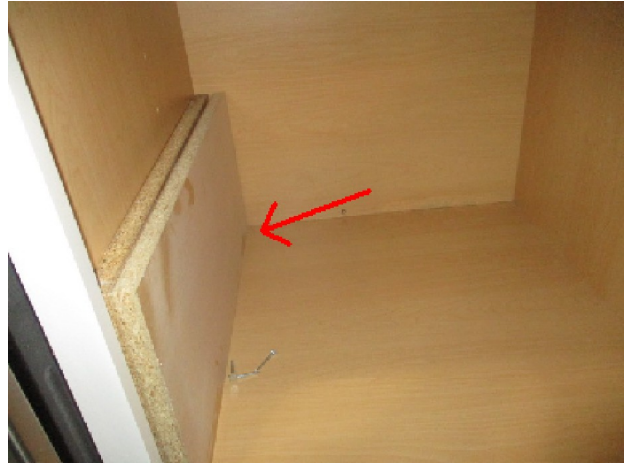
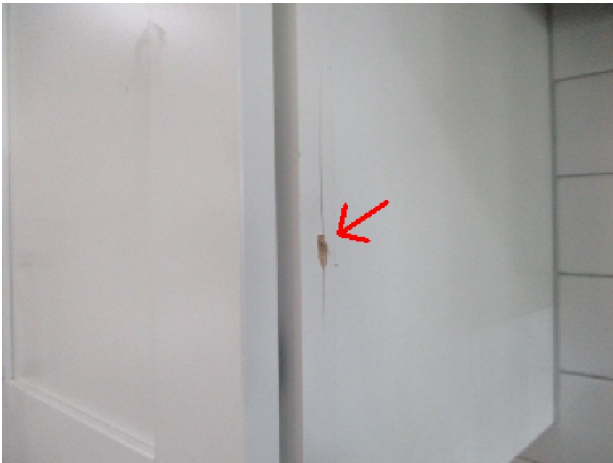
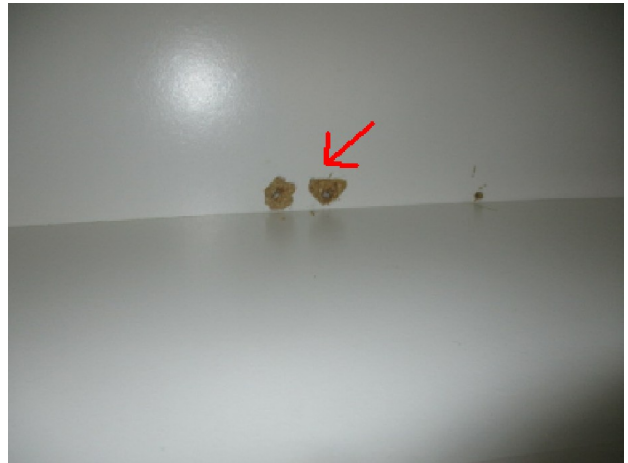
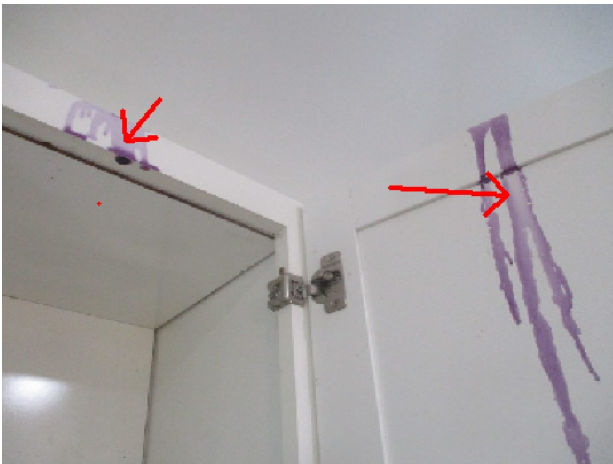
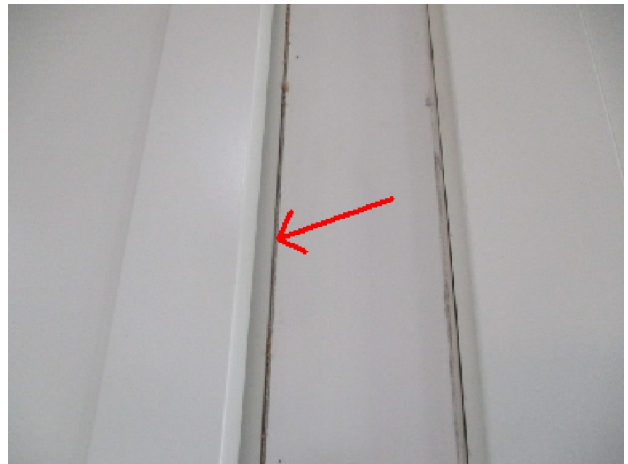
### Kitchen Cabinets

Damaged areas were noted and should be repaired.  
Some shelving was not installed.  
Some stains were noted.  
Poorly finished areas were noted and should be repaired.  
Poorly installed handles and missing handles were noted and should be repaired.

Damaged areas were noted and should be repaired.

Some stains were noted.

Poorly finished areas were noted and should be repaired.

Poorly installed handles and missing handles were noted and should be repaired.

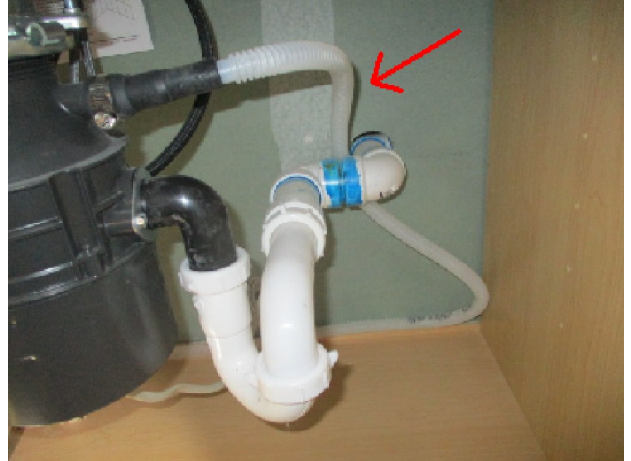
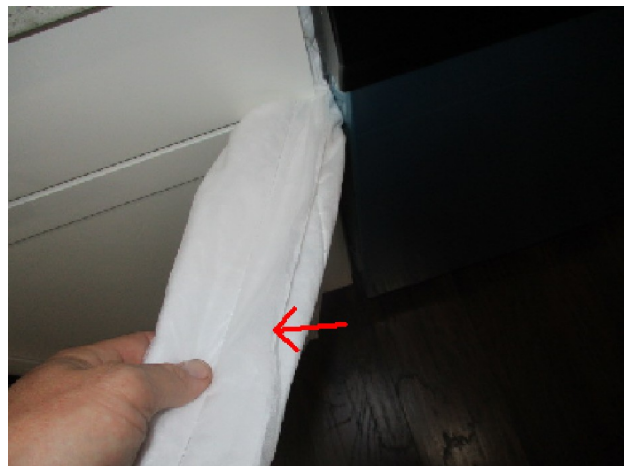
### Dishwasher Mfg.

Insulation is exposed and should be repaired.  
Dishwasher should be better attached to the cabinets.  
Poorly installed drain line was noted. Dishwasher drain line should have a high loop to prevent backup of dirty drain water into dishwasher.

Insulation is exposed and should be repaired.

Poorly installed drain line was noted. Dishwasher drain line should have a high loop to prevent backup of dirty drain water into dishwasher.

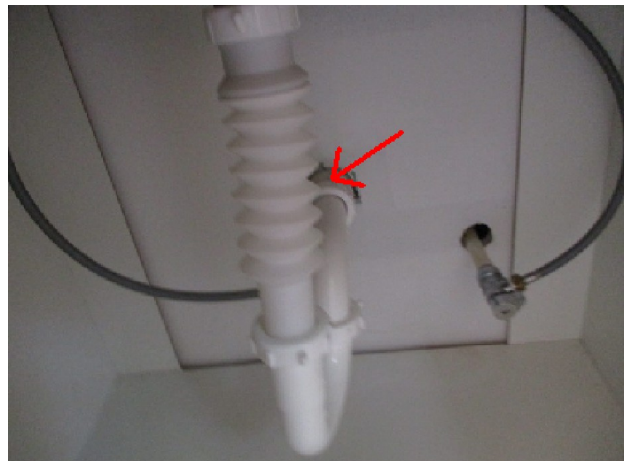
### Bathroom Sink Drain and Trap

Flex pipe was noted. Master bathroom,

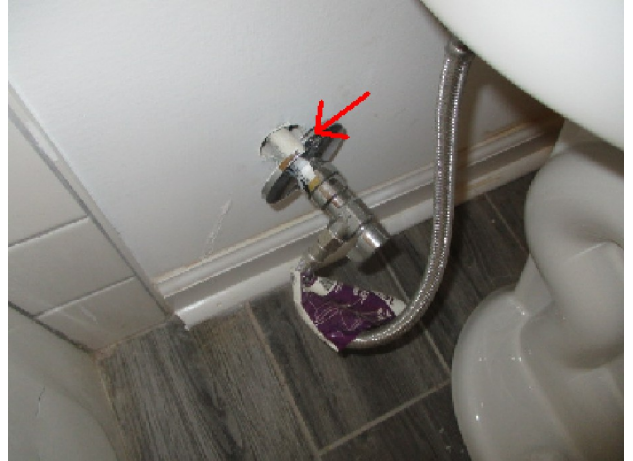
### Toilet Operation

Supply line is loose from the wall and should be repaired. Hallway bathroom.

Supply line is loose from the wall and should be repaired.Hallway bathroom.

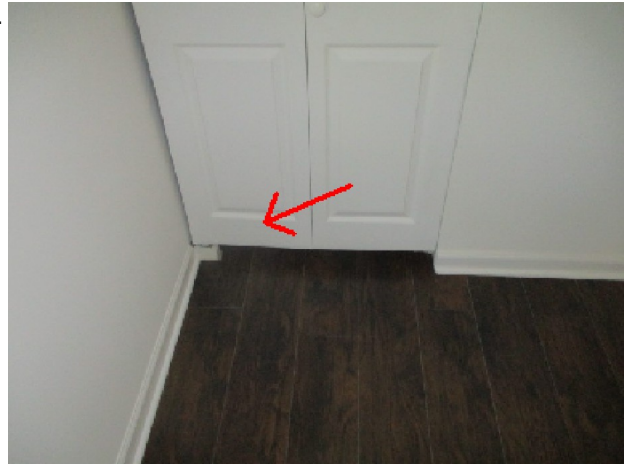
### Closets

Some interior doors would not close properly and should be repaired. Poorly fitting doors were noted.

Some interior doors would not close properly and should be repaired.  
Poorly fitting doors were noted.

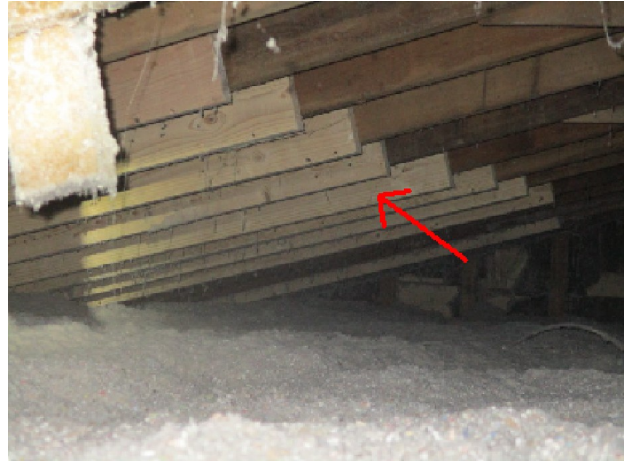
#### Attic Structural Framing Type

Some past repairs were noted.
