Reliable Home Inspection Service
100 Old Kennet Rd
Wilmington, DE 19807
302-993-9100
<https://www.reliablehomeinspectionsservice.com/>

FRONT VIEW

Inspection Summary

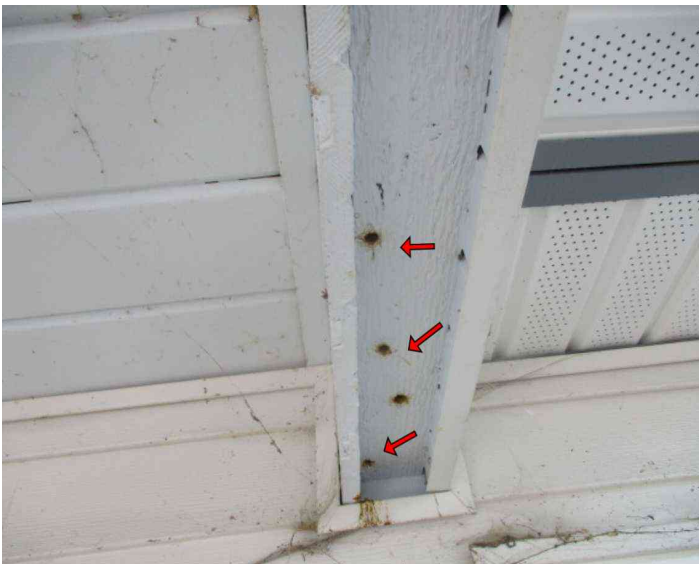
0205: Porches

Some loose paint and rot noted
Wood boring insect damage was noted.
All exterior wood products should be evaluated by
qualified contractor and all needed repairs should be
made.
Cracks and settlement were noted.

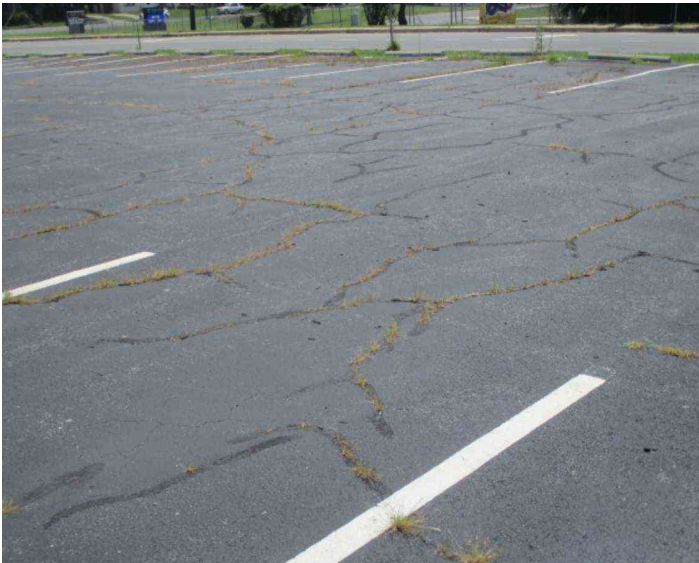
0207: Driveway/Parking Lot

Some cracks noted.
Deterioration of the parking was noted and should be evaluated by a qualified contractor and all needed repairs should be made.

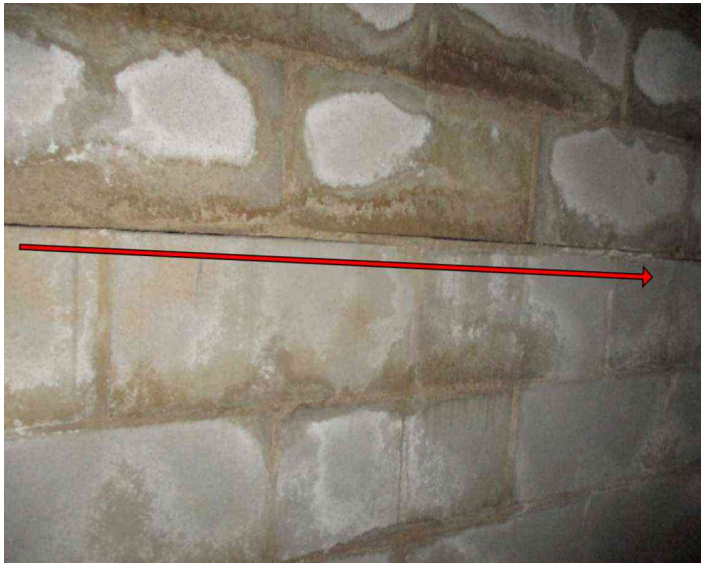
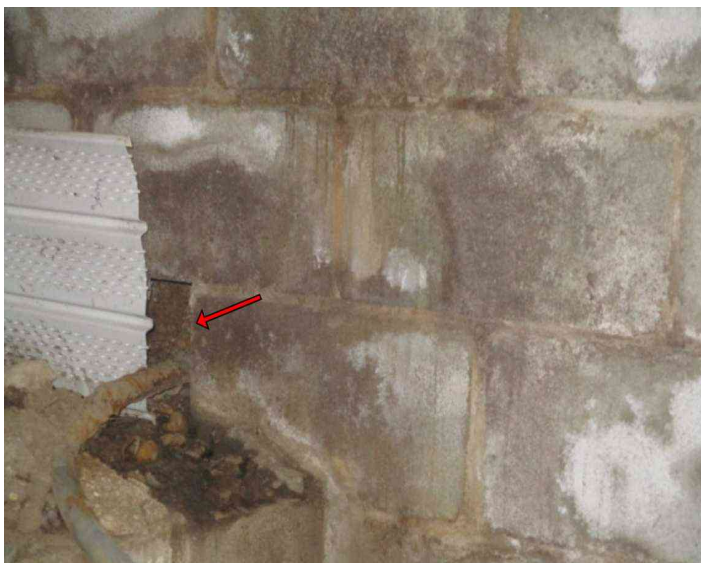
1604: Crawl Space Foundation Walls

Some cracks and water penetration noted. There was efflorescence on the walls. Some horizontal cracks were noted and should be evaluated by a structural contractor and any needed repairs should be made.

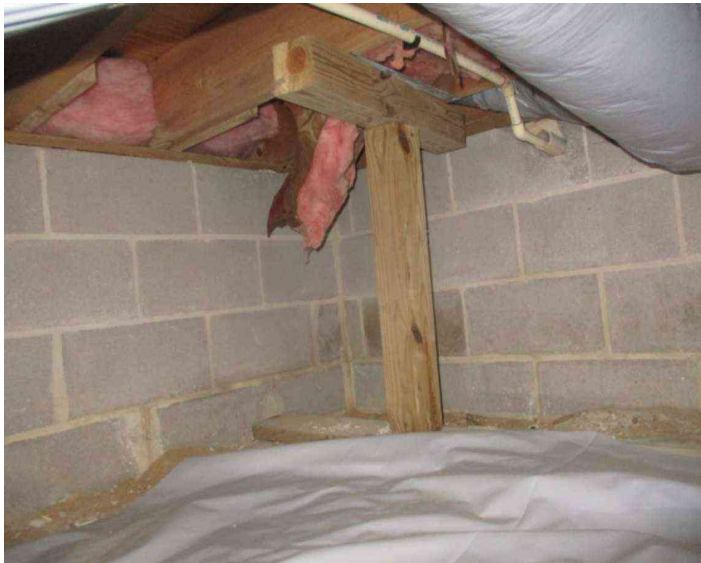
1606: Crawl Space Structural Columns

The column is a temporary makeshift support and not properly footed. The entire structural condition should be evaluated by structural contractor or engineer and all needed repairs should be made

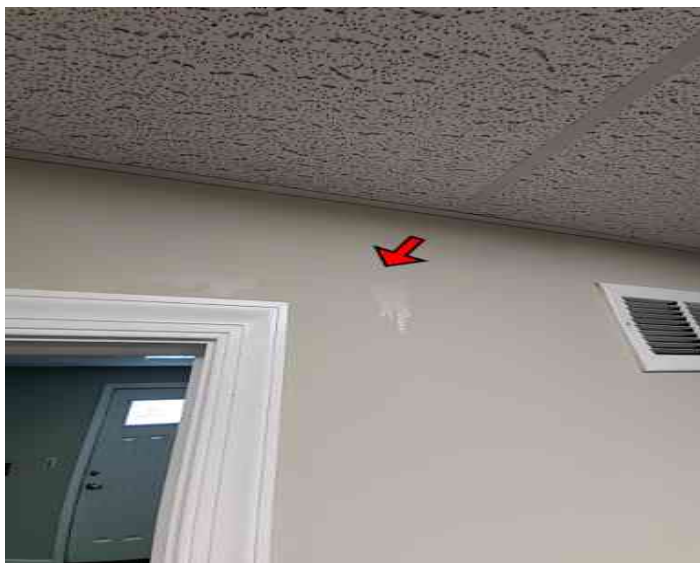
2104: Interior Walls

Typical drywall flaws were noted. Currently wet areas were noted at unit 3 hallway upper walls, unit 2 and the source should be identified and all needed repairs should be made.

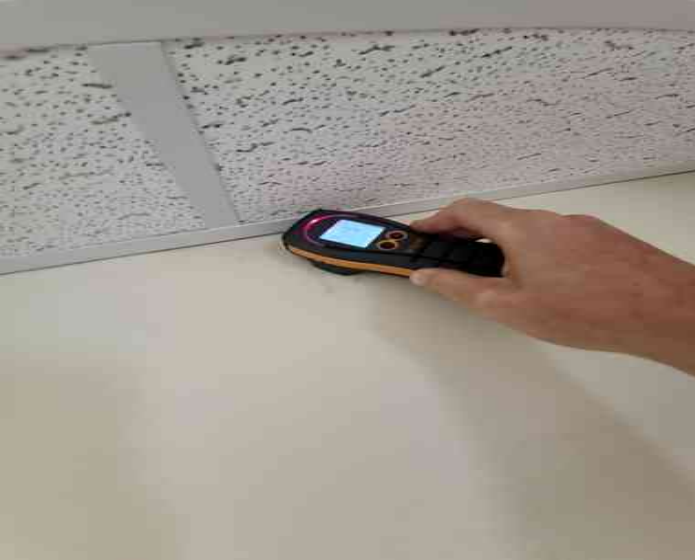
2105: Interior Ceilings

Other = Drop ceilings limit inspection. Some sagging areas were noted and should be repaired. Unit 2
Some stains were noted and were dry at inspection. unit 1

Currently wet areas of the drop ceiling was noted. The source should be identified and all needed repairs should be made. Unit 3

Wet insulation was noted above the drop ceiling and should be replaced as needed.

Some mold/mildew was noted and should be evaluated and cleaned by qualified personnel. As mold and mildew are not part of the home inspection the client may decide to do further evaluation to determine the extent of the problem and cost to cleanup/repair.

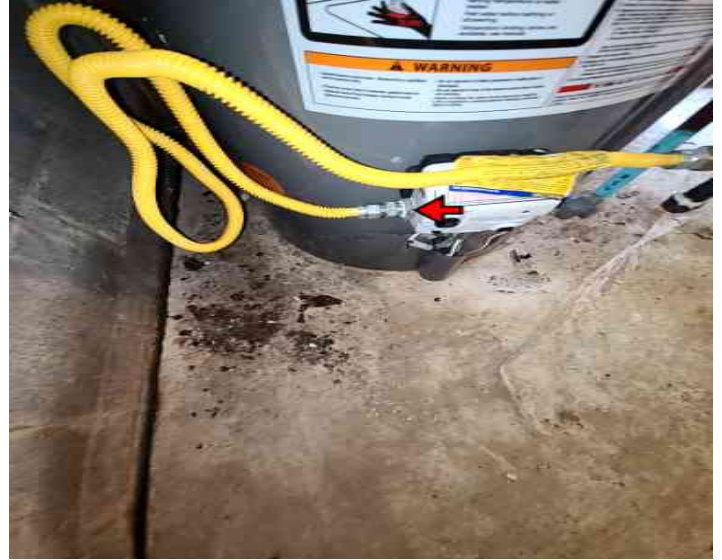
1109: Water Heater Gas Piping

The unit was fed with flex and it should be hard piped.

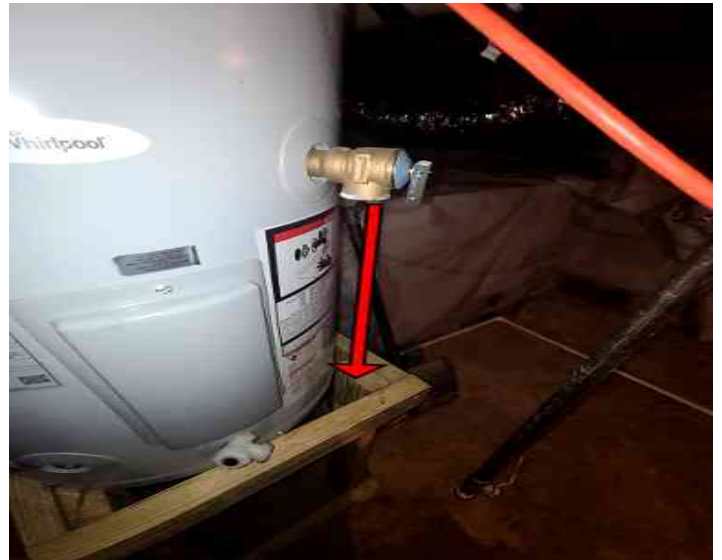
1111: Temp. Pressure Relief Valve and Pipe

Temp and pressure valve extension should be extended to within 6" of floor.

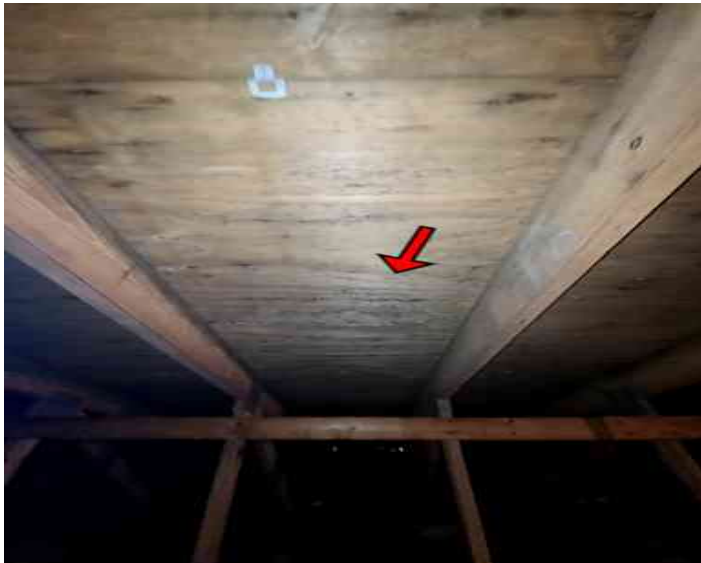
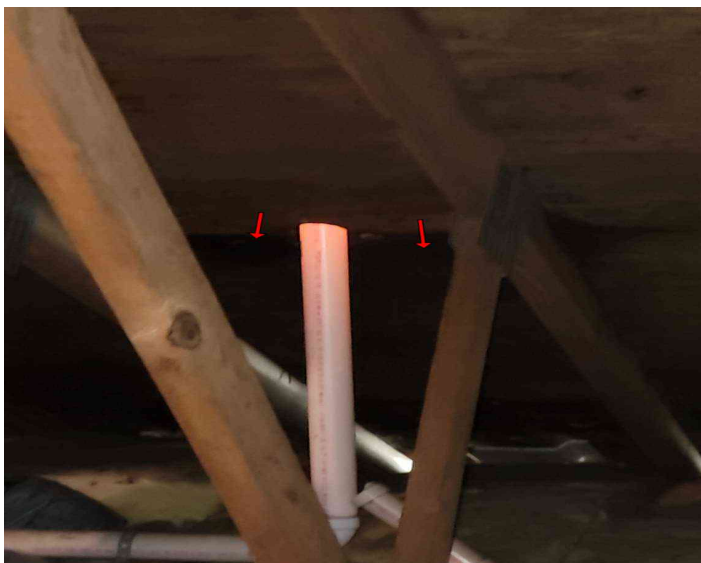
2007: Attic Sheathing

Some mold/mildew was noted in the attic and should be evaluated and cleaned by qualified personnel. As mold and mildew are not part of the home inspection the client may decide to do further evaluation to determine the extent of the problem and cost to cleanup/repair.

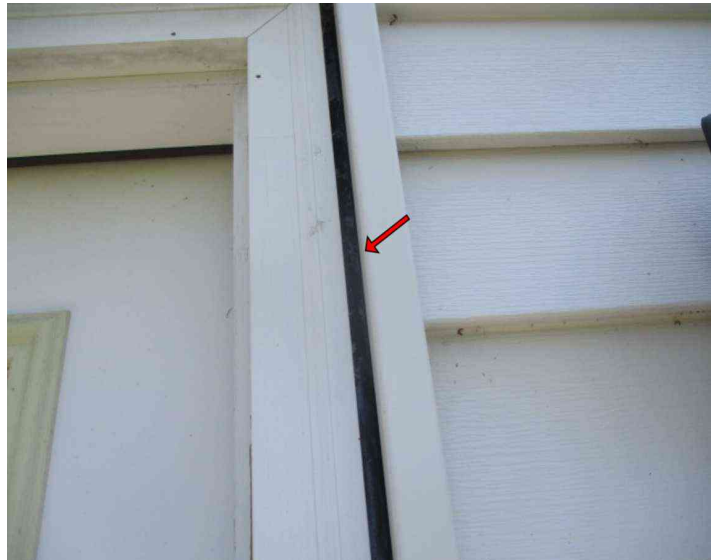
0320: Caulking

Caulking should be improved.

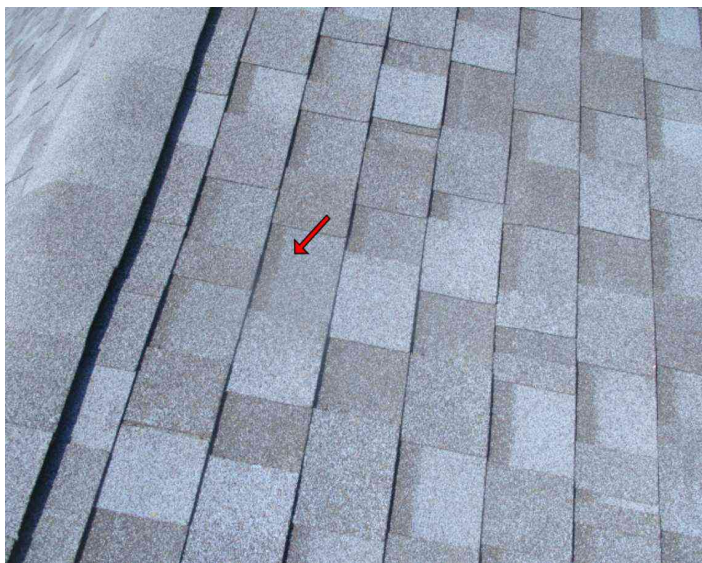
0505: Roof Covering Primary Type

Tree limbs should be cut back from the roof.
Raised areas of the sheathing was noted and should be repaired.
Some waviness was noted.

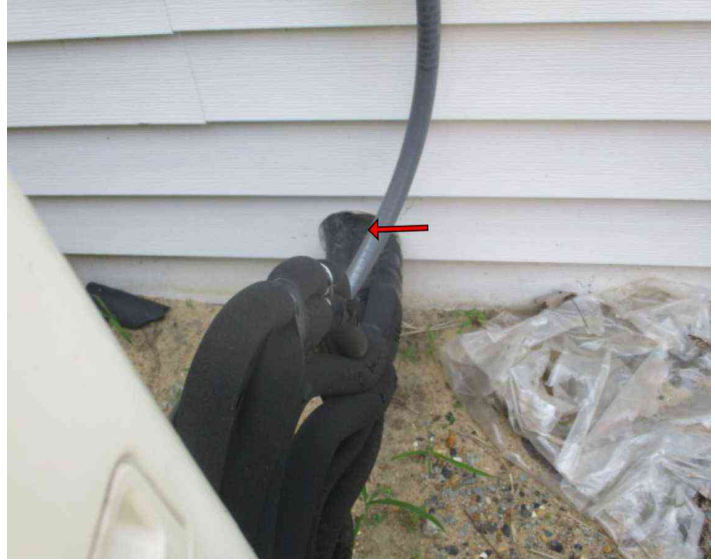
0708: Cooling Lines

Penetrations through siding should be sealed.
