Reliable Home Inspection Service
100 Old Kennett Rd
Wilmington, DE 19807
302-993-9100
<https://www.reliablehomeinspectionsservice.com/>

Inspected By:
Francis Glynn H4-0000078 ASHI #253366 MD# 33646

Inspection Summary

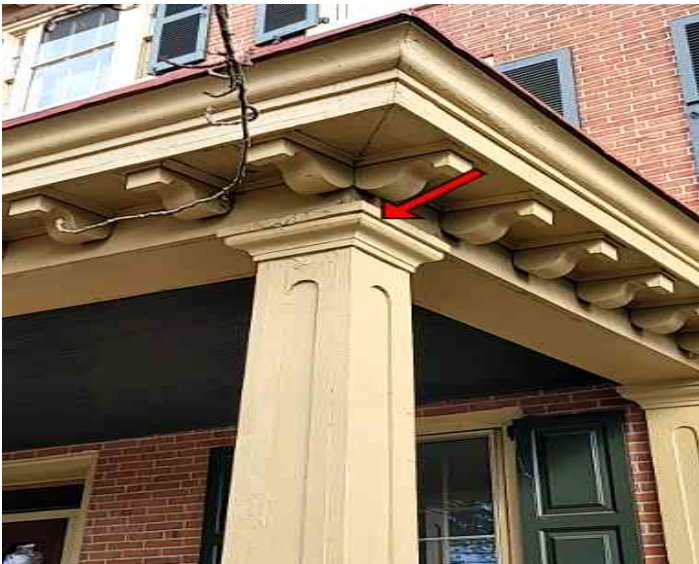
0206: Porches

Some loose paint and rot noted.

Evidence of on going leaking was noted at the front right corner of the front porch. The entire porch system should be evaluated and all needed repairs should be made.

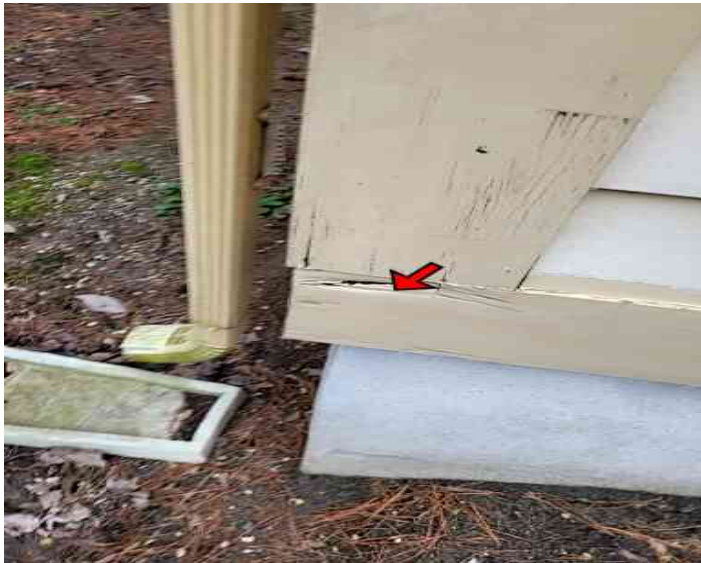
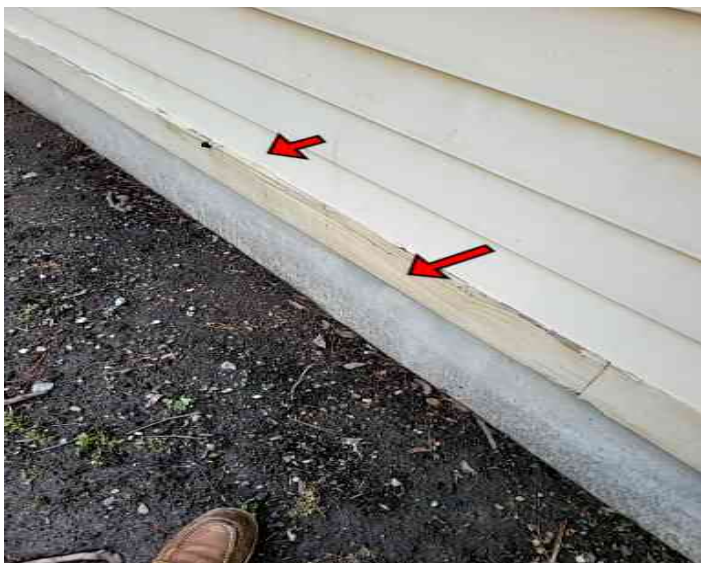
0803: Garage Exterior Walls

Rotted areas were noted.

All exterior wood should be evaluated and all needed repairs should be made.

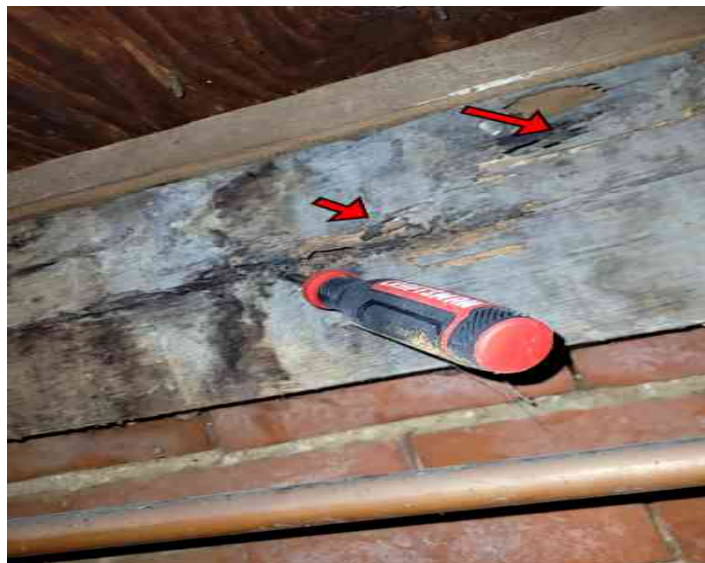
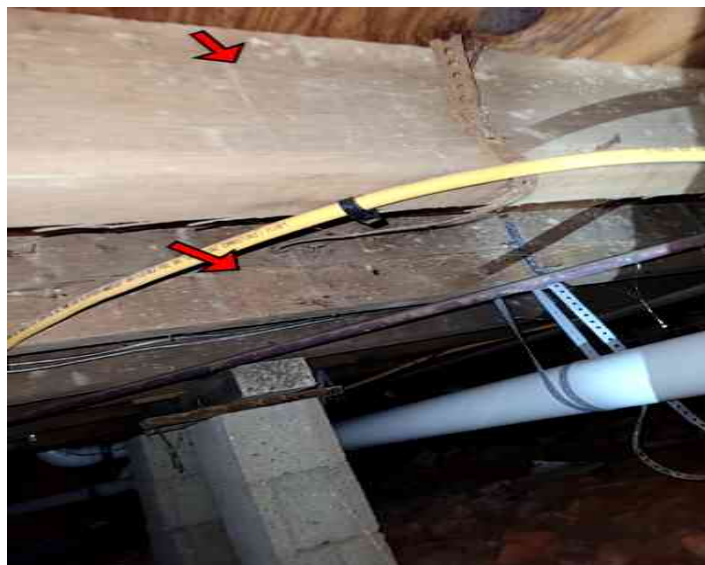
1609: Crawl Space Ceiling Joist

Termite tubes and some termite damage were noted and should be evaluated by structural contractor or engineer and all needed repairs should be made. Some mold/mildew was noted in the crawl space and should be evaluated and cleaned by qualified personnel. As mold and mildew are not part of the home inspection the client may decide to do further evaluation to determine the extent of the problem and cost to cleanup/repair. Wood boring insect damage was evident. It should be evaluated by a qualified pest control contractor and a structural engineer to determine extend of damage and make any repairs or treatments as required.

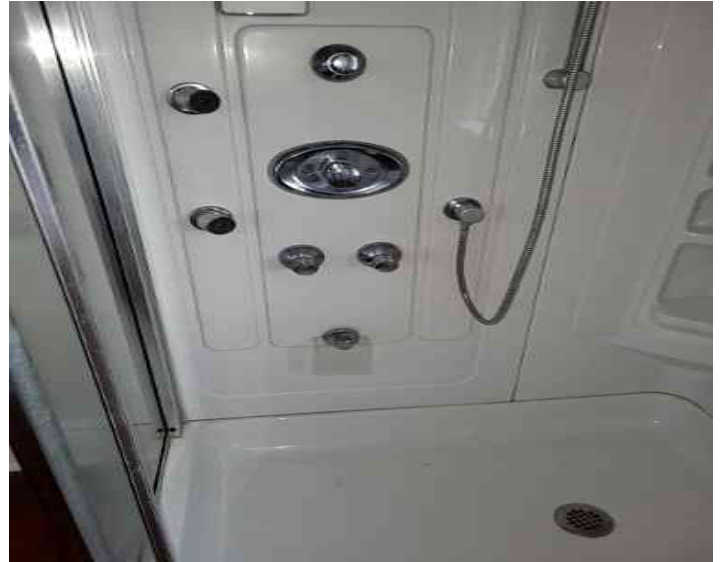
1923: Shower Faucets

Master shower stall was not operational at time of inspection and should be evaluated and demonstrated prior to settlement.

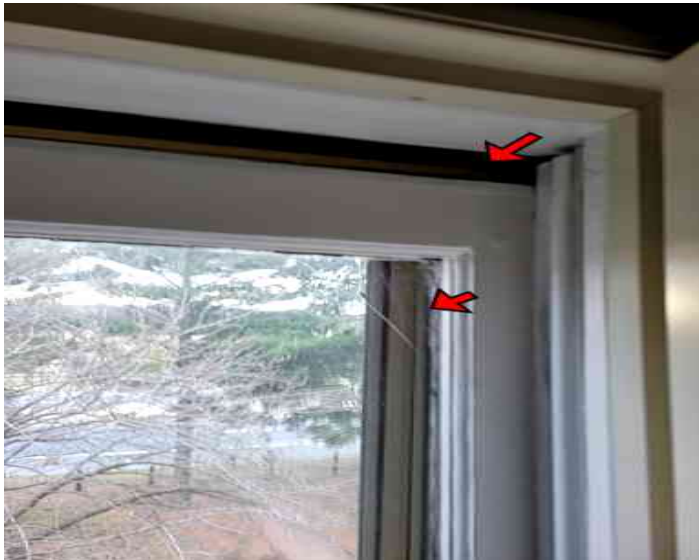
Damaged balance stairway of the kitchen 2nd floor.

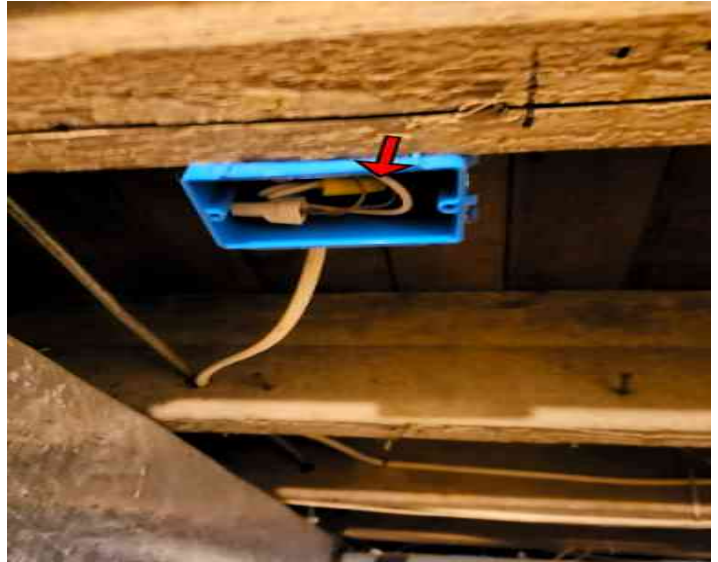
No switch at the 3rd floor front right bedroom.

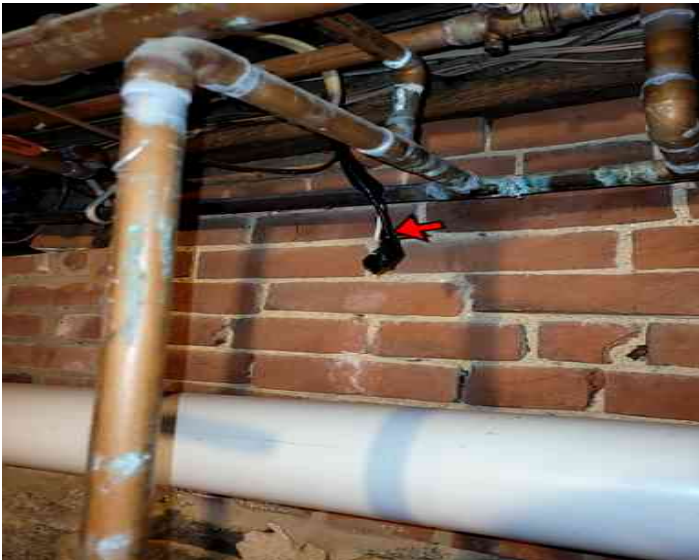
Basement junction box should be covered.

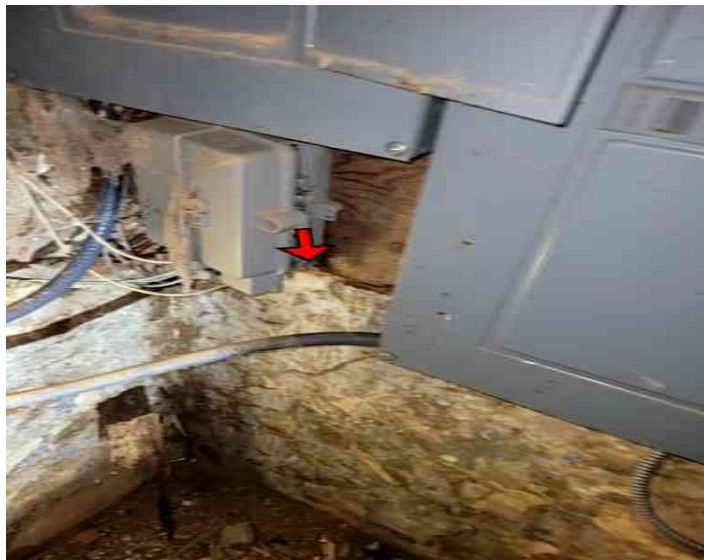
Rot was noted a the wood behind the electrical panels and should be repaired as needed.

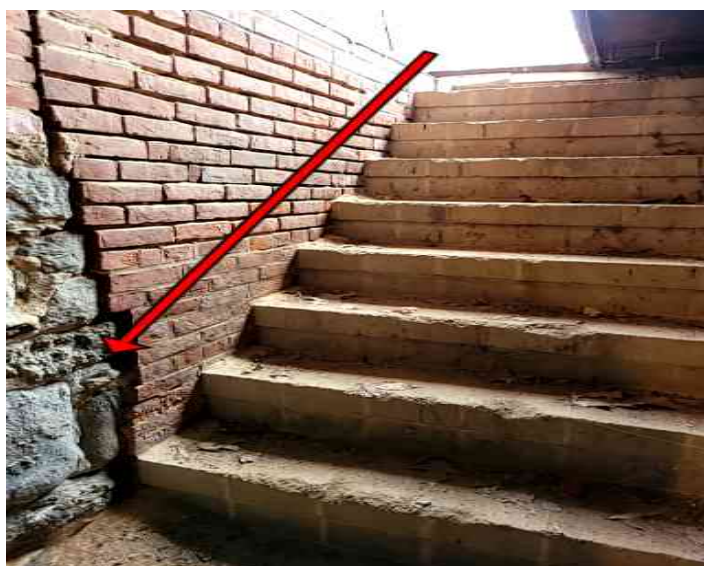
There was no hand rail noted in basement and one should be installed.

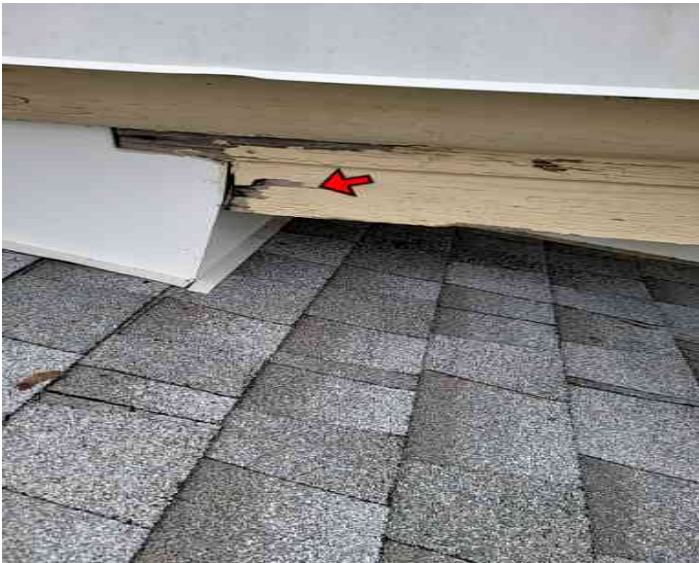
0306: Soffit\Fascia

Some loose paint and wood rot noted.

Loose fitting metal at the roof line and should be repaired.

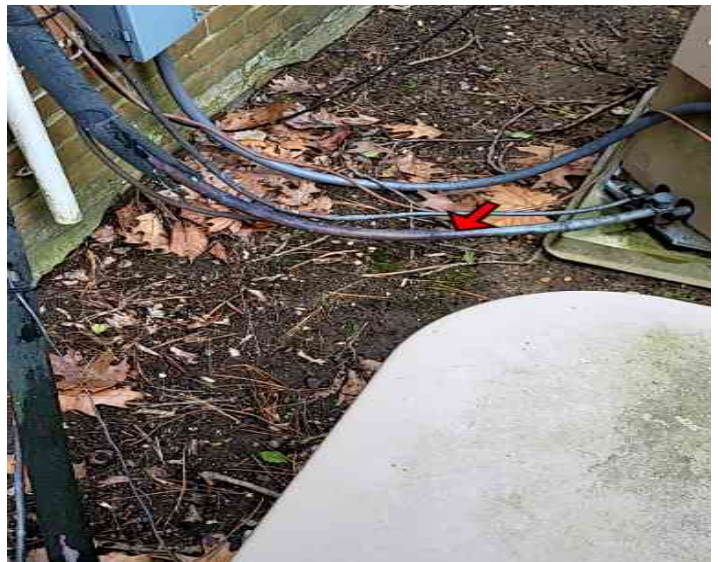
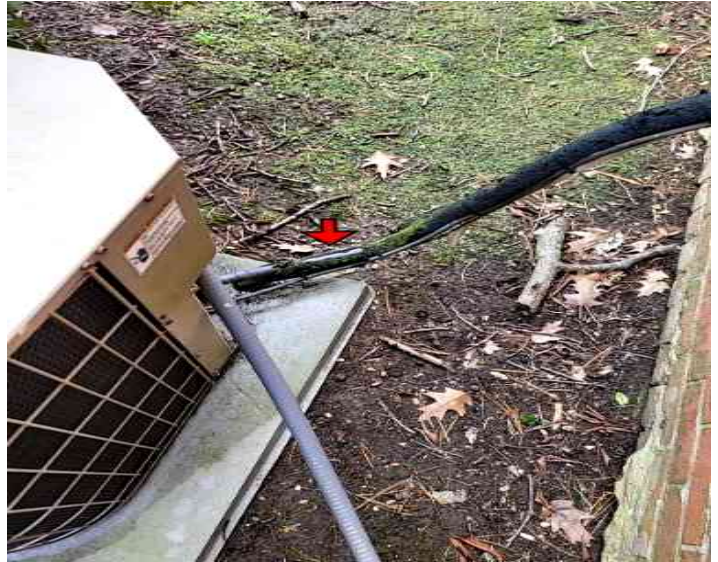
0708: Cooling Lines

The insulation should be improved.

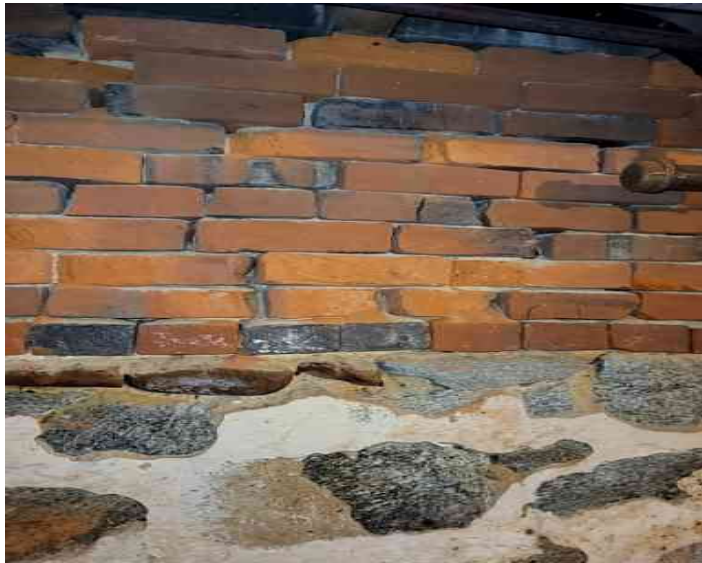
1504: Basement Foundation Walls Primary Visable type

Some cracks and water penetration noted. Older style foundation and should be monitored.
There was efflorescence on the walls.
There were some areas of loose parging and water penetration.
